Bedford Square (No. of Trees: 77)

## Bedford Square (No. of Trees: 77)

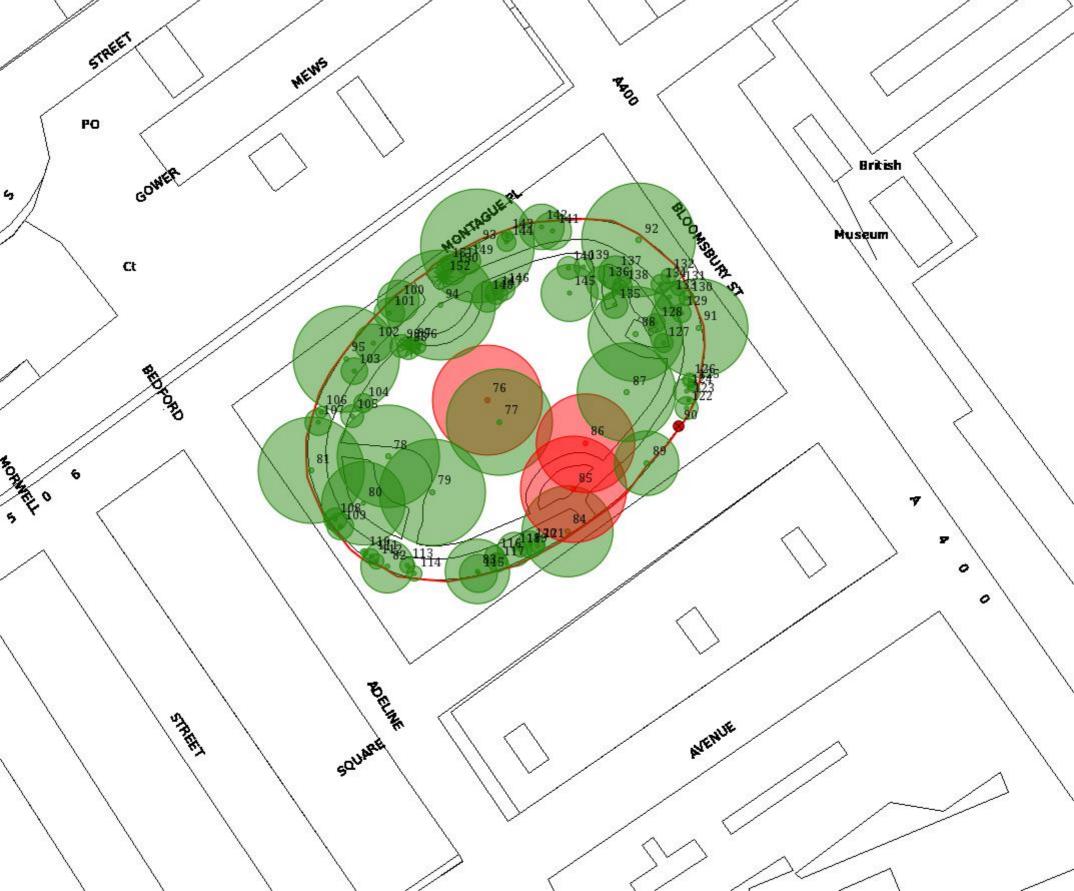
bedioid Square (No. or Trees. 77)											
ID Old tag	No. Species name	Height (m)	DBH (cm)	Crown spread(m)	Vitality	Life Stage	Physiological Condition	Structural Condition	Targets	Condition Notes Recommendations	Status - Safety action date
T76	Platanus x hispanica     London Plane	32.0		29.0	Low	Mature	Poor	Poor	Footpath within falling distance of tree. Seating area within falling distance of tree.	Bark exudation. Branch weight - Heavy. Bark wound - Minor. Dieback - Throughout crown. Decline - Evident / observed. Decay / structural defect in crown limb / limbs - Extensive. Decay / structural defect - Localised. Epicormic growth - Crown. Fungal fruiting body - structural decay suspected. Lesion or fracture on limb / limbs - Major. Lesion or fracture on stem / bole - Major. Woodpecker holes. Neofusicoccum parvum identified Fell - Ground level Fell & grind stump to facilitate replanting - Tree	Proposed - (2019-03-29)

in very poor physiological and structural condtion with significant decay present in large leader and main stem. Removal of the decayed leader section only would leave a large wound at the crown break (where additional decay is already present) with increased potential for remaining crown failure. Tree removal is therefore recommended to prevent catastrophic failure of the decayed section of the tree and avoid harm to people in park underneath  Plant replacement tree extra heavy standard Pinus nigra as a	Proposed - (2019-03-29)
										replacement tree exita heavy standard Finds high as a replacement tree. This species is particularly well suited to the location, where the current tree population includes an informal mixture of medium and large trees. The TDAG tree species selection for green infrastructure guide for specifiers document lists Pinus nigra as being capable of becoming very large, tolerant of drought, air pollution and salt as well as being an extremely robust species for urban conditions.	110p03eu - (2013-03-23)

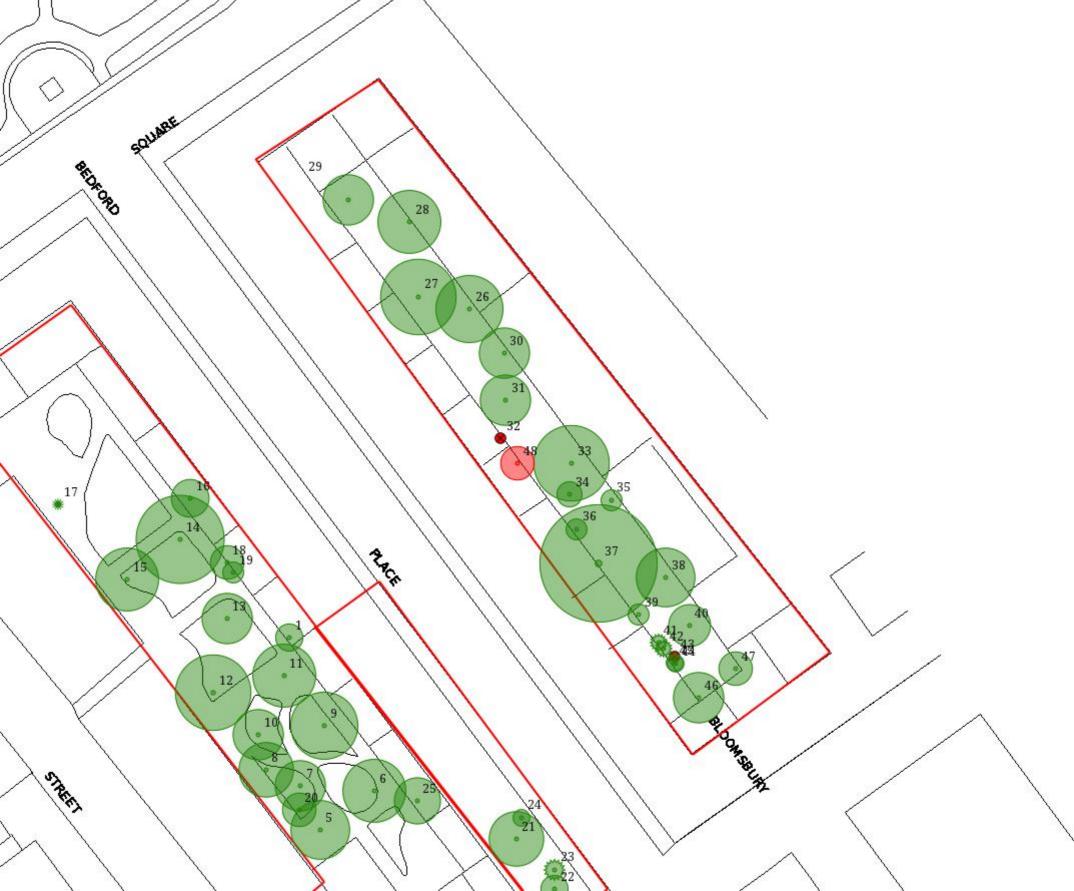
ID Old tag	No. Species name	Height (m)	DBH (cm)	Crown spread(m)	Vitality	Life Stage	Physiological Condition	Structural Condition	Targets	Condition Notes Recommendations	Status - Safety action date
T48	Ailanthus altissima     Tree Of Heaven	10.0	15	8.0	High	Early Mature	Good	Good	Building within falling distance of tree.	Access to inspect base - Restricted / obscured. Crown conflict - Structure / boundary / wire / tree. Leaning trunk - Minor. Structural impact - Potential. Structural impact - Suspected. Self-sown, growing through fence over r/gdn 11 Bedford Place Fell - Ground level and poison stump to prevent otherwise inevitable damage to boundary wall and fence	Proposed - (2019-03-31)
