Arboricultural Survey

Stephenson Way
Euston
London
NW1 2HD

10th October 2018

PJC ref: 4973/18-01 Rev 01

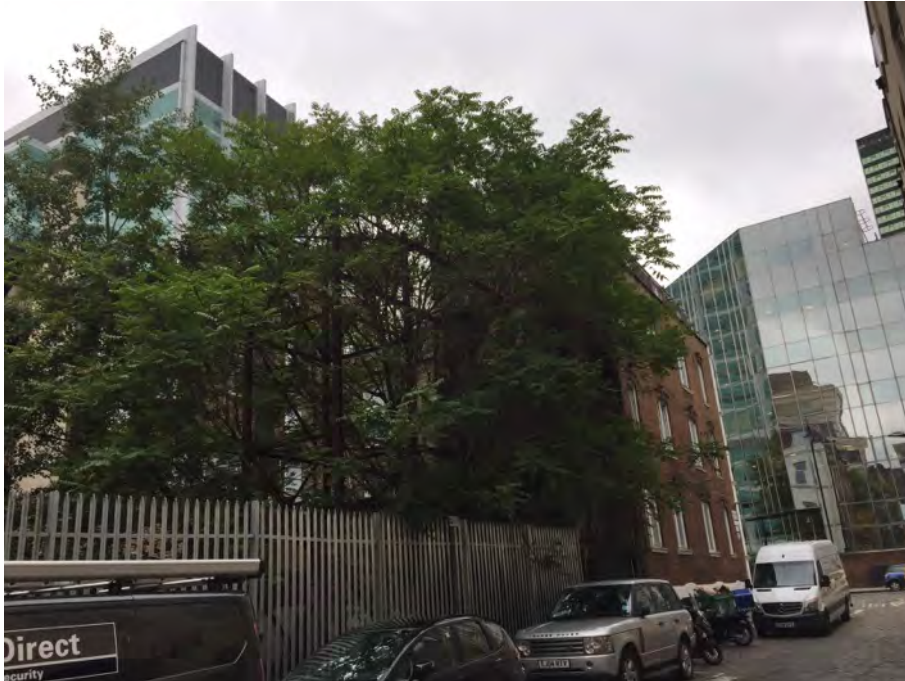
3.7 The area of Stephenson Way adjacent to the site is devoid of trees, and from the outside the trees within the site could be seen as an asset to the visual amenity of the street scene. However upon close inspection it is clear that these trees are not suitable in this location, as they are causing significant damage to their immediate surroundings.

Photograph 1 – Trees T1–T3 viewed from Stephenson Way.

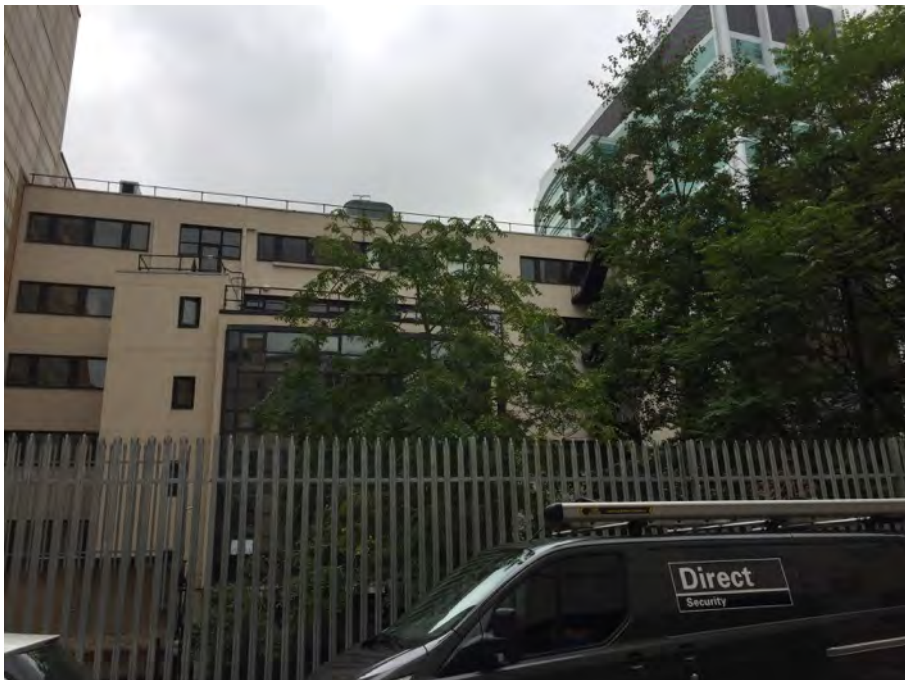
Photograph 2 – Tree T3 viewed from Stephenson Way.

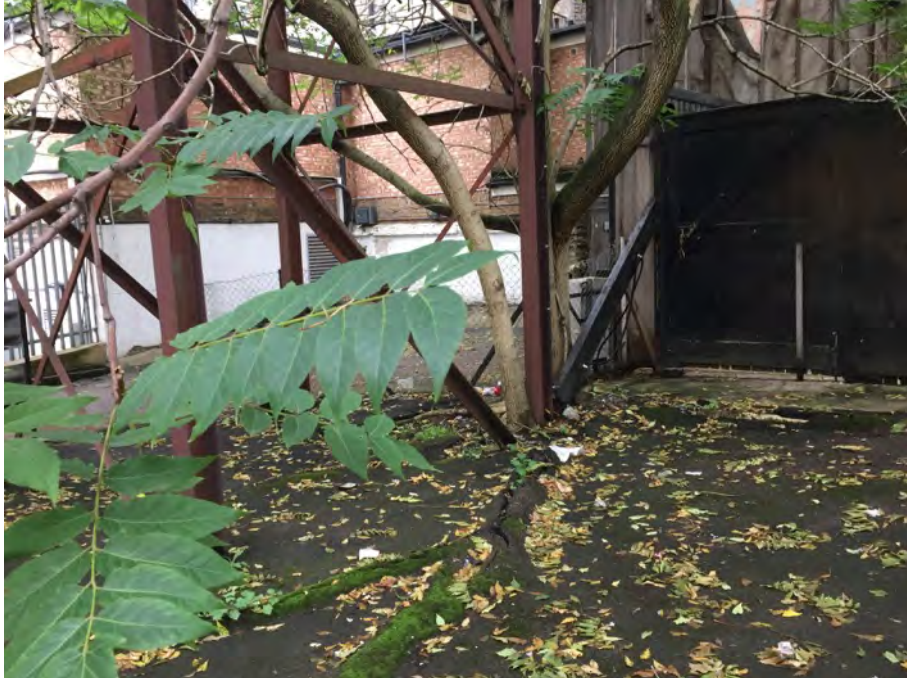
3.3 Appraisal of tree stock: T1 is a large tree of heaven (*Ailanthus altissima*) with a large spreading crown. The tree has grown through and out of the steel structure, and in places is supported and leaning on the structure. Tree of heaven is a fast-growing species with shallow surface roots which sucker readily. This species tends not to be an ideal choice in urban settings, as they can cause severe damage to built infrastructure if not properly managed. In this instance the tree roots have caused extensive damage to the surrounding tarmac and pavement.

Photograph 3 – Damage caused to tarmac by T1.

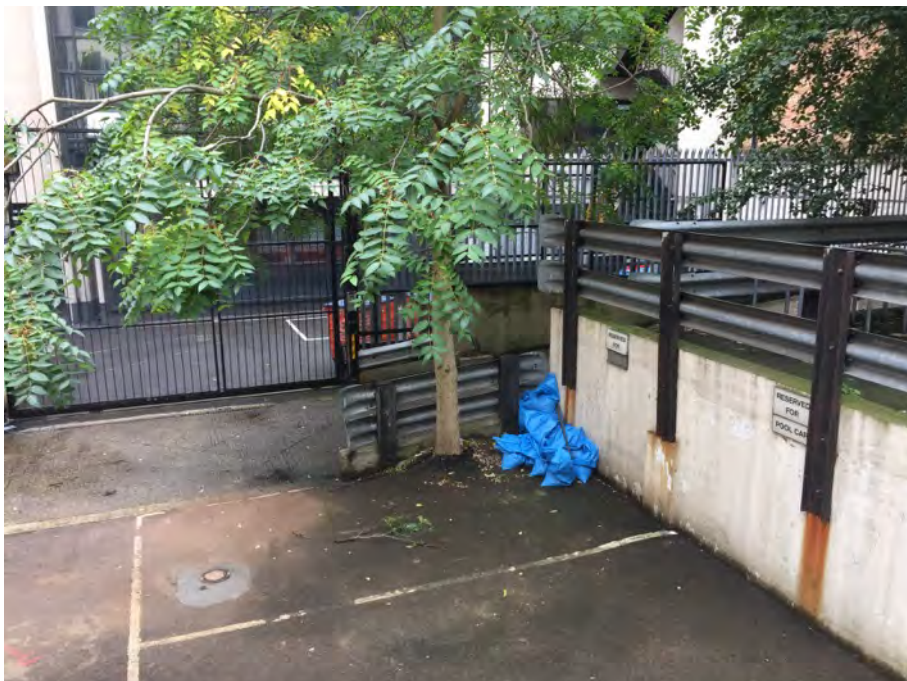
3.6 T3 is a tree of heaven (*Ailanthus altissima*), located in the corner of the asphalt car park. Incremental root growth has damaged the surrounding tarmac surface. The stem and crown of T3 are encroaching and rendering unusable a single parking space. To the north and south, low hanging limbs partially inhibit access for larger vehicles. During the site visit a van was observed turning around in this area, and small limbs were snapped as a result of direct conflict with the vehicle. Due to the vigorous nature of this species it is expected that this tree will cause further nuisance and direct damage to the site, surrounding tarmac and Armco barriers. Despite currently being of reasonable condition, it is anticipated that T3 will need to be removed within 10 years to avoid significant damage to the surrounding infrastructure. This has resulted in its categorisation as U.

Photograph 4 – Damage caused to tarmac by T3.

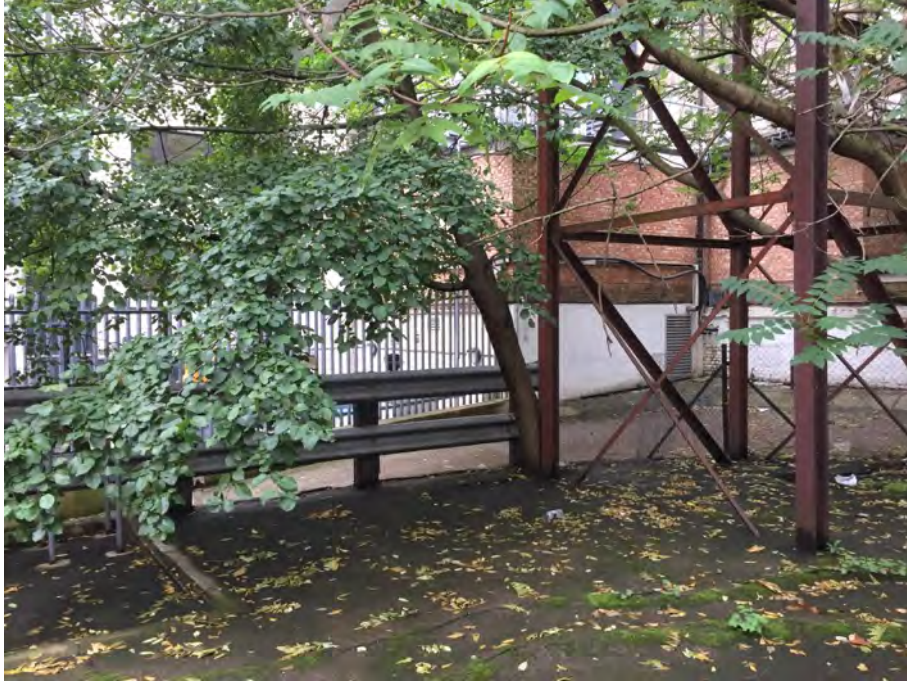
3.5 T2 is a medium sized Italian alder (*Alnus cordata*) which exhibits a drawn-up growth habit. Its crown is slightly suppressed on its west side by the adjacent tree of heaven. Significant damage has been caused to the tarmac surrounding the steel structure by this tree. On the date of the survey the tree appeared in good condition with good branch unions and a dense crown. This tree is likely to be self-set, due to its very close proximity to a metal post and the Armco barrier behind it. Despite currently being of reasonable condition, it is anticipated that T2 will need to be removed within 10 years to avoid significant damage to the surrounding infrastructure. This has resulted in its categorisation as U.

Photograph 5 – Tree T2 growing next to steel frame.

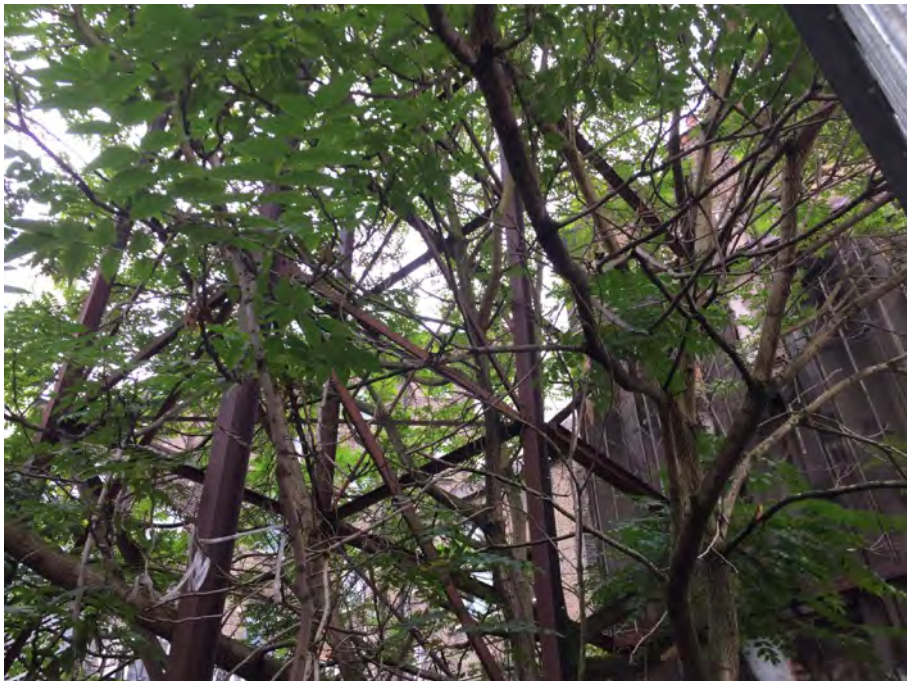
Photograph 6 – Tree T1 growing through steel structure.

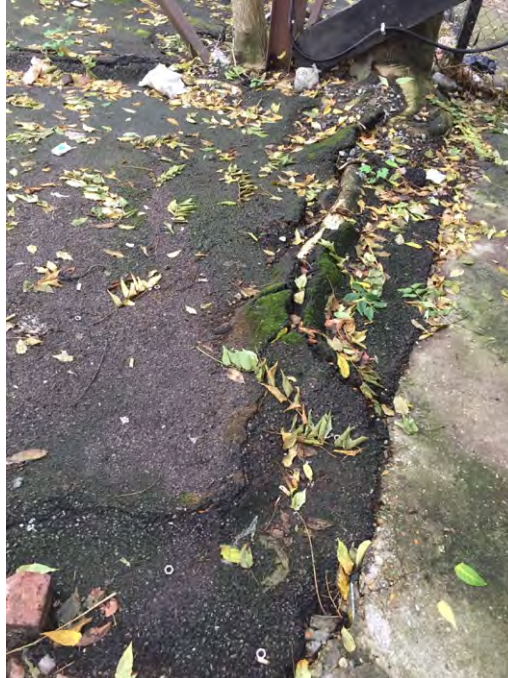
Photograph 7 – Damage caused to tarmac by incremental root growth.

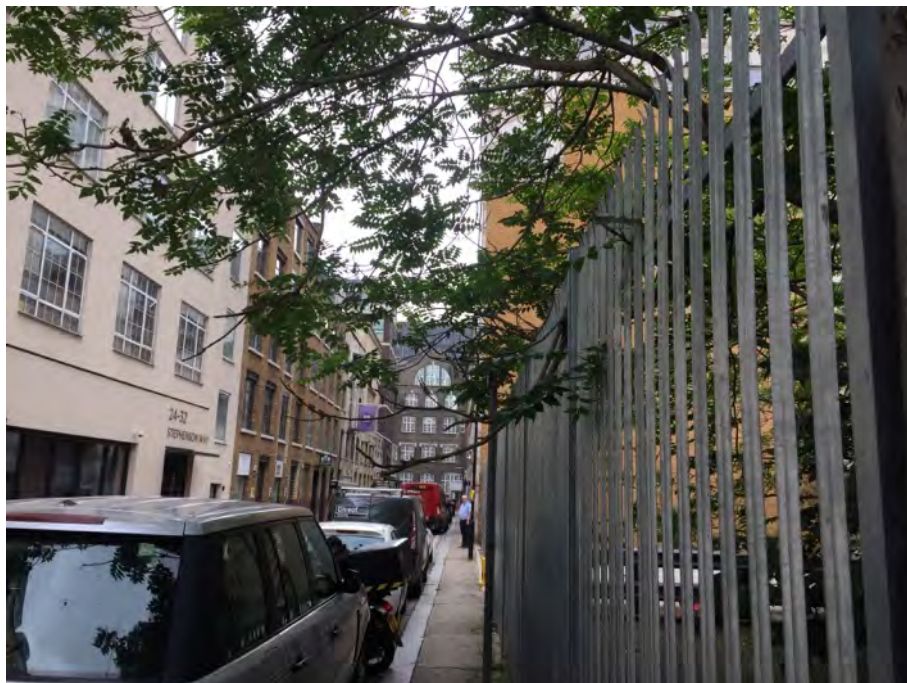
3.4 At its western extents T1 is coming into contact with the neighbouring building and will need to be reduced to avoid direct conflict, also to facilitate future renovation works occurring to the building. On the north side of the tree a large overextended limb is growing through the galvanised security fence, overhanging the pavement and parking areas. Due to its size and location, this tree presents the risk of further damage to the surrounding tarmac and pavement. It was likely never intended to be growing in its current location. Future pressures to remove the tree to prevent further damage to the surrounding infrastructure have resulted in the tree having a predicted useful life expectancy of less than 10 years and its categorisation as U.

Photograph 8 – Limbs from T1 overhanging the pavement and road.

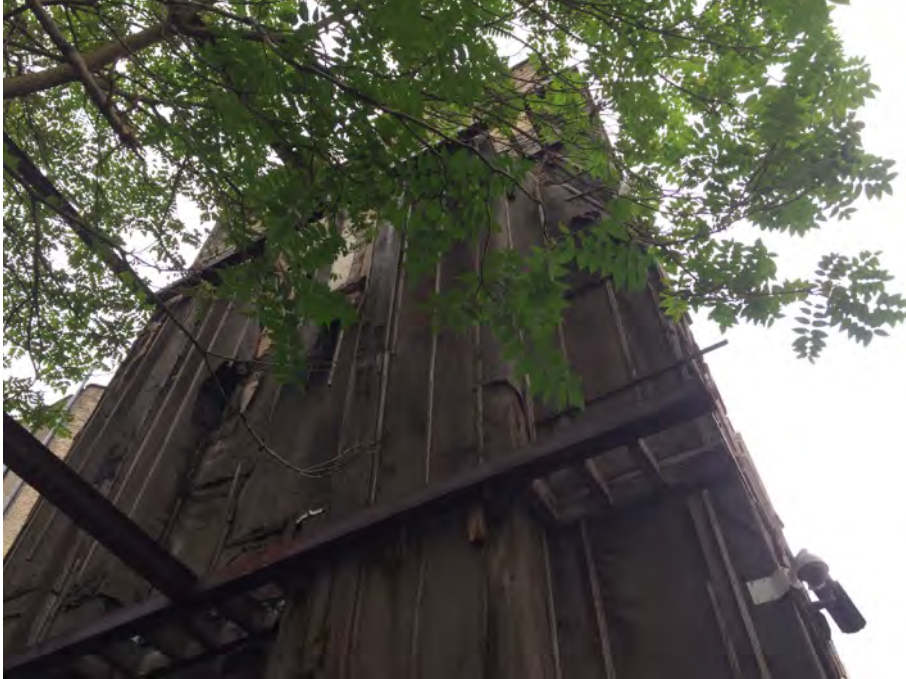
Photograph 9 – Limbs from T1 contacting derelict building.
