# 16 The Mount Square

## PHOTOGRAPHS

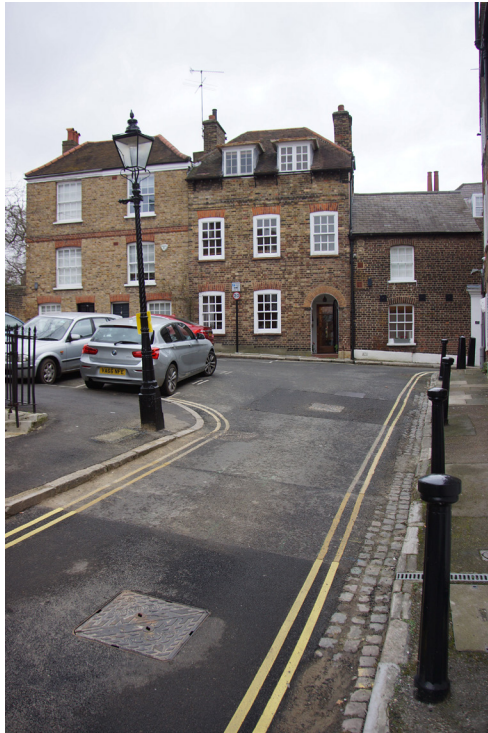
Front facade on The Mount Square.

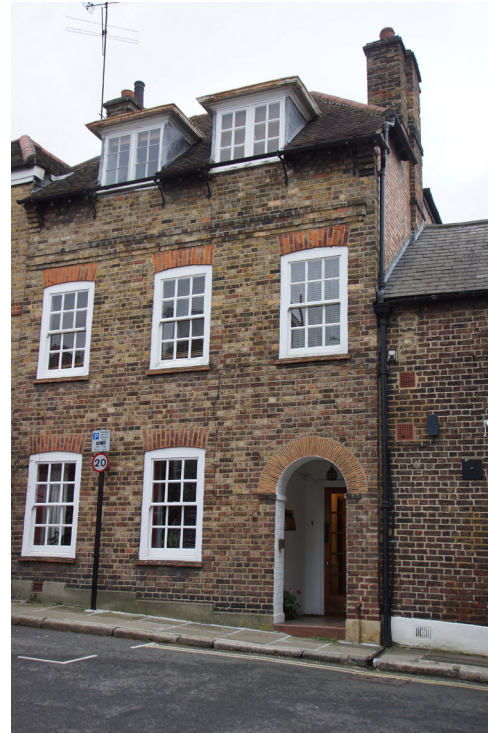
Front facade and entrance. Mortar has come loose and needs to be repointed.

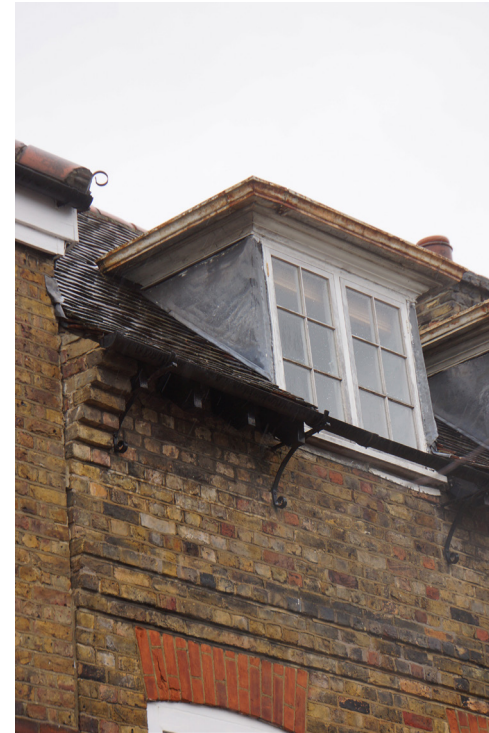
Dormer cheeks and mouldings are in a poor state of repair and need remedial work.

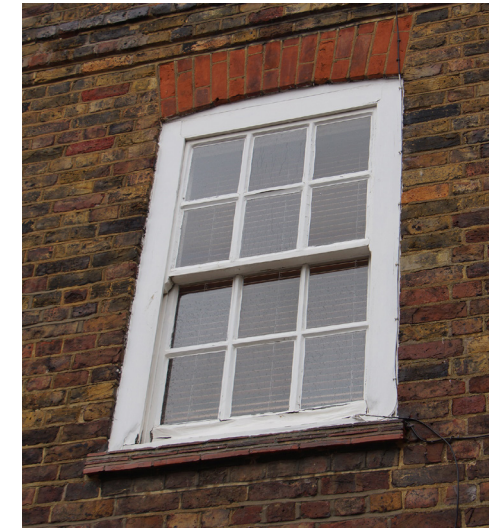
Some of the windows are rotten and need repairing and redecorating to make good.

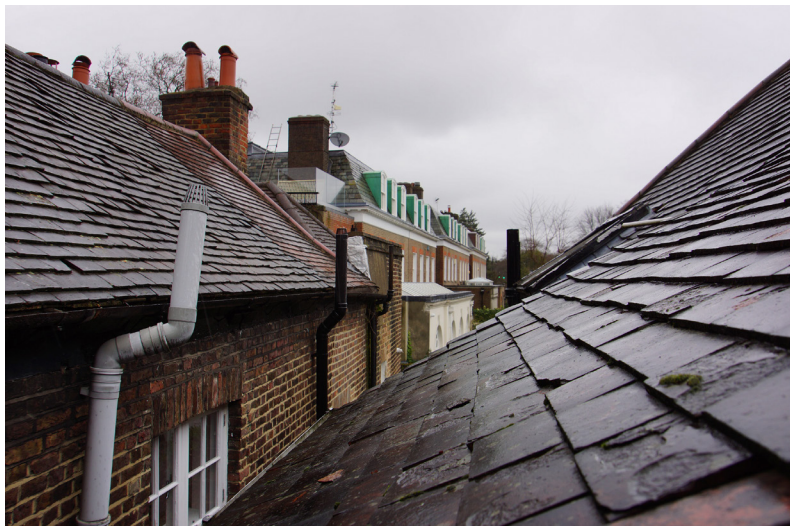
The existing roof clay tiles are at the end of their serviceable life and need replacing. The waterproof layer beneath is plastic and not breathable, which results in condensation building up on the structure beneath. This needs to be replaced with a breathable membrane.

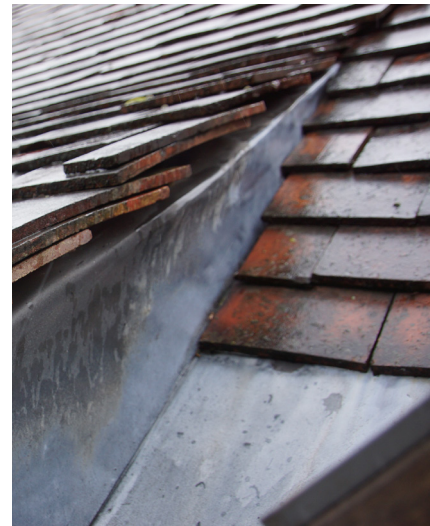
The tiles were originally terracotta colour but have weathered and become dark in colour.

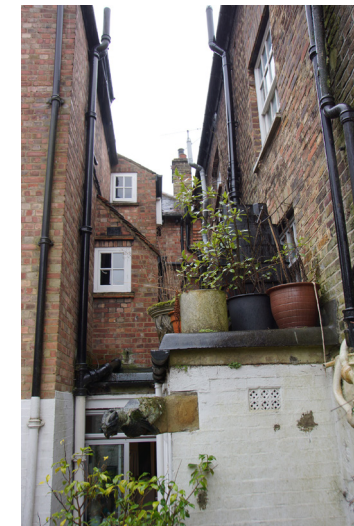
The flat roof at the rear leaks. The asphalt is at the end of its life and needs to be replaced with a more durable finish.
