11 PRINCE ALBERT ROAD
LONDON NW1 7SR

CONDITION REPORT ON
THE NORTH, SOUTH AND WEST
BOUNDARY WALLS

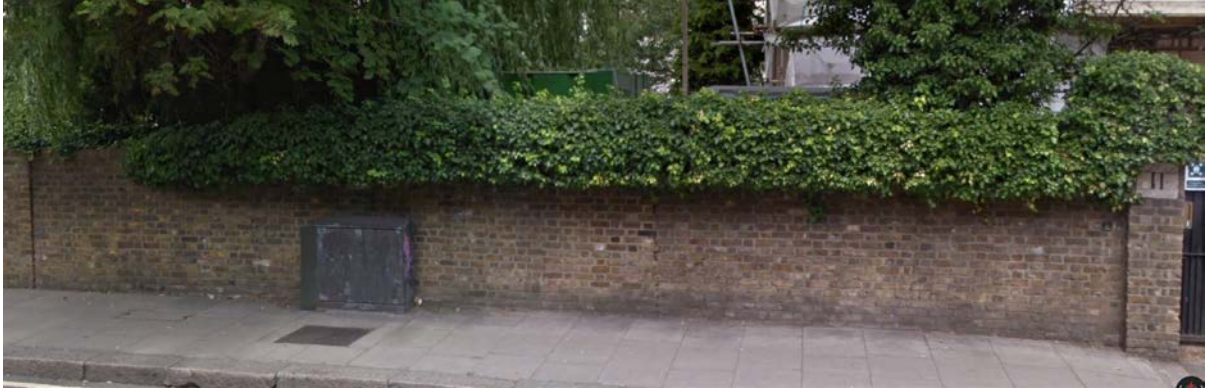
. PHOTO 1

The South boundary wall abuts the public footpath on Prince Albert Road and follows the plan curvature of the footpath and adjacent carriageway. It is 12.94m in length and 1.7m in height and has a pier at the east end adjacent to the gate post supporting the main entrance gates (Photo 1). The west end of the wall is not connected to the wall of the adjacent property. The wall is 9 inches (228.6mm) thick and is constructed in English bond. Located at the rear of the wall and in very close proximity are three mature trees protected by preservation orders. It is believed that the wall was constructed when the house was built.

Because of its dangerous condition the south boundary wall poses a serious health and safety risk to the public. It is imperative that it is demolished and is rebuilt on new foundations. The presence of the trees and tree roots would make it difficult to employ a conventional raft or trench foundation for the wall. An alternative is to use small diameter hand driven steel screw piles at discrete centres supporting a compact ground beam. The torsion generated from any wind moments can be taken by outrigger piles and ground beams located at the main pile centres.

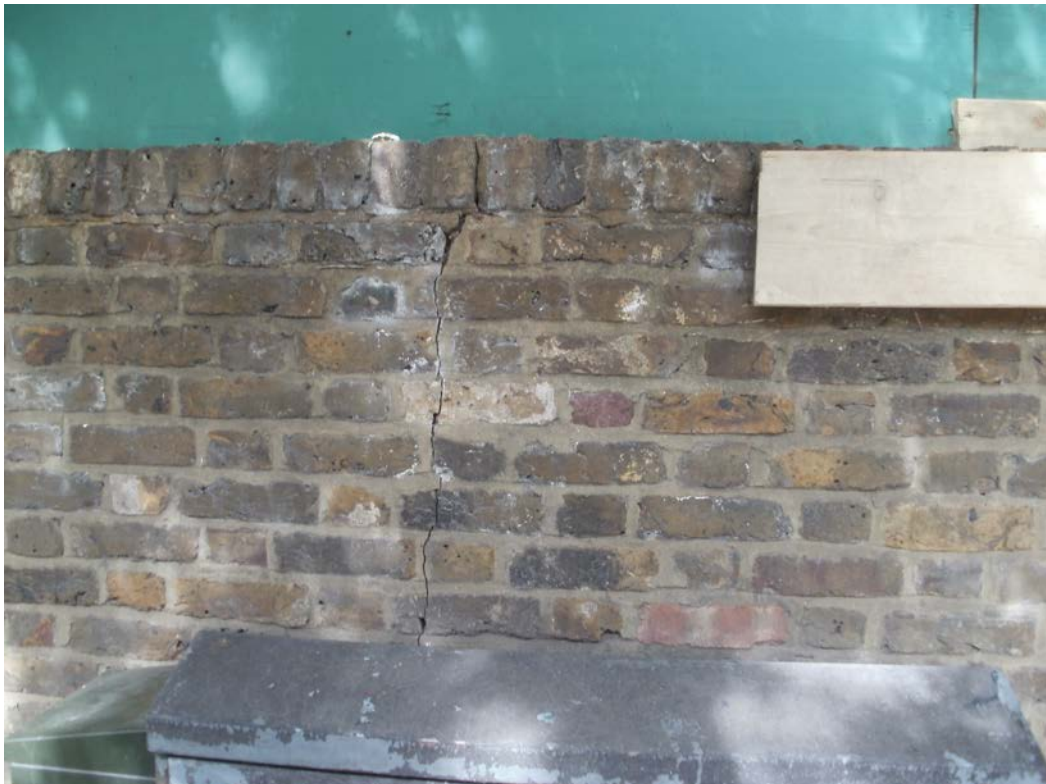
PHOTO 2

There are two full height vertical cracks situated at approx. 5.2m (Photo 2) and 8.4m (Photo 3) distance from the pier at the east end of the wall. The cracks extend for the full depth of the wall. The larger of the cracks is in excess of 7.0mm in width at its worst point. A horizontal crack adjacent to the west end of the wall continues for approximately 3.0m. The wall has an inward lean which varies over the length of the wall and is 68mm out of plumb at the point of worst lean. Measurements have been taken along the length of the wall to record the horizontal displacements at the top of the wall (see drawing K1914-500-0). Temporary propping has been erected to the inner face of the wall for a distance of approximately 9.0m from the west end to beyond the large vertical crack and point of maximum inward lean (Photo 4) to prevent the wall from falling down. The pier adjacent to the main entrance has a horizontal crack running for the full width and depth of the pier (photo 5) the pier is currently being supported by the large timber gate post.

The South boundary wall has a maximum out of plumb of 68mm. Without foundations the kern for the wall is 38mm. The eccentricity from the wind moment plus eccentricity moment from the wall being out of plumb is greater than the length of the kern therefore the wall is unstable.

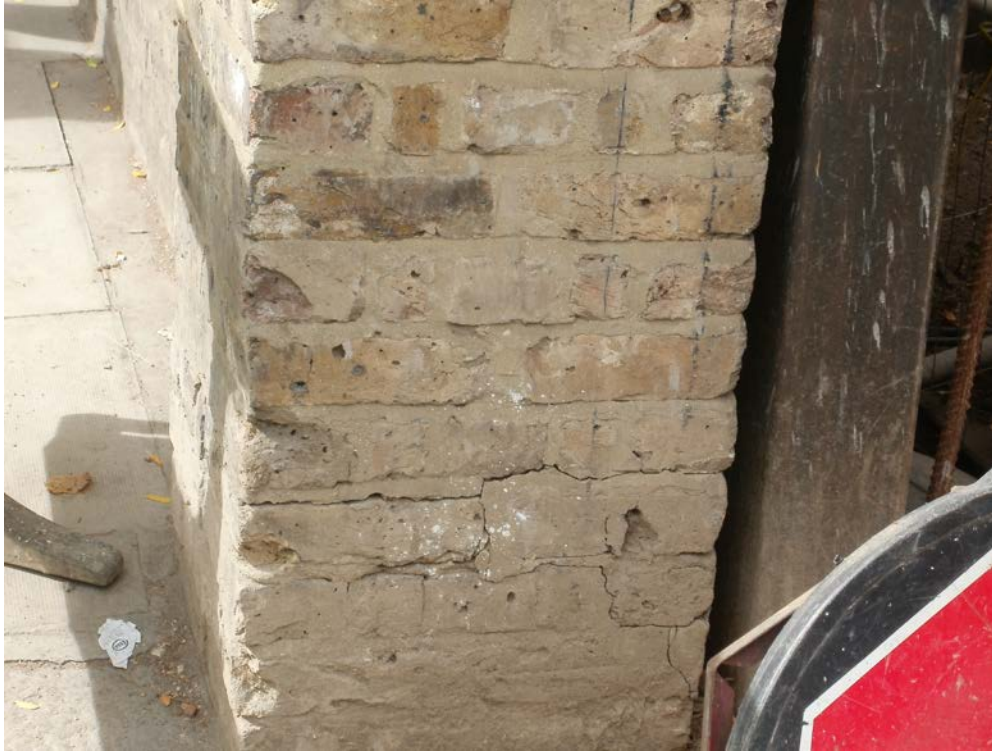
PHOTO 5

Foundations would appear to be non-existent.

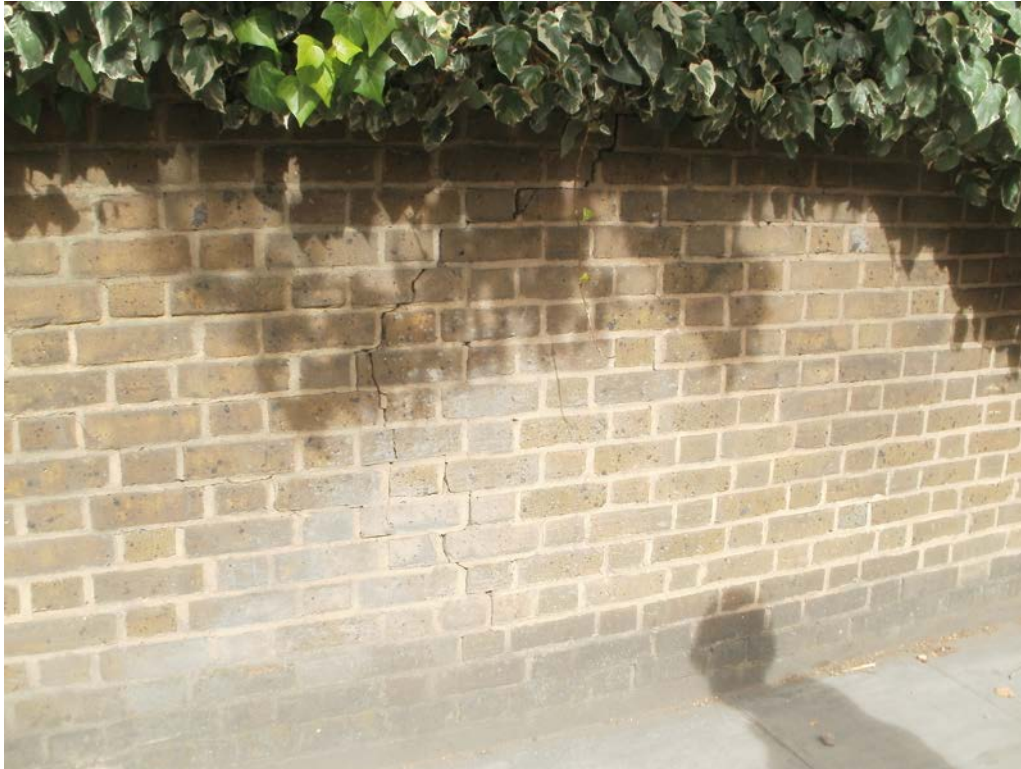
PHOTO 6

The front boundary wall of the adjoining property (Number 10) also shows evidence of cracking (Photos 6 – 8) although to a much lesser degree, this has occurred after the recent long hot dry spell.

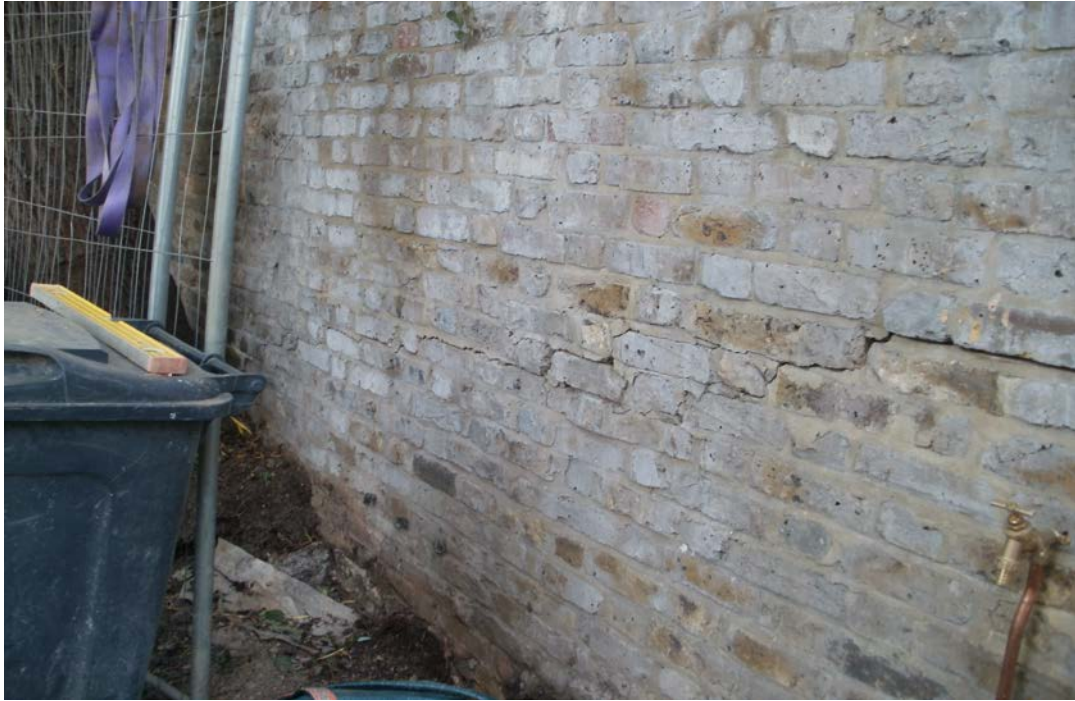
PHOTO 9

Horizontal cracking can be observed at approximately mid height. The crack runs from close to the large tree at the southern end of the wall to the southern end of the concrete lintel. At this point the crack meets a vertical crack located at the end of the lintel bearing point. A further vertical crack is apparent at the other end of the lintel bearing (Photos 11 and 12) these are probably due to the local hard points caused by the lintel support points.

Although not showing signs of imminent failure it is possible to move the wall by inserting a lever in between the horizontal crack this would suggest that it is only the self-weight of the wall holding the top portion in place.

Demolish the wall completely from the southern end up to the vertical crack local to the concrete lintel. Rebuild the wall with new foundations similar to the south wall and repair the vertical crack to the wall on the northern side of the concrete lintel.

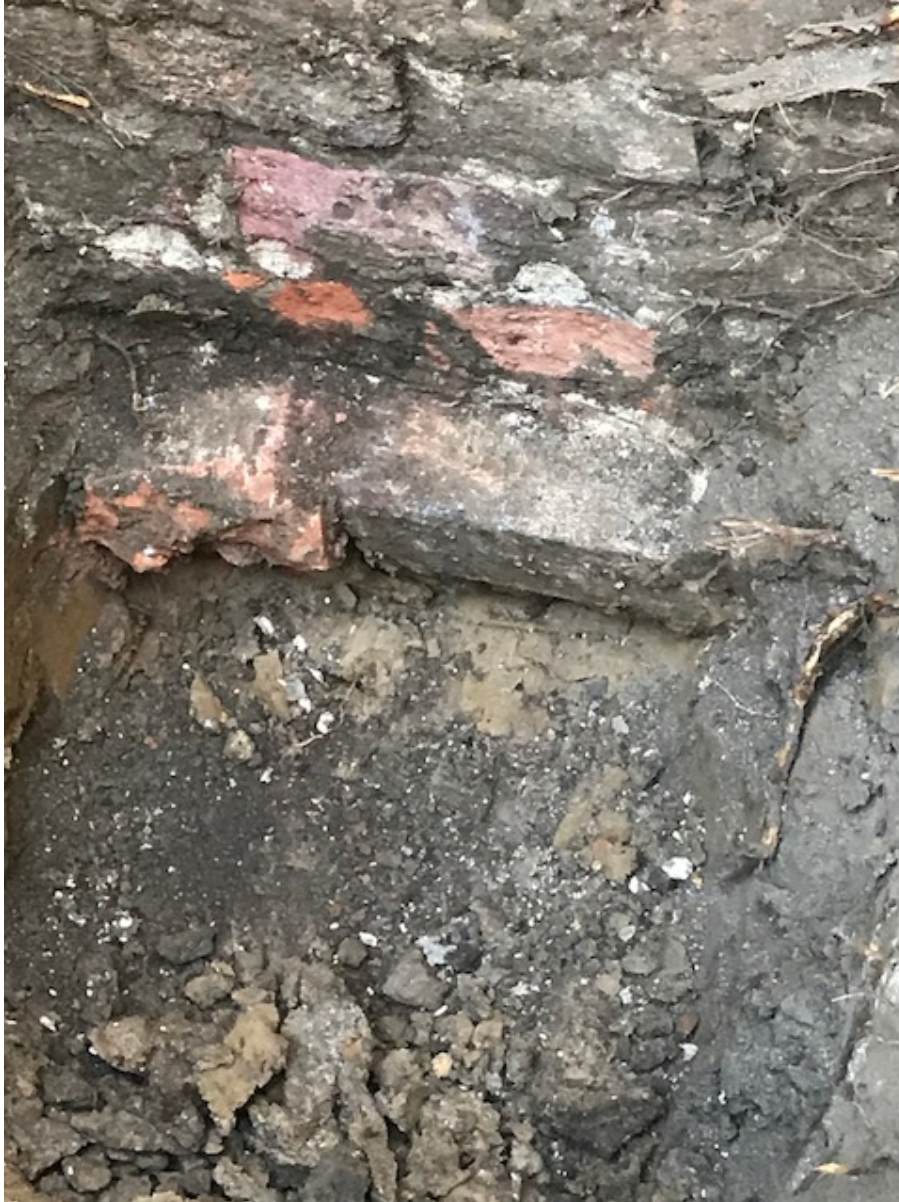
PHOTO 13

The wall is leaning inwards into number 11 the maximum out of plumb is 130mm at approximate midpoint along the wall. There are three piers in the length of the wall. From the evidence of a trial hole the foundations appear to be 100mm thick and extend for ½ brick either side of the wall. (photo 13)

The wall is showing signs of distress and currently has temporary propping installed along its length. With a maximum out of plumb of 130mm the centre of gravity of the wall falls outside of the kern and the wall is therefore unstable.

Because of its dangerous condition the north boundary wall poses a serious health and safety risk to the occupants of number 11. It is imperative that it is demolished and is rebuilt on new foundations. The foundations should consist of small diameter hand driven steel screw piles at discrete centres supporting a compact ground beam. The torsion generated from any wind moments can be taken by outrigger piles and ground beams located at the main pile centres similar to the method proposed for the south wall.
