## Arboricultural Report

Site Visit	9 <sup>th</sup> September 2018	Date Completed	September 2018
Document Version	V1r0	Updates	n/a
Author	RSH	Date	11th September 2018

Reference: Impact Assessment / Site & Tree Survey, Laurel Tree in westerly adjacent garden.  
Tree Ownership: One Laurel owned by Freeholder, adjacent property to west. No.7 Regents Square, WC1H 8HZ.

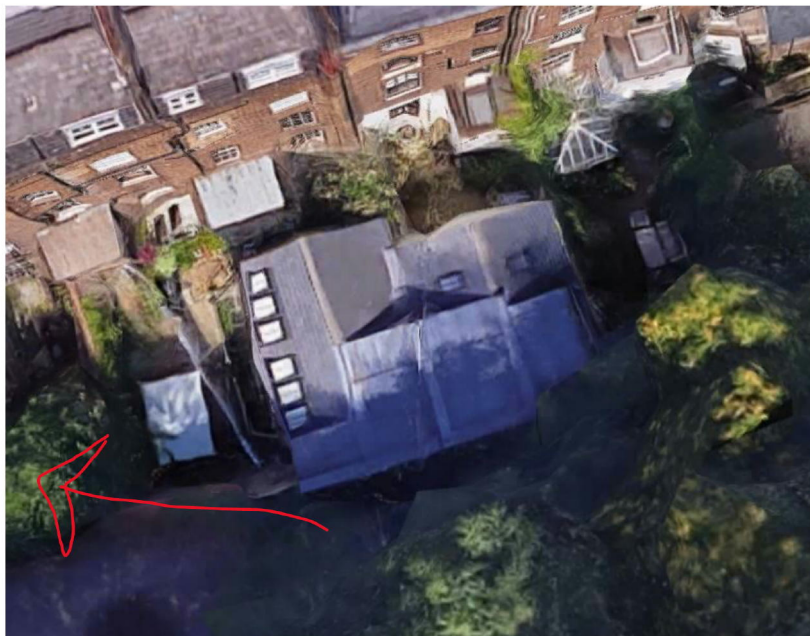
The laurel in question is arrowed above

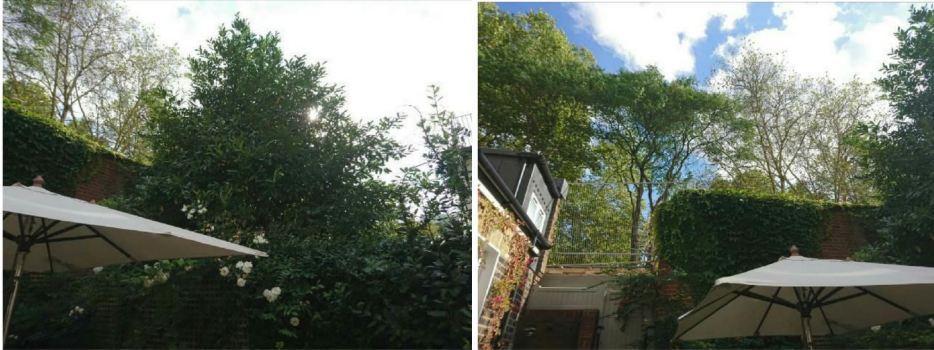
The laurel been left to grow, no maintenance has taken place in a long time, evidence though the amount of leaf litter and rubbish underneath the tree at time of assessment. Once the sun has passed the southern arc, heading southeast to west, the laurel casts a great deal of shadow, the down stairs lights in no.6 are having to be switched on during a sunny afternoon. Due to shading the patio to the east never dries out, creating lichen patches which are becoming a slip/trip hazard. This is having to be cleaned regularly by the homeowners.

This photo, facing west, shows the proximity of the Laurel and the high level of shading. The right-hand photo confirms the sunny conditions.

To prune the tree is pointless due to root bundle location with walls, and where the large shrub/small tree will try and grow to. Remove the tree/large shrub to ground level and poison with a brush-based application of a non-trans locational poison, suitable for gardens etc.

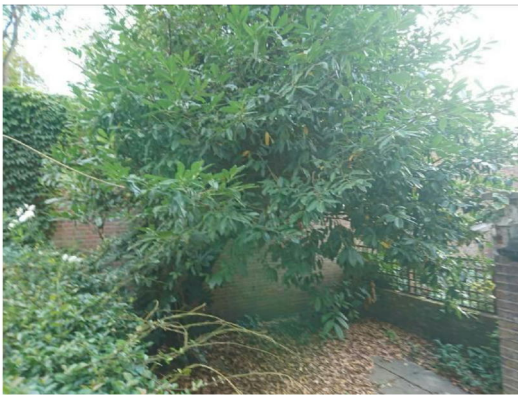
The laurel has become the inappropriate large shrub/small tree in the wrong garden. Due to the biomechanics being setup through phototropism, the tree will try and bend to present as much canopy to the sun as possible, which will have a detrimental issue on the integral strength of the stem, also crating a lot of leverage in the root area. Which is located quite close to two masonry walls.

This photo identifies the lack of maintenance and level of lean the stem is experiencing.

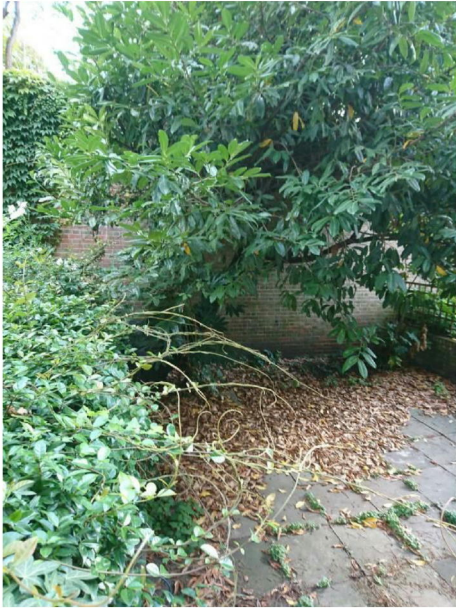
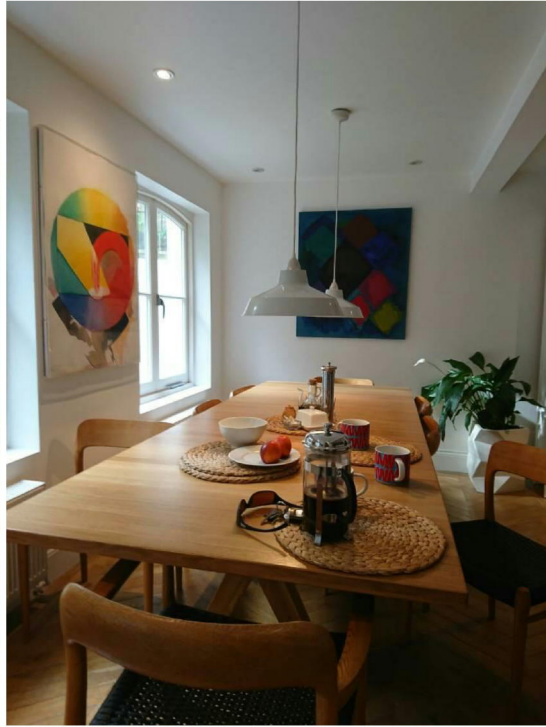
These photos show the lack of maintenance and the lights on in the house at 1400 on a sunny afternoon
