## 240 Grays Inn Road, London, WC1X 8JR

Report Prepared By:  
**David Broom,**  
**M.I.C.E Chartered Engineer**

**August 2018**  
Project Number: 102431

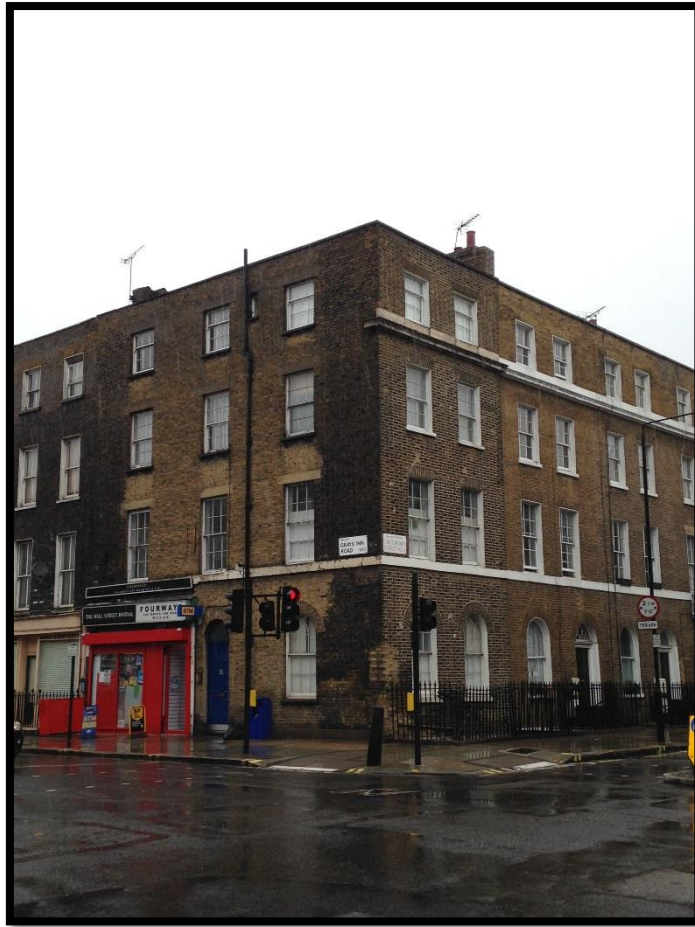
- 3.1. No significant cracking or distortion was noted to either of the visible external elevations consistent with recent significant structural movement.

- 4.2. As noted previously, the external façade displays evidence of significant historic repairs and reconstruction, possibly following damage due to enemy action, but the appearance of the façade gives no cause for concern regarding the adequacy of work undertaken.

**General view of front and right-hand elevations**

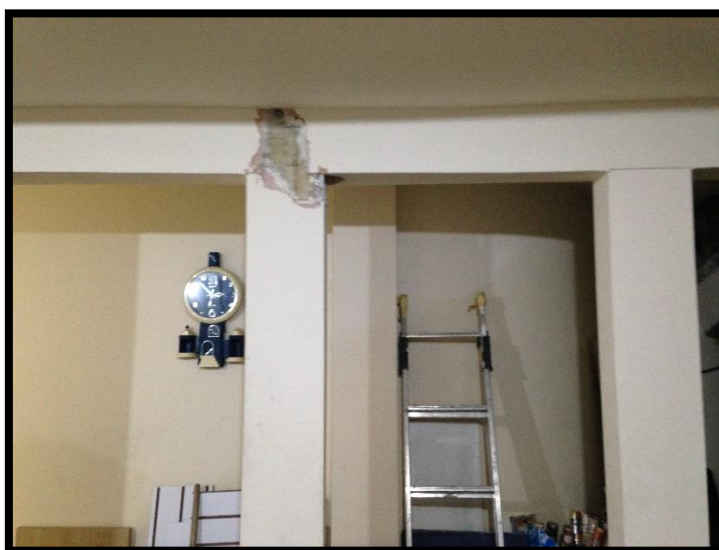
- 3.4. The steel beam supports a total of four upright columns. Localised exposure established that the columns consist of 200 x 100mm timber sections, 2180mm high, clad with plasterboard. The centre of the first column from the rear is located approximately 610mm from the rear wall, and the columns are spaced an average of 1055mm apart. The column nearest the front is situated some 830mm from the front elevation of the main property. There is an ancient oven situated within a brick arch in line with the support structure.

- 3.5. The columns appeared to be free of any bowing which might result from severe overloading, no rot was visible where exposure took place, and no splitting of timber was apparent.

**General view of support feature showing exposure at high level**

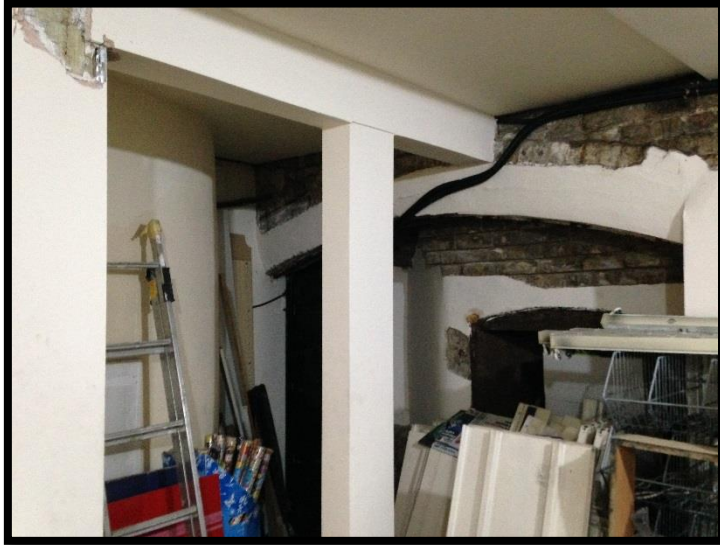
**Support feature close to front wall and arch**

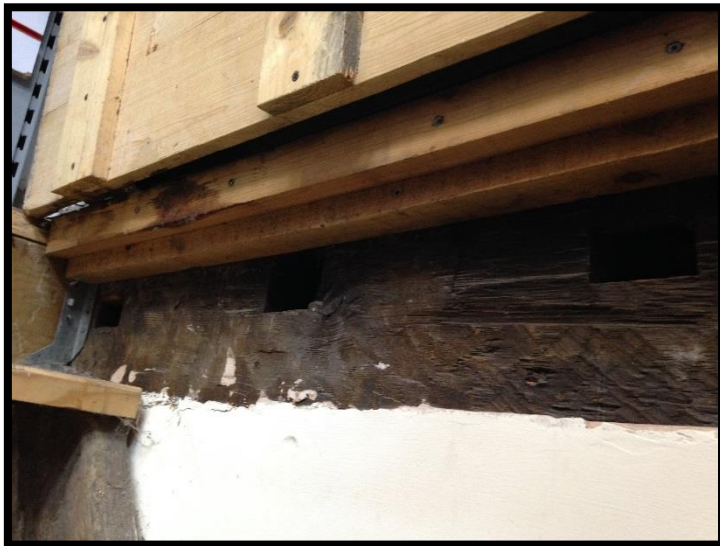
- 3.6. The columns support a timber beam also of 200 x 100mm section, extending from front to rear. This beam is also clad in plasterboard.
- 3.7. An original timber beam was visible in the trapdoor opening directly above the support feature. Interestingly the timber beam had been morticed horizontally, which could suggest that it had previously been used elsewhere in the structure. The horizontal mortices would reduce the strength of the timber in bending and deflection, and this might in turn have given cause for concern, resulting in the installation of a support structure, initially using Acrows, and subsequently in the current form. However, as we have not seen any records, the above explanation is conjecture only.

**Original beam above support feature – note horizontal mortice**

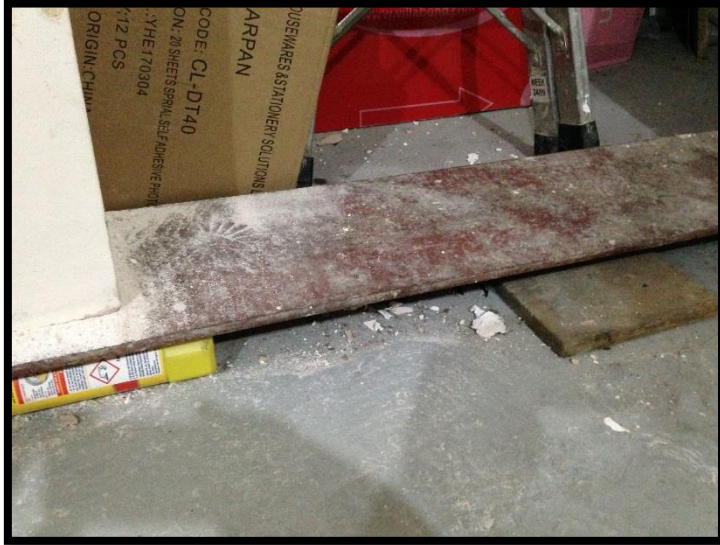
- 3.3. Within the basement, the support feature which forms the principal subject of this report was inspected in detail. As noted above, there is a steel beam embedded within the concrete floor. The top flange is 205mm wide and approximately 80mm above floor level. The surface of the steel had been painted and there was no evidence of corrosion. Inspection of the floor did not reveal any obvious cracking which might be associated with settlement of the support structure.

**Steel beam embedded in basement floor**

- 4.5. Since there is no indication that the support feature is unfit for purpose, it is not considered that further exploratory investigation is justified at the present time. Indeed, breaking out of the concrete basement slab could well impair its structural integrity and would therefore be counterproductive.

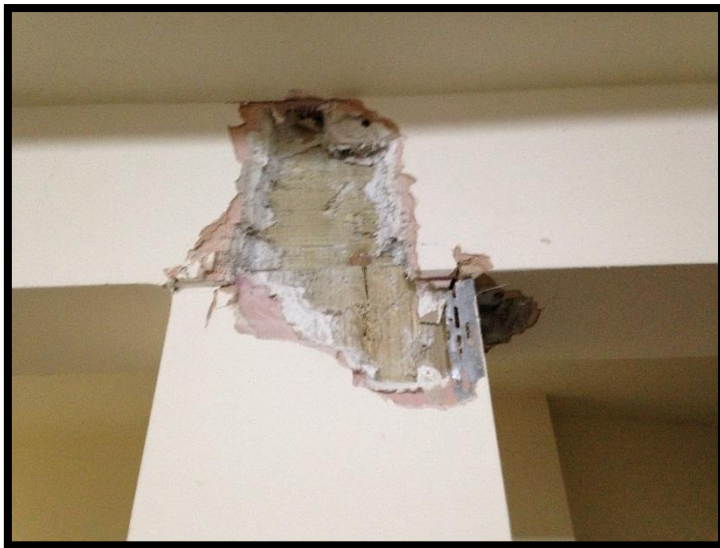
**Exposure of timber members forming the support feature**
