Tree Condition Survey

Crown Estate Paving Commission

Albany Street
Regent's Park
London
NW1

July 2018

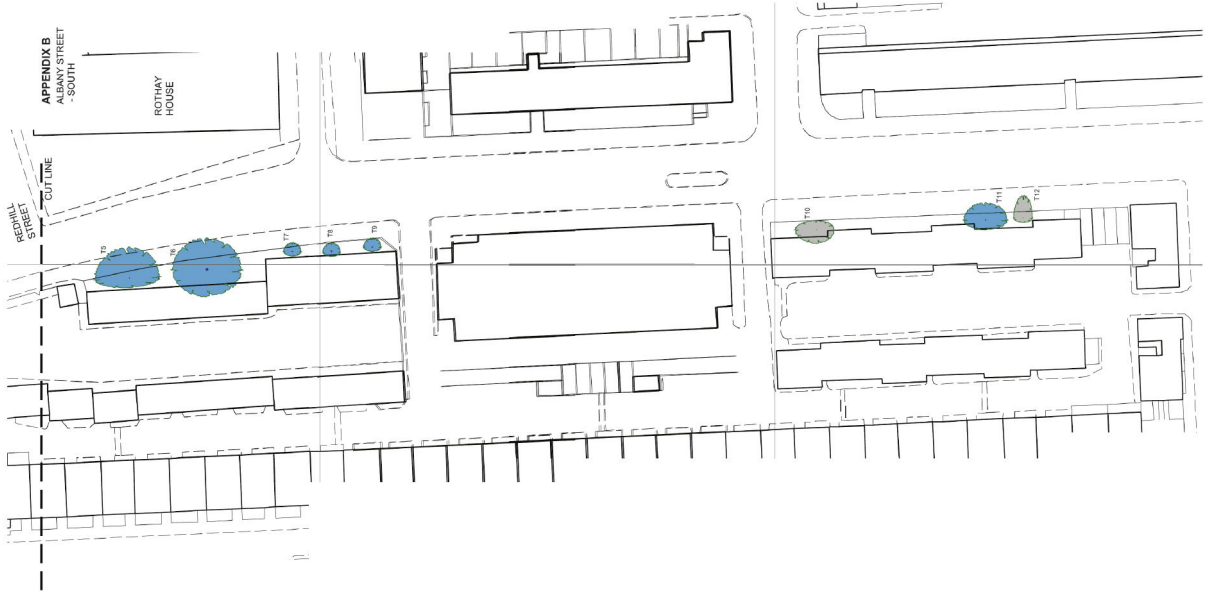
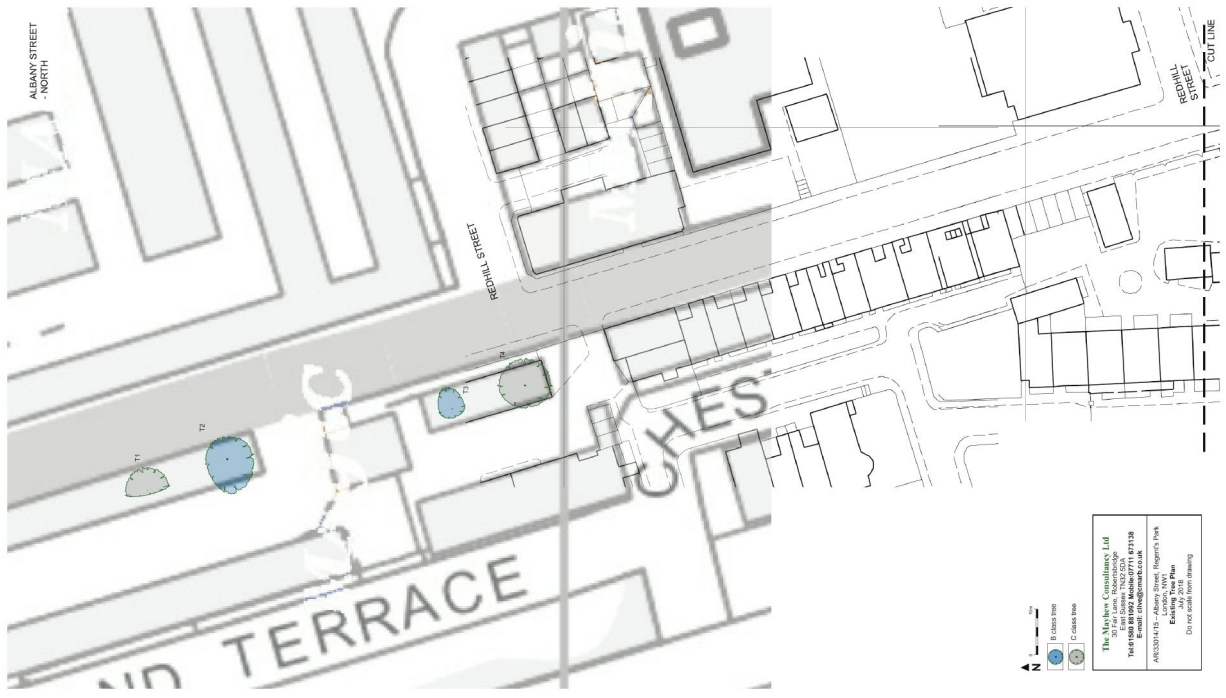
Tree Survey date – 19th July 2018

Tree No	Species	Condition	Recommendation
T3	<i>Taxus baccata</i> 'Fastigiata'	Crown adjacent building.	Cut back crown to give 1.5m separation with building.
T4	<i>Prunus pissardii</i>	Crown over roof.	Cut back crown to give 1.5m separation with building.
T5	<i>Prunus spp.</i>	Crown adjacent building.	Cut back crown to give 2m separation with building.
T6	<i>Carpinus betulus</i>	Crown adjacent building.	Cut back crown to give 2m separation with building.
T7	<i>Taxus baccata</i> 'Fastigiata'	Crown adjacent building.	Cut back crown to give 1.5m separation with building.
T8	<i>Taxus baccata</i> 'Fastigiata'	Crown adjacent building.	Cut back crown to give 1.5m separation with building.
T9	<i>Taxus baccata</i> 'Fastigiata'	Crown adjacent building.	Cut back crown to give 1.5m separation with building.
T10	<i>Taxus baccata</i>	Crown adjacent building.	Cut back crown to give 1.5m separation with building.

T11	<i>Taxus baccata</i>	Crown adjacent building.	Cut back crown to give 1.5m separation with building.
