Tree Condition Survey

Crown Estate Paving Commission

Chester Close North
Regent's Park
London
NW1

APPENDIX B
CHESTER CLOSE
NORTH

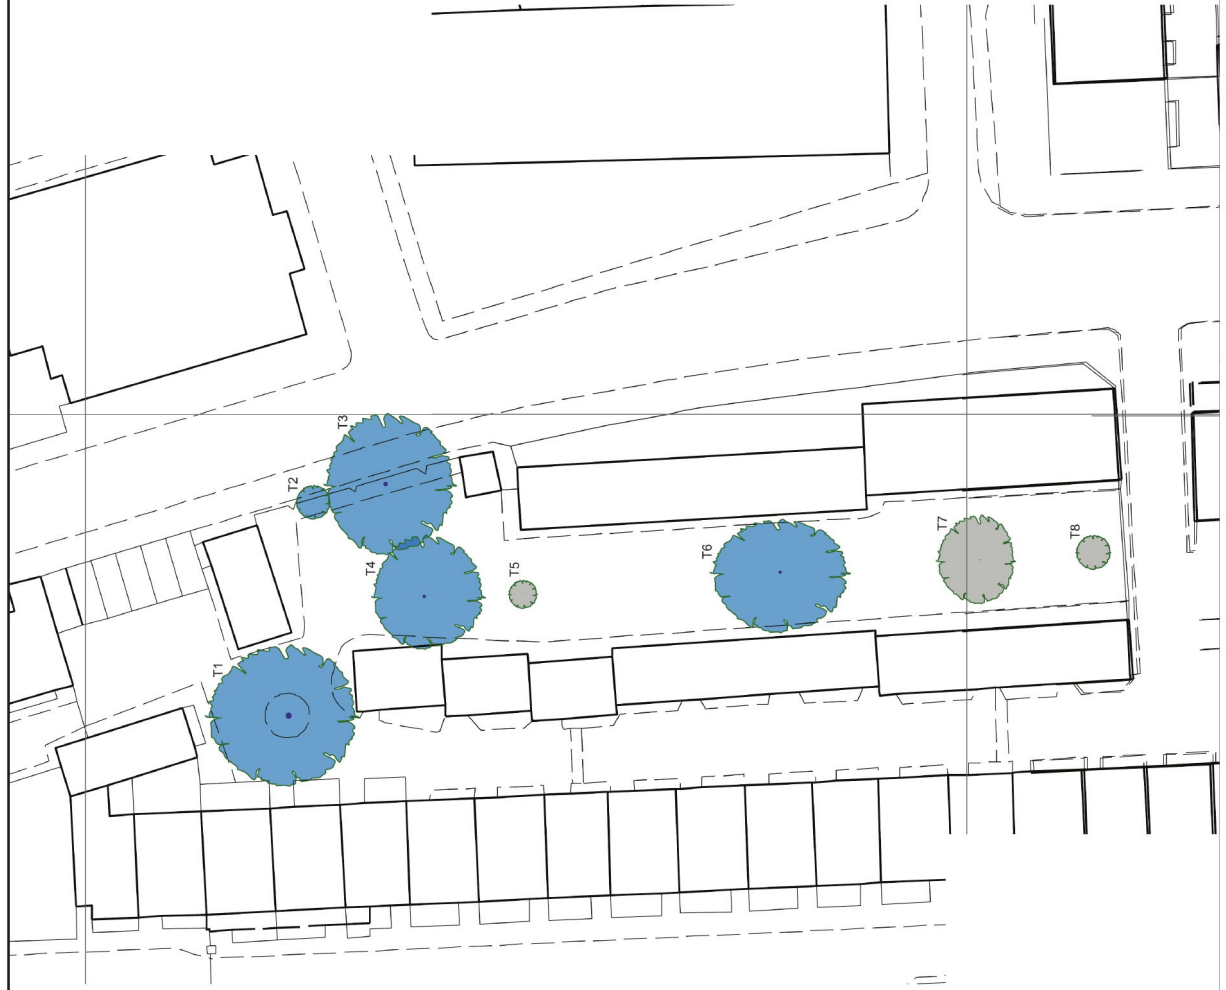
Tree No	Species	Ht.	Stem dia.	Crown spread N – S – E - W				CB	Age class	Phy con	Str con	ECR	Class	Observations & recommendations
T1	<i>Acer platanoides</i>	18	70	7	8	8	8	3	M	G	G	M	B	Good, established and prominent tree to car park.
T2	<i>Ginkgo biloba</i>	6	5	2	2	2	2	2	Y	G	G	L	B	Young, established tree.
T3	<i>Gleditsia triacanthos</i>	15	50	7	8	8	8	4	M	G	G	L	B	Prominent tree. Crown density appears to be a little thin.
T4	<i>Acer platanoides</i>	12	40	6	7	7	6	3	SM	G	G	L	B	Prominent tree to car park.
T5	<i>Prunus spp.</i>	7	10	1.5	1.5	1.5	1.5	2	Y	G	G	L	C	Young, but self-supporting tree.
T6	<i>Carpinus betulus</i>	16	40	8	8	7	8	4	M	G	G	L	B	Prominent tree to car park.
T7	<i>Prunus spp.</i>	7	15	5	4	5	5	2	M	G	F	M	C	Ornamental cherry. Crown density appears to be thin.
T8	<i>Liquidambar styraciflua</i>	6	5	2	2	2	2	1.5	Y	G	G	L	C	Good, young sweet gum.

Tree No	Species	Condition	Recommendation
T2	<i>Ginkgo biloba</i>	Crown hangs low over path.	Lift crown to 2m and formative prune.
T3	<i>Gleditsia triacanthos</i>	Crown hangs low over road.	Lift crown to 4m.
T6	<i>Carpinus betulus</i>	Crown close to adjacent buildings.	Prune crown to leave 2m separation from building.
T7	<i>Prunus spp.</i>	Crown hangs low over road.	Lift crown to 2.5m.
T8	<i>Liquidambar styraciflua</i>	Crown hangs low over road.	Lift crown to 2m and formative prune.
