# **Tree Condition Survey**

## **Crown Estate Paving Commission**

Chester Close South  
Regent's Park  
London  
NW1

AR/33014/22 – Chester Close South  
Regent's Park, London, NW1  
**Existing Tree Plan**  
July 2018

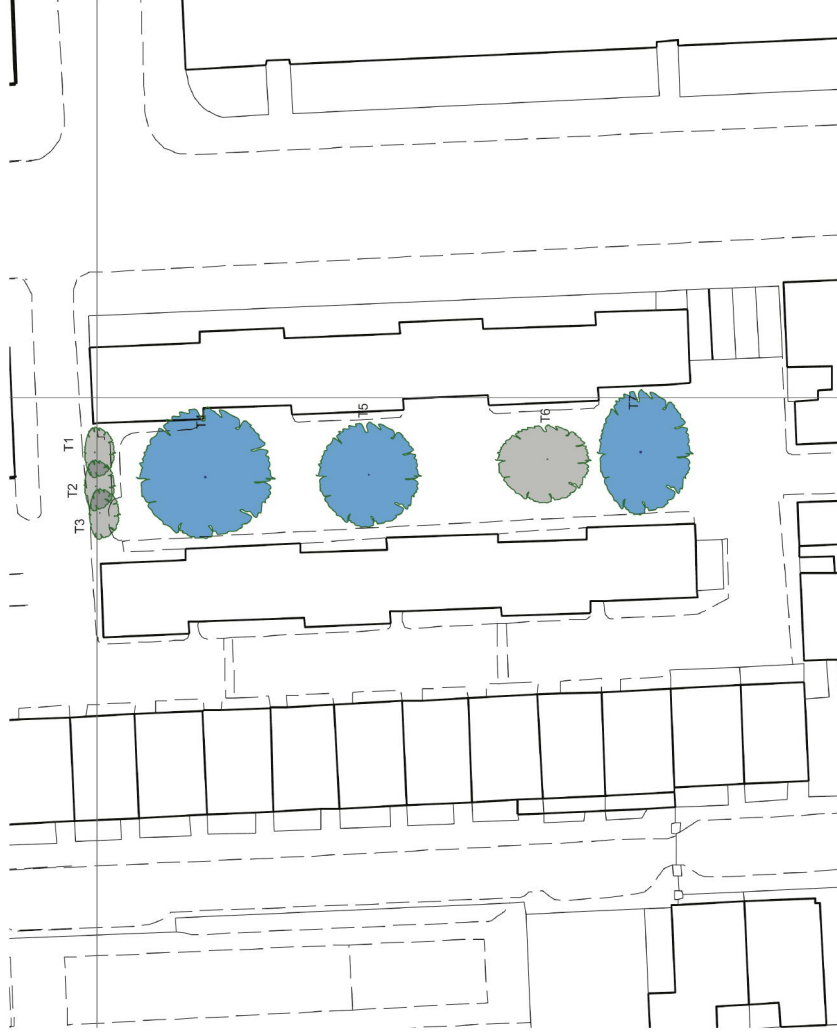
**APPENDIX B**  
**CHESTER CLOSE**  
**SOUTH**

Tree No	Species	Condition	Recommendation
T4	<i>Betula jacquemontii</i>	Crown hangs low over parking area / roadway.	Lift crown to 3m.
T5	<i>Betula pendula</i>	Crown hangs low over parking area / roadway.	Lift crown to 2.5m.
T6	<i>Betula pendula</i>	Crown hangs low over parking area / roadway.	Lift crown to 2.5m.
T7	<i>Betula jacquemontii</i>	Crown hangs low over parking area / roadway.	Lift crown to 3m.
