Tree Condition Survey

Crown Estate Paving Commission

Chester Place
Regent's Park
London
NW1

The Mayhew Consultancy Ltd

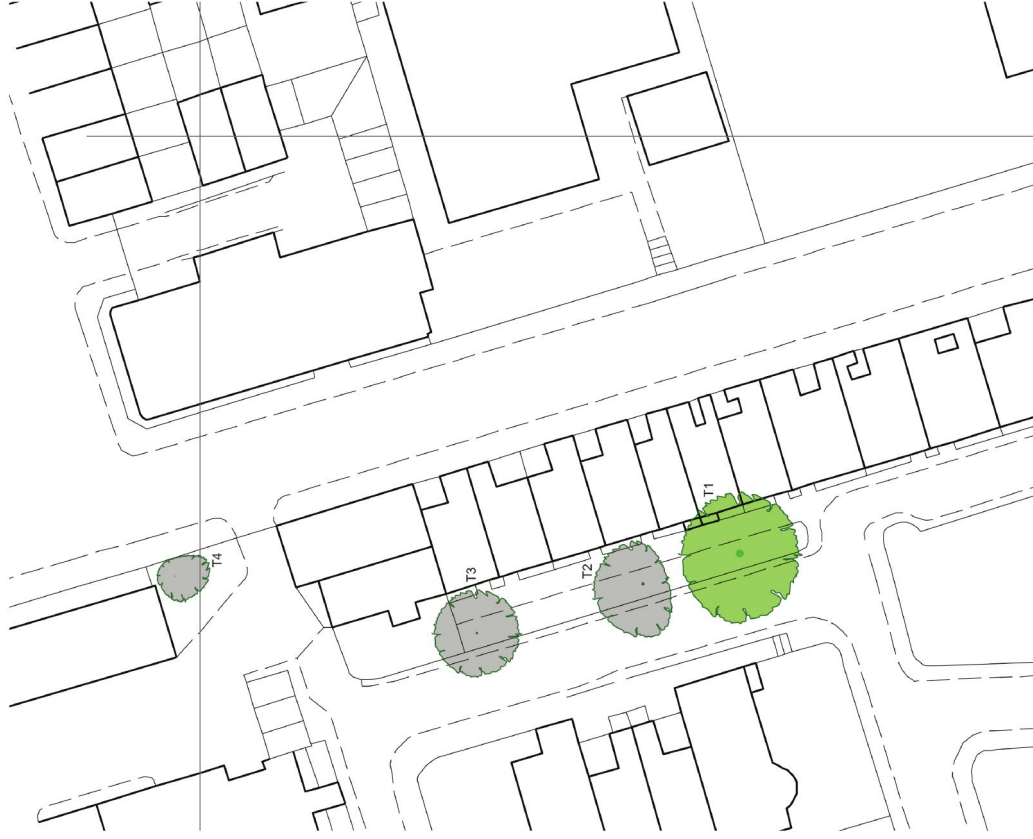
APPENDIX B
CHESTER PLACE

Tree No	Species	Condition	Recommendation
T1	<i>Ailanthus altissima</i>	Crown hangs low over road.	Lift crown to 5m over road.
T3	<i>Prunus spp.</i>	Crown low over road.	Lift crown to 3m over road.
