# Bedford Row Chambers

## STRUCTURAL INSPECTION REPORT

Job No: 1800

Document: 1800 IR1 Rev 0

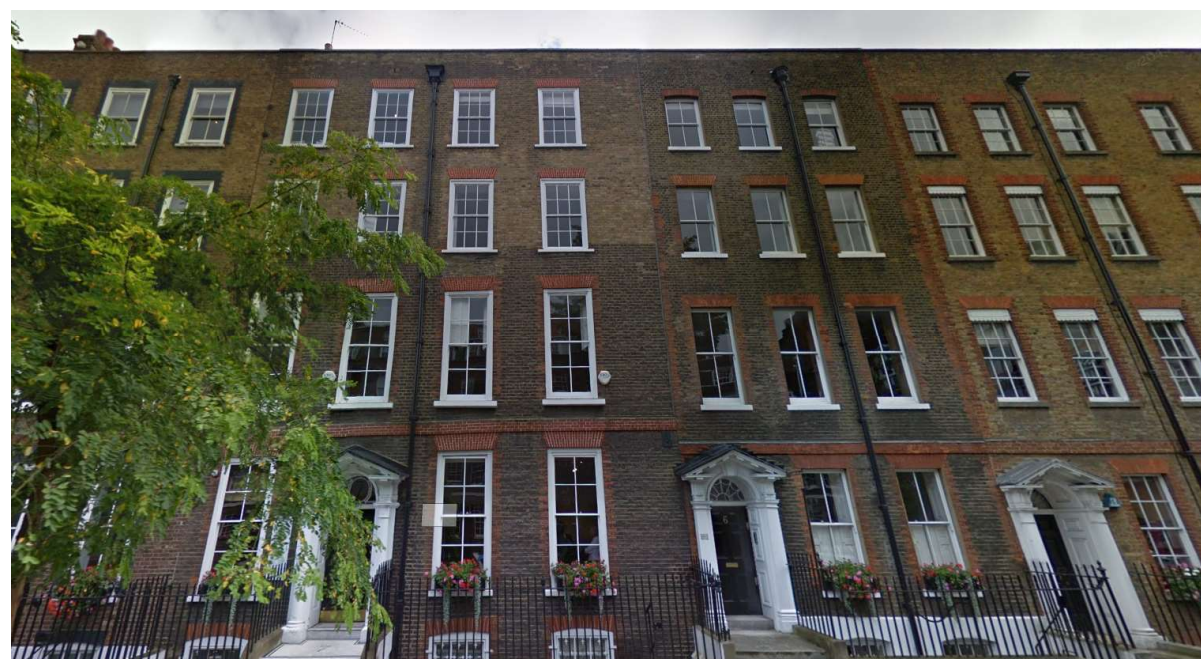
Figure 3. Bedford Row elevation © Google

Close inspection of the front elevation of No7 (see figure 3) reveals what appears to be newer (lighter) brickwork above 1<sup>st</sup> floor. This suggests that the upper floors were either added as additional floors or that they were re-built. Given the similar height of the adjoining properties, which from the appearance of the brickwork do not appear to have been significantly altered, it is likely that the upper floors of No7 were re-built, possibly after sustaining bomb damage during the Second World War. This, unlike the addition of new floors, should not have added additional load to the foundations.

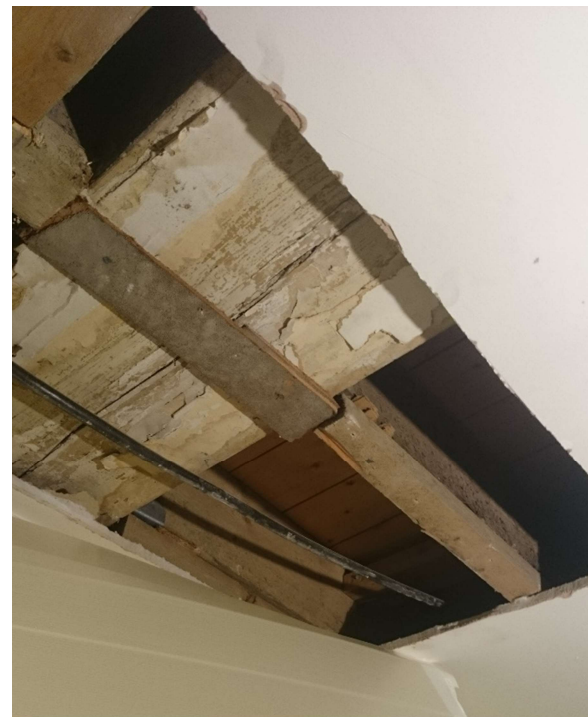
Figure 6. Typical timber joists and transfer beam

Inspection of the opening up works showed that the joists typically are 190mm deep x 55mm wide sections at approx. 400mm centres spanning approx. 4m parallel to the street onto a combination of the solid brick party walls, the solid brick internal wall in No7 and internal timber transfer beams spanning from front to back. The transfer beams typically comprise of 2no approx. 200mm deep x 150mm sections bolted together to act as a single section (see figure 6).

Both the joists and transfer beams appear to be in good condition with no major deterioration or section loss due to insect attack or rot noted. However, neither the joists nor transfer beams appear to be original suggesting that at some point in the past they have been installed as part of a refurbishment of the building – this could possibly explain why they appear to be in good condition.

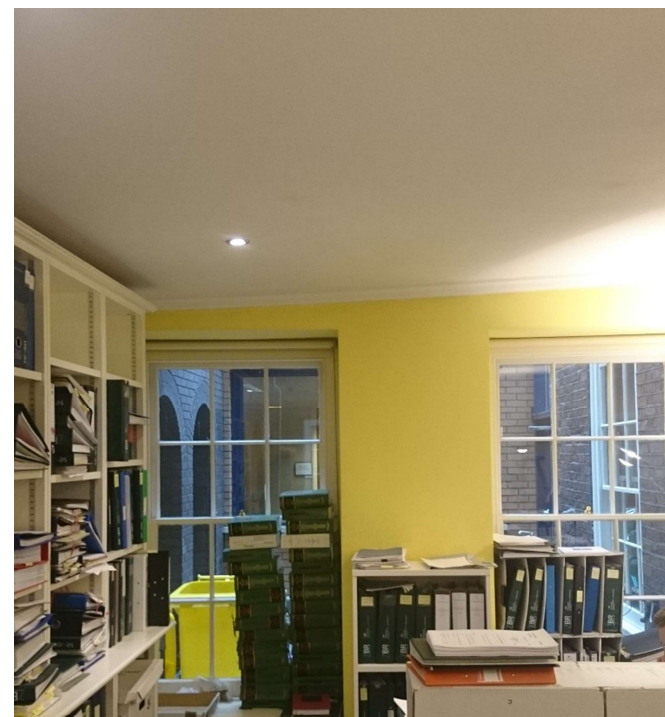
Figure 7. Sloped floor to No7

The floors appeared to be solid throughout with little to no bounce or springiness noted at sample locations where a dynamic load, simulated by light jumping up and down, was applied. This would additionally suggest that the floor joists are in good condition. There is a notable slope to the floor in some areas, particularly in No7 where the floors appear to slope towards the internal supporting wall (see figure 7). This is likely to have been caused by settlement of the supporting wall (see section 6) and is not thought to indicate any structural issues with the floor joists themselves.

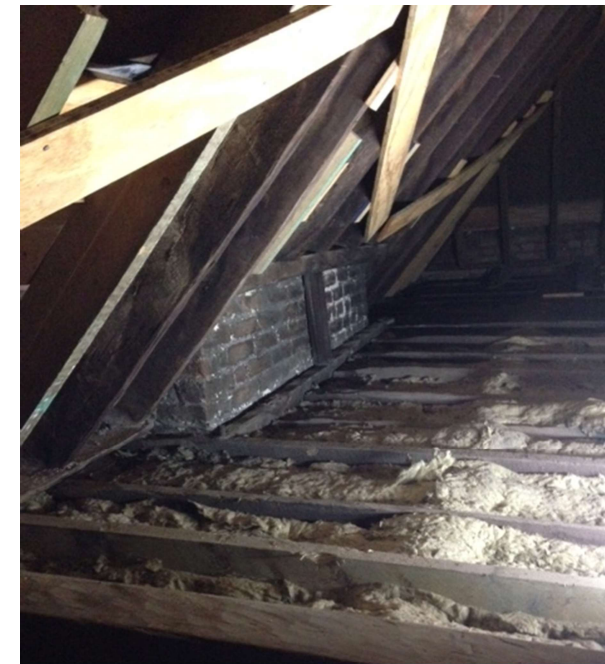
Figure 8. Typical timber roof rafters and loft joists

The rafters were inspected via the loft access hatches in the ceiling of the top floor. The loft areas appeared to be dry with no damp or evidence of water ingress being noted. The rafters appeared to be in good condition with no evidence of sagging and no significant deterioration or section loss due to insect attack or rot noted.

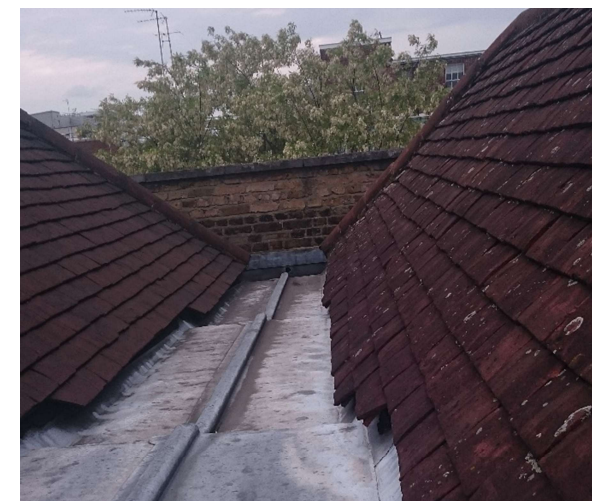
Figure 10. Typical guttering to roof valleys

Arrangements for the drainage of rain water from the pitched roofs appeared to comprise an open valley gutter in the space between the pitched roofs with the water flowing down a series of steps to downpipes located in the front and rear elevations (see figure 10). Again, this guttering was only inspected locally from the small dormer windows but where visible appeared to be in good condition and well maintained. However, we would note the importance of good ongoing maintenance of these areas as any water ingress down to the structural roof timber due to defective guttering or ponding could cause problems with rotting of the timber. The potential for ponding is particularly pertinent as the level of the overflow pipes appeared to be approx. 100mm above the surrounding roof level.

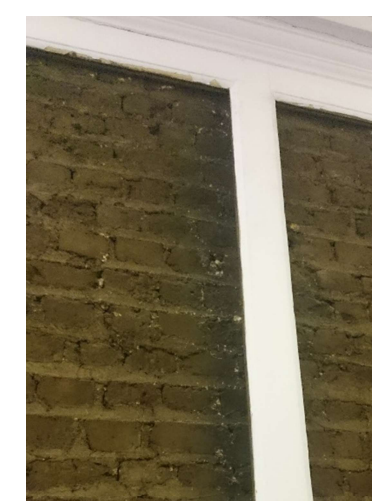
Figure 11. Typical solid brick wall at basement

The inspection of the load bearing brick walls where the finishes had been removed generally confirmed that the cracking visible to the plaster and timber panelling was not evident to the brickwork (see figure 11). The brickwork workmanship did appear to be somewhat adhoc in places however this was fairly common at the time of construction and structurally the walls appeared to be in sound condition. Wall thicknesses ranged from 440mm at basement level to 215mm further up the building.

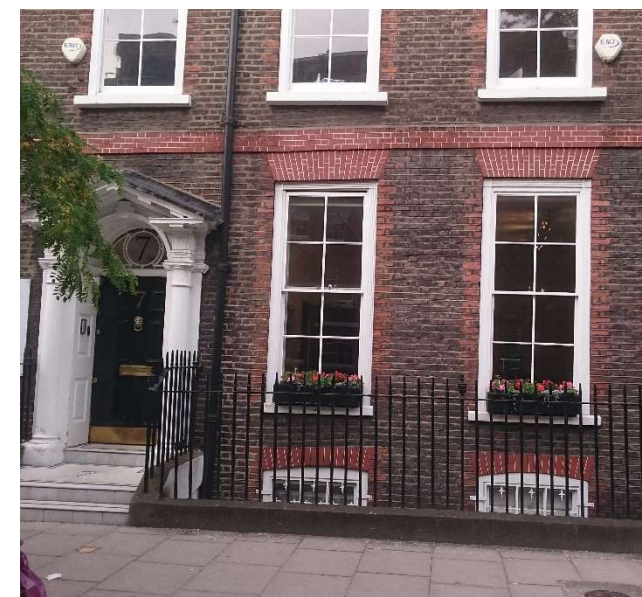
Figure 12. Settlement to front elevation

Settlement to the front elevation of No 7 is visible from the public highway as can be seen in figure 12 where there is a visible slope to the red brick banding and lintels above the windows immediately to the right of the front door. A similar occurrence, albeit less pronounced, was noted to the rear elevation. The location of the above slopes to the brickwork matches the location of the sloped floors to No 7 (see section 4) – i.e. adjacent to the central brick wall in No 7.

The slopes to the brickwork noted above, together with the slopes to the floors noted in section 4, appear to have been caused by settlement of the central brick wall in No 7. The floors it supports then settle unevenly to give the slopes noted during the inspection. Areas of cracking to the plaster were also noted internally to both the central areas of this wall and the corner junctions where it meets the front and rear elevation walls (see figure 13).

To establish if the settlement is ongoing or historic it will be necessary to monitor the cracks and the central wall. This is typically carried out by a line and level survey using fixed base points which can be used to accurately measure any movement over time. We recommend that this is started as soon as possible with measurements being taken every 6 weeks over a period of 6 to 9 months.

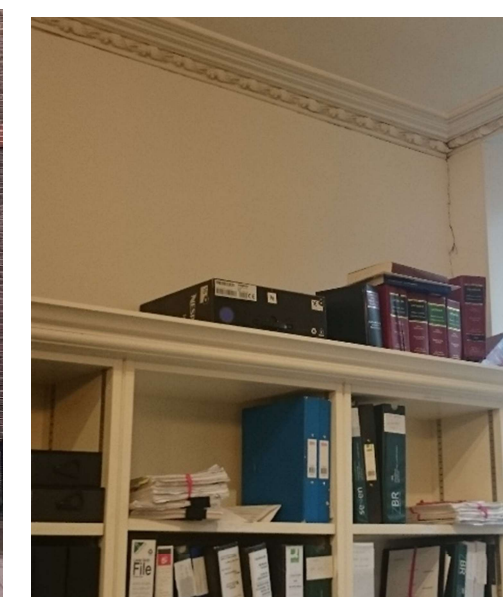
Figure 13. Cracking to corner of internal wall and rear wall

This cracking was noted during Parmarbrook's initial site visit and appears to be largely historic however further survey works will be required to substantiate any progressive movement.

Where cracking has been identified at the junction of two brick walls, particularly to No7 where there is known to have been settlement of one or more of the walls (see figure 13) we would recommend that the wall finishes are removed to expose the brickwork and determine the extent of any cracking within the brickwork, how effective the bonding between the walls is and how much they have moved apart from each other. The separation and de-bonding

of brickwork walls at corner junctions is a common occurrence in historic buildings of similar age where there are known to have been problems with settlement and remedial works to tie the walls back together may be required.

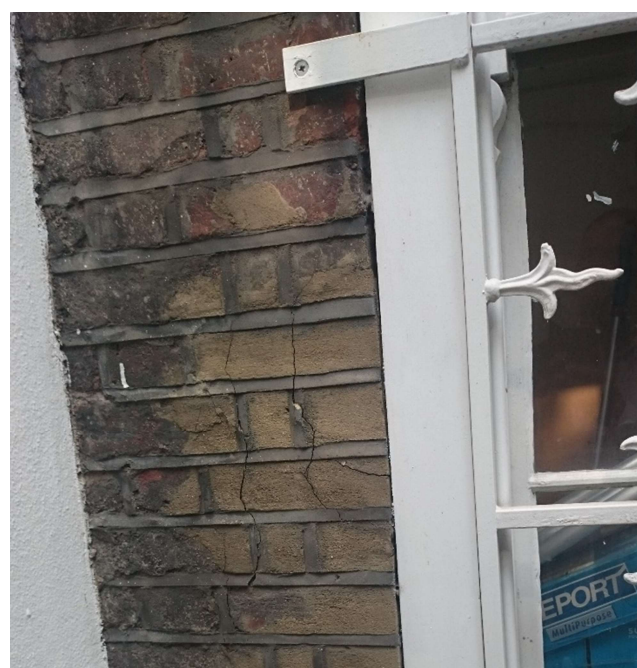
Figure 15. Hair line cracking to front elevation

Externally, any cracking that was identified was only hairline and localised in nature (see figure 15). If desirable these could also be repaired as above (this may require listed building consent) or by localised re-pointing, however these works would be considered cosmetic as there is no structural requirement for them.

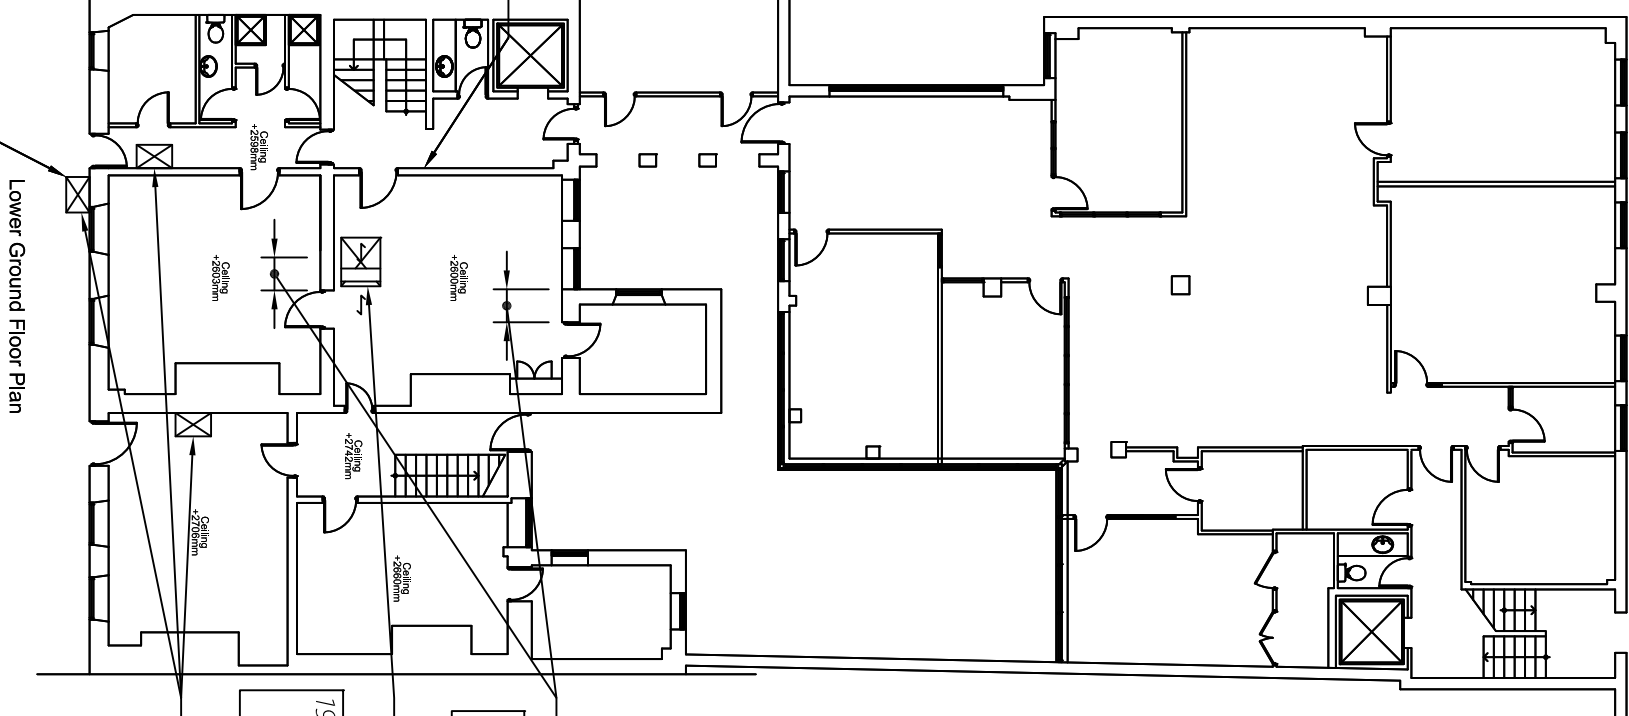
REMOVE PLASTER  
AROUND CRACK  
*crack extends into  
brickwork(hairline only)*

190x55 joists @ 400C/C and  
230x340 timber  
*beam as shown*

REMOVE WALL  
PANELLING  
*Brickwork appears to  
be poor quality but  
no evidence of  
cracking or significant  
movement*
