# LIGHTHOUSE REPORT

**TITLE** Heritage Statement  
Repair and refurbishment work  
**OF** 244 Camden Road, London, NW1 9HE  
**DATE** 15 October 2018  
**VERSION** 01

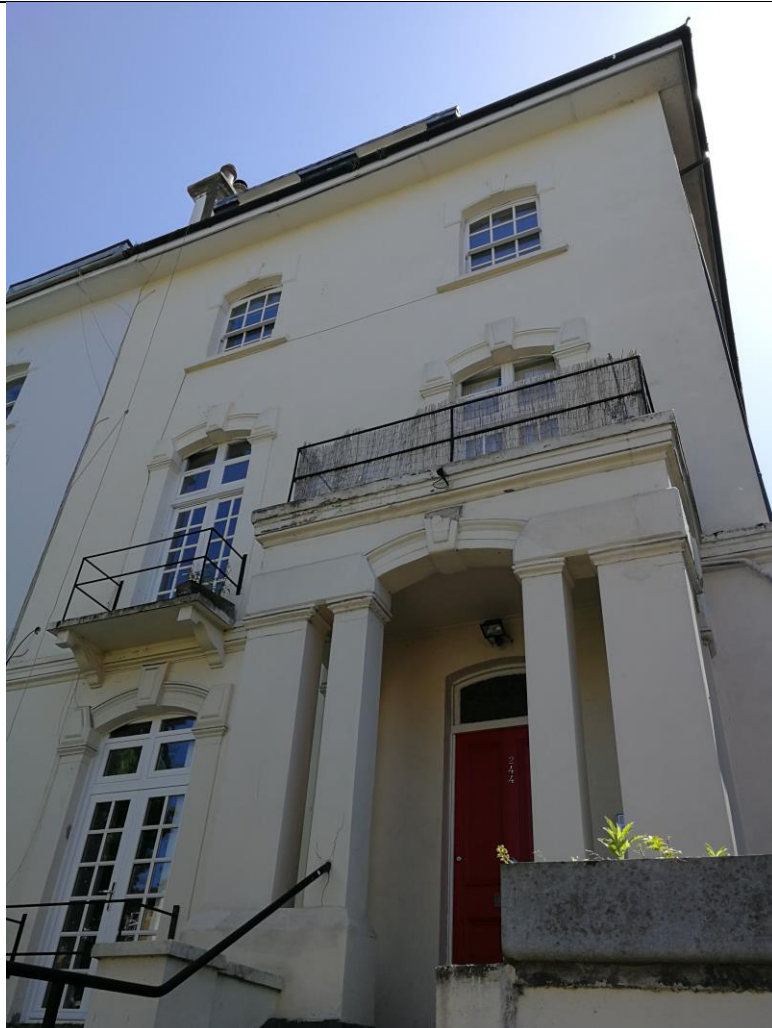
There are noted cracks formed to the front elevation rendered finish above and below window openings. Cracking is also noted to the flank and rear brickwork elevations. Isolated areas of brickwork pointing are also in need of replacing. Water ingress has caused problems within the Lower Ground Floor flat within the small storage room beneath the main entrance steps. From external inspection this is mainly the result of failing asphalt covering to the steps, as well as plant growth at the junctions of the asphalt and rendered elevations. Timber windows and balcony doors are in poor decorative order, particularly at high level. It has been identified that as part of the cyclical maintenance for the building the following works are required;

Photo 1 - Front elevation

- Patch repairs to the main roof over 3<sup>rd</sup> Floor,
- Rainwater goods clearance and maintenance,
- Elevation brickwork repairs and repointing. This includes crack stitch repairs to cracking over window openings,
- Front elevation and porch render repairs, where cracked and loose,
- Front elevation and porch render redecoration,
- Repairs to the front entrance steps,
- Repairs to the front boundary wall and front yard hardstandings,
- Redecoration of all external timber elements.

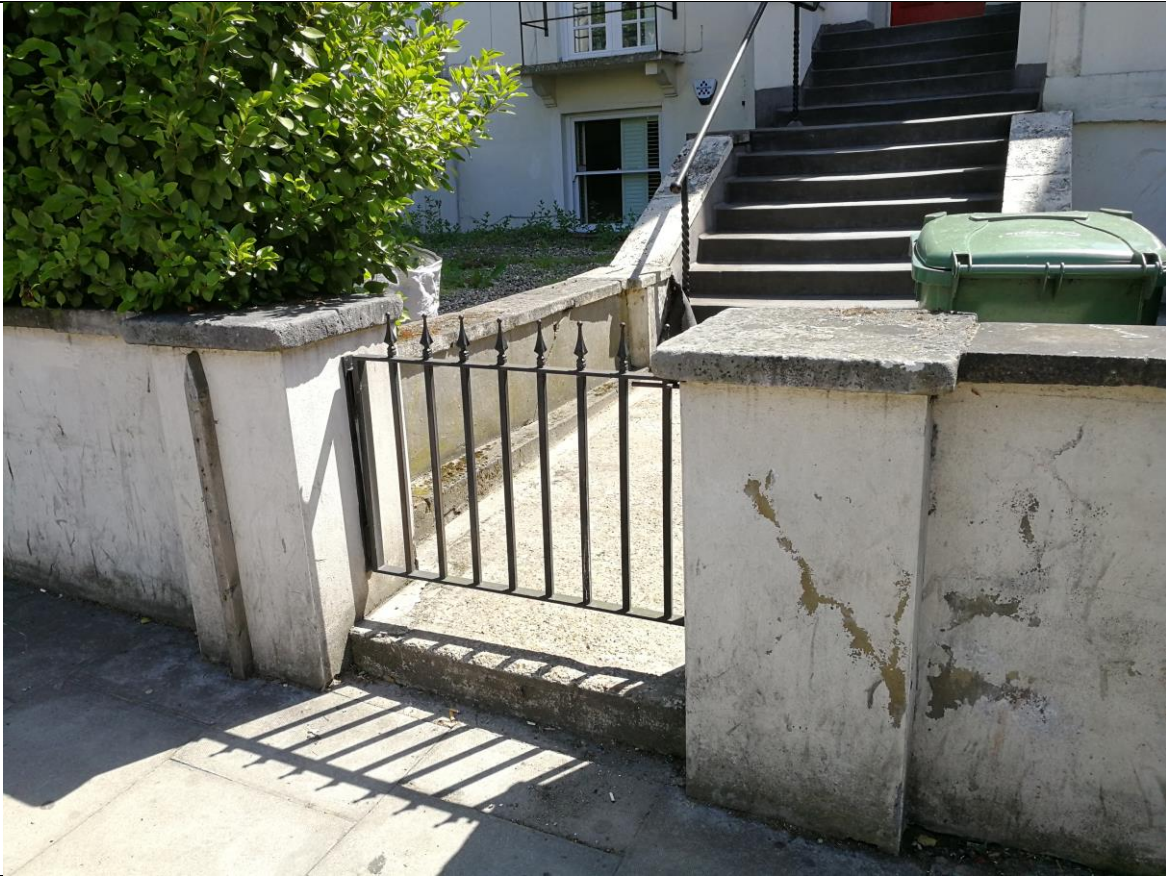
Photo 2 – Entrance gate and front boundary wall

There are repairs included in the works package to front elevation boundary wall as the current rendered and painted finish is poor and in need of replacing. It is also the intention to replace the current gate to the centre of the wall and raising the brickwork rendered columns either side of the opening. The current opening to the far right hand side of the wall is also to be infilled. The wall, and infill, will be re-rendered to match the existing and decorated. The metal gate will be replaced with new and metal railings are to be installed to the top of the lowered sections of wall, installed to the level of the top of the columns either side of the main entrance, approximately 1.7m high. The railing and gate design are detailed within the Schedule of Works.

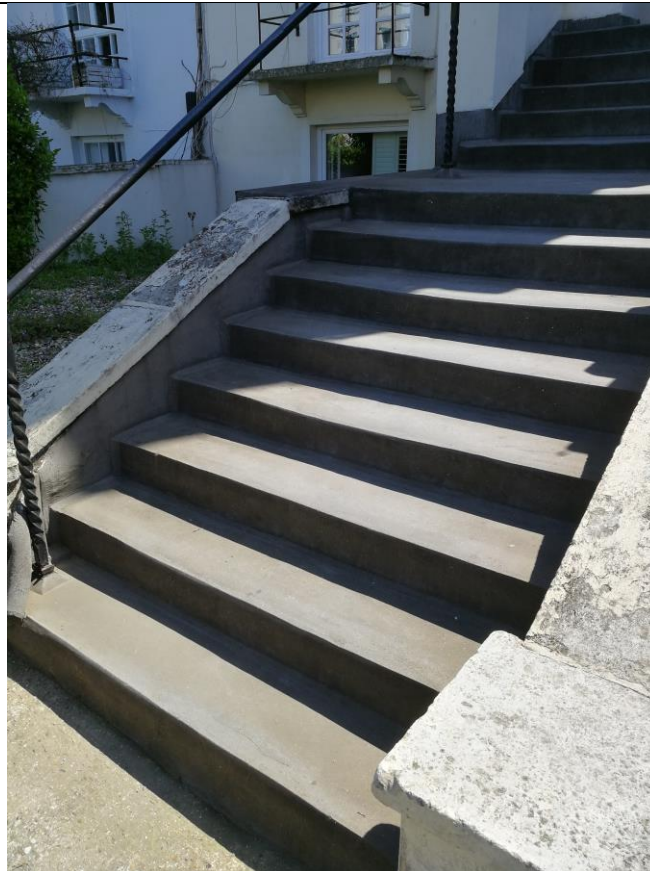
Photo 3 – Existing asphalt covering to steps and metal handrail

It is also the intention to supply and install new metal balustrade railings and handrails to both sides of the front entrance steps. Currently there is a single handrail to the left hand side of the steps with no balustrade railings. It is the intention to remove this and replace with handrails to both sides of the entrance steps, and to extend metal railings around the small section of flat roof to the right hand side of the steps half landing.

The entrance steps, as noted in section 3, are covered with mastic asphalt and, having failed and split in numerous locations, requires replacement. It is the intention to replace the step covering with Yorkstone treads and risers from the bottom step up to the entrance door landing, rather than replace with a new asphalt covering. This will enhance the appearance of the steps and provide a suitable longer term durable material for the entrance.

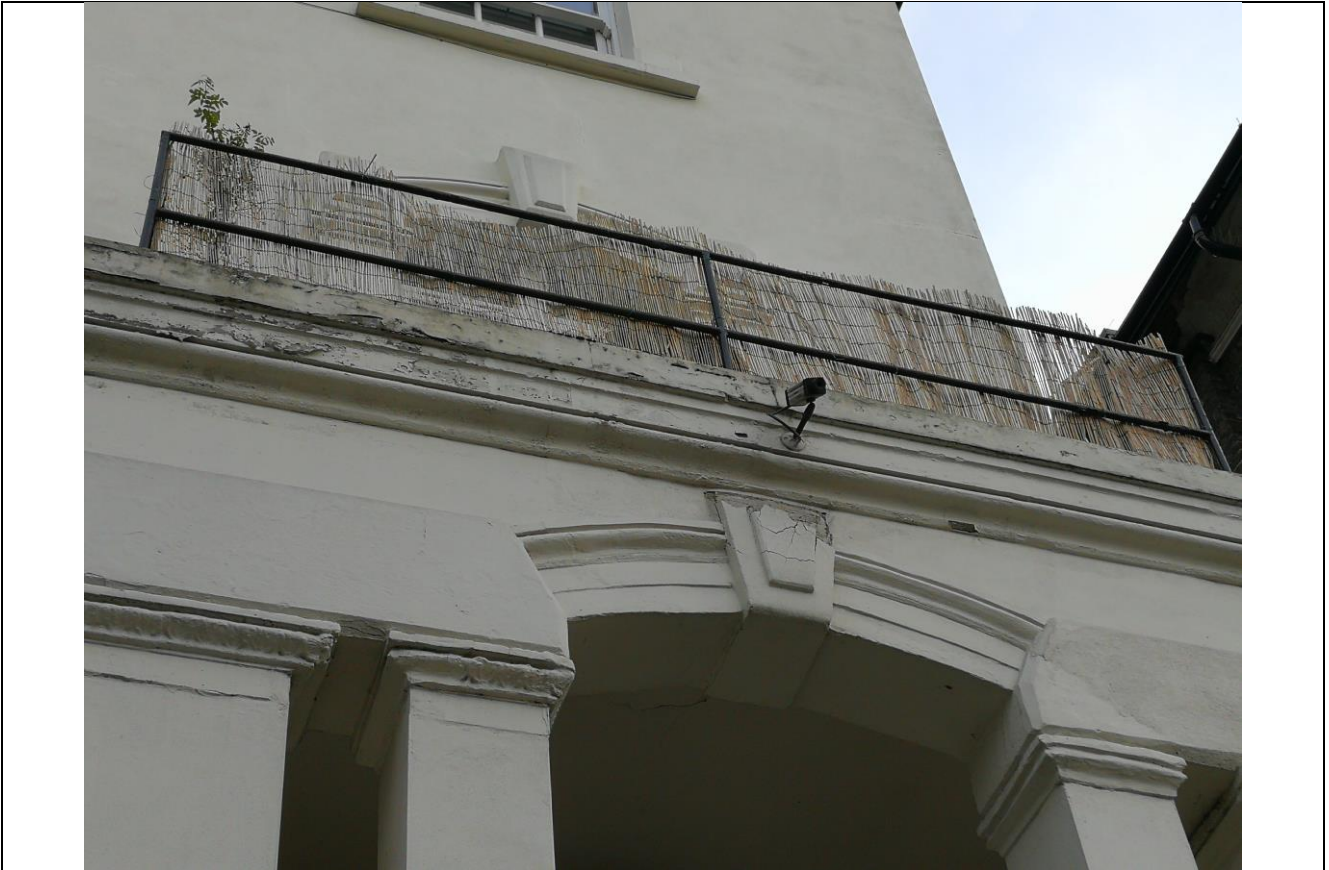
The current metal railings that have been installed to the perimeter of the front elevation porch roof and 2no projecting balconies are poor installations formed of upper and lower rails with large gaps between and no decorative balustrade. These balcony railings are face fixed into the front elevation render and are generally loose. The design of the railings with significant gaps which do not meet the standards for minimum railing gap widths. Residents are concerned about the sizes of the gaps between the railings and the risk of falls from height, especially for minors. It is our intention to replace these railings with new decorative cast iron railings of Victorian era design and enclosed to ensure that gaps to the railings, as well as height and lateral loadings meet the modern building regulations requirements.

Photo 4 – Entrance porch metal railings

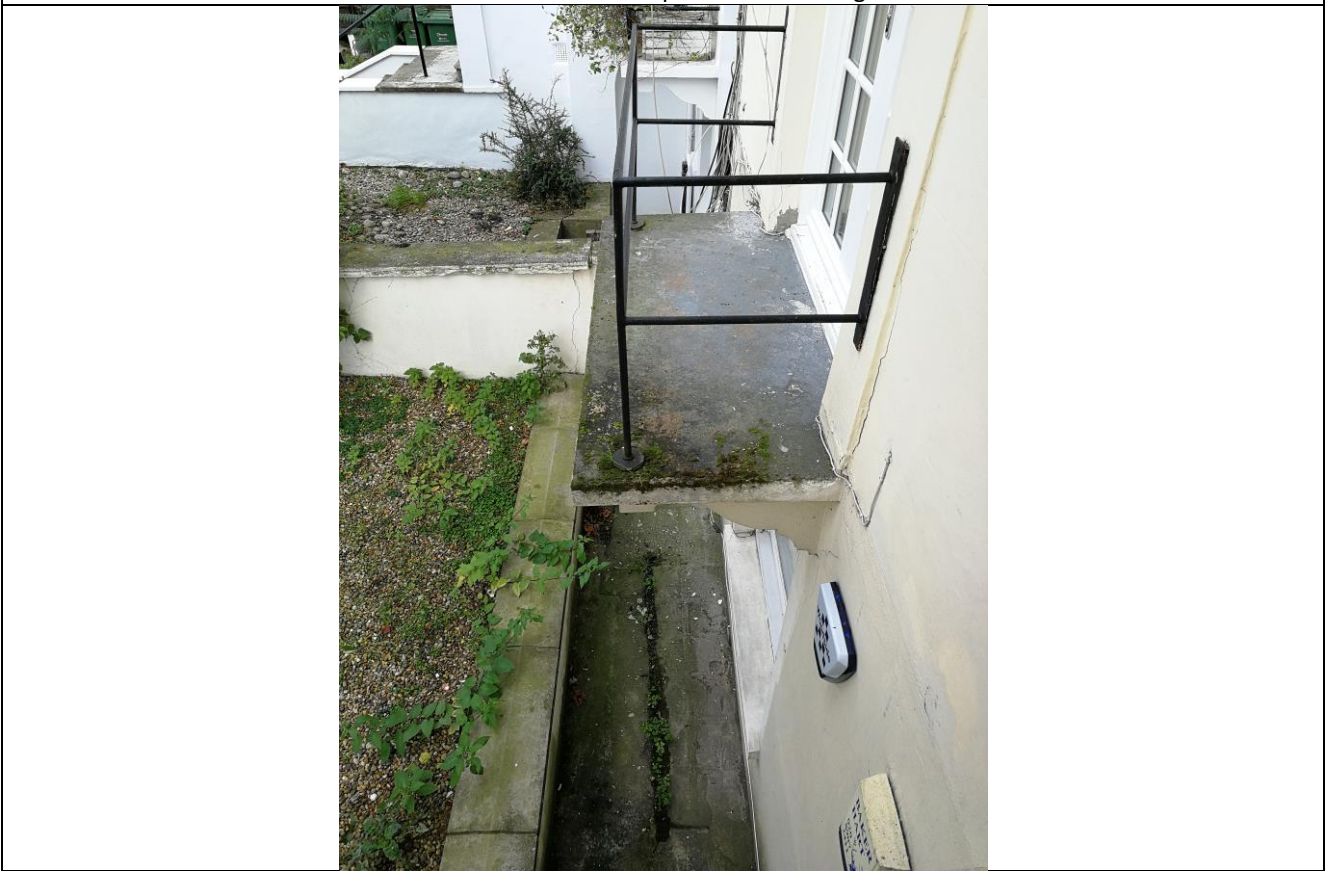
Photo 5 – First Floor projecting balcony railings

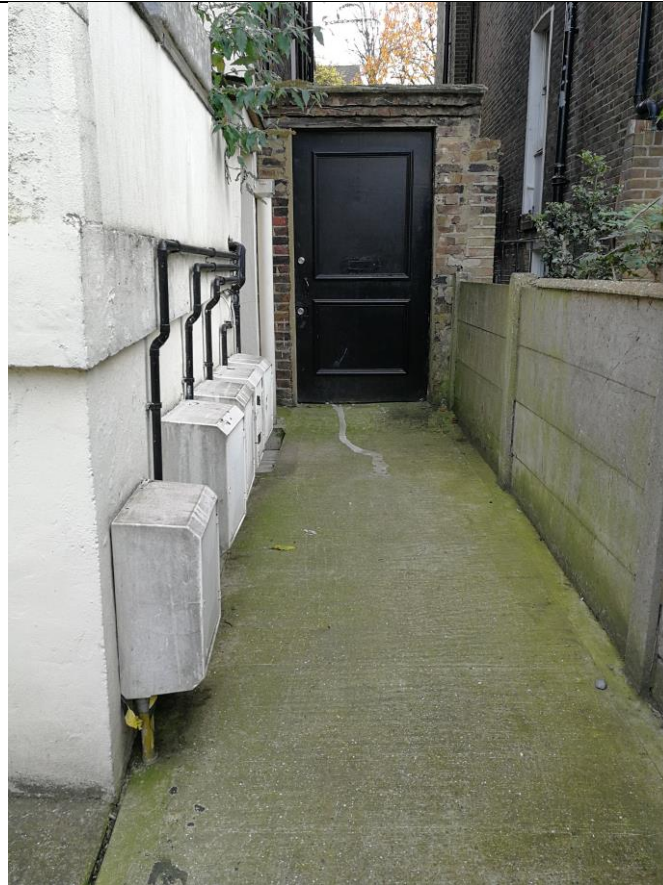
Photo 6 – Right flank wall of entrance steps. External gas meters.

Currently the gas meters for each of the residential flats are located on the right flank elevation wall of the entrance steps. The schedule of works includes the design and installation of an external brickwork cupboard to enclose these. This construction will have a slate roof and timber doors. This is designed to enhance the appearance of the side of the property and the access to the Lower Ground Floor flat and rear access path.

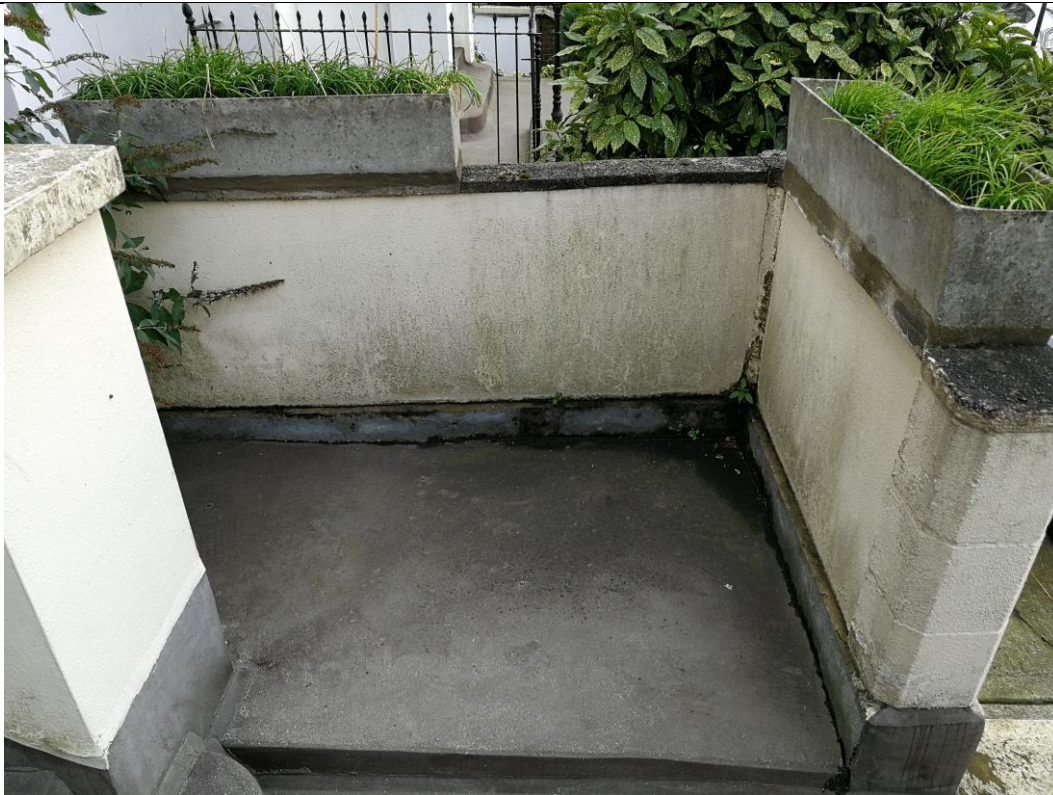
Photo 7 – Section of flat roof to the right hand side of the entrance step. Blockwork parapet wall detail.

This design will require the removal of a poorly constructed blockwork painted wall that forms the current perimeter of the flat roof and the formation of a low parapet, to which the metal railings will be installed to.

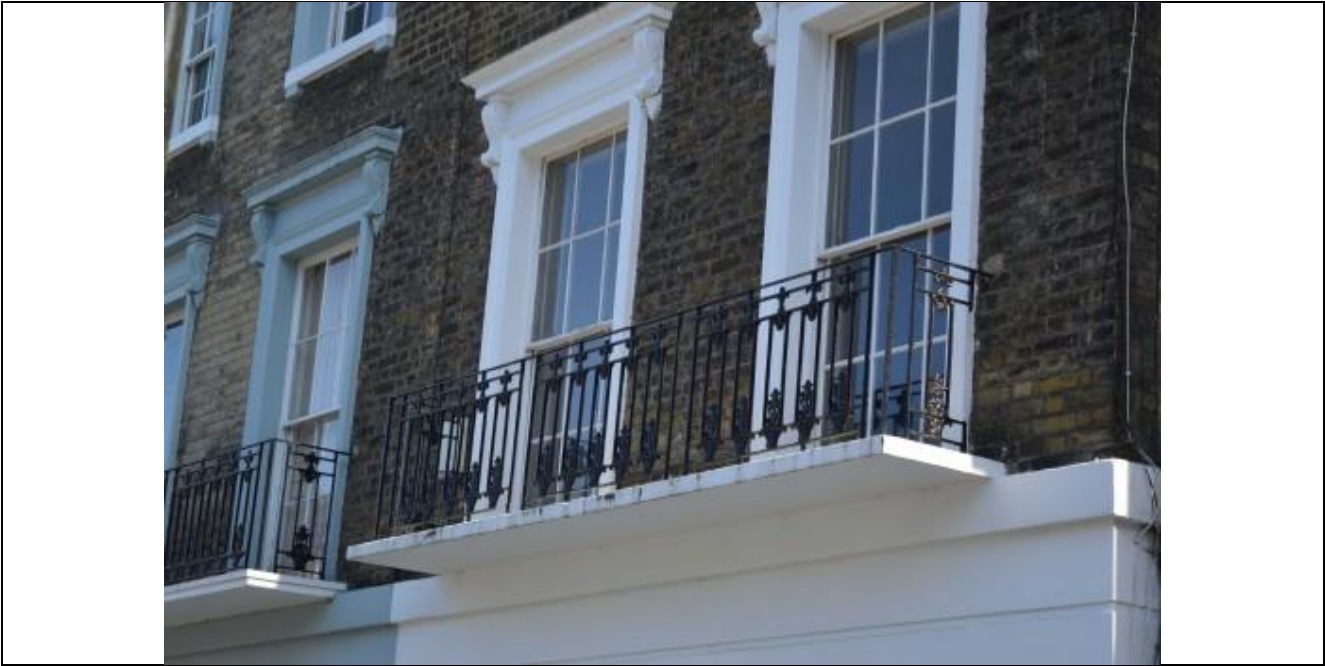
Photo 8 – Proposed cast iron railing detail for replacement balcony railings

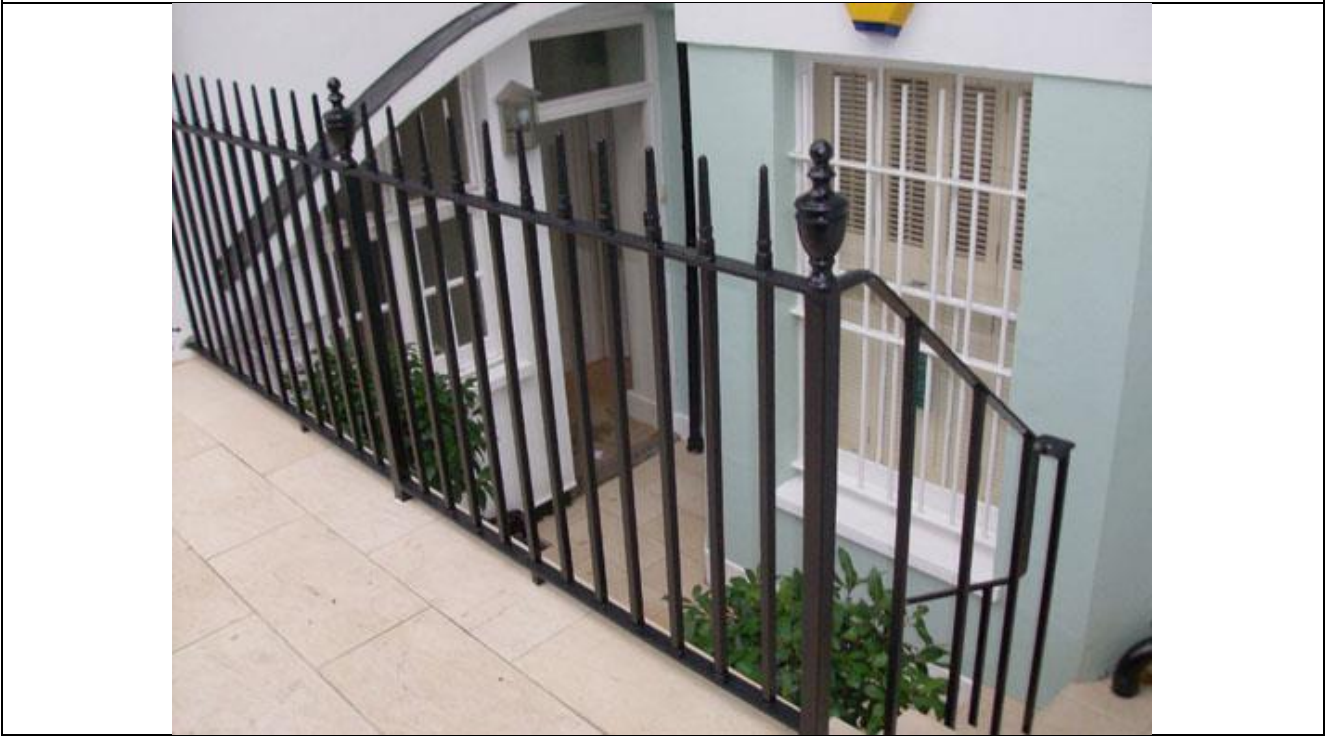
Photo 9 – Proposed railings detail for the perimeter of the small flat roof over the entrance steps

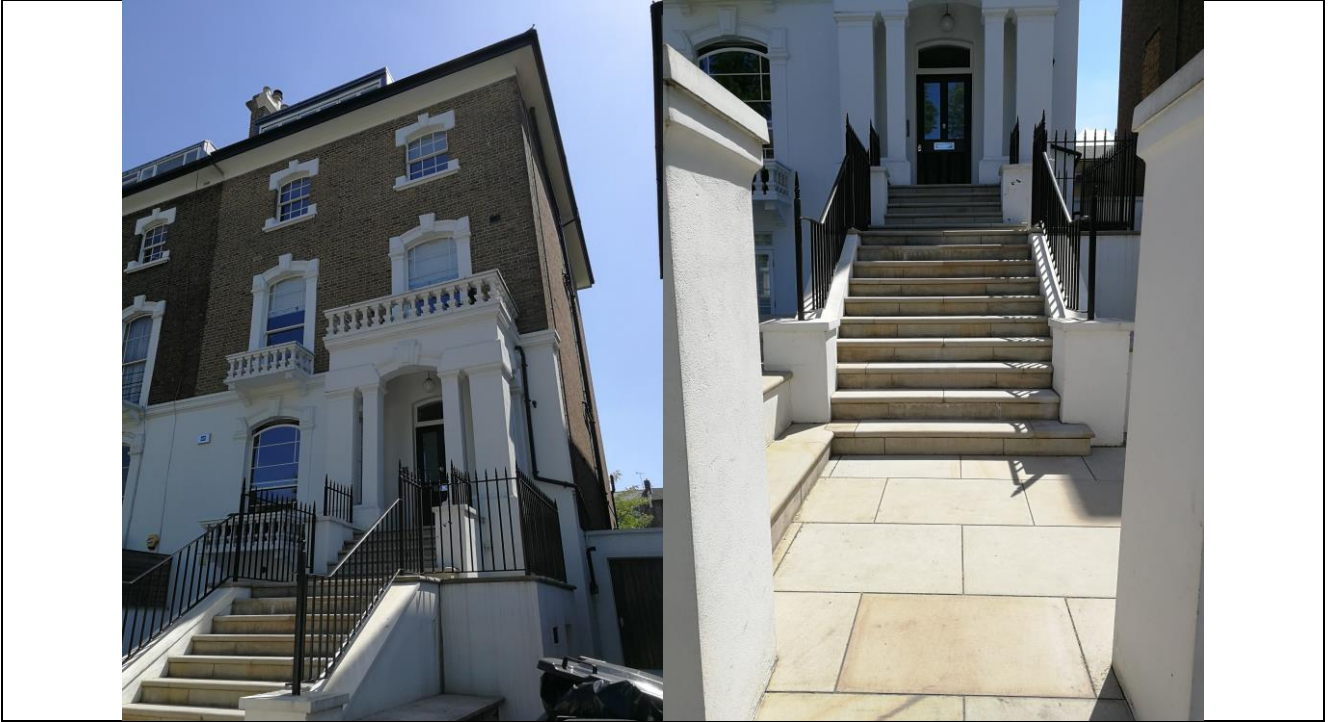
Photo 10 – Adjacent property entrance steps and railings, to be replicated. No.236 Camden Road.
