Our reference: K34  
25<sup>th</sup> October 2018

**Tree management at 107 Highgate West Hill**

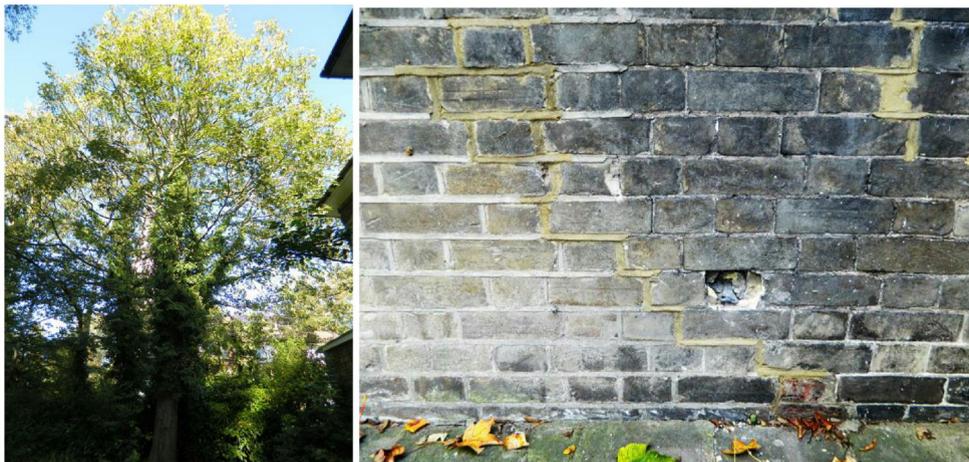
3. Sycamore T1 is a mature tree with a single upright main trunk which is in good health and has a long life expectancy. It has been crown reduced in the past but has received no attention within about the last decade. The tree is very close to the house (approx. 4 m away) and there is evidence in the form of external diagonal stepped cracks that the tree has contributed to a minor episode of subsidence (Figure 1) to the main house and single storey extension.

**Figure 1.** Sycamore T1 (left) and current and repaired crack damage (right)

4. Sycamore T1 is too close to the house to be retained without it being controlled to minimise the future potential to cause subsidence damage. I recommend that the tree should be crown lifted to 8 m by the removal of low branches back to the trunk and the shortening of low hanging branches back to a growth point. It should also be crown reduced by 25% (3 m height reduction taking the height from 16 m to 13 m and 3 m crown diameter reduction taking crown diameter from approximately 10 m to 7 m).

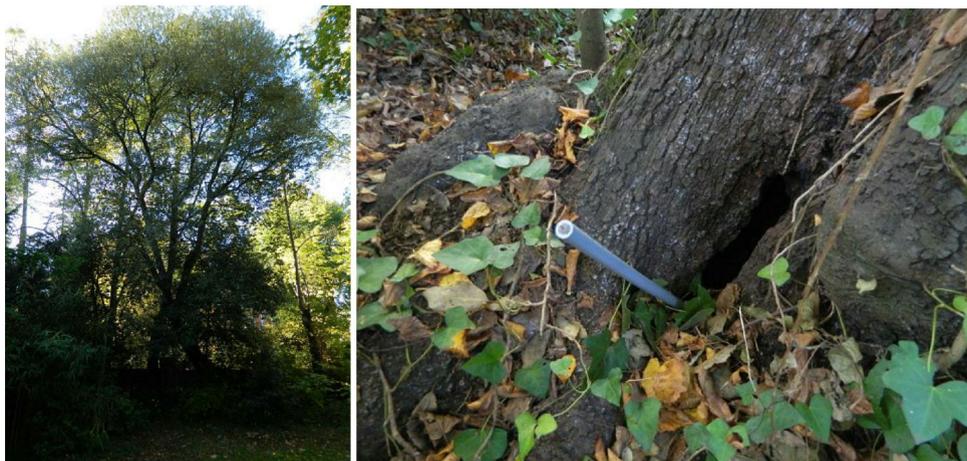
9. T6 is a mature holm oak which leans to the east, towards the house and has most of its crown over the garden casting dense shade for much of the day. There is a cavity at the base of the trunk which leads into a hollow central area. A probe was inserted into the cavity and revealed a void to a depth of 1.2 m indicating that the former tap root has become totally decayed. The cavity extended 300 mm horizontally into the tree, i.e. almost half of the trunk diameter. In view of the extensive decay the tree cannot be regarded as safe, especially given its significant lean towards the house and the large weight of canopy. It is recommended that the tree should be felled and replaced.

**Figure 2.** Holm oak T6 with significant decay and internal void – to be felled.
