1 Chamberlain Street

**Statement Related to Approval of Conditions Associated with Application-
2017/4723/L**

Revision 1

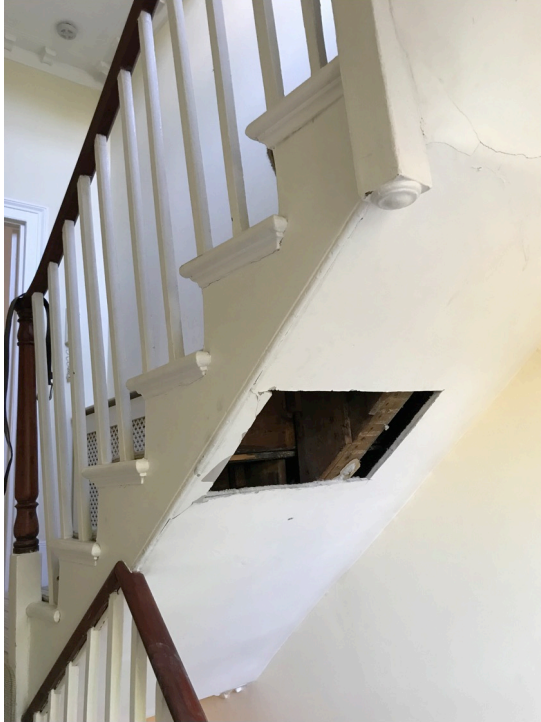
Stairs First floor to Second floor

It is proposed that the leaning stair flight from first to second floor is replaced due to the structural instability.

This statement is accompanied with a report from structural engineer's Michael Chester and Partners who have assessed the stair and summarise that a new stair is the only feasible option.

The new stair will match the existing with softwood timber stringers, treads and risers, square section spindles, painted. Timber handrail reused if possible and repolished as existing, newel posts reused if possible or to match existing. Detailing will be as existing.

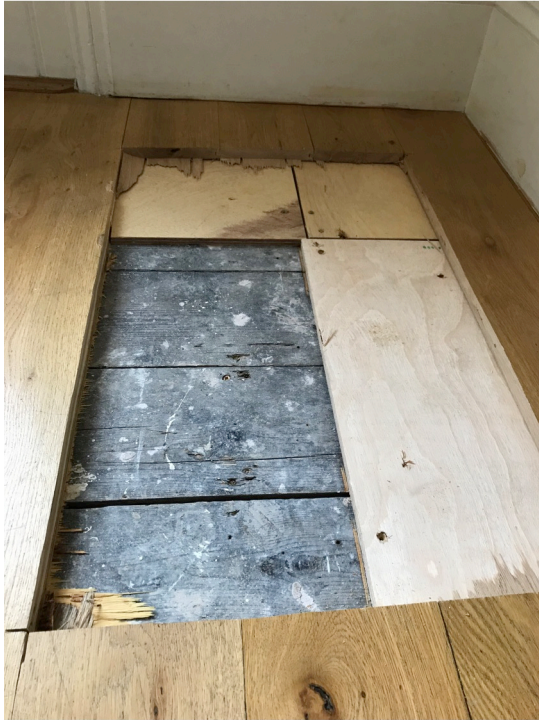
Ground Floor- Existing Floor Materials-
18mm non-original floorboards, 12mm plywood, older floorboards

Ground Floor- the existing non-original boards and 12mm plywood are taken up to expose the existing floorboards. The existing floorboards will be left insitu and new floorboards laid onto the existing boards.

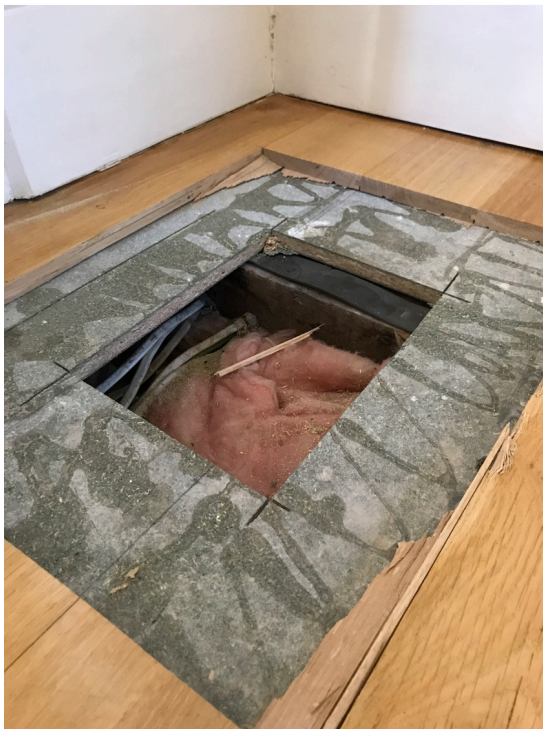
First Floor- Existing Floor Materials-
18mm non-original floorboards, 18mm chipboard

First Floor- the 18mm non-original floorboards and 18mm chipboard are removed and new floorboards laid onto the existing joists. Underfloor heating between joists.

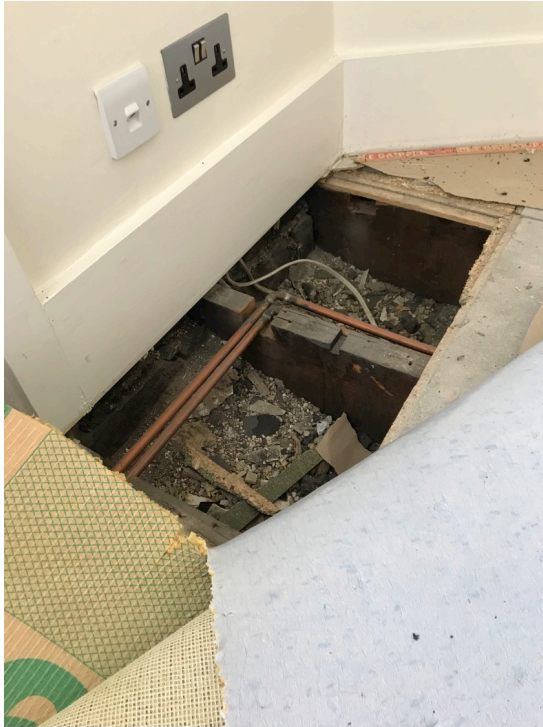
Second Floor- Existing Floor Materials-
carpet / 18mm chipboard

Second Floor- the carpet and 18mm chipboard are removed and new floorboards laid onto the existing joists. Underfloor heating between joists.

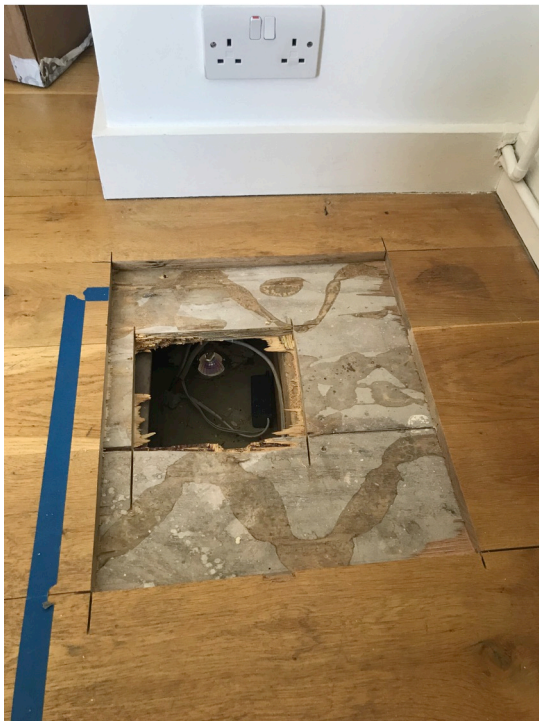
Third Floor- Existing Floor Materials-
18mm non-original floorboards / 18mm plywood

Third Floor- the 18mm non-original floorboards and 18mm plywood are removed and new floorboards laid onto the existing joists. Underfloor heating between joists.
