MICHAEL CHESTER & PARTNERS Consulting Civil and Structural Engineers
8 Hale Lane London NW7 3NX tel 020 8959 9119 fax 020 8959 9662 mail@michaelchester.co.uk

Our Ref: 17125

24th October 2018

1 CHAMBERLAIN STREET, LONDON NW1

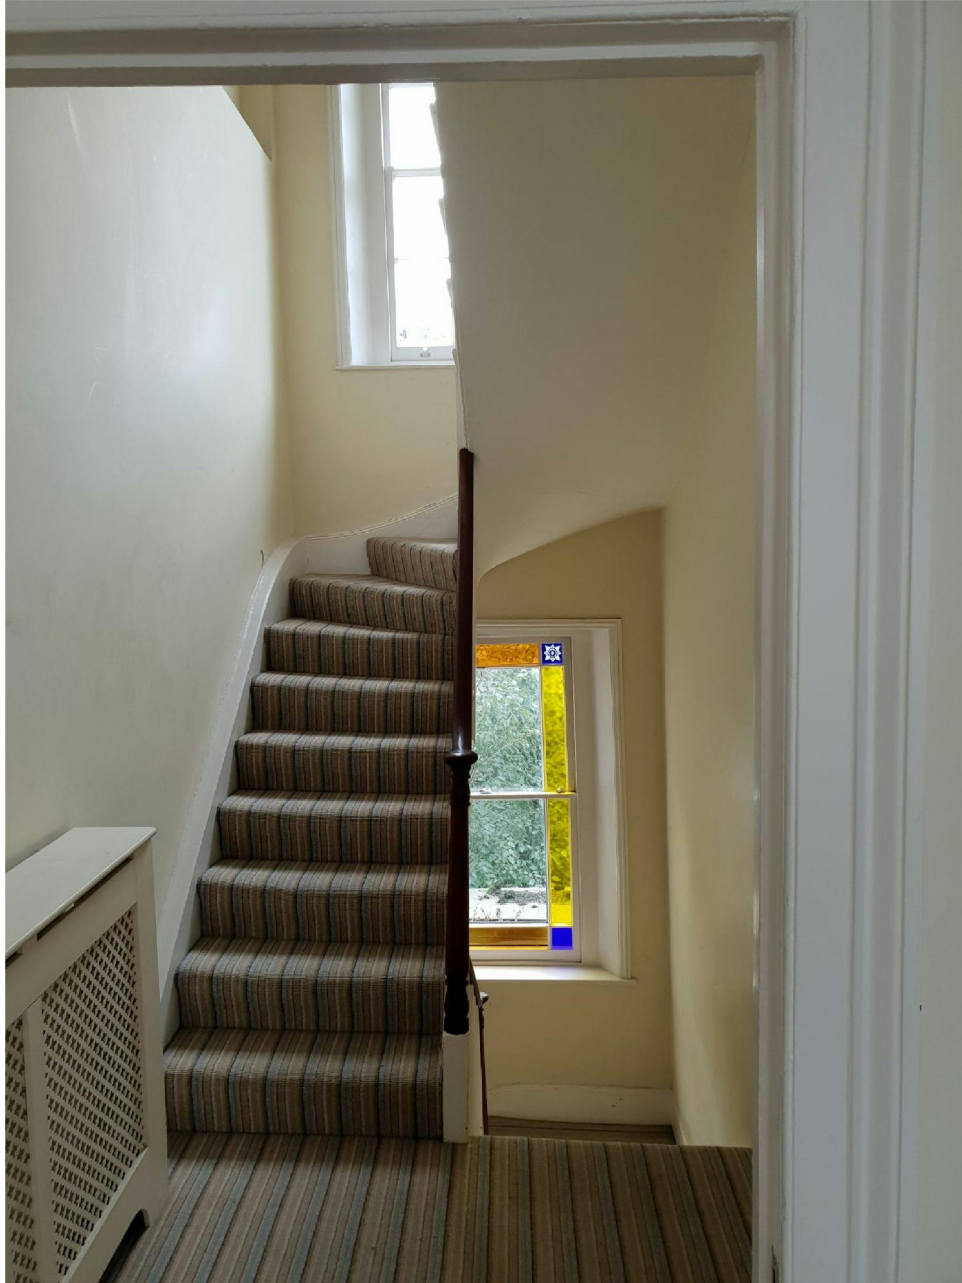
PHOTOGRAPH 1: first to second floor flight

The part of the stair in question is the first to second floor flight, see photograph 1, though similar concerns but to a lesser degree have been raised about the flight from second to third floor levels. Even from the photograph it is clear that the first floor stair is dropping significantly around the central newel post; this was measured at about 50mm. The thickened skirting board along the party wall also suggests that the stair is pulling away from the wall, compare this for instance with the more "normal" skirting at the half landing below in the same photograph.

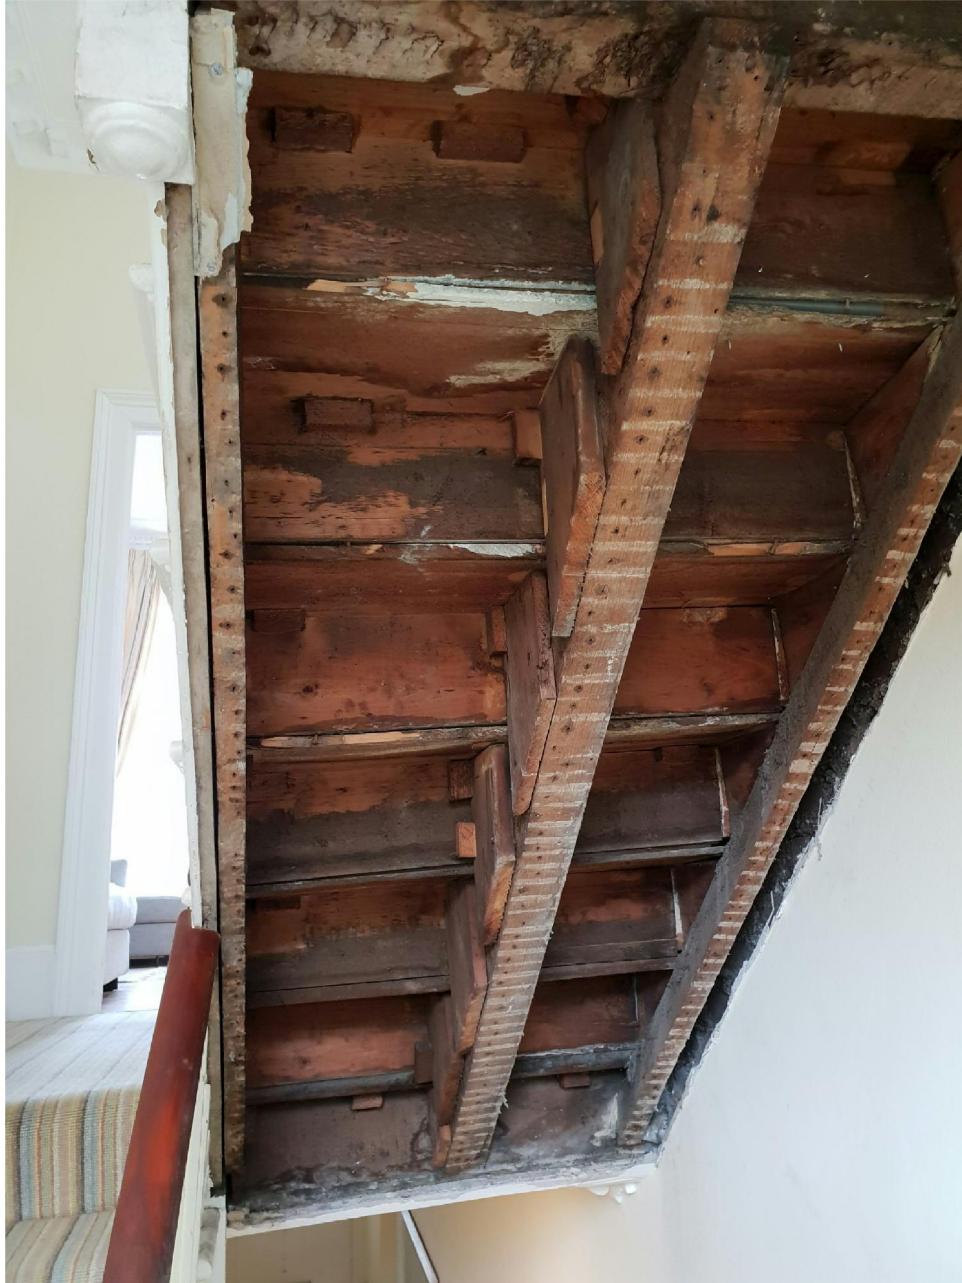
PHOTOGRAPH 2: underside of flight, lathe & plaster removed

Investigations were limited to the lower flight of this section of stair and the lathe and plaster had been previously stripped to allow a closer inspection of the underside of the first flight of the first to second floor stair, that is, the flight from first floor level up to the winders against the rear wall – see photograph 2.

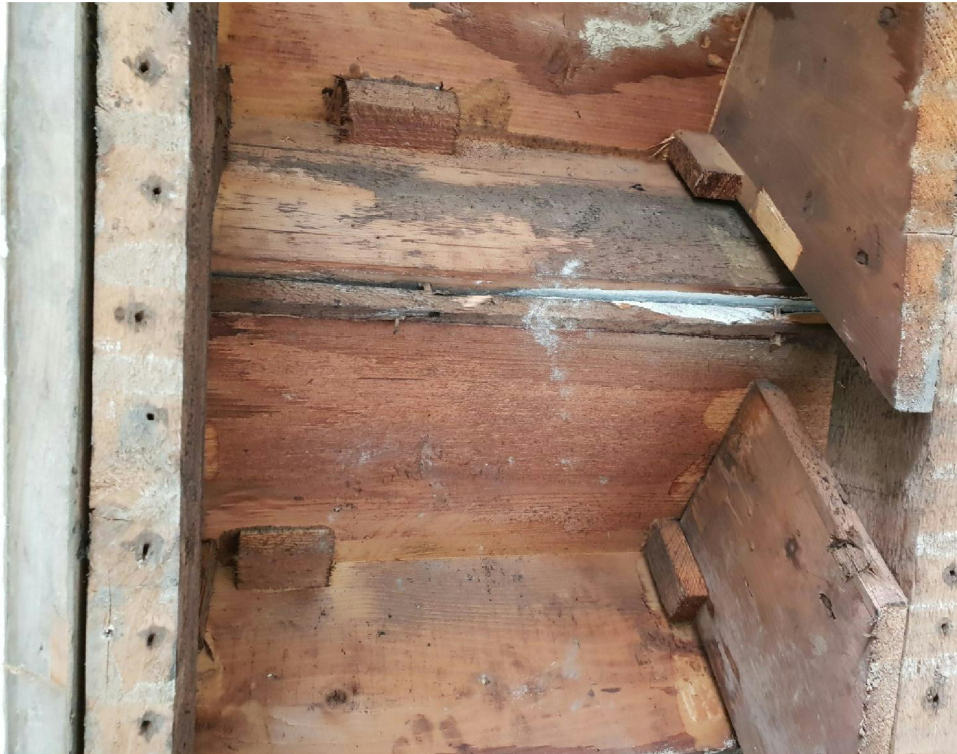
PHOTOGRAPH 3: first to second floor flight

It was clear even from a precursory inspection that the stair structure is in some distress. There has been some 10mm of movement in the plane of the stair causing the nailed joints between the goings and the risers to open up; most of the goings at these joints had split, see photograph 3. Many of the mitred joints between the risers and the internal stringer had also opened up and a significant number of the blocks intended to fix the goings and risers together were missing. The stair has also pulled away from the party wall by at least 25mm causing the risers and goings to pull out of original stringer which was still apparently securely fixed to the wall, see photograph 4. Previous repairs between the carriage beams and the original risers, goings and stringer have also failed.

It is difficult at this point to be sure of the cause of the failure of the stair but the structural integrity of these types of stair relies very heavily on the support at the foot of the stair and then on the fixity between the goings, risers and stringer. In this respect it is interesting to note that the trimmer joist which supports the stair at first floor level has dropped quite noticeably towards the wall which separates the stair from the rear ground/first floor reception rooms and that a section of this wall has been removed at basement level.

Any loss of support at the foot of the stair would certainly cause the sort of vertical and horizontal movements we see here and also this type of damage because of the subsequent overloading of all the associated joints. It is my view, therefore, based on what I have seen to date, that the cause of the stair movement is probably associated with the removal of the basement wall. There are no obvious signs of significant continuing movement in the stair wall (though there is a minor hairline crack over the ground floor door) so the loss of support may actually have occurred during course of the works rather than after it. This is quite common in situations like these where contractors think stair walls are non-structural because the main floor joists span from front-to-back and so provide these walls with limited temporary support.

Unfortunately, given the degree of damage, it is difficult to see how the stair could be successfully repaired in situ. So many of the goings and risers would need to be removed and replaced that only the very slender carriage beams would remain. This would be very unstable structurally but it would also result in a significant loss of the original fabric. Even if the damage is less extensive in the upper section of flight (which we have not inspected), just the removal of the lower flight would be such a major disruption that the upper flight would probably not survive.

Whilst it is always a shame to lose this type of original feature, given the extent of the damage, replacement with a new stair would seem to be the sensible option from a purely structural point of view.
