## **1.0 Brief**

- 1.1 This report has been prepared for Mrs Candice Hurwitz as detailed in our fee quotation dated 25<sup>th</sup> June 2018.
- 1.2 CTP were instructed by to carry out a visual structural inspection of 6 Sharples Hall Street, London, NW1 8YL.

## 2.0 Introduction

- 2.1 6 Sharples Hall Street is a Grade II listed terraced property in Primrose Hill. The building dates from the early 1860s and is a three storey townhouse with partial basement, similar to others in the terrace. To the rear is a small, part three storey and part two storey extension.

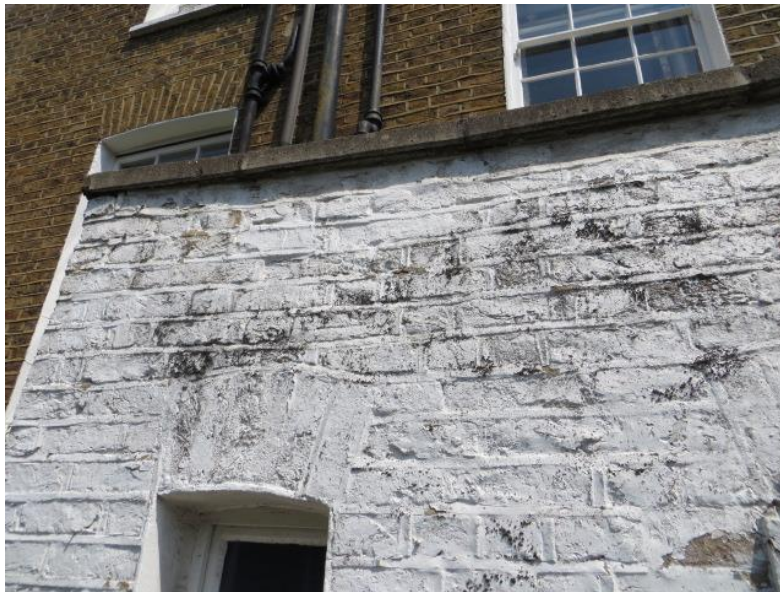
- 3.2 The rear extension has been painted in a latex-based white paint. This is not breathable and so water has become trapped within the masonry behind, freezing and causing damage to the brickwork and mortar. This paint should be carefully removed by an approved method. Trials should be carried out to determine the safest way to remove this layer, and if required the extension re-coated in a limewash or similar.

**Photograph 3 - White latex paint to rear extension causing damage to brick faces**

- 4) Remove all overgrown and unwanted vegetation in the rear garden to enable a thorough inspection of the existing retaining wall and party wall structures.
- 5) Clean all external brickwork of latex based paint coatings.
- 6) Monitor the extension balcony parapet walls for further movement.
- 7) Allow for structural works as outlined in SK03 and SK04.

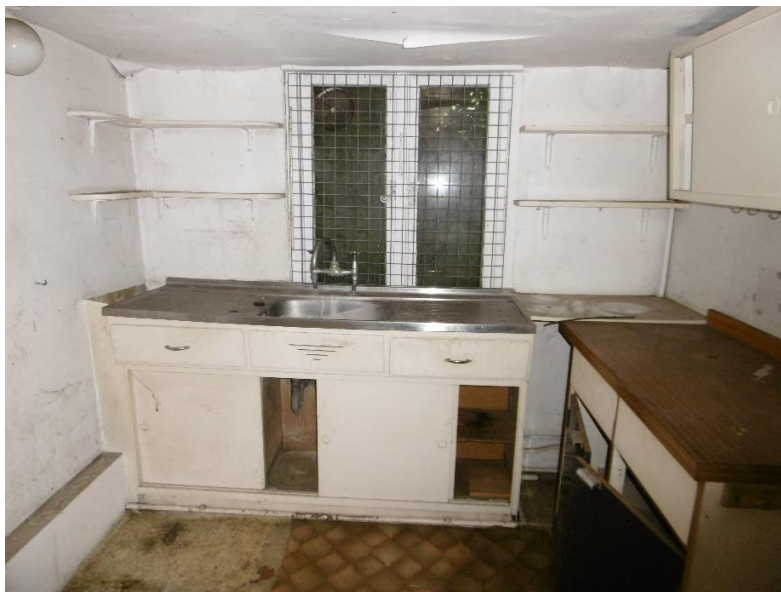
**Photograph 4 - Shallow ceiling height in basement**

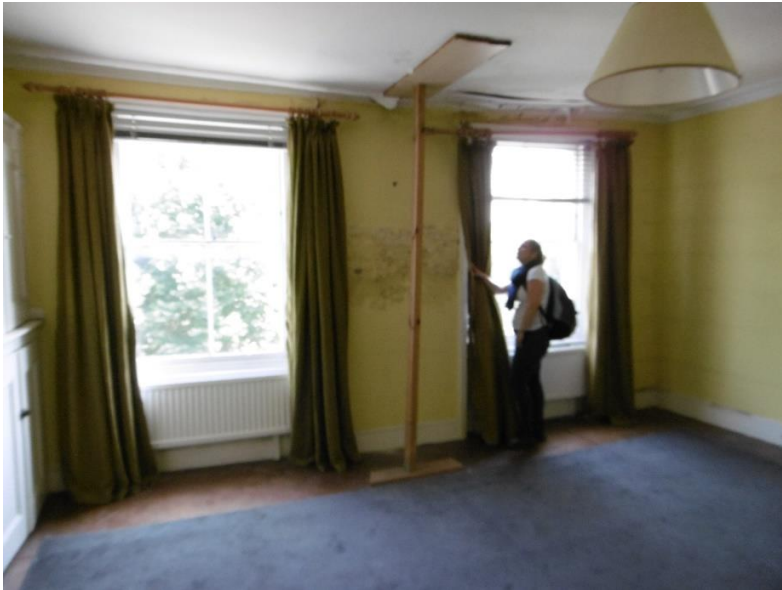
- 3.8 Of greatest concern in this building is the condition of the butterfly roof. Historically there has been significant water ingress at either end of the central valley gutter. Within the second floor front room the ceiling is currently propped with a timber piece.

- 3.10 The pitched roof appears to be 'cut and pitch' timber construction, with pitched rafters supported on the party walls and assumed to be picked up on a pair of valley gutter beams. The concern is that the connection of these valley beams to the external walls has been compromised by water ingress. These beams are likely to be timber and therefore may be rotting, reducing their connection to the walls and their tying action which will be restraining the walls. There is concern that if this is not addressed there is a risk of the roof collapsing.

**Photograph 5 - Second floor front bedroom ceiling propping**

- 3.11 As a first stage it is recommended that the ceiling be opened up as a priority to review the connection detail and condition of elements. Access should also be gained to the roof space to confirm the general condition of rafters, but this alone would not allow sufficient access to the valley beam connection. Once the beam size and connection has been determined then remedial works can be proposed. The aim would be to retain as much of the structure as possible, and possibly splice a new connection for the decayed end sections. It will be important to ensure a good connection to the wall to reinstate any tying action

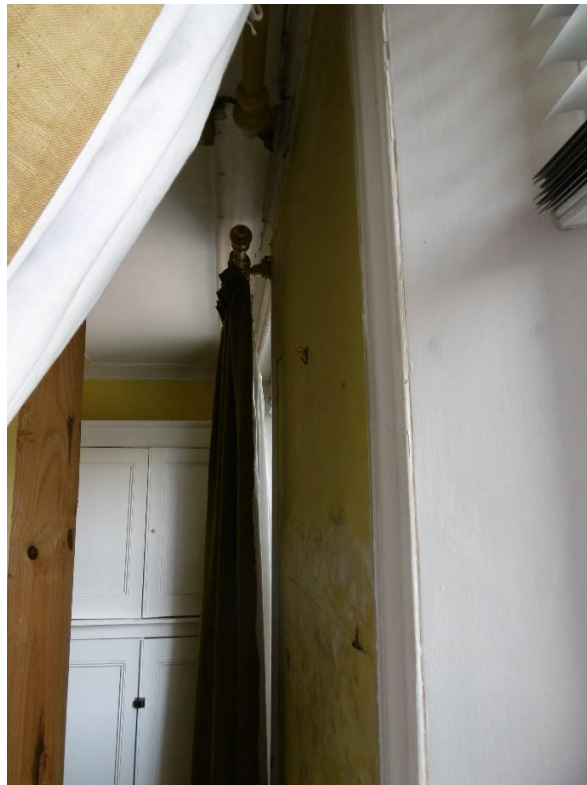
- 3.9 The front and back walls are exhibiting signs of bowing and movement around the centre. The rear wall in particular appears to be moving away from the internal dividing wall, indicated by the vertical crack which has opened up.

**Photograph 6 - Bow to second floor front wall at roof level**

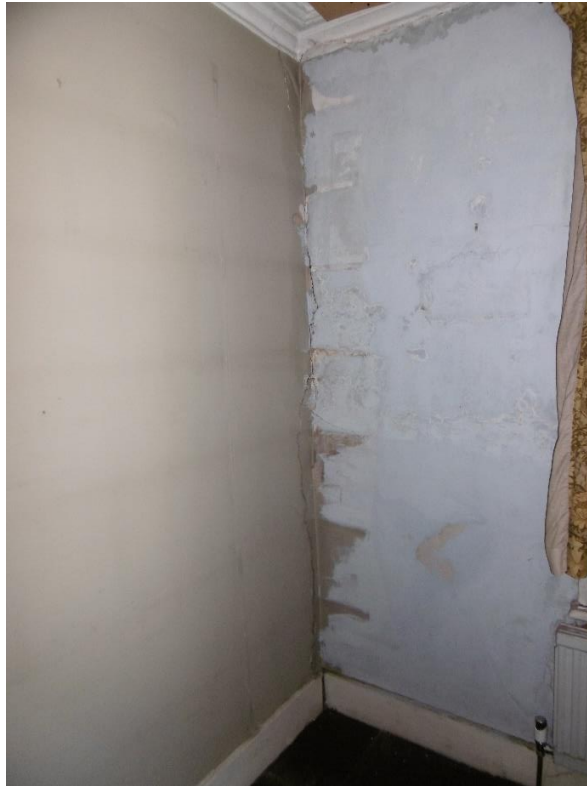
**Photograph 7 - Cracking to cross wall with rear wall at second floor**

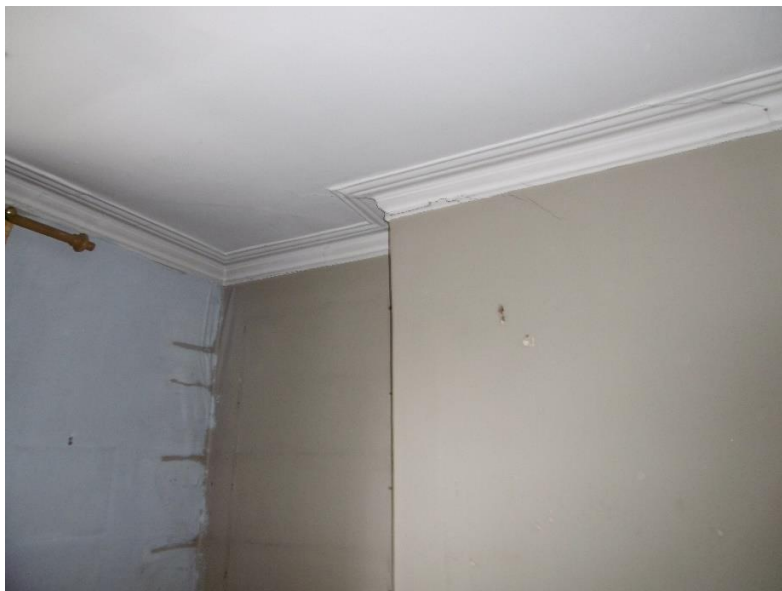
- 3.12 The base of the rear wall shows cracking at the junction with the floor level. This implies that the joist connection tying the wall may be failing. It is therefore recommended that opening up be carried out at this location to confirm the condition of the joist ends and their connectivity to the wall.

**Photograph 8 - Cracking to ceiling and party wall at rear wall**

- a) Opening up the floor to the rear wall at second floor to investigate the joist connection.
  - b) Opening up to the extension bathroom floor to investigate the joist connection.

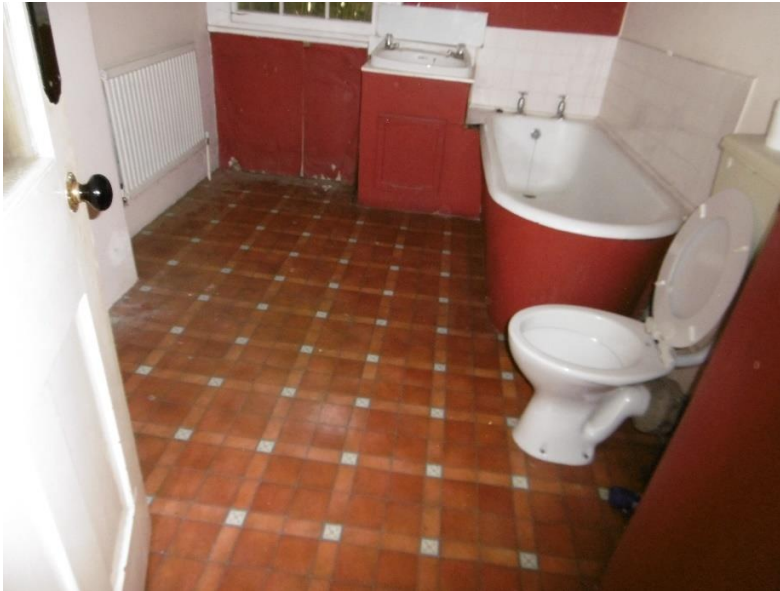
- 3.6 There is a bathroom within the rear extension at ground floor level. The floor appears to have sunk towards the rear wall. It is recommended to open up in this location to confirm the condition of the joists and their connectivity into the wall for tying action.

**Photograph 9 - Sag under rear extension ground floor window**

Carefully open up the floor under the window to confirm the floor joist bearing detail.

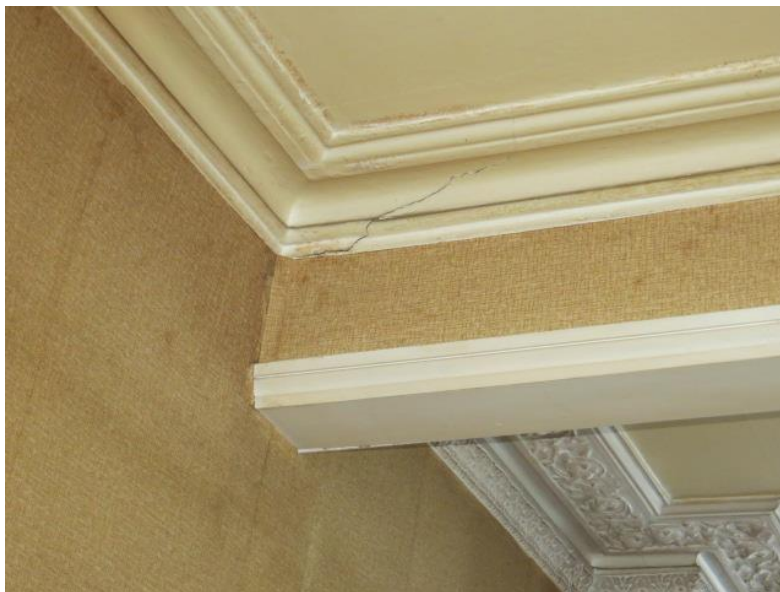
- 3.4 The opening through the drawing room at first floor appears to have previously widened. There is diagonal cracking at the corners of the opening where a lintel would be bearing. It would be prudent to open up in these locations to confirm the condition of lintel and bearing.

**Photograph 10 - Cracking to first floor opening around lintel bearing**

Carefully and neatly remove plaster either side around bearing to determine the lintel bearing detail and condition. Allow for 300mmx300mm openings. Do not damage cornice.

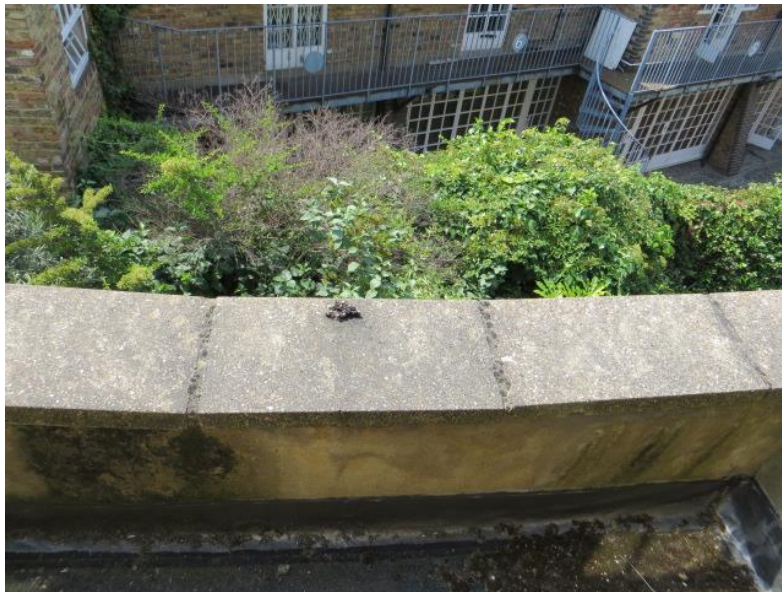
- 3.3 The parapet to the roof of the extension appears bowed, but there is no sign of cracking and a similar profile can be noted to parapets to the other terraces. It is recommended that no works be currently undertaken, but this should be monitored in the future for cracking or signs of movement. The gutter should be cleaned and maintained.

**Photograph 11 - Bow to parapet showing no sign of cracking**

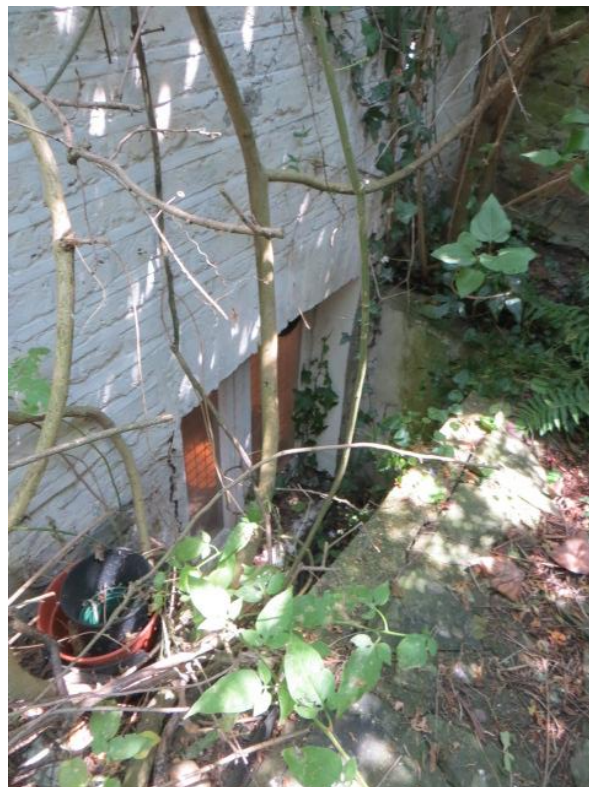
- 3.7 The rear wall of the extension is acting as a retaining wall for the garden, buttressing the sides of the lightwell around it. The wall appears to be bowing inwards, likely as a result of the lateral forces being applied to it. It is not known whether this movement is historic or ongoing. Opening up of the bathroom floor (above) will help show if the wall is suitably propped at ground floor level. Proposals to the rear garden will need to take into account the lateral pressures from the retained soil.

**Photograph 12 - Bow to rear extension basement wall and cracking at render**

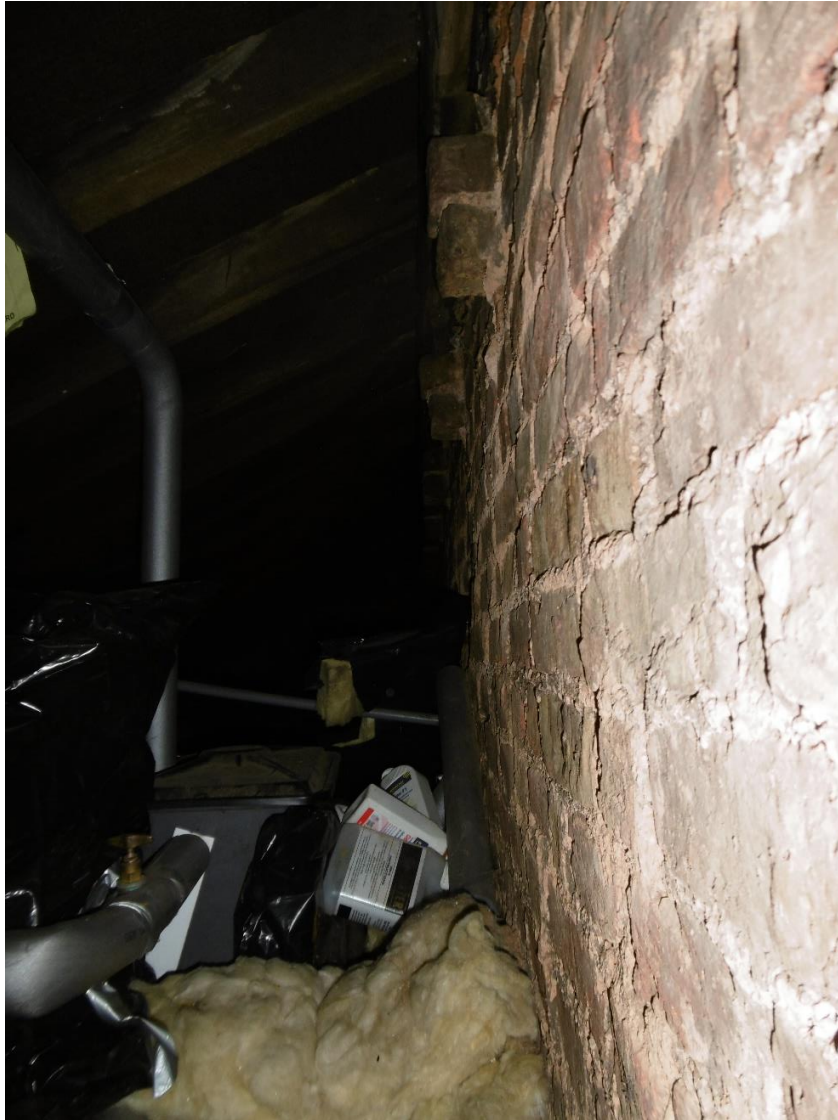
**Photograph 13 - Rafters to butterfly roof supported on corbels on party wall**
