## 106 ALBERT STREET, LONDON NW1 7NE

### SCHEDULE OF WORKS CARRIED OUT AND DESCRIPTION OF INTERVENTIONS OCTOBER 2018

This document provides information on the most recent alterations (post-consented 2014 scheme – REF: 2014/2836/P;2014/2964/L ) that have been identified as unauthorised. The information is arranged in a table format and includes photographs of the identified alterations as they exist currently and, where possible, older photos taken in 2002 and 2013.

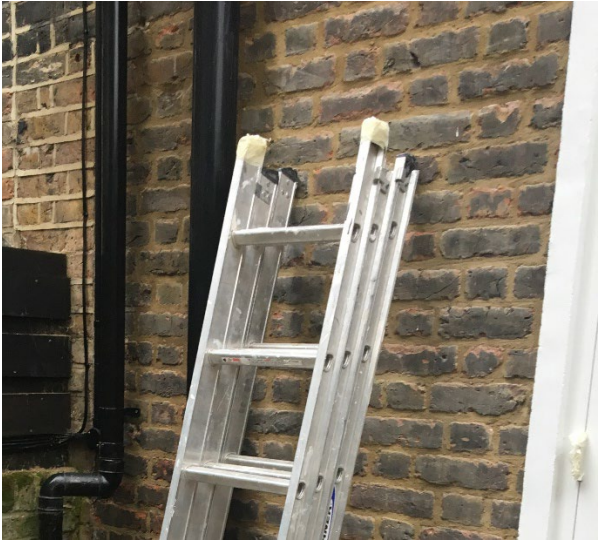
Schedule of Works and Impact Assessment					
Location and element	Action	Impact Assessment & Description of the Works/Intervention		Relevant Photographs (Current – post consented 2014 refurbishment)	Relevant Photographs (2002, 2013 and 2014 works)
Rear Elevation					
Rear elevation - Repointing of brickwork	Apply for LBC	<p><b>Minor-Moderate / Beneficial</b></p> <p>Prior to the most recent works, the brickwork to the rear elevation was in poor condition. The ribbon pointing and hard cement mortar were harmful to the appearance of the building. It was also encouraging water retention and evaporation through the bricks.</p> <p>The new mortar is repointing to a brushed finish – mix 5 sharp: 1 soft: 1 cement: 1 lime with recessed profile. This is a more compatible ratio for the historic bricks and the profile and brushed finish are suitable.</p> <p>The removal of the hard cement mortar has caused some damage around the edges of the bricks, however, in the long term, the repointing with the current mortar improves the breathability of the wall and overall condition of the building.</p>

<p>Figure 2: Current rear elevation, brushed pointing.</p>

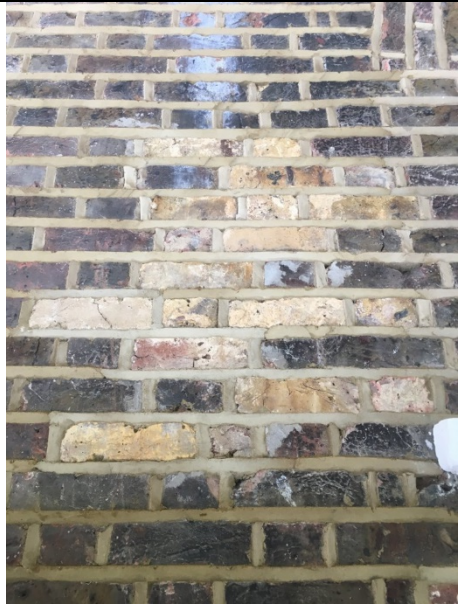
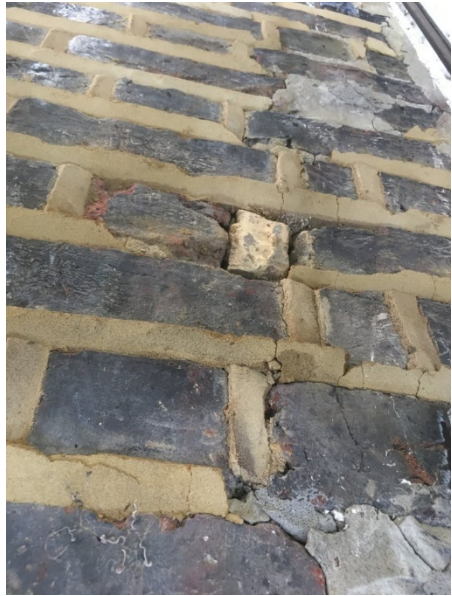
<p>Figure 3: Cement ribbon pointing carried out as part of the works in 2014.</p>

<p>Figure 4: Cement ribbon pointing carried out as part of the works in 2014.</p>

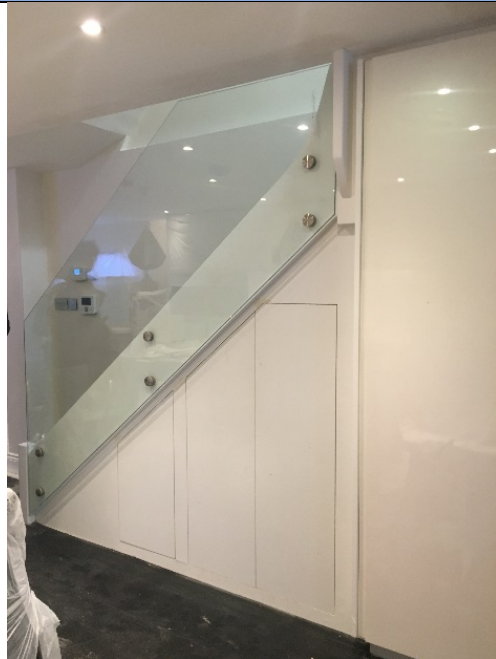
Schedule of Works and Impact Assessment					
Location and element	Action	Impact Assessment & Description of the Works/Intervention		Relevant Photographs (Current – post consented 2014 refurbishment)	Relevant Photographs (2002, 2013 and 2014 works)
Lower Ground Floor					
Glass balustrade to stairs	Replace existing balustrade with simple timber one with timber handrail. Details to be approved via conditions.	<p><b>Minor / Beneficial</b></p> <p>Originally, this staircase would have had a simple bannister in keeping with the utilitarian character of the basement level.</p> <p>Prior to the works carried out in 2014, the basement level was a separate residential unit. It was brought to 21<sup>st</sup> century standards as part of the 2014 works and amalgamated with the house, as originally intended. This new glass balustrade is a contemporary addition to the later staircase from the latest phase of works.</p> <p>The entire basement level has a contemporary design and it was largely altered in the 2014 works, including the lowering of the floor, the removal of partitions, new finishes and a new kitchen. The proposal for this staircase in the 2014 application was to “reinstater bannister to match extg. at other levels” (see Figure 8). This was consented, however, it would have been inappropriate to replicate the bannister on the upper levels, as this would have not been in keeping with the original hierarchy of the house and there would have been no differentiation between the utilitarian area and family living areas.</p> <p>The proposal is to reinstate a simple, ‘utilitarian’ balustrade. This will be timber with a simple timber handrail (see image below for intended design). Exact details to be approved via conditions.</p> <div>

</div> <p>Figure 6: Current balustrade.</p>

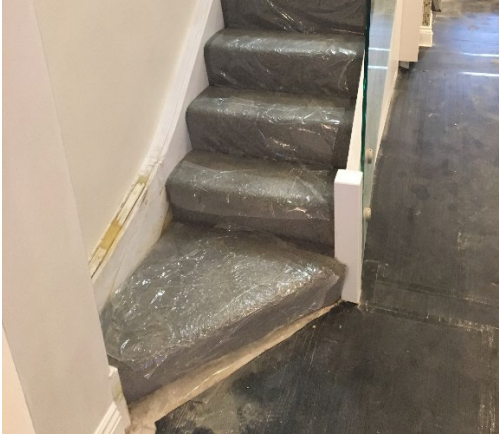
Schedule of Works and Impact Assessment					
Location and element	Action	Impact Assessment & Description of the Works/Intervention		Relevant Photographs (Current – post consented 2014 refurbishment)	Relevant Photographs (2002, 2013 and 2014 works)
Bottom tread of the staircase is angled	Apply for LBC	<p><b>Minor / Adverse</b></p> <p>The lower ground floor staircase is of lower significance and the alteration to the last stair tread does not detract from the historic character or legibility of the original layout or hierarchy. The removal of (potentially) historic fabric is minor.</p> <p>The lower ground floor staircase has been altered in the past and the lowering of the floor has necessitated the addition of a riser to accommodate the new level. The consented scheme from 2014 allows for this, however, the tread is different in form from the consented drawings. As this part of the stair is an addition and the skirting has been changed in previous interventions, the new stair does not impact any historic fabric.</p>

<p>Figure 7: Current - bottom tread at lower ground floor</p>

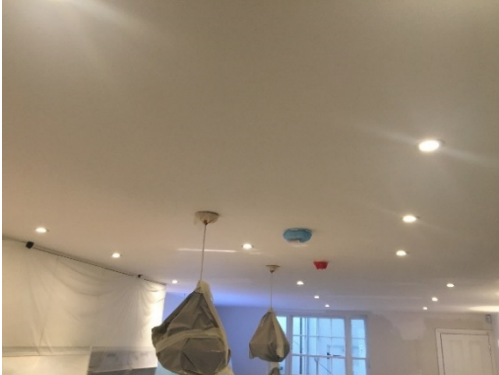
Spotlights throughout and wall mounted lights	Apply for LBC	<p><b>Minor Adverse</b></p> <p>The lower ground floor level has very limited visibility from the public realm. The lower ground floor is also of lower significance relative to the ground and first floors. There appears to be a suspended ceiling with embedded spotlights. Spotlights on this level are therefore very low impact and are of low visibility from the public realm.</p> <p>The spotlights are embedded in the ceiling. The window head to ceiling height difference appears to have been reduced, which suggests the ceiling is suspended. The 1978 application included 'fireproof partitions, door and ceilings', which comprised the addition of plasterboard lining to the ceilings. The fabric beneath the suspended ceiling is unknown.</p> <p>The wall mounted lights appear to be in the alcoves on either side of the chimney breast (see Figure 10).</p>

<p>Figure 9: Current ceiling with spotlights</p>

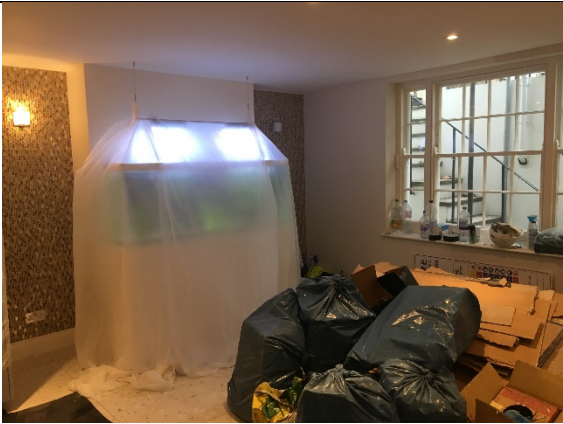
Cooking equipment installed adjacent to chimney breast in front room	No action needed	<p><b>Negligible</b></p> <p>Earlier photographs from 2014 and 2002 show that there was no fireplace in the front room at lower ground level in more recent years. The kitchen equipment was installed as part of the 2014 works (2014/2836/P) and clearly shown in the 'as proposed' drawings –no. 3013-00-011. Demolition drawing no. 3013-00-21 shows that kitchen units had already been installed, and the fireplace that was once there was already lost.</p> <p>Prior to the most recent works, there was no fireplace here. The chimney breast is still legible, arguably more legible than pre-2014 works (see Figure 11). It is in an area that has been altered in the past.</p>

<p>Figure 10: Chimney breast as existing.</p>

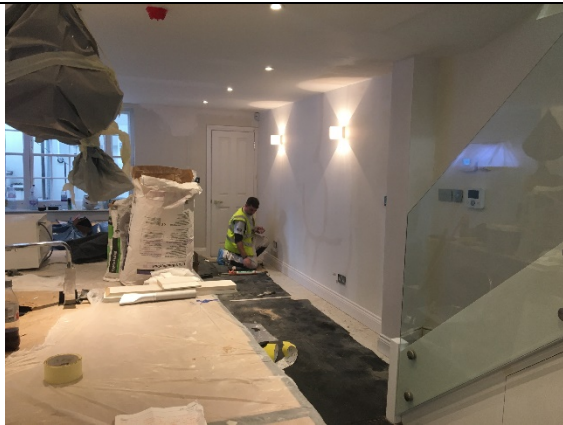
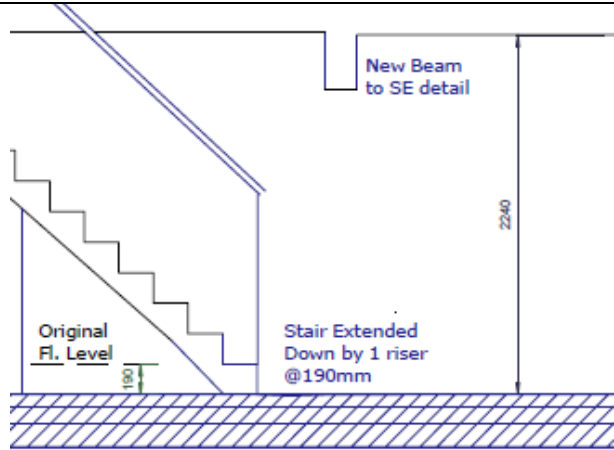
Schedule of Works and Impact Assessment						
Location and element	Action	Impact Assessment & Description of the Works/Intervention		Relevant Photographs (Current – post consented 2014 refurbishment)	Relevant Photographs (2002, 2013 and 2014 works)	
Between front and rear room - Removal of downstand	Reinstate a downstand of 300mm	<b>N/A</b>  As part of the 2014 application, partitions at basement level were proposed for removal. Mitigation measures for this was leaving nibs and a downstand to retain the legibility of the original layout (see Figure 13). As seen in Figure 12, the downstand has not been retained; the span may be supported by a new beam within the ceiling/ground floor.

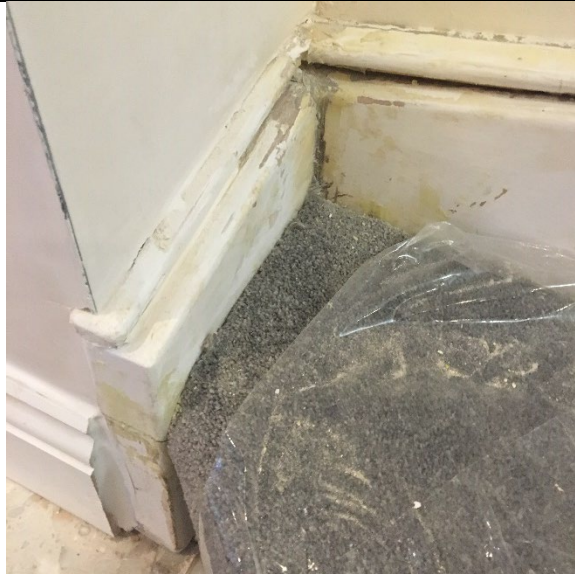
Historic Skirting Boards removed and replaced.	Apply for LBC	<b>Minor Adverse</b>  The basement floor was lowered by 150mm as part of the works in 1978. This was to create a more habitable space for the new single unit at basement level. Alterations to the joinery (including the skirting and doors) would have been inherent in the consented proposal to lower the floor level. There was further reduction in level by 190mm in the 2014 application (consented – see Figure 13).  The replacement of the previous skirting with the current is therefore negligible in terms of impact on historic fabric. The profile of the existing is marginally more embellished than what would have been there originally.

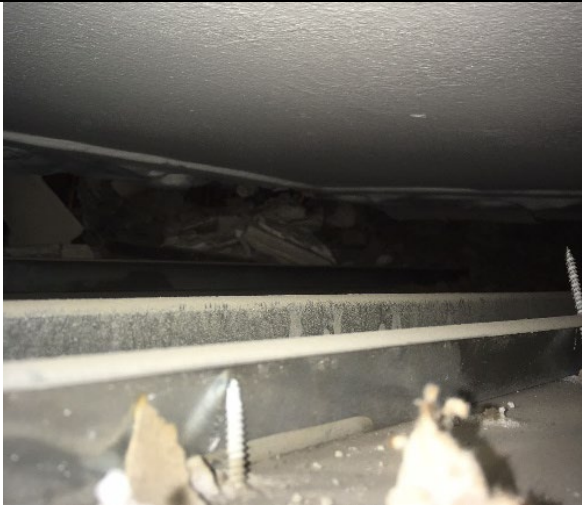
Ground Floor Level					
All rooms – suspended ceilings (concealing historic cornices)	Carefully remove the suspended ceiling and make good any areas that may have been damaged.	<p><b>N/A</b></p> <p>An appreciable difference was made to the historic character of the rooms. The suspended ceiling detracts from the historic patina of the house and the existing cornice is not historically in keeping with the period of the house.</p> <p>Camden’s September 2017 letter states ‘removal’ of cornice, whereas it appears to have been retained above the suspended ceiling, see Figure 17. The window head to ceiling height difference appears to have been reduced compared with earlier photos. Figure 18 shows a ceiling void above the suspended ceiling, and what appears to be the cornice in situ.</p>

<p>Figure 18: Image of void between ceiling and suspended ceiling. Cornice is just about visible in the background. It is likely these have all been retained. The image of the cornice from the 2014 D&amp;A statement shows a later cornice, possibly Arts and Crafts.</p>		
Front room, rear room and hallway - Spotlights	Carefully remove the suspended ceiling which contain the spotlights. Central pendants to be reinstated.	N/A  Both front and rear room appear to have a suspended plasterboard ceiling with embedded spotlights. These are to be removed.

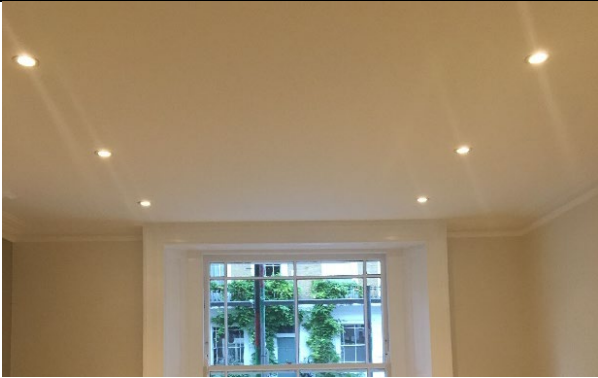
<p>Figure 20: Spotlights in front room - current</p>	<p>Figure 21: Photo from 2013. There is a larger gap between the window head and ceiling than in the existing.</p>

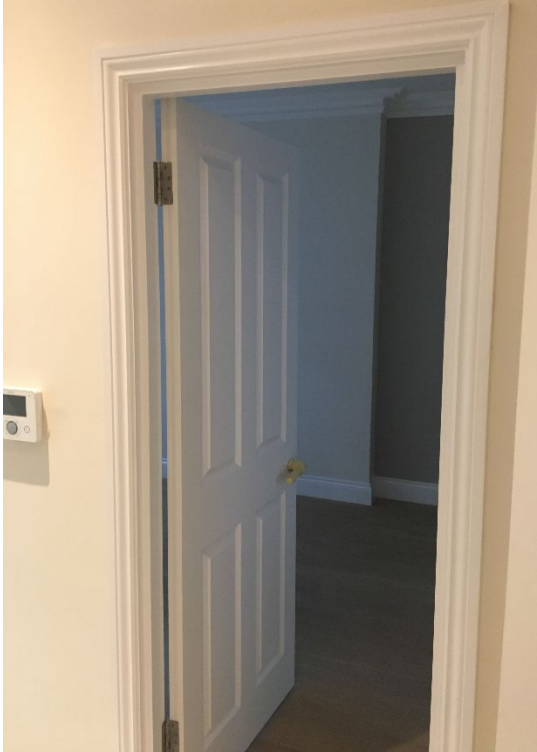
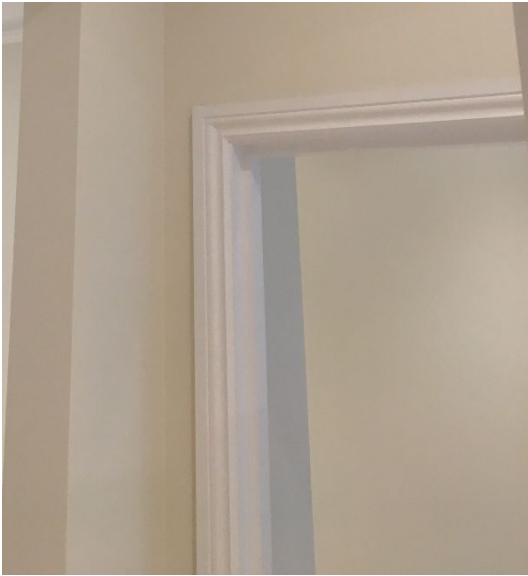
Schedule of Works and Impact Assessment					
Location and element	Action	Impact Assessment & Description of the Works/Intervention		Relevant Photographs (Current – post consented 2014 refurbishment)	Relevant Photographs (2002, 2013 and 2014 works)
Door to rear room	Reinstate door to match the original/ early door as seen in Figure 25. Details to be approved via conditions.	<p><b>N/A</b></p> <p>The door will be reinstated. The existing architrave in the rear ground floor room (Figure 23 and Figure 24) appears to match that of the first floor door architrave for the front room (see Figure 25 and Figure 26). Decoratively, it's very likely that these mouldings would have been the same for ground and first floor.</p>

<p>Figure 23: Existing door to rear room at ground floor</p>

<p>Figure 24: Existing architrave to rear room at ground floor</p>

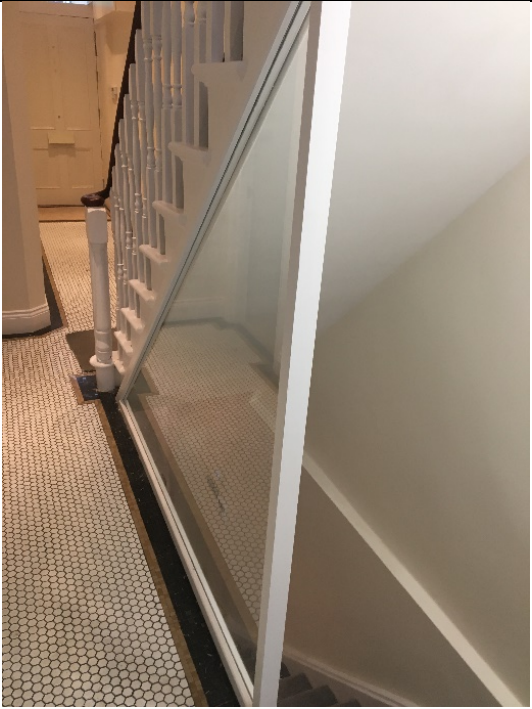
Figure 28: Existing door		
Hallway - Glass balustrade leading to lower ground floor	Replace with timber panel  Details to be approved via conditions.	<b>Minor / Beneficial</b>  Originally there would have been a stud wall, possibly panelled, to separate the servants from the main house and prevent odours rising from the kitchen.  This part of the staircase was concealed behind a partition wall as part of the conversion of the basement and ground floor into separate residential units (see Figure 22) in 1978. When the the house was reinstated into a single dwelling in 2014, the removal of the partition left the basement stairway open.  Removal of original fabric occurred during the 1978 works and subsequent phases of the subdivision.  The proposed timber panel will resemble the below image – taken from a house of similar period. The details are to be approved via conditions.

Figure 29: Glass partition for lower ground floor staircase – current

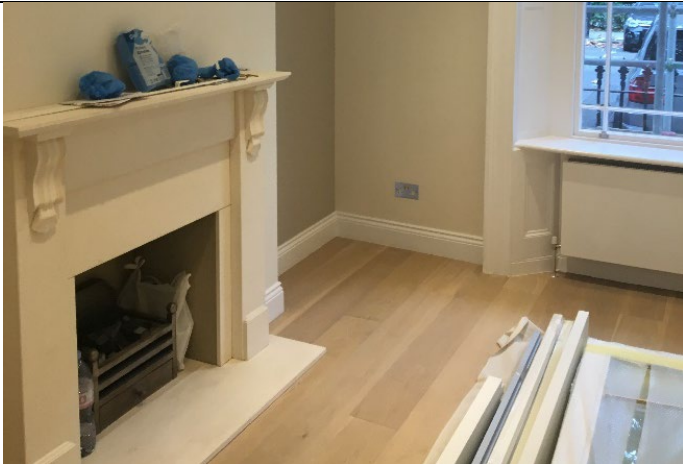
Front room, rear room and hallway - Floor finishes and skirting	<p><b>Apply for LBC for floor finishes and skirting in the hallway. Details to be approved via conditions.</b></p> <p><b>Replace existing skirting with one to match original material and profile as seen in Figure 33. Details to be approved via conditions.</b></p>	<p><u>Floor finishes and hallway skirting: Impact Minor / Adverse</u></p> <p>The floor finish in the rear room pre 2014 works appears to be either tiled or linoleum. The skirting in both rooms, as seen in the 2013 photos, was original.</p> <p>The front room floor, as seen in Figure 34, appears to be original.</p> <p>The floorboards were retained under the current floor finish. The finish is a laminate set on underlay.</p> <p>The skirting in the hallway that existed before the latest works was of a similar height and profile to the existing one (see Figure 40 and Figure 35). The impact is therefore minor.</p> <p><u>Skirting: Impact N/A</u></p> <p>The current skirting is lower than the original. The profile and material of the new existing are of a generic traditional design. Existing skirting is to be replaced with original design.</p>

<p>Figure 30: Floor finish and new skirting – current. It is unclear whether the original floorboards exist under the current floor finish.</p>

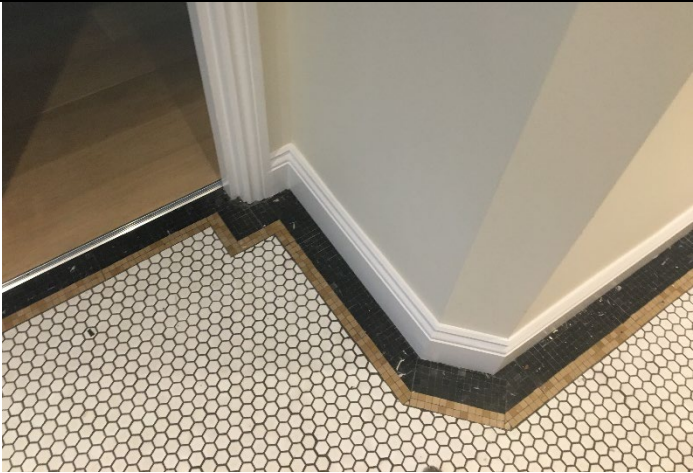
<p>Figure 32: Existing skirting in the entrance hallway</p>

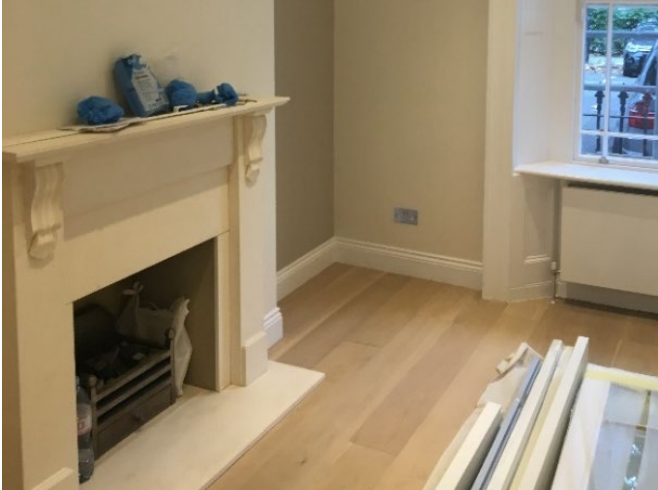
Figure 37: The full-length glazed doors were consented in the 2014 application.		
Front and rear room - Removed Fire Places	<b>Reinstate the fireplace in the front room as per original design (as seen in Figure 41).</b>  <b>Exact details to be approved via conditions.</b>	<b>N/A</b>  Photos taken before the 2014 works show that the rear room did not have a fireplace by the time the most recent works took place. There is no archival evidence of when it was removed (pre-listing or post listing).  The fireplace to the front room (see Figure 41) appears to be original and is fitting for a house of this status and period. The current fireplace is clearly recent, sits on a raised hearth and is inconsistent with the house's historic character in terms of proportion and detail.

Figure 39: Current fire place in front room	Figure 41: The photo of the front room from 2013 shows a fire place that is likely to be original.

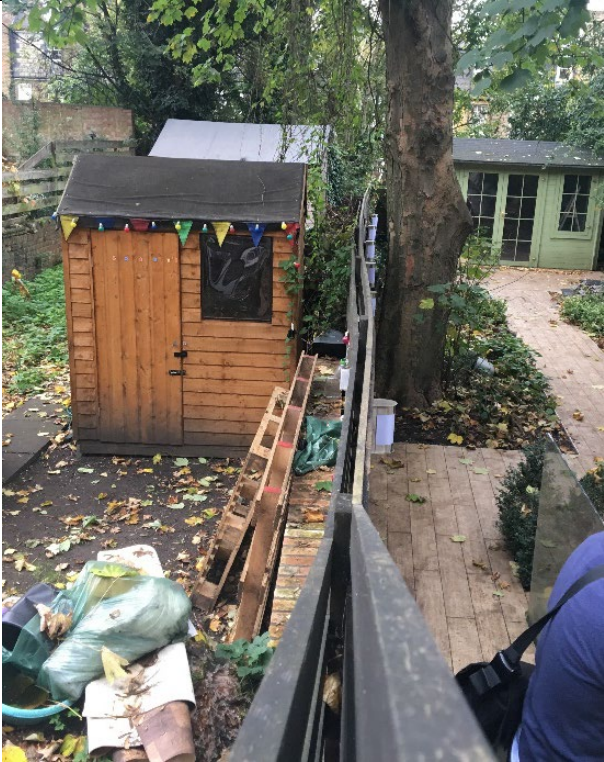
<p>Figure 42: Photo from 2013 shows that there was no fireplace at the time the photo was taken.</p>
Boundary Fence	Apply for LBC	<p><b>Negligible</b></p> <p>Timber fence on the southmost wall has consent (as per 2014 application). The northmost side is a timber fence that has replaced the later brick party wall between 106 and 108. As seen in Figure 44 and Figure 45, that wall was rebuilt recently and there was little or no original or early fabric.</p> <p>Originally there would have been a brick boundary wall, probably low level (as seen in the next door neighbour’s property in Figure 43).</p>

<p>Figure 43: Current timber garden fence</p>

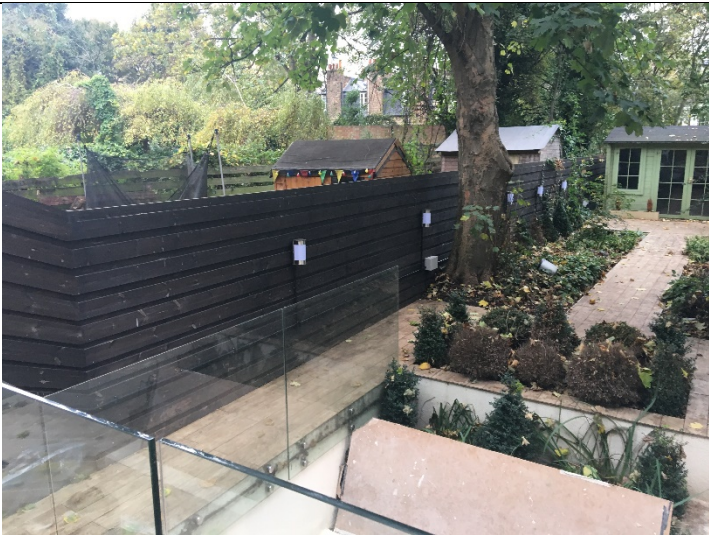
<p>Figure 46: Approved drawing from 2014 application</p>	
External glass balustrade	Apply for LBC	<b>Negligible</b> A glazed balustrade parraelle to the garden fence was consented in 2014. The existing balustrade is set further towards the fence than the consented scheme. The glazed balustrate is minimal in design and impact and follows the outline of the consented glazed scheme of 2014.

<p>Figure 47: Glazed balustrade to rear</p>	<p>Figure 48: Consented 2014 scheme</p>

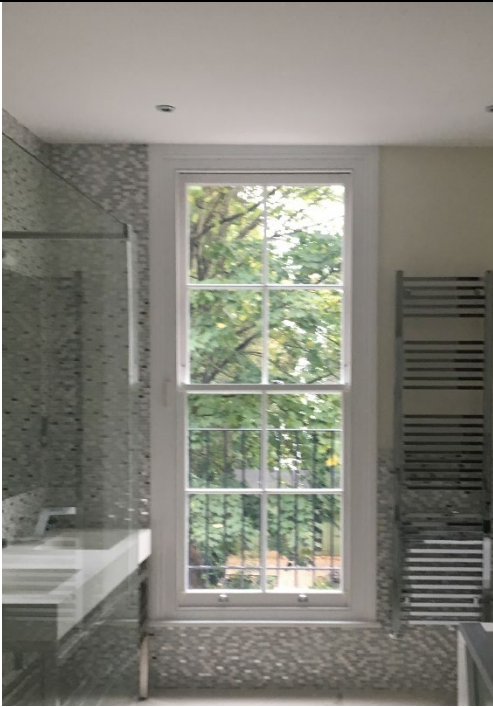
First Floor Level					
All rooms – suspended ceilings (concealing historic cornices)	Carefully remove the suspended ceiling and make good any areas that may have been damaged.	<p><b>N/A</b></p> <p>The suspended ceiling is evident in the window head and ceiling relationship. The ealier photos show a height difference between the cornice and the window heads (Figure 53 and Figure 54), whereas the recent photos show no gap (Figure 52 and Figure 55). The cornice is likely to have have been retained above the suspended ceiling (similar to ground floor level) and will be made good as necessasry.</p>

<p>Figure 52: The original ceiling was higher, as seen in the 2002 photos. Here there is no gap between the window architrave and the ceiling, suggesting that the new ceiling is suspended beneath the earlier one.</p>	<p>Figure 54: Photo taken of rear room 2002– cornice possibly Arts and Crafts</p>	
Spotlights	Carefully remove the suspended ceiling which contain the spotlights. Central pendant to be reinstated.	N/A Both front and rear room appear to have a suspended plasterboard ceiling with embedded spotlights. These are to be removed.

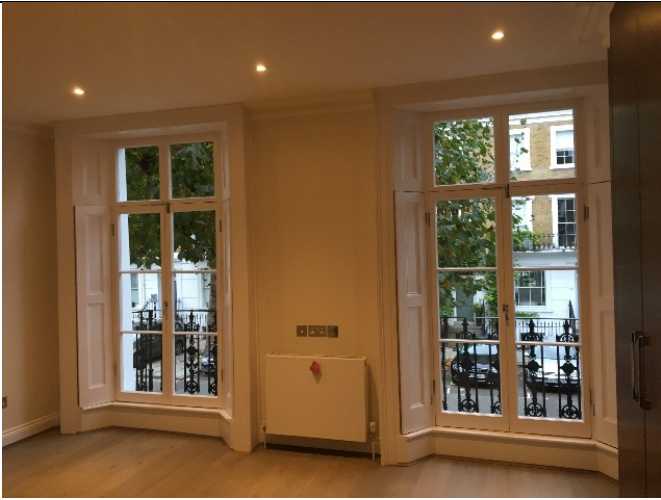
<p>Figure 55: Spotlights in first floor front room – current</p>

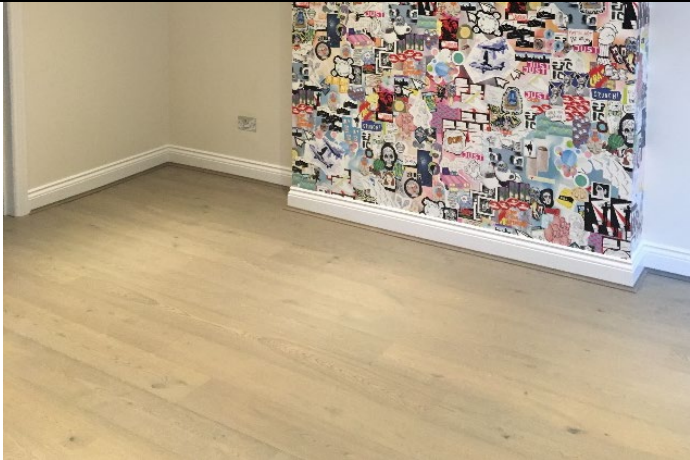
Schedule of Works and Impact Assessment					
Location and element	Action	Impact Assessment & Description of the Works/Intervention		Relevant Photographs (Current – post consented 2014 refurbishment)	Relevant Photographs (2002, 2013 and 2014 works)
Floor finishes and new skirting	<p><b>Apply for LBC for floor finishes and skirting in rear room. Details to be approved via conditions.</b></p> <p><b>Replace existing skirting with one to match original material and profile as seen in Figure 33. Front room only. Details to be approved via conditions.</b></p>	<p><u>Floor finishes: Impact - Negligible</u></p> <p>The floor finishes in both rooms had ‘timber effect’ floors as seen in the photos from 2013. The skirting in the front room, as seen in the 2013 photos, was original. The skirting in the rear room was removed before the 2014 consented works and there is no proof of its existence prior.</p> <p>The floorboards were retained under the current floor finish. The finish is a laminate set on underlay.</p> <p><u>Skirting: Impact - N/A</u></p> <p>The current skirting is lower than the original. The profile and material of the new existing are of a generic traditional design. Existing skirting is to be replaced with original design.</p>

<p>Figure 56: Floor in in first floor front room – current</p>

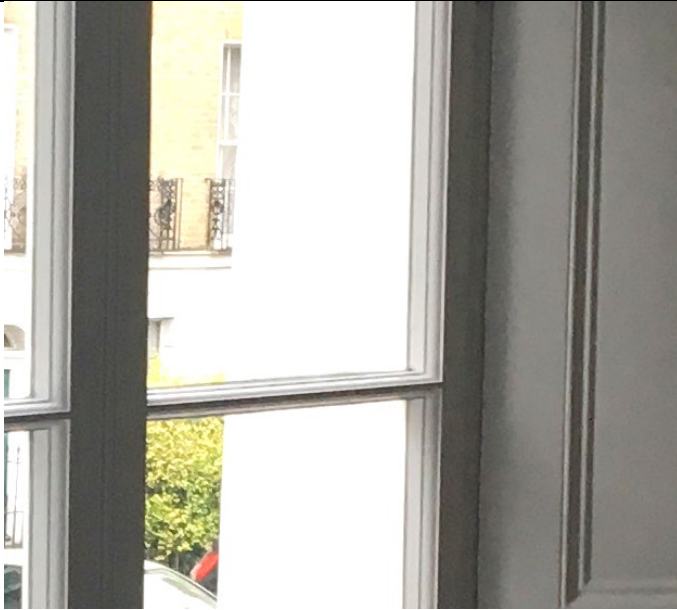
New Windows to all openings	Apply for LBC and Planning. Details to be approved via conditions.	Minor / Adverse Rear room: The windows to the rear elevation are double glazed timber sash and match the original windows in glazing bar pattern and materials. Though the windows that previously existed are lost (unknown whether or not these were original), the visual impact is limited as it faces the rear of the building and will not be seen from the public realm. Windows in the front room: The windows in this room are French doors opening onto a balconette. The difference between the current photo (Figure 62) and the 2002 one (Figure 64) is the profiles appear sharper and there are minor differences in the beading in the transoms and mullions. The windows appear to be new, replicated in profile, material and configuration. Overall, the historic character is retained by the change, as the materials and glazing bar profile and patterns match the early/original ones.

Figure 62: Current window in front room. Single glazed. This is a recent window installed post 2002.
