| Schedule of Works and Impact Assessment | | | | | |

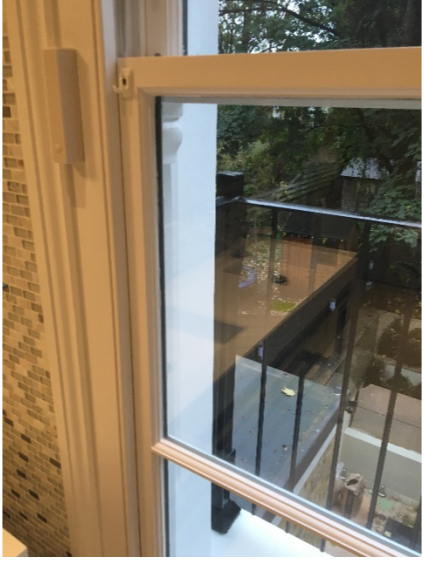
| Schedule of Works and Impact Assessment | | | | | |
|---|---|--|---|--|--|
| | | | <p>Figure 63: Current window in rear room. Double glazed.</p> | | |

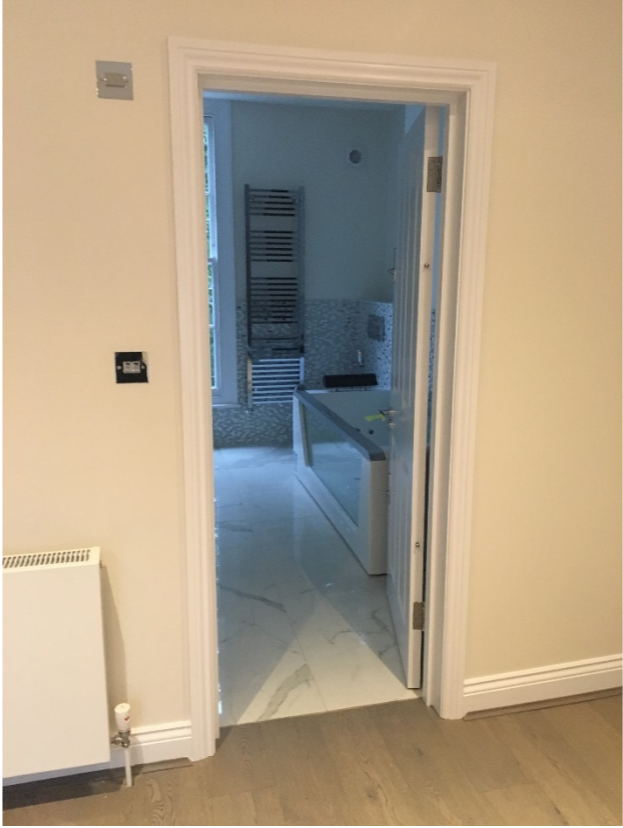
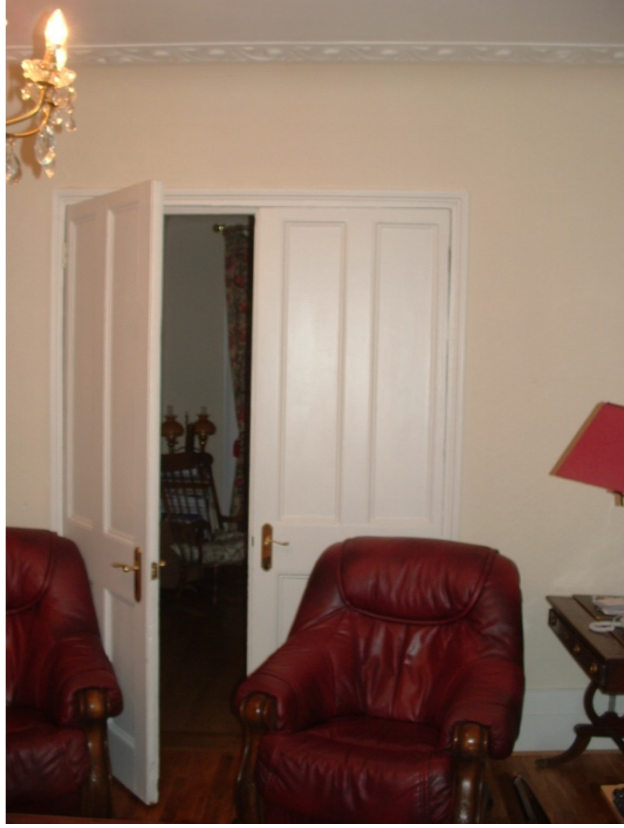
| Schedule of Works and Impact Assessment | | | | | |
|---|---|--|---|--|--|
| <p>Double door opening between front and rear room has been reduced to single door opening.</p> | <p>Apply for LBC to retain single door opening; replacement of the door with new security door.</p> <p>Architrave to remain. Details to be approved via conditions.</p> | <p>Door opening- Negligible</p> <p>The reduction in door size does not impact the historic fabric as this had already been altered in the past as part of consented works.</p> <p>New door - Minor / Beneficial</p> <p>The existing door was inserted during the 2014 works. The new door would match the early/ historic profile (see Figure 25).</p> | <p>Figure 65: Current single door opening.</p> | <p>Figure 66: Photo from 2002 showing double doors to rear room</p> | |

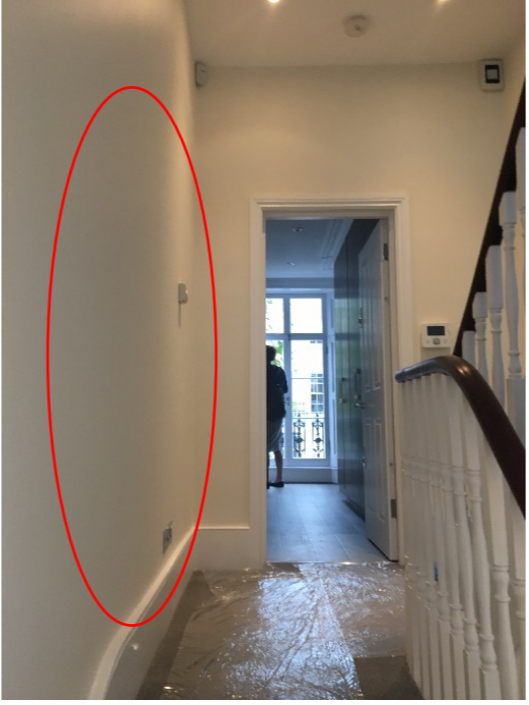
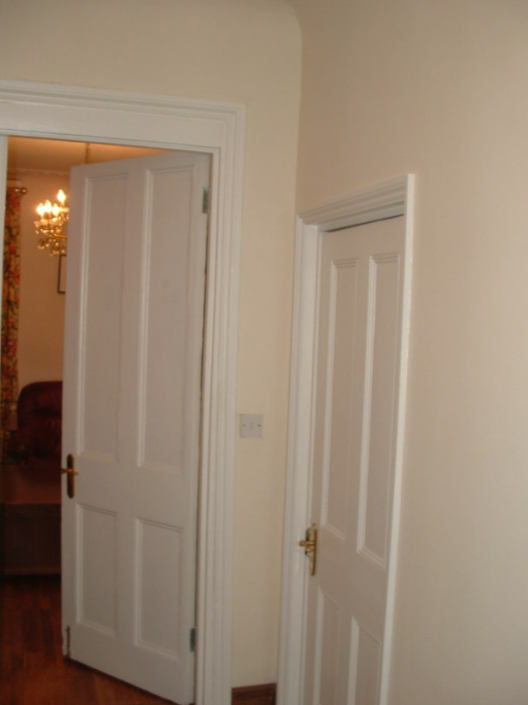
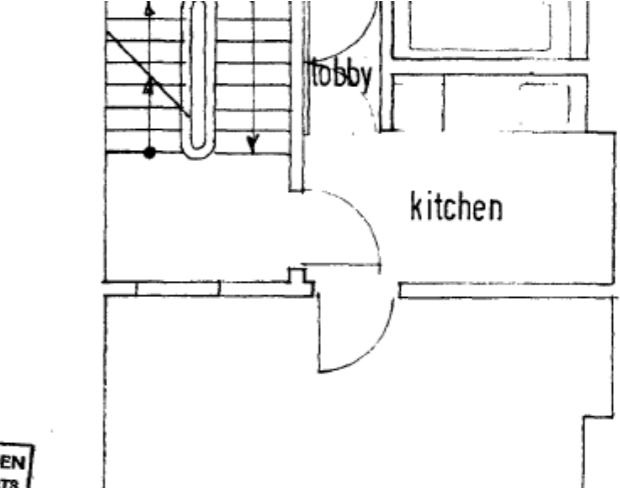
| Schedule of Works and Impact Assessment | | | | |
|--|--|---|--|---|
| Removal of original doorway between landing and rear room. | <p>Apply for LBC for the reinstatement of the door and architrave to the front room. Details to be approved via conditions.</p> <p>Remedial works: reinstate the door and architrave to match that in the photo from 2002 (Figure 68).</p> | <p>N/A</p> <p>The door and architrave to the rear room have been removed and the opening infilled. Door and architrave to match original details (see Figure 68) will be reinstated.</p> <p>Minor / Beneficial</p> <p>Doorway to front room was infilled in the consented 1978 scheme (Figure 69). Architrave appears to be the same as in the 2002 photo. There were no subsequent applications for the reinstatement of the opening. Retrospective LBC for the reinstatement of the doorway is proposed as it has a beneficial impact on the original layout. Door to be reinforced security door, design to match that seen in 2002 photo (Figure 68).</p> | <p>Figure 67: Current landing. Left hand side originally had a doorway into the rear room.</p> | <p>Figure 68: Door on the right-hand side is the original opening. Photo taken 2002.</p> <p>Figure 69: Door into the front room at first floor was blocked off/infilled as part of the consented 1978 scheme.</p> |

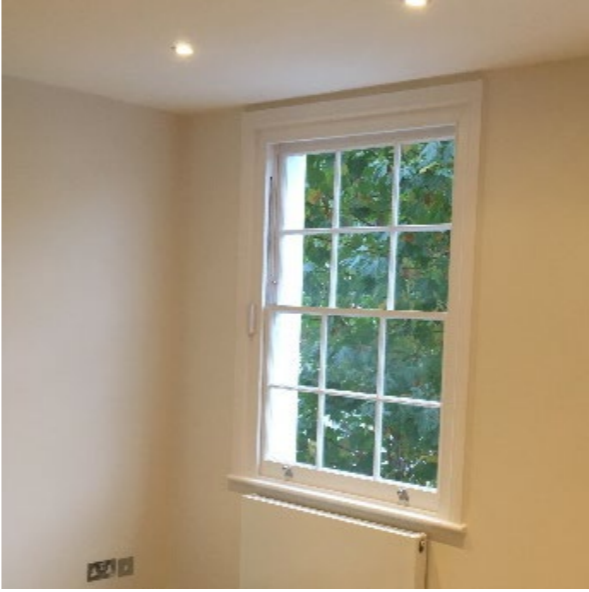
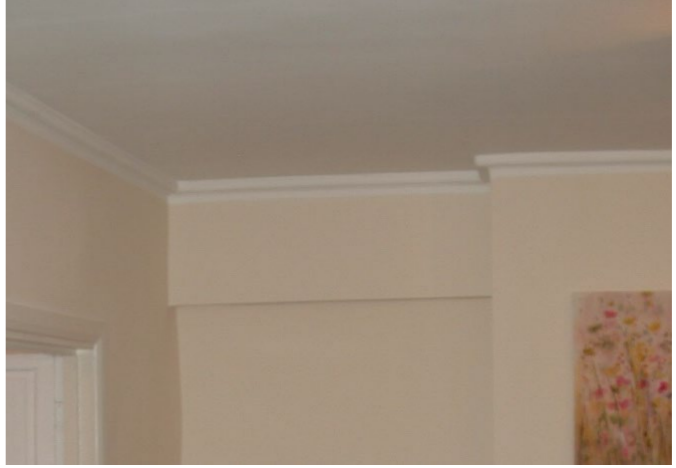
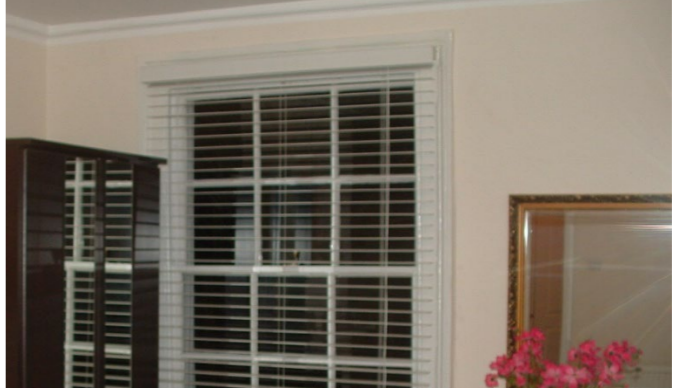
| Schedule of Works and Impact Assessment | | | | | |
|---|---|--|--|--|--|
| All rooms – suspended ceilings (concealing historic cornices) | <p>Carefully remove the suspended ceiling and make good any areas that may have been damaged.</p> <p>Apply for LBC for suspended ceiling in the hallway and rear room.</p> | <p>Front room N/A</p> <p>The suspended ceiling is evident in the window head and ceiling relationship. The earlier photo (Figure 72) shows a height difference between the cornice and the window heads, whereas the recent photos show a very small gap (Figure 70). The cornice may have been retained above a suspended ceiling (similar to ground floor level).</p> <p>Minor / Adverse (rear room and hallway)</p> <p>The rear room does not appear to have had a cornice before the most recent works (Figure 73). The suspended ceiling has a level of reversibility and the impact is therefore considered to be minor. In terms of visual impact, spotlights are of lower impact on this floor, relative to ground and first floor, which are deemed to be of higher significance. The spotlights on this floor in the rear room will not be visible from the public realm and therefore impact is considered to be minor.</p> | <p>Figure 70: Current suspended ceiling, no cornice.</p> | <p>Figure 71: Cornice, early or possible original. Photo taken in 2013.</p> <p>Figure 72: There is a greater difference in height between the window head and the ceiling. Photo from 2002.</p> | |

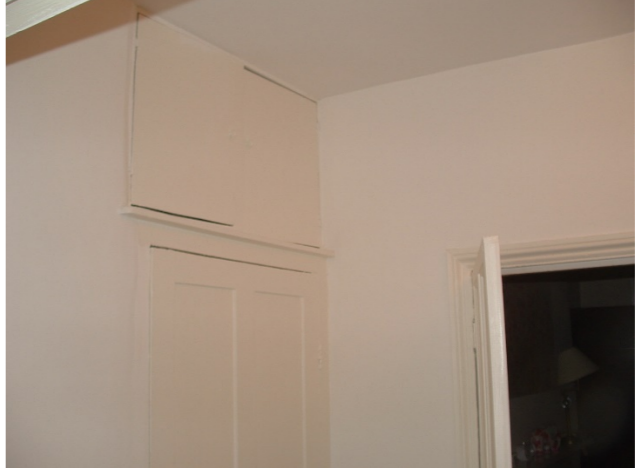
| Schedule of Works and Impact Assessment | | | | | |
|---|---|--|--|--|--|
| Spotlights in front and rear rooms and hallway | <p>Carefully remove the suspended ceiling which contain the spotlights in front room. Central pendant to be reinstated.</p> <p>Apply for LBC for spotlights in the hallway and rear room.</p> | <p>N/A (front room)</p> <p>Both front and rear room appear to have a suspended plasterboard ceiling with embedded spotlights.</p> <p>The suspended ceiling is to be removed in the front room to reveal the cornice and remediate the visual impact (albeit minor) to the conservation area.</p> <p>Minor / Adverse (rear room and hallway)</p> <p>The rear room does not appear to have had a cornice before the most recent works (Figure 73). The suspended ceiling has a level of reversibility and the impact is therefore considered to be minor. In terms of visual impact, spotlights are of lower impact on this floor, relative to ground and first floor, which are deemed to be of higher significance. The spotlights on this floor in the rear room will not be visible from the public realm and therefore impact is considered to be minor.</p> | | <p>Figure 73: Rear room ceiling – showing no cornice.</p> | |

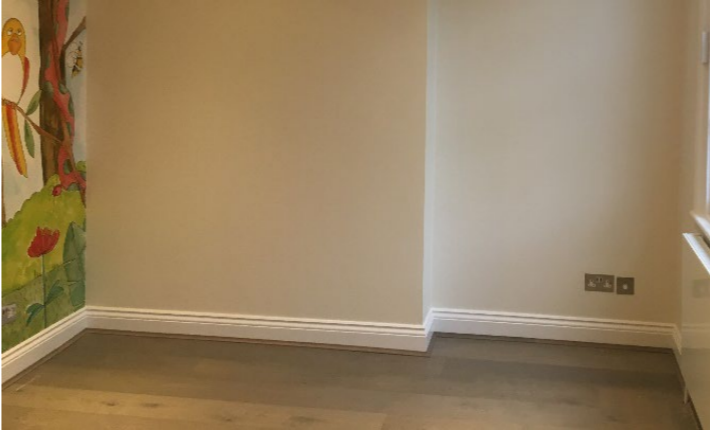
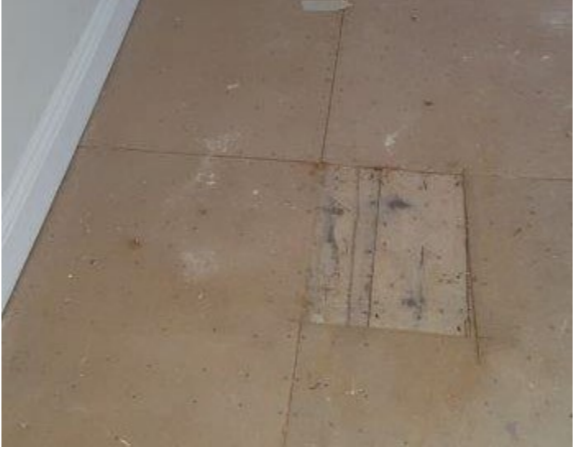
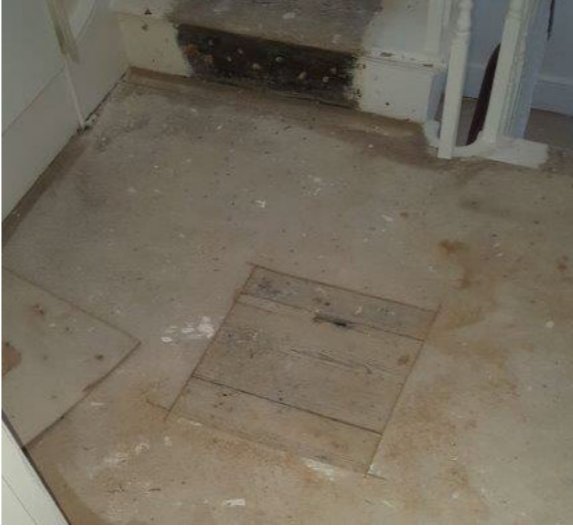
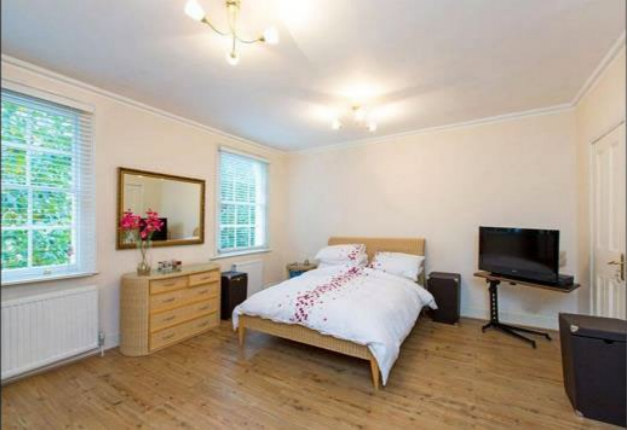
| Schedule of Works and Impact Assessment | | | | |
|---|---|--|---|--|
| Floor finishes and new skirting | Apply for LBC for floor finishes and skirting in all rooms on this floor. Details to be approved via conditions. | <p>Minor / Adverse - Negligible</p> <p><u>Floor finishes:</u> The floor finish as seen in the 2013 photo appears to be a laminate flooring. Impact of the new flooring is negligible. The floorboards were retained under the current floor finish. The finish is a laminate set on underlay as seen in Figure 75 and Figure 76.</p> <p><u>Skirting:</u> Though the profile does not match what would have been there originally, the current skirting is of the same height and material as the previous. Impact is therefore minor.</p> | <p>Figure 74: Floor finish and skirting – current</p> <p>Figure 75: Second floor front room floorboards – appear to be original and have been retained.</p> <p>Figure 76: Second floor hallway floorboards – appear to be original and have been retained.</p> | <p>Figure 77: Second floor front room in 2013 – showing there was a floor finish already existing on this floor.</p> <p><i>It is unclear whether there was any original skirting before the most recent works. There is no proof or indications from previous applications that they were removed.</i></p> |

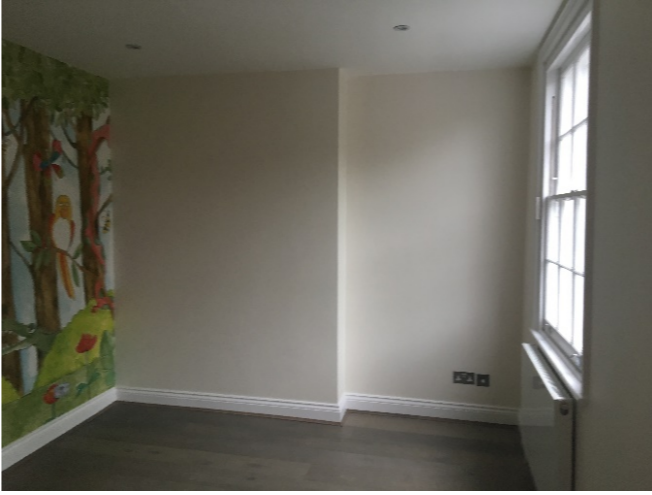
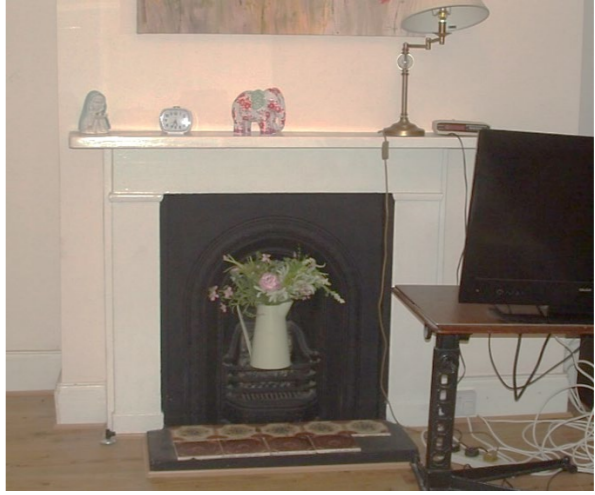
| Schedule of Works and Impact Assessment | | | | | |
|---|---|--|---|--|--|
| Removed Fire Place in front room | Reinstate the fireplace in the front room as per original design (as seen in Figure 79). | <p>N/A</p> <p>Photos taken before the 2014 works show that the rear room did not have a fireplace by the time the most recent works took place. There is no archival evidence of when it was removed (pre-listing or post listing).</p> <p>The fireplace to the front room (see Figure 79) appears to be original and is fitting for a house of this status and period. This photo was taken post-listing and was removed without consent. The surround and insert will be reinstated as per the 2002 photo.</p> | <p>Figure 78: Current chimney breast in front room – fireplace removed.</p> | <p>Figure 79: Fireplace in front room in 2002.</p> | |

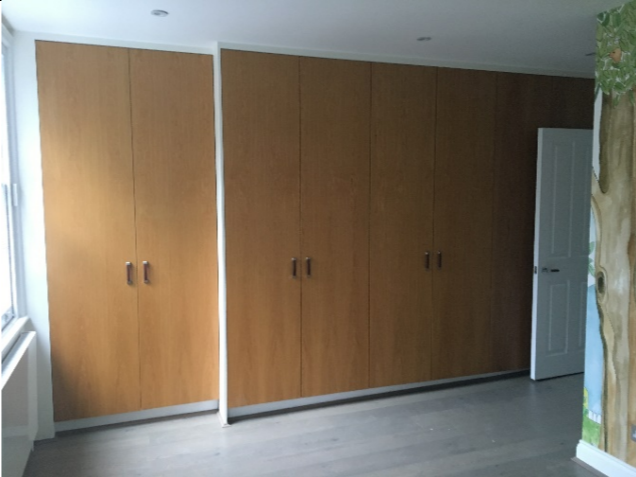
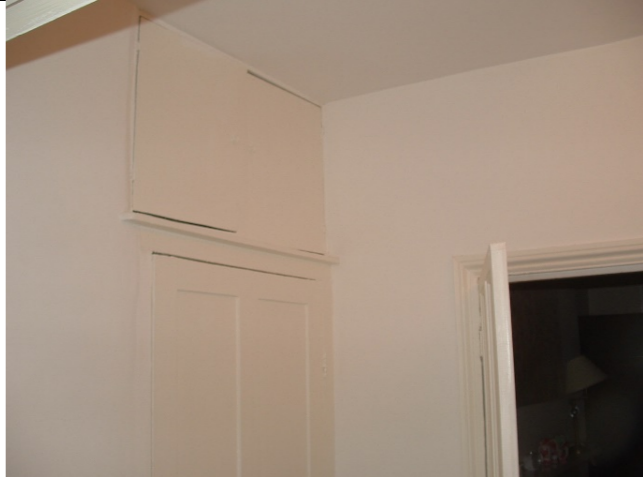
| Schedule of Works and Impact Assessment | | | | | |
|---|---|--|---|--|--|
| Fitted wardrobes | Remove fitted wardrobe, fit floor finish where necessary and make good | <p>N/A</p> <p>The fitted wardrobe in the front room is full length and alters the character and footprint of the room. This is to be removed.</p> <p>The full length wardrobe in the rear room is a replacement of an earlier wardrobe in the same position (see Figure 81), which was carried out prior to the most recent works.</p> | <p>Figure 80: Full length wardrobe in front room – current</p> | <p>Figure 81: Full length fitted wardrobe in rear room in 2002.</p> | |

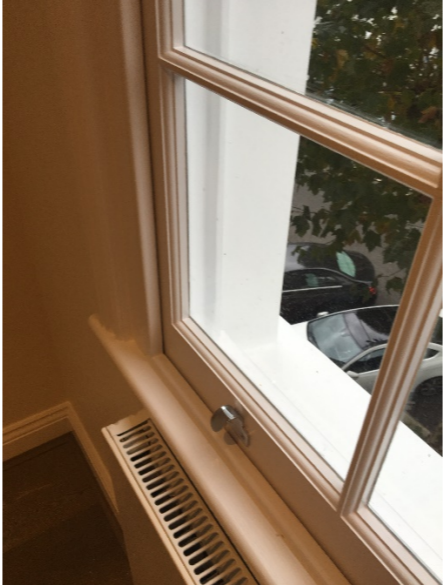
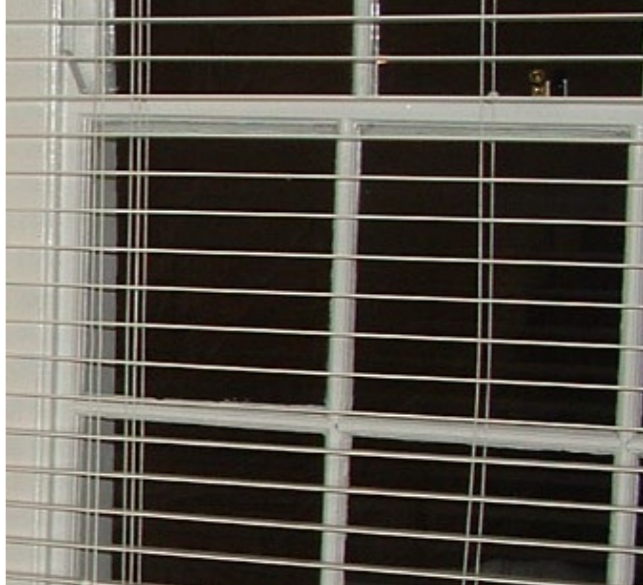
| Schedule of Works and Impact Assessment | | | | | |
|---|---|--|---|--|--|
| New Windows to all openings | Apply for LBC and Planning. Details to be approved via conditions | <p>Minor / Adverse</p> <p>Rear room: The windows to the rear elevation are double glazed timber sash and match the original windows in glazing bar pattern and materials. Though the windows that previously existed are lost (unknown whether or not these were original), the visual impact is limited as it faces the rear of the building and will not be seen from the public realm.</p> <p>Front room: The windows in this room are single glazed and match the original windows in glazing bar pattern and materials. The glazing bars differ slightly, which affect the historic character and patina of age within the listed building; however, the overall design does not detract from the historic character of the conservation area.</p> | | | |

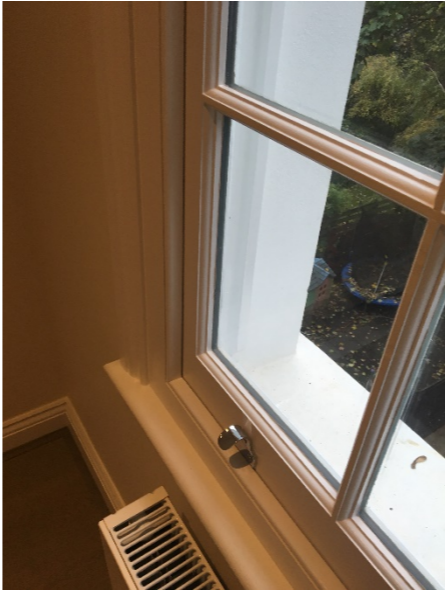
| Schedule of Works and Impact Assessment | | | | | |
|--|---|--|--|--|--|
| | | | <p><i>Figure 82: Front room window. Single glazed. This is a recent window installed after consented works in 2014.</i></p> <p><i>Figure 83: Double glazed window to rear room. This is a recent window installed after consented works in 2014.</i></p> | <p><i>Figure 84: Front room window . Appears to be early or original. Photo taken in 2002.</i></p> | |

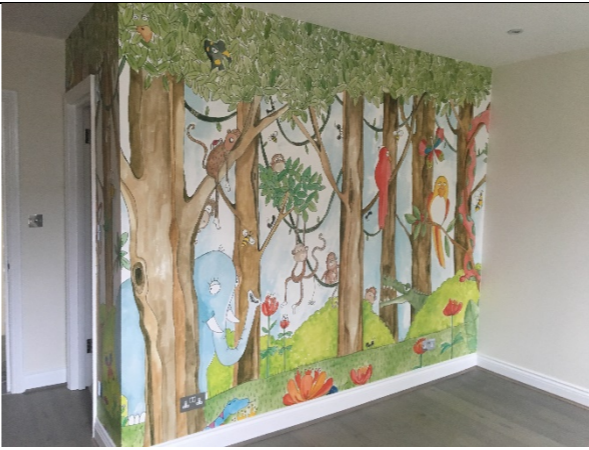
| Schedule of Works and Impact Assessment | | | | | |
|--|---|--|--|--|--|
| New partition to form 'Jack & Jill' bathroom in the front room | Apply for LBC | <p>Minor / Adverse</p> <p>This is a later addition that alters the original footprint of the room and impedes the perception of the original chimney breast. However, there are limited spaces where sanitary units can be located within a house of this size. The location and size of the sanitary unit is considered to be sensitive as it is located on an upper floor (of lower significance relative to the lower floors) and is of a small size. This approach also enables the continued use of the rooms as bedrooms.</p> | <p><i>Figure 85: Jack & Jill bathroom from front room - current</i></p> | | |

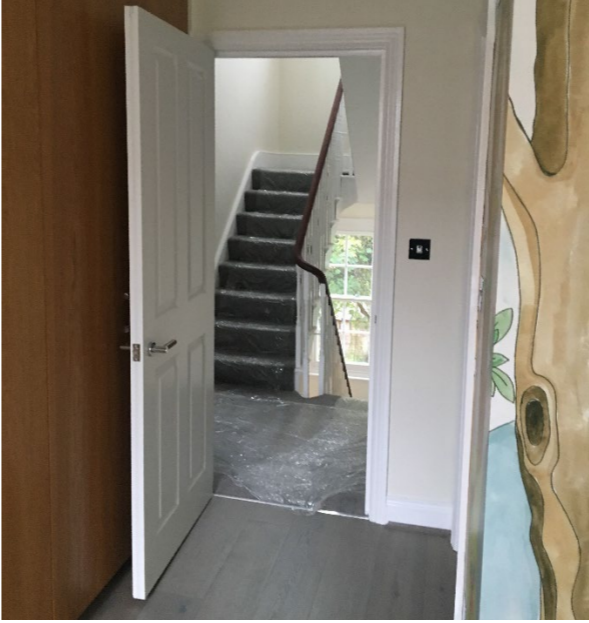
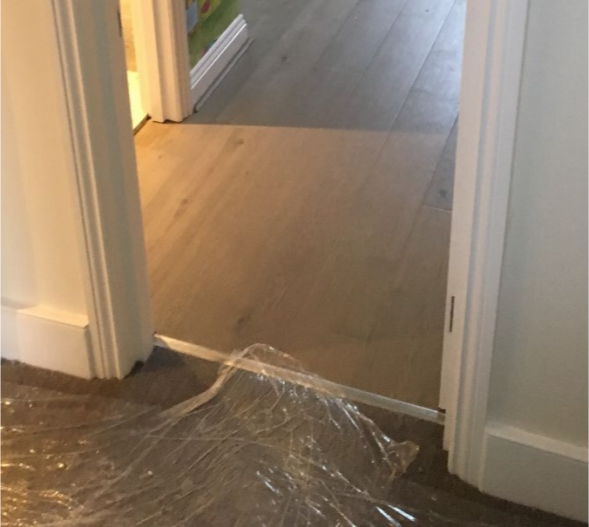
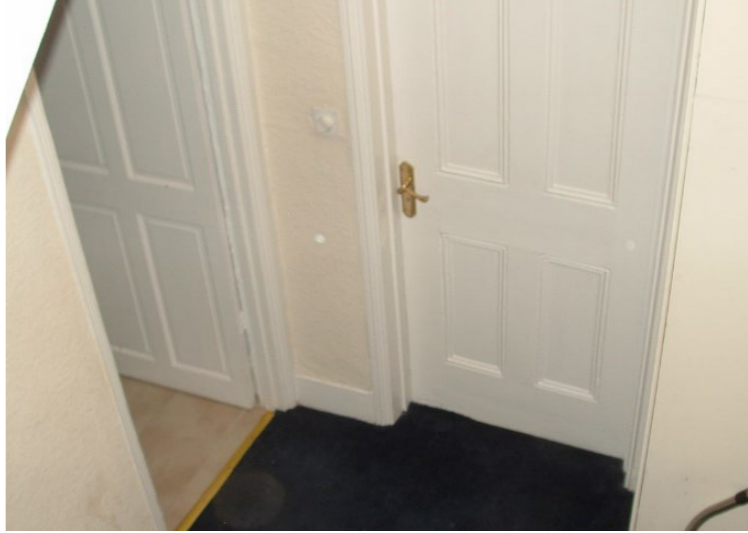
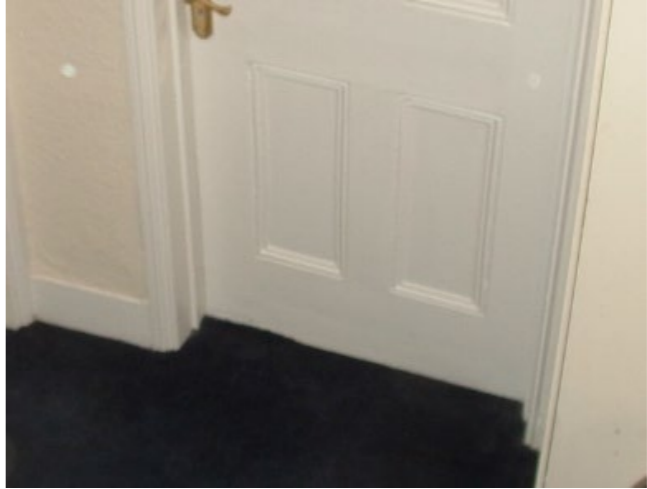
| Schedule of Works and Impact Assessment | | | | |
|---|--|---|---|---|
| Joinery | Reinstate doors to match original design (as seen in Figure 88). | <p>Doors - N/A</p> <p>New doors to front and rear rooms were fixed after the consented 2014 works. These will be removed and replaced as remedial works.</p> <p>Architraves - Minor / Adverse</p> <p>The current architraves appear to have a very similar profile as the ones photographed in 2002 (see Figure 87 and Figure 89). The removal of possible early or original architraves had an adverse impact; however, though the existing architraves may not be original, they adhere to the historic character of the listed building.</p> | <p>Figure 86: New door to the front room.</p> <p>Figure 87: Architraves on landing – as currently existing</p> | <p>Figure 88: Front room door in 2002.</p> <p>Figure 89: Architraves on landing in 2002.</p> |

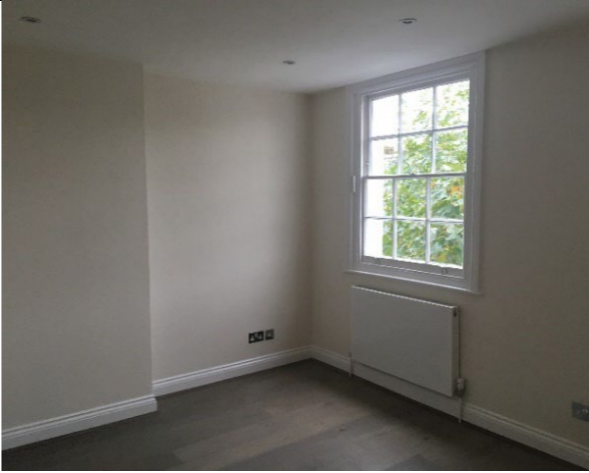
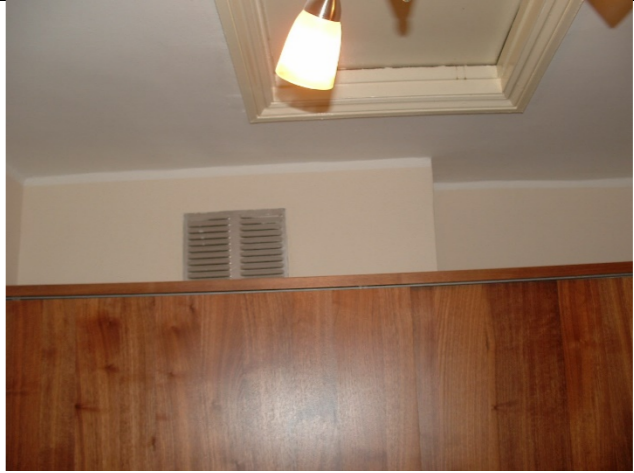
| Schedule of Works and Impact Assessment | | | | | |
|---|--|--|--|--|--|
| All rooms – suspended ceilings (concealing historic cornices) | Apply for LBC for suspended ceiling in the front room, hallway and rear room. | <p>Minor / Adverse</p> <p>The suspended ceiling is evident in the window head and ceiling relationship. The earlier photo (Figure 90) shows a height difference between the ceiling and the window heads, whereas the recent photos show no gap.</p> <p>According to the photographs from 2002, none of the rooms at this level had a cornice before the most recent works (Figure 90). Impact of the historic character is therefore limited at this level. The suspended ceiling has a level of reversibility and the impact is therefore considered to be minor.</p> | | <p>Figure 90: Front room showing suspended ceiling - current</p> | <p>Figure 91: Ceiling in the front room, 2002.</p> |

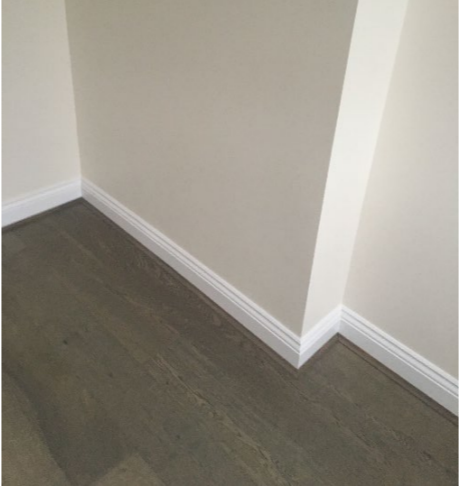
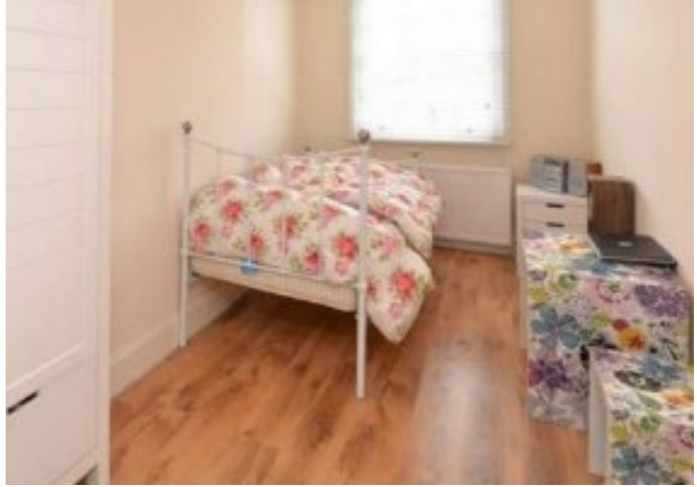
| Schedule of Works and Impact Assessment | | | | | |
|---|--|--|--|--|--|
| Floor finishes and new skirting | Apply for LBC for floor finishes and skirting in all rooms on this floor. Details to be approved via conditions. | <p>Minor / Adverse - Negligible</p> <p><u>Floor finishes:</u></p> <p>The floor finish as seen in the 2013 photo appears to be a laminate flooring. Impact of the new flooring is negligible. The floorboards were retained under the current floor finish. The finish is a laminate set on underlay as seen in Figure 93 and Figure 94.</p> <p><u>Skirting:</u></p> <p>Though the profile does not match what would have been there originally, the current skirting is of the same height and material as the previous. Impact is therefore minor.</p> | | <p>Figure 92: Floor finish and skirting – current</p> | <p>Figure 96: Later floor finish in the front room (subdivided) - 2013</p> |

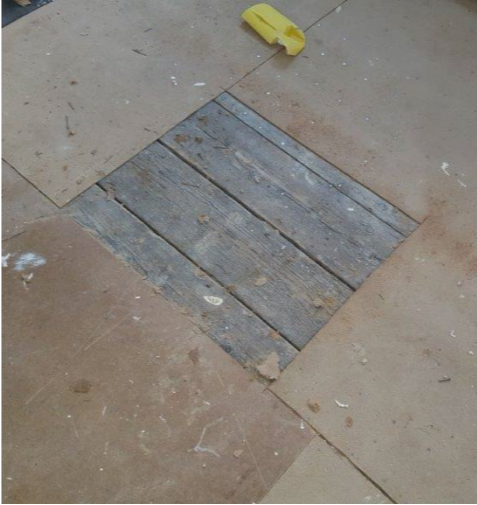
| Schedule of Works and Impact Assessment | | | | | |
|---|---|---|--|--|--|
| | | | <p><i>Figure 93: Third floor front bedroom floorboards – appear to be original and have been retained.</i></p> | | |

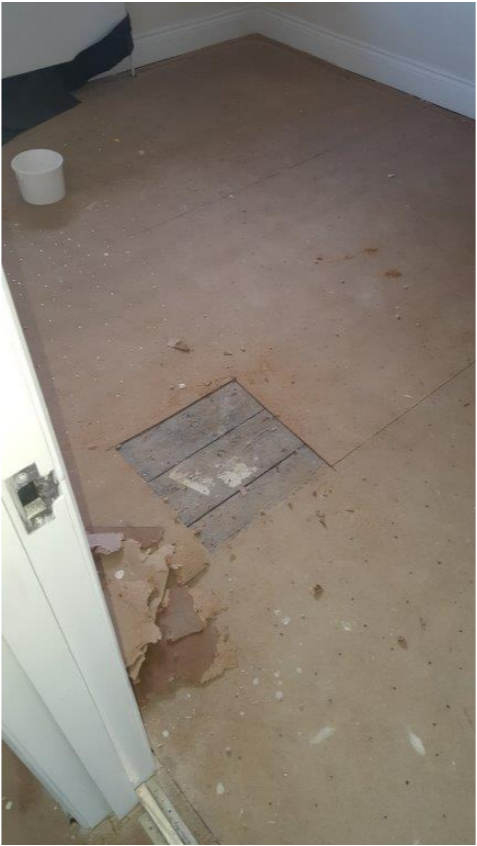
| Schedule of Works and Impact Assessment | | | | | |
|---|---|---|--|--|--|
| | | | <p><i>Figure 94: Third floor rear bedroom floorboards – appear to be original and have been retained.</i></p> | | |

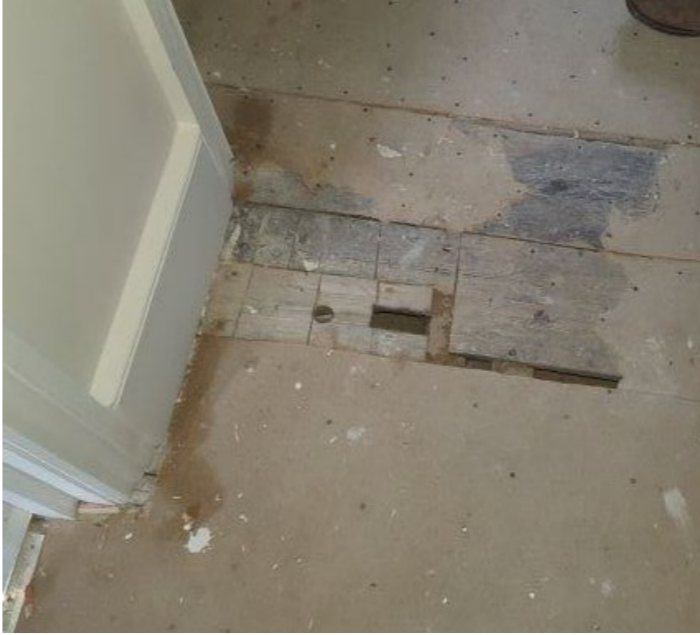
| Schedule of Works and Impact Assessment | | | | | |
|---|---|---|--|---|--|
| | | | | <p>Figure 95: Third floor hallway floorboards – appear to be original, albeit fragmented, and have been retained.</p> | |

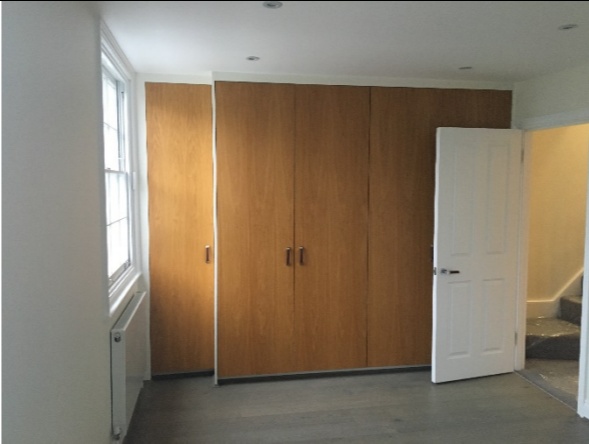
| Schedule of Works and Impact Assessment | | | | | |
|---|---|---|--|---|--|
| Fitted wardrobes | Apply for LBC – retain existing fitted wardrobe | <p>Minor / Adverse</p> <p>The fitted wardrobe in the front and rear rooms are full length. Though this does alter the original footprint of the room, this room is considered to be of lower significance relative to the lower floors, there is no disruption of original cornice and impact is therefore proportionally lower.</p> | | <p>Figure 97: Full height fitted wardrobe in front room - current</p> | |

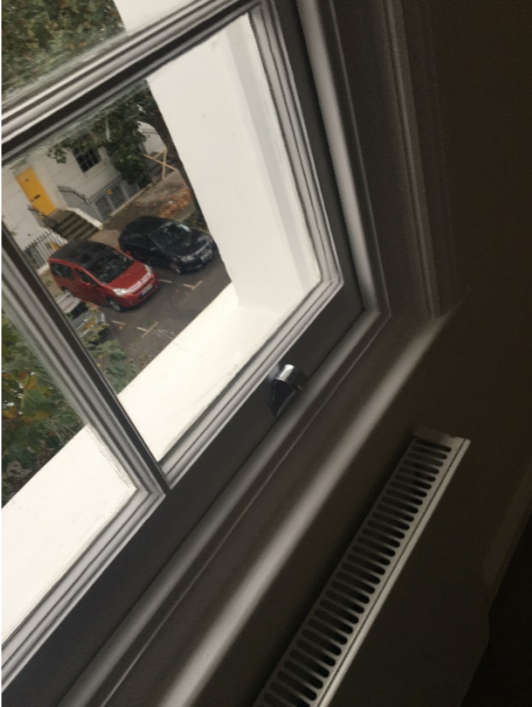
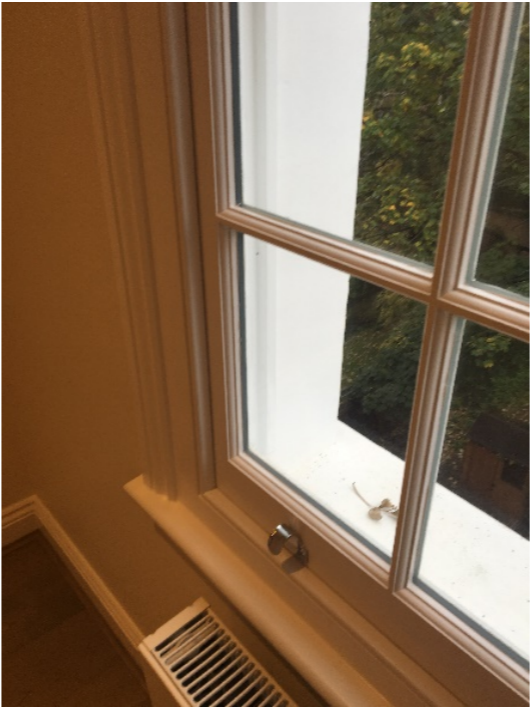
| Schedule of Works and Impact Assessment | | | | | |
|---|---|--|--|--|--|
| New Windows to all openings | Apply for LBC and Planning. Details to be approved via conditions | <p>Minor / Adverse</p> <p>Rear room: The windows to the rear elevation are double glazed timber sash and match the original windows in glazing bar pattern and materials. Though the windows that previously existed are lost (unknown whether or not these were original), the visual impact is limited as it faces the rear of the building and will not be seen from the public realm.</p> <p>Front room: The windows in this room are single glazed and match the original windows in glazing bar pattern and materials. The glazing bars differ slightly, which affect the historic character and patina of age within the listed building; however, the overall design does not detract from the historic character of the conservation area.</p> | <p>Figure 98: Front room window. Single glazed. This is a recent window installed post 2002.</p> <p>Figure 99: Double glazed window in rear room - current</p> | | |

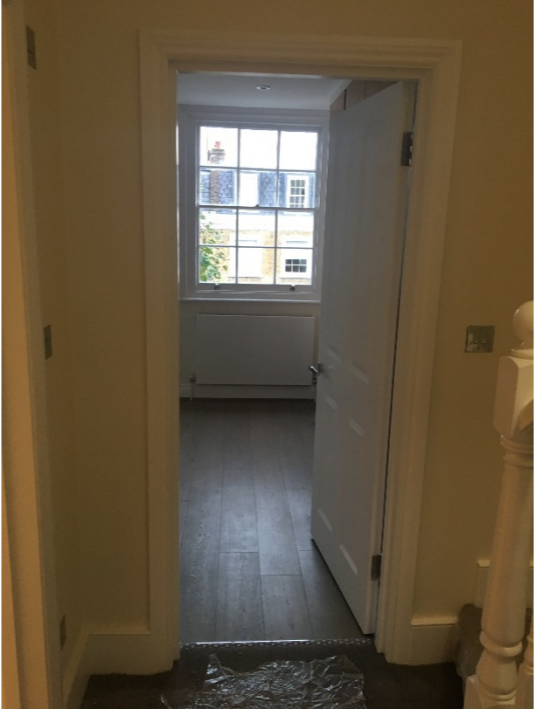
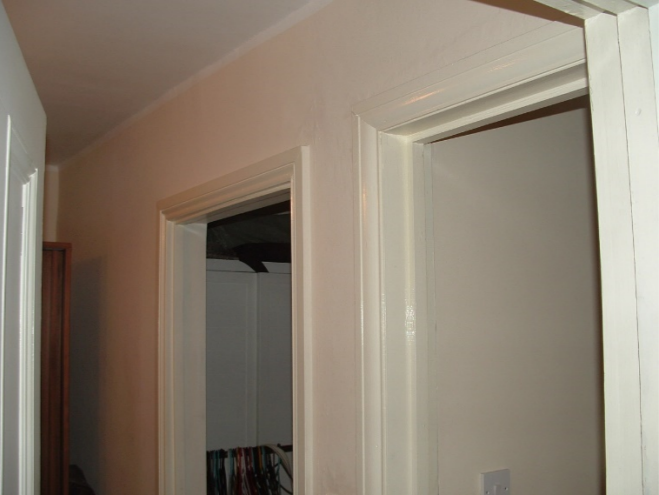
| Schedule of Works and Impact Assessment | | | | | |
|--|---|---|---|---|--|
| Doors from hallway to front room, WC and rear room | Apply for LBC to reinstate doors to match a simplified version of original design (as seen in Figure 25). Architraves to remain | N/A New doors to front and rear rooms were fixed after the consented 2014 works. These will be removed and replaced. | | | |

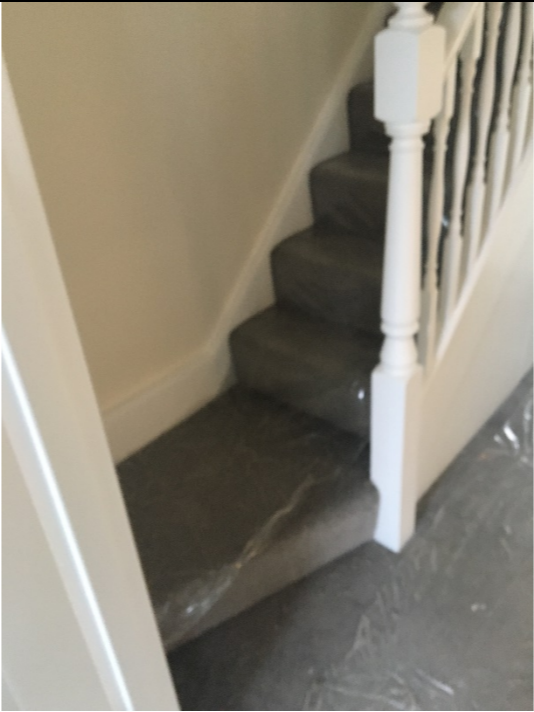
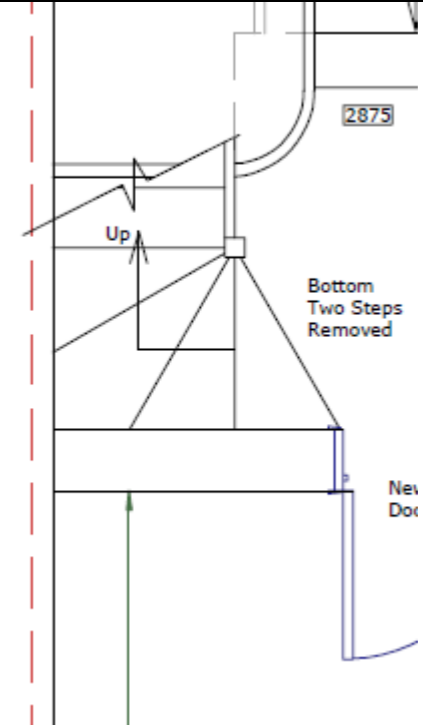
| Schedule of Works and Impact Assessment | | | | | |
|--|---|---|---|---|--|
| Bottom tread of the staircase is angled | Apply for LBC | Negligible The third floor staircase is of lower significance and the alteration to the last stair tread does not detract from the historic character or legibility of the original layout or hierarchy. The stair a later addition concurrent with the extension into the roof space, therefore there is no removal of (potentially) historic fabric. The consented scheme from 2014 allows for this new stair, however, the tread is different in form from the consented drawings. As this part of the stair is an addition and the skirting has been changed in previous interventions, the new stair does not impact any historic fabric. | | | |
