← 8 KELLEY STREET →

8 KELLEY STREET  
NWK 18TH  
07-11-2018

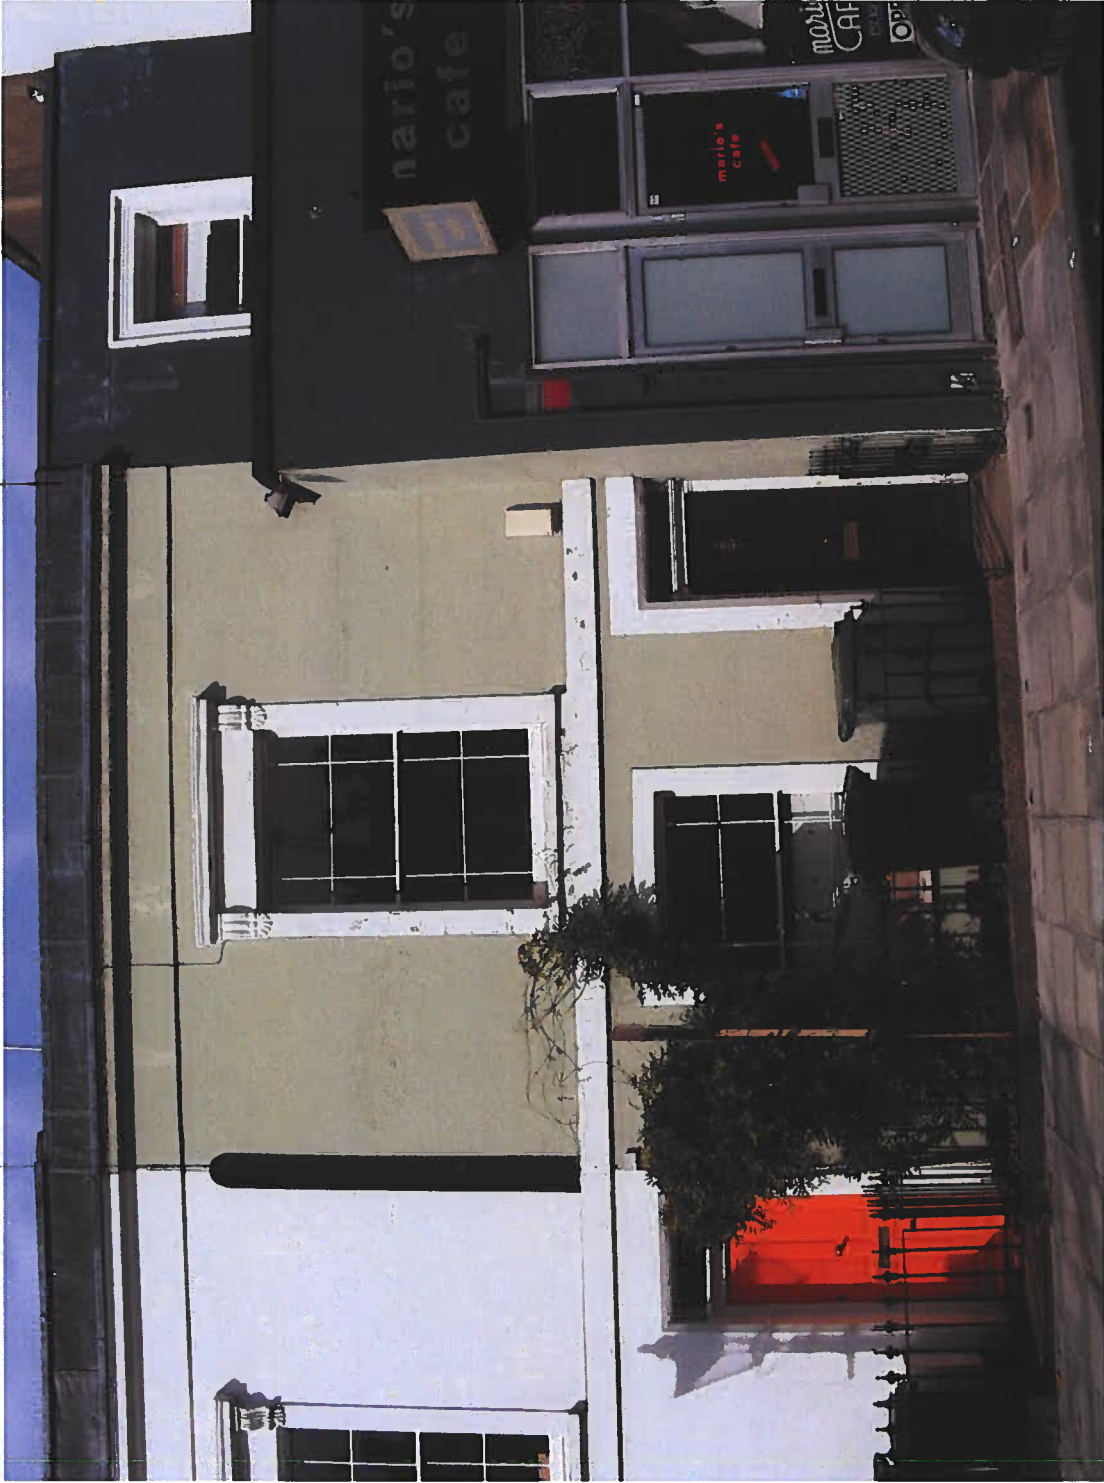
FRONT ELEVATION.  
SEE DRG RE 012 FOR LOCATION

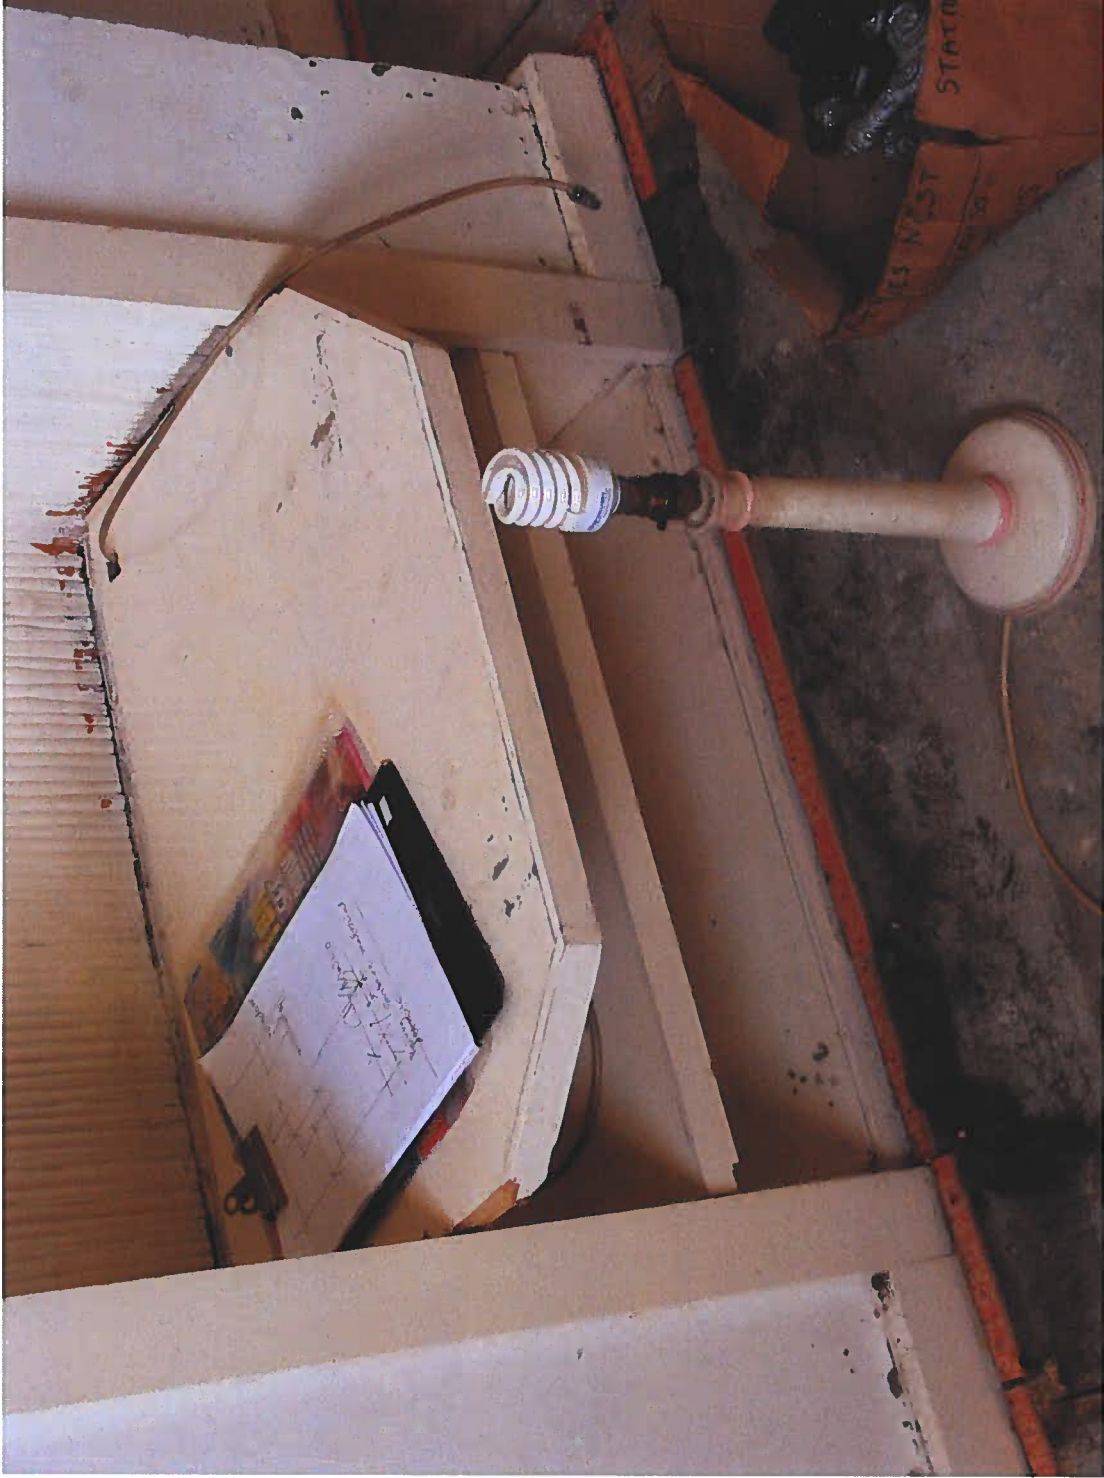
2

EXISTING FURNITURE IN DISUSED AND BLOCKED FIRE PLACE  
SEE DRG RE-012 FOR LOCATION

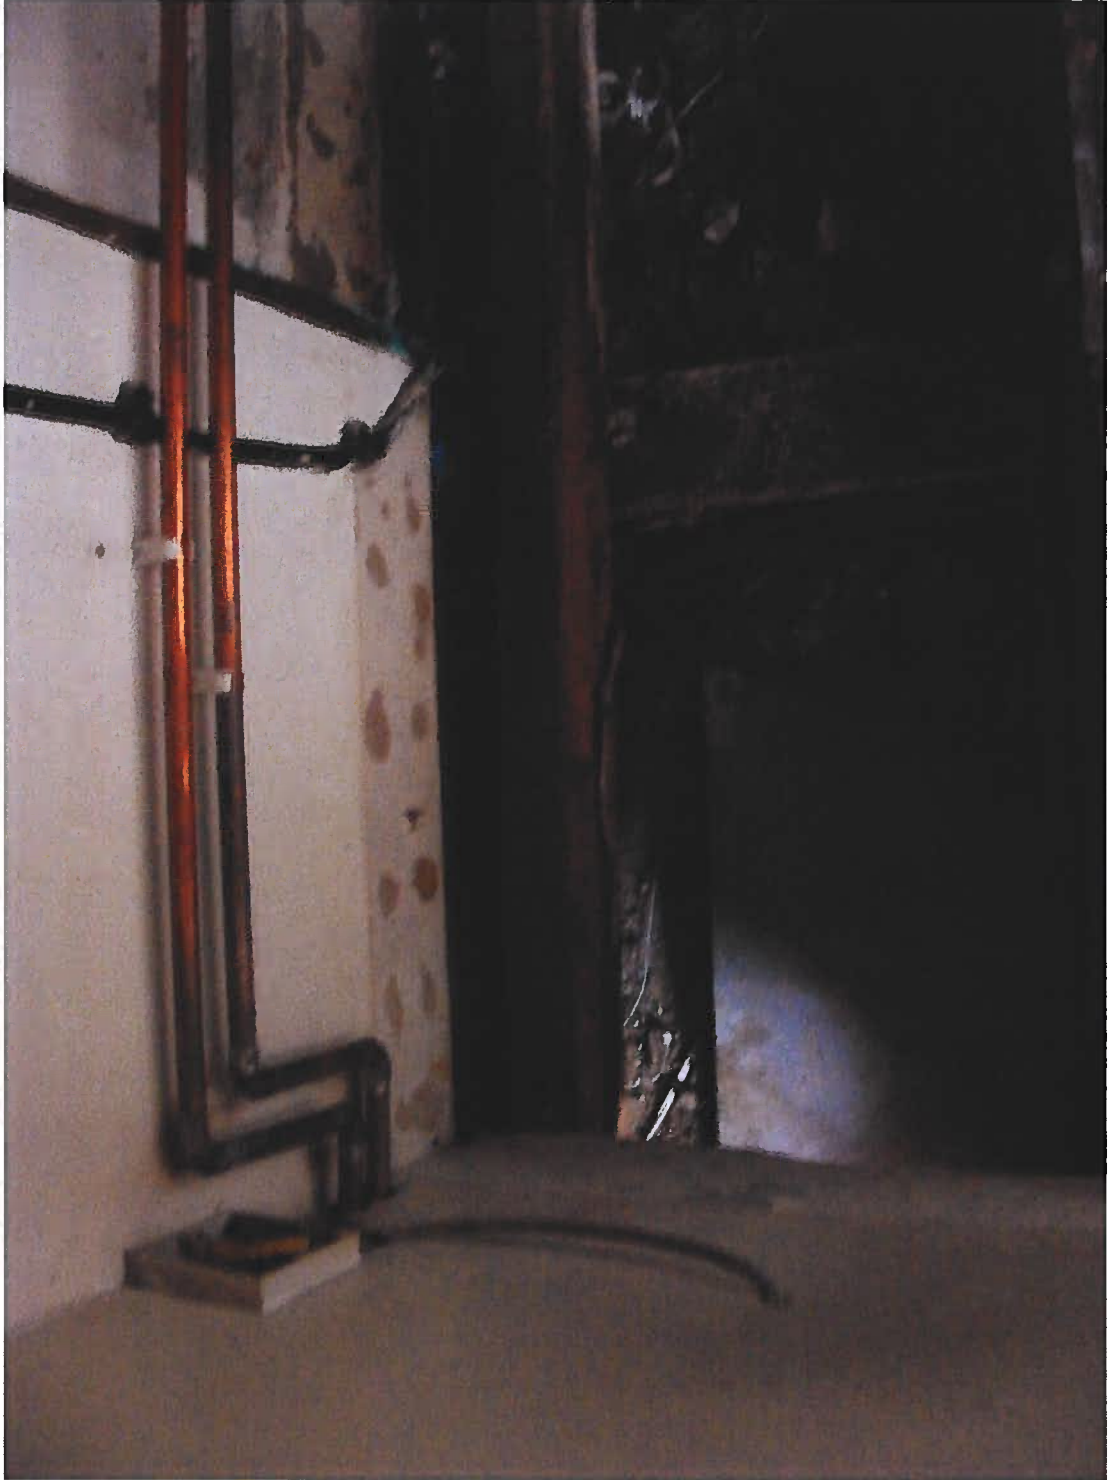
3

LOOKING ON TO FLOOR IN MEEXERCUPBOARD  
SEE DAG REQ12 FOR LOCATION

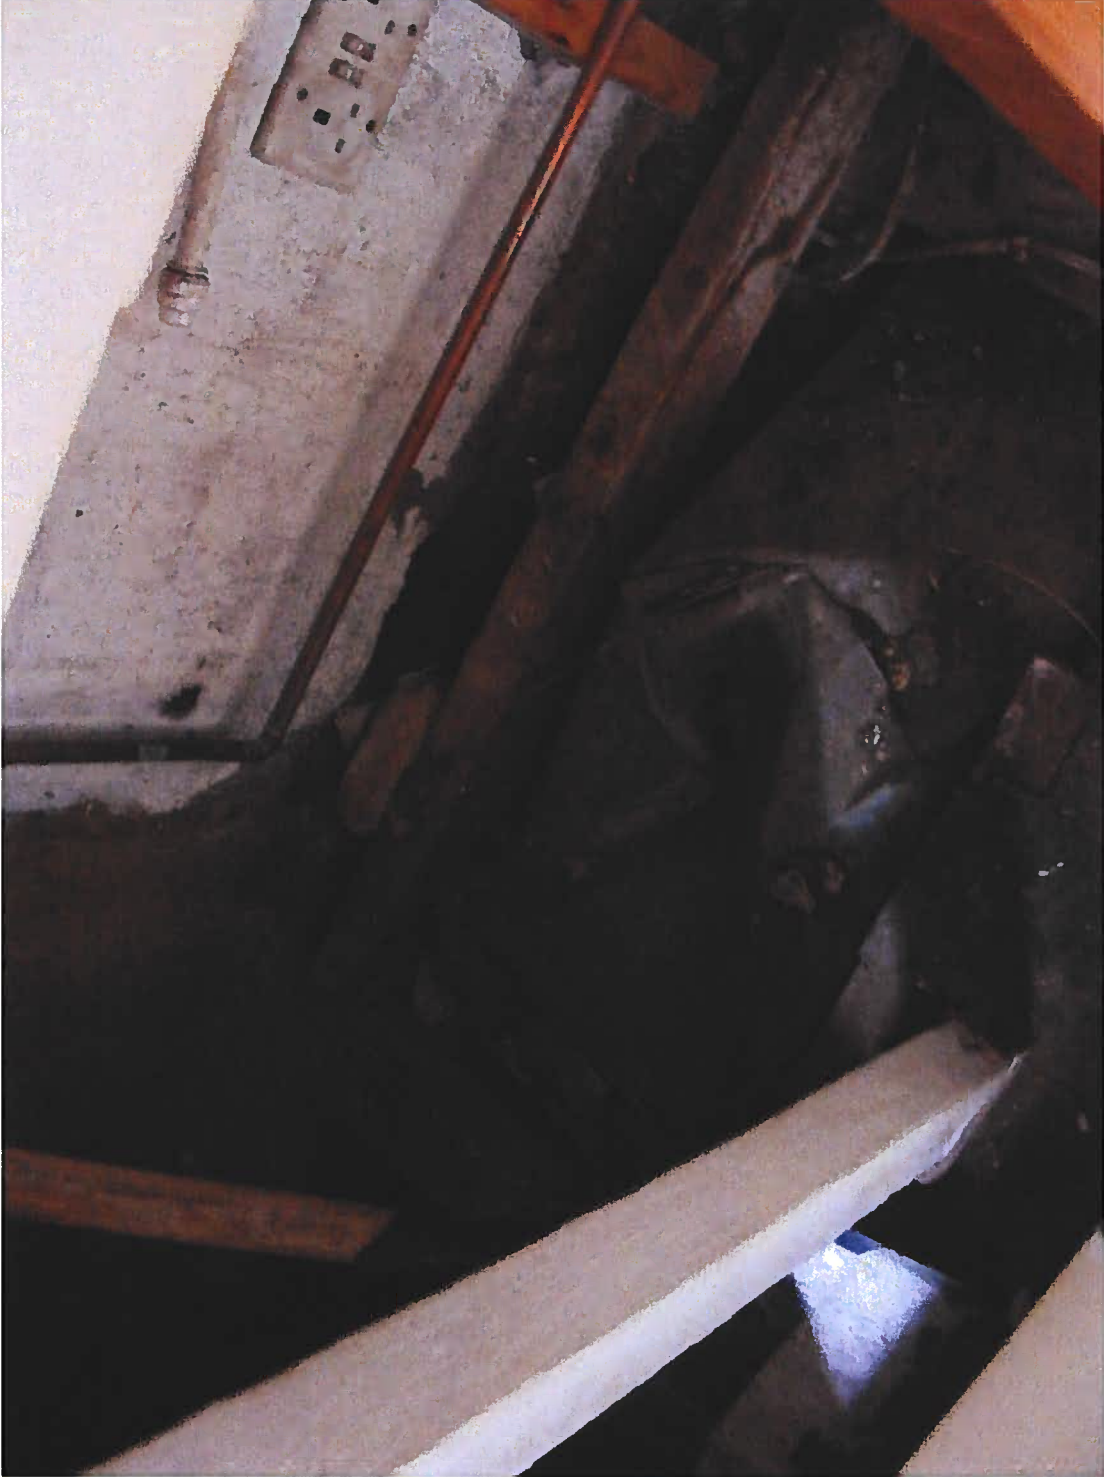
4

LOOKING ON TO FLOOR IN KITCHEN STORE CUPBOARD  
SEE DRG RE 012 FOR LOCATION

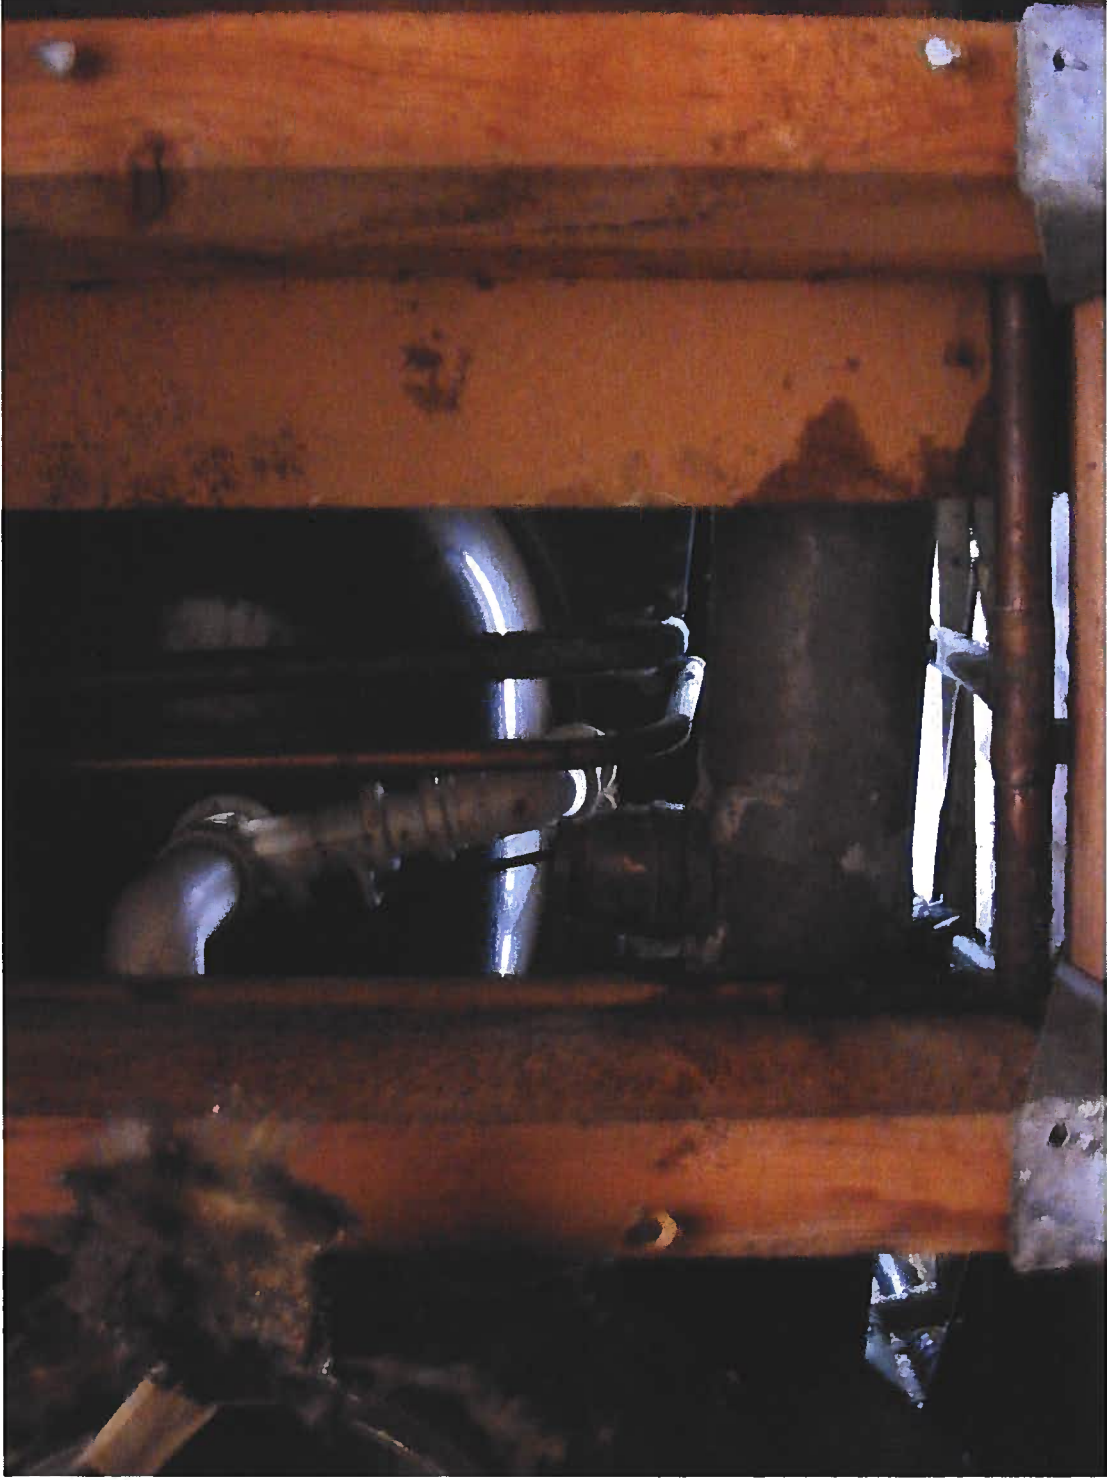
5

LOOKING AT KITCHEN STOVE CEILING .  
FIRST FLOOR BATHROOM BATH TUB  
AND PLUMBING AND DRAINAGE IN FULL VIEW!  
BASE FLOOR FOR PART OF BATHROOM MISSING.  
SEE DAG RE 012 FOR LOCATION

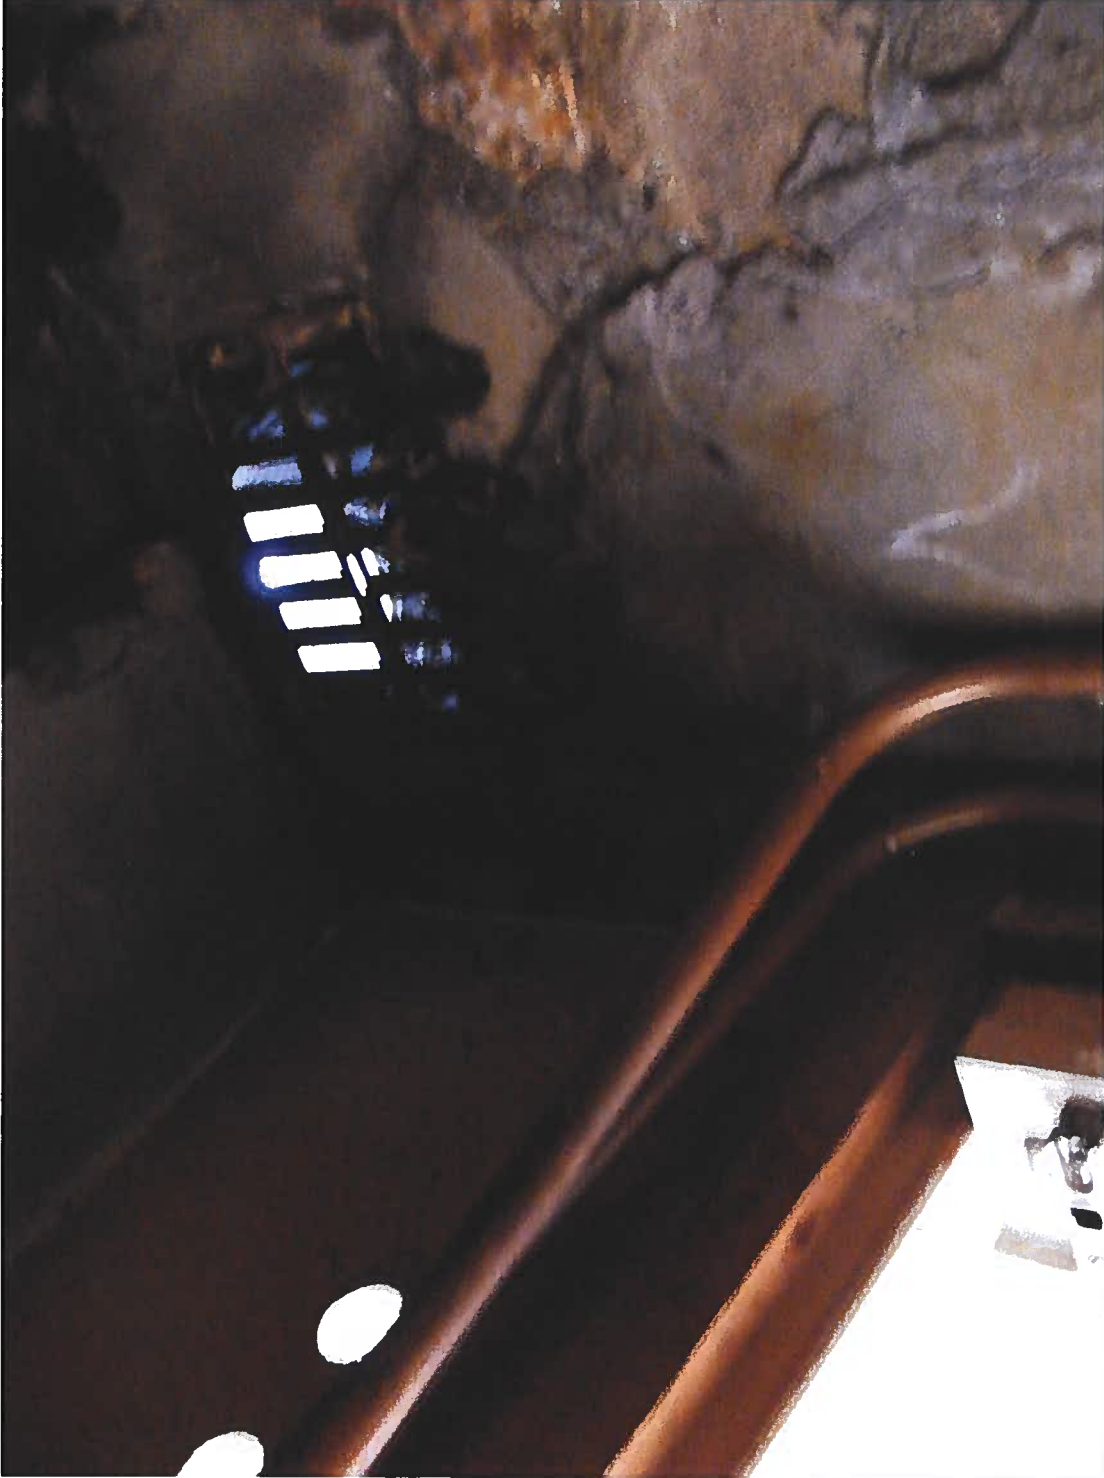
6

LOOKING UP TO CEILING IN KITCHEN STROE  
CEILING. OPEN GRILLE IN REAR WALL  
ALLOWS WATER INGRESS. DAMPNESS  
AND DAMAGE TO REAR WALL IS EVIDENT.  
SEE DRG PE012 FOR LOCATION.

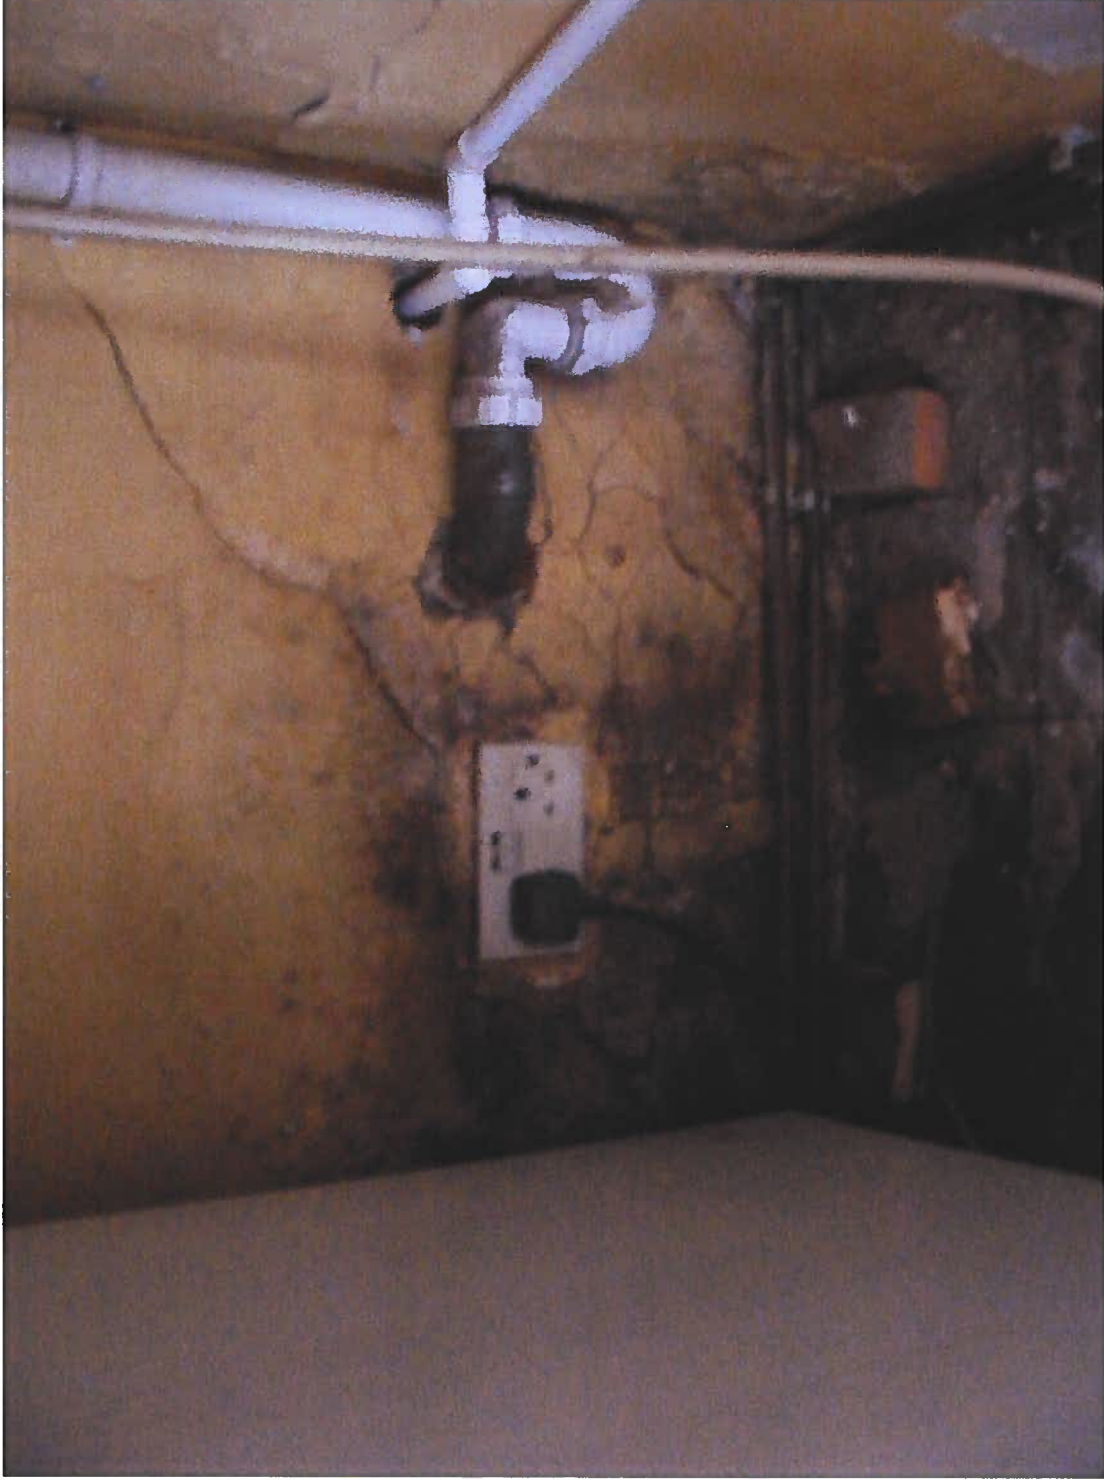
7

NORTH WALL OF REAR EXTENSION ROOM WALL/FLOOR INTERFACE.  
DAMP DAMAGE TO PLASTER.  
SEE DRG. RE 012 FOR LOCATION

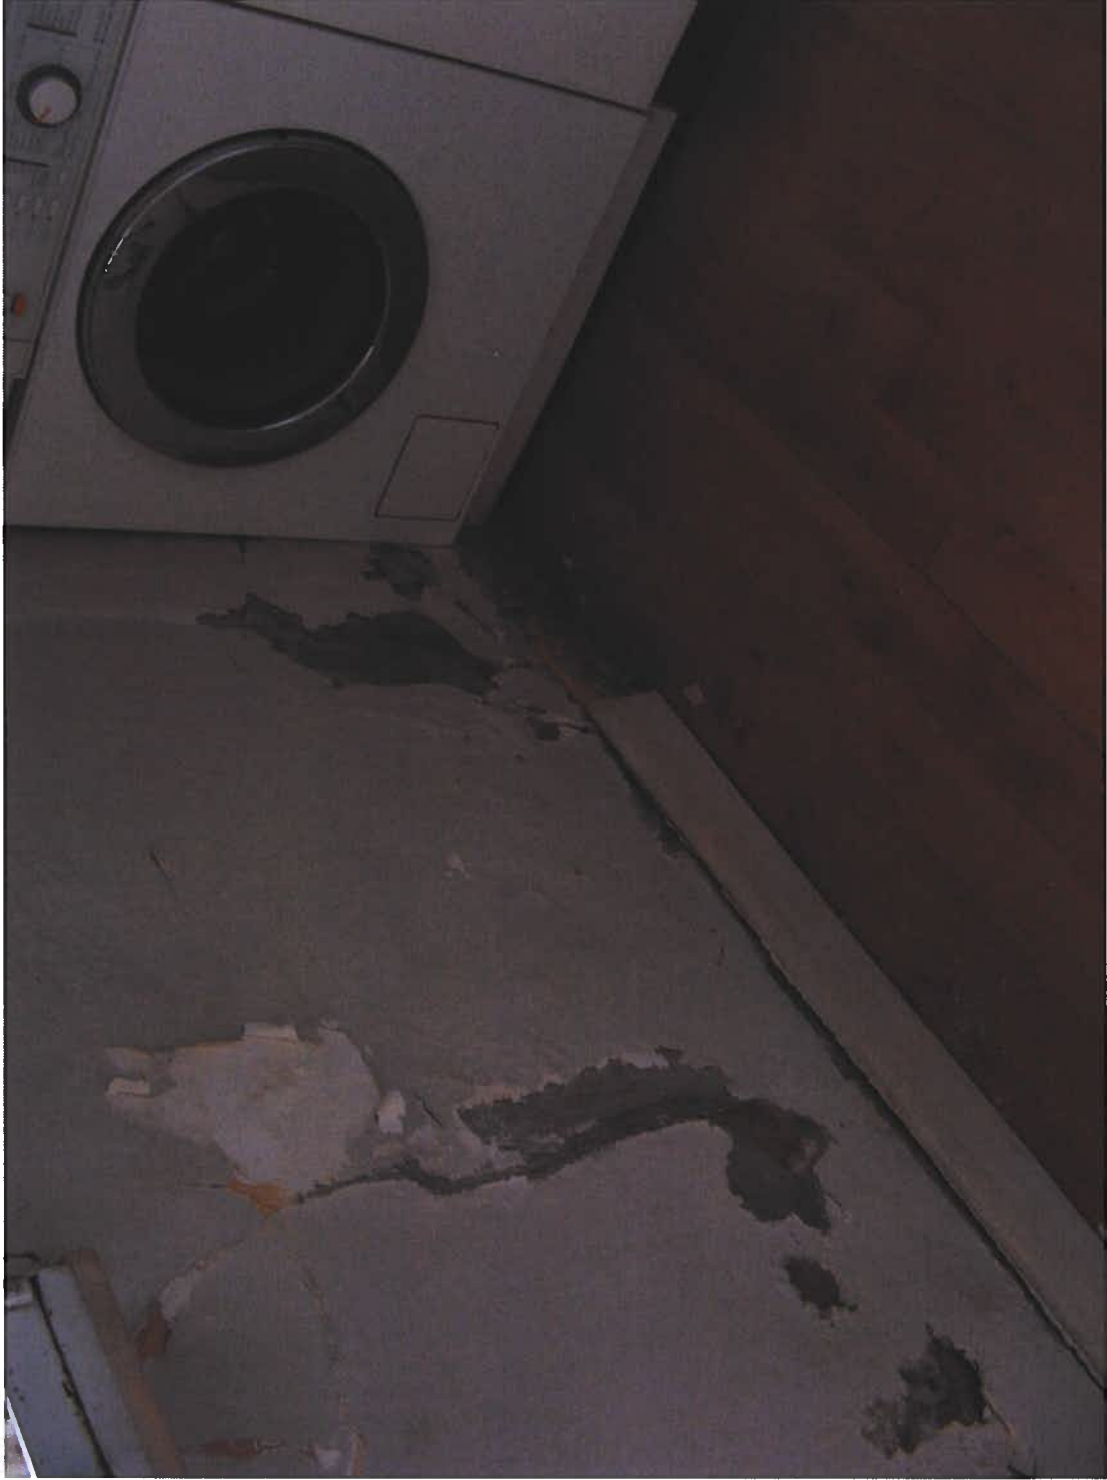
8

REAR EXTENSION ROOM. WEST WALL.  
SEVERE DAMP DAMAGES.

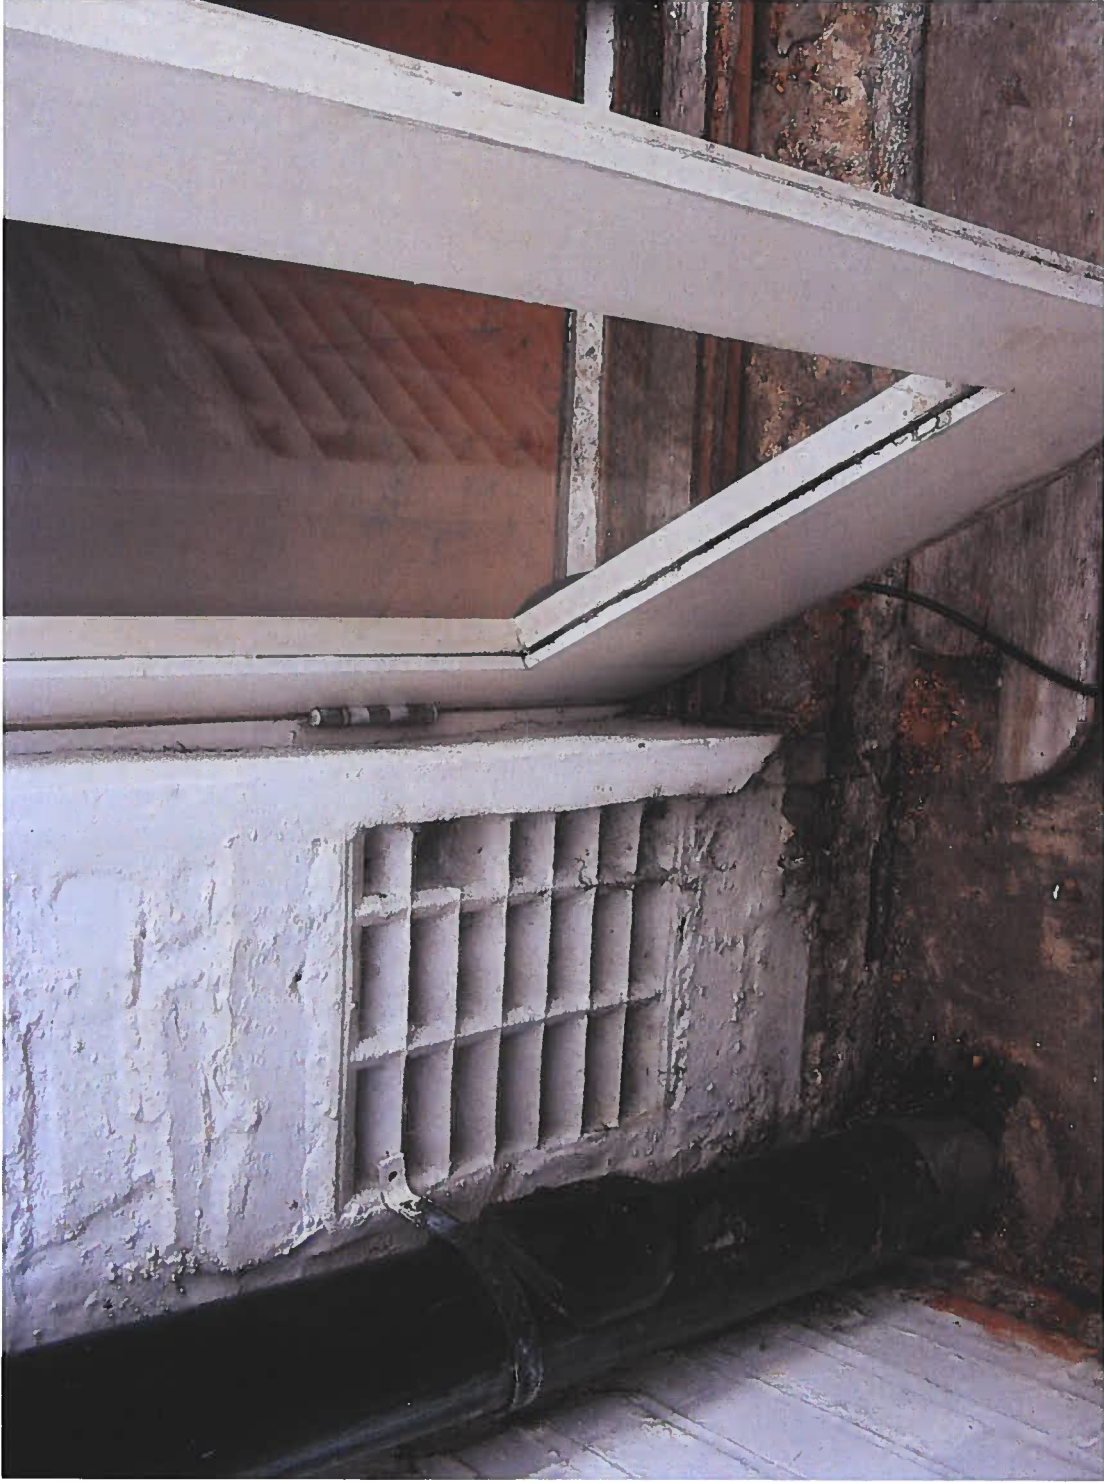
6

OUTSIDE VIEW OF THE CORNER AT EAST JAMB  
OF REAR PATIO DOOR  
PER LOCATION SEE DRG REC012

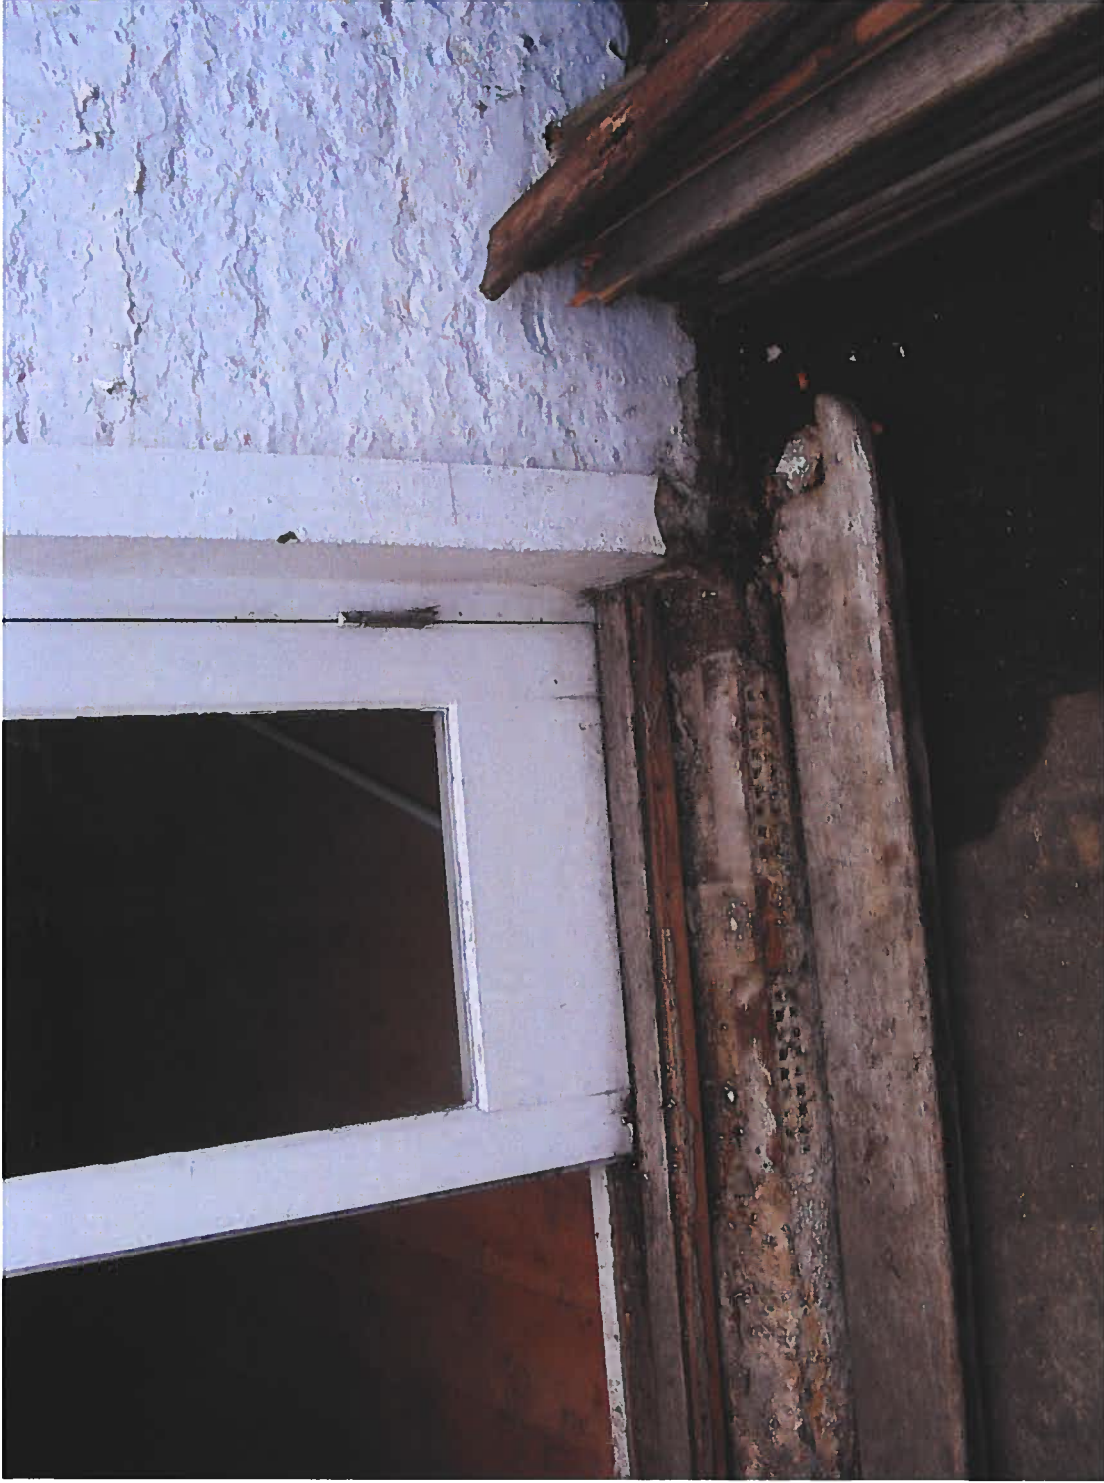
10

OUTSIDE VIEW AROUND WEST JAMB OF REAR PATIO DOOR

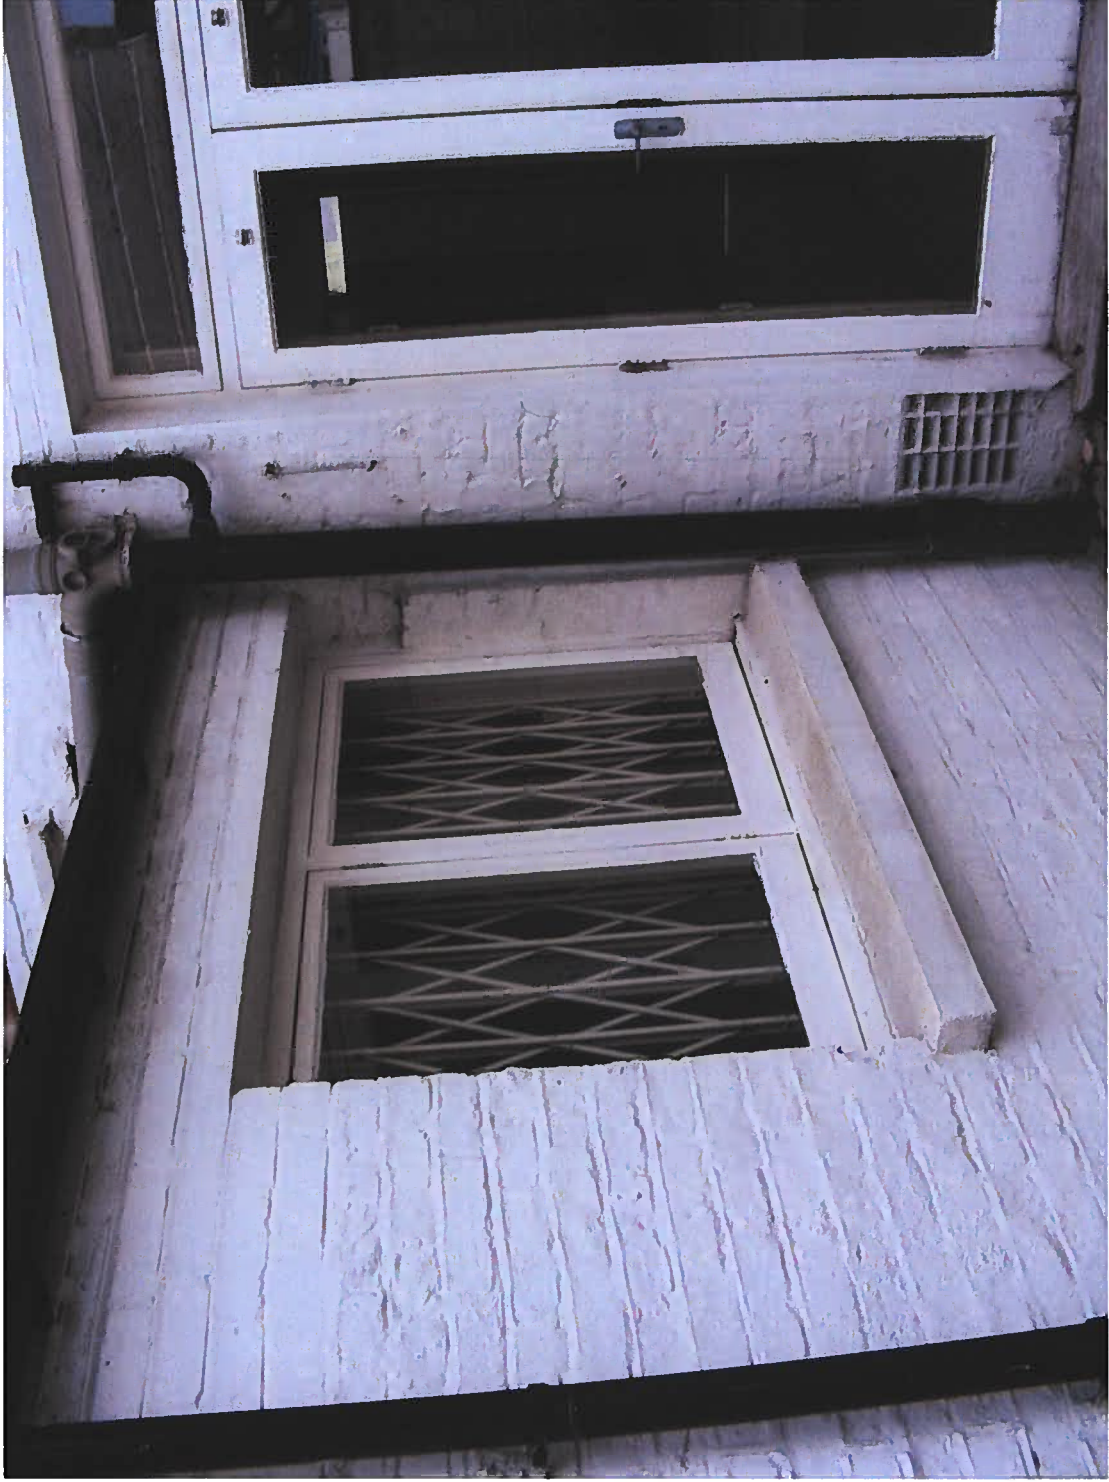
11

REAR EXTENSION WEST WALL / ROOF / MAIN BUILDING REAR WALL  
INTERFACE  
NOTE: CROWNED GUTTER / ROOF / SOIL PIPE ETC JUNCTION  
FOR LOCATION SEE DRG PE-012

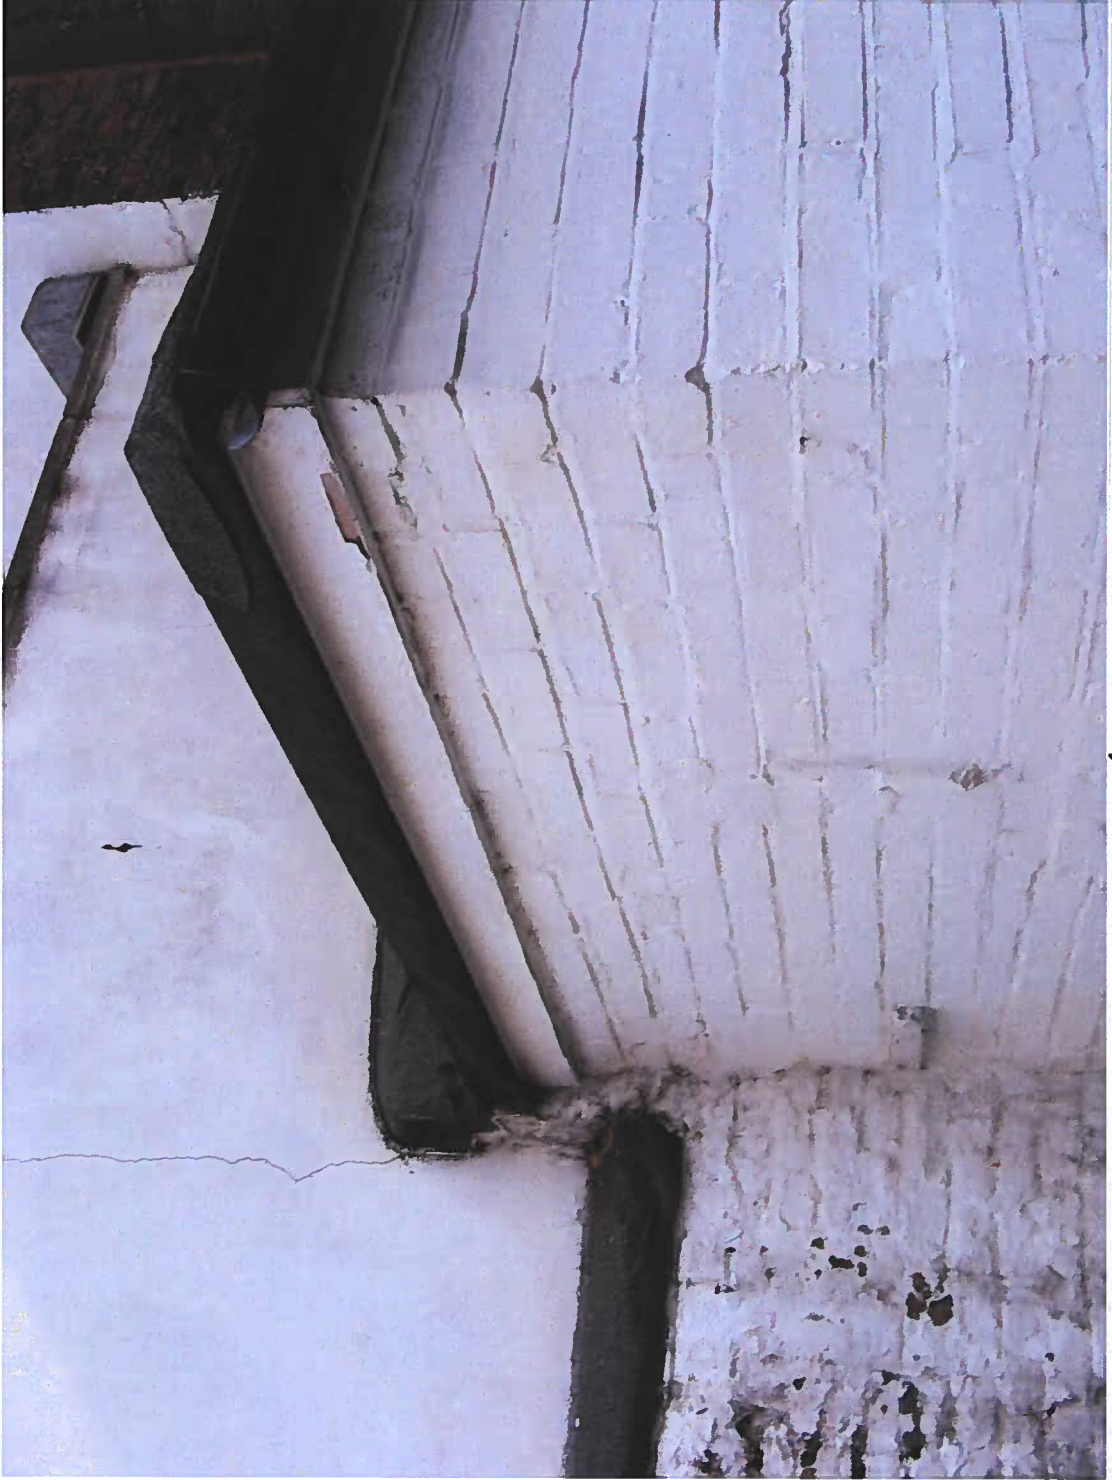
12

REAR EXTENSION NORTH SIDE / EAST BOUNDARY WALL / ADJOINING  
PROPERTY WALL INTERFACED DETAILS + ROOF EDGE DETAILS.  
FOR LOCATION SEE DRG PE 012

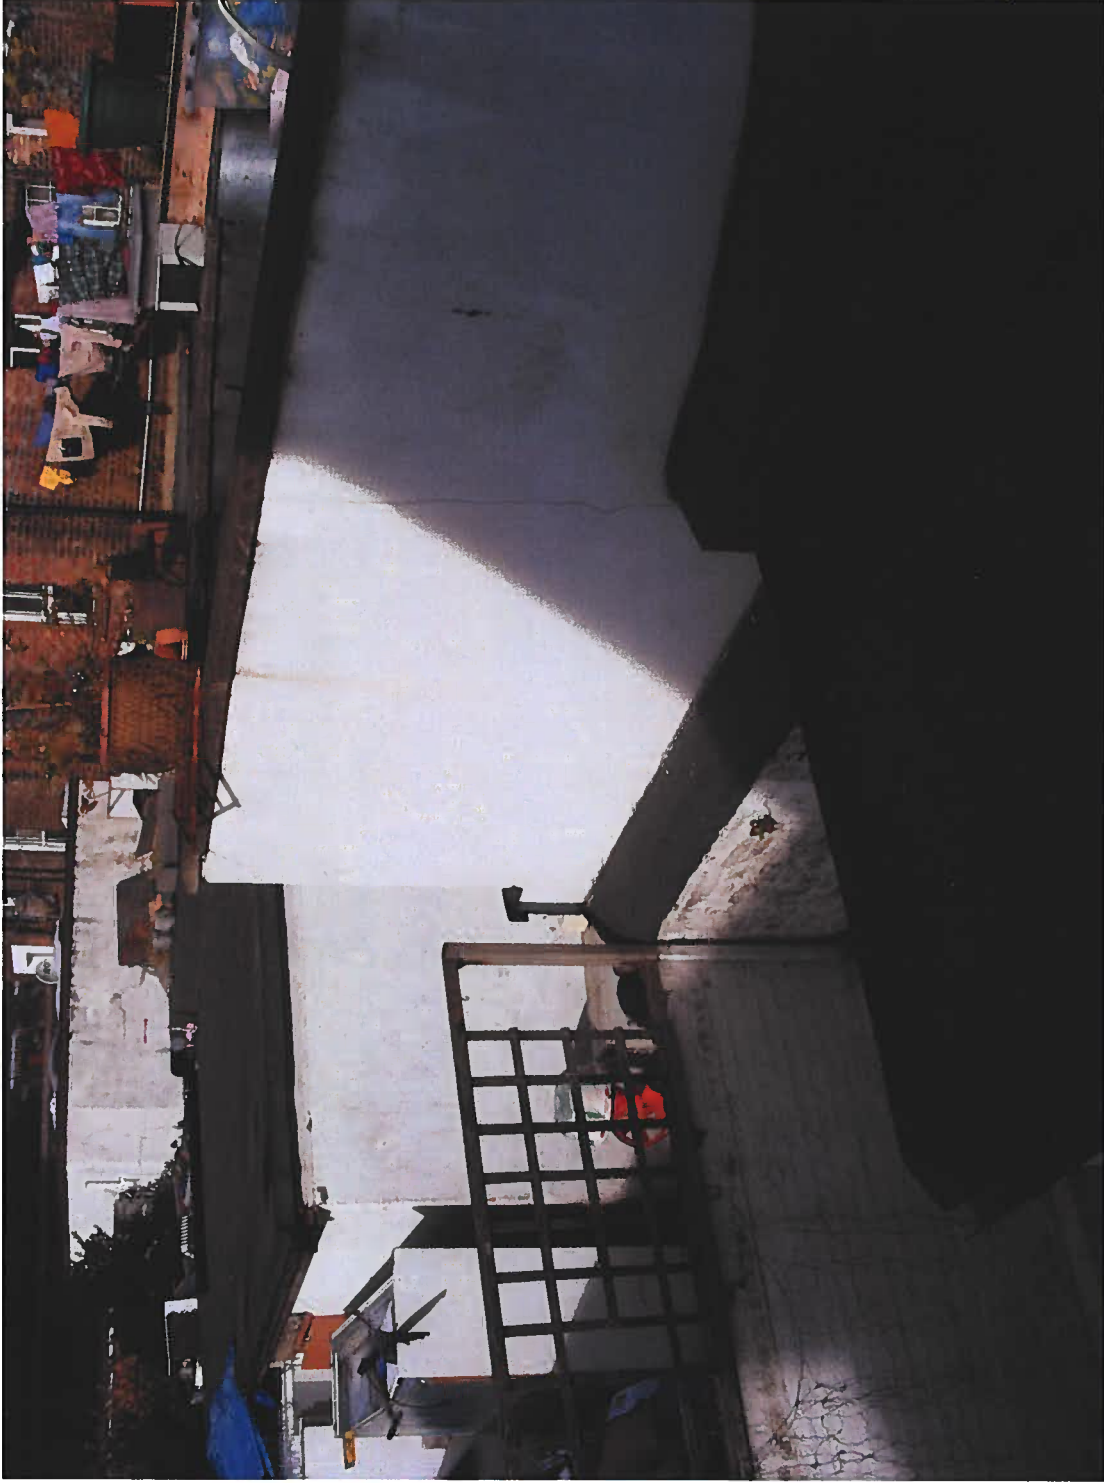
13

VIEW TO NORTH AND EAST BOUNDARY WALLS  
AND BEYOND. NOTE: EXISTING BROKEN TIMBER TRELUSS  
AND THE STUNK DEPOSIT BEYOND.  
SEE DRG. RE 012 FOR LOCATION.

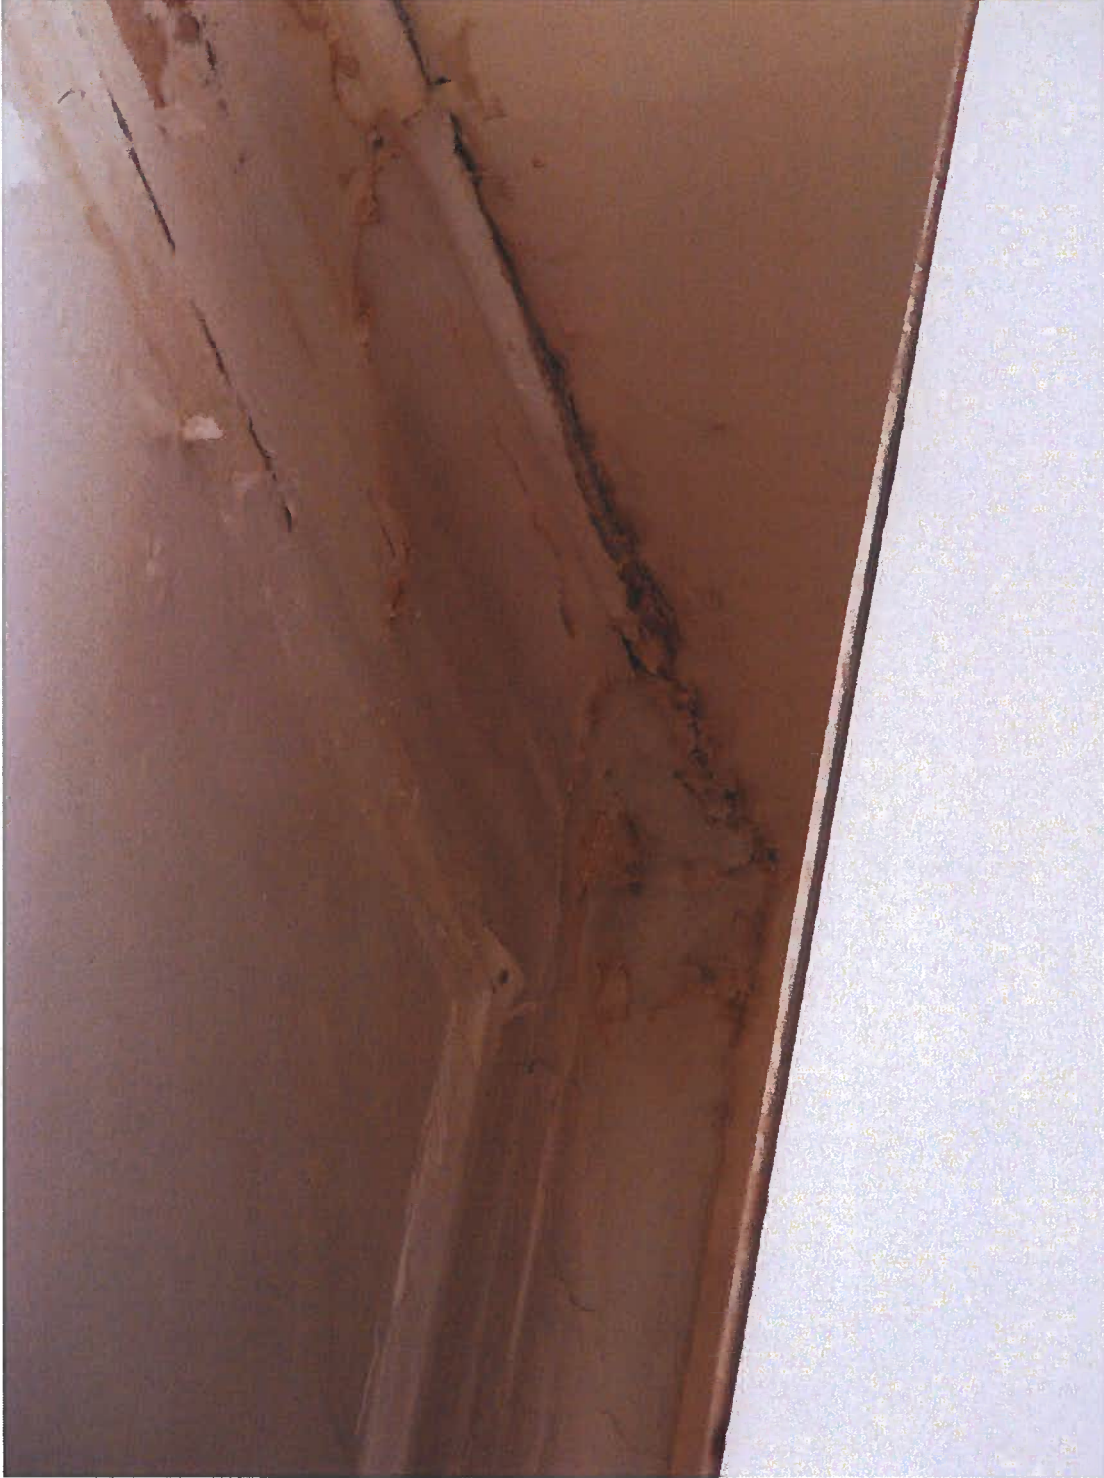
15

CRUMBLING CEILING COVE IN BEDROOM 2  
SEE DRG. RE 012 FOR LOCATION
