← 8 KELLEY STREET →

8 KELLEY STREET  
NWK 18TH  
07-11-2018

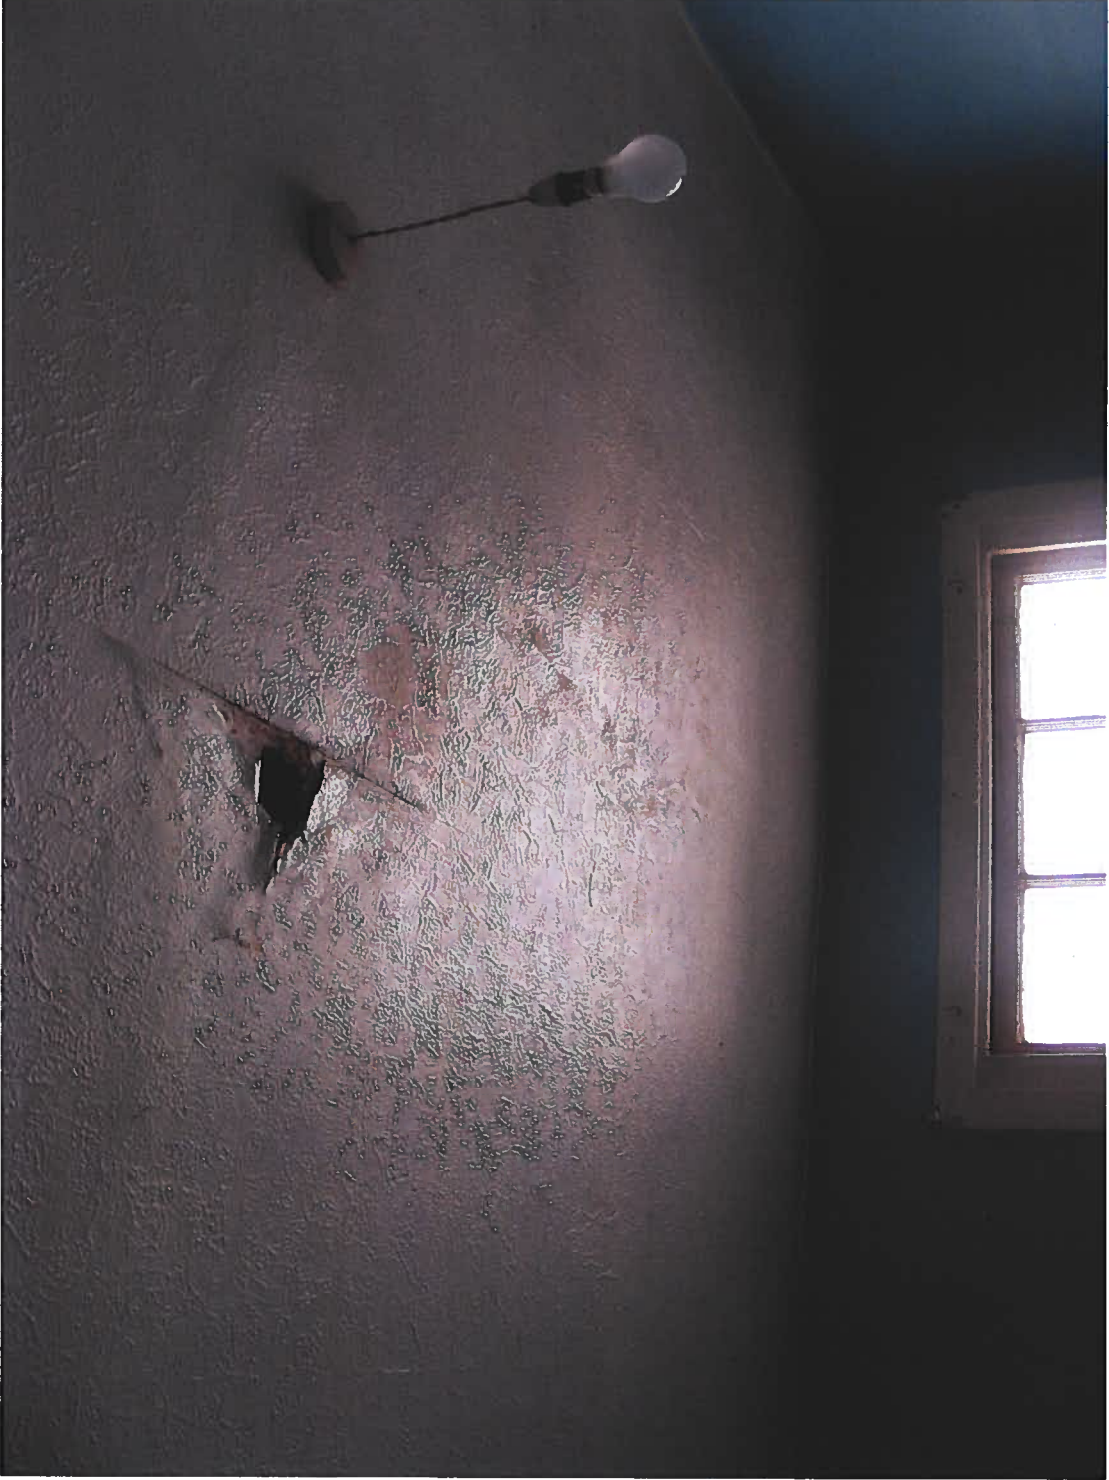
16

BED ROOM 1 CEILING  
SEE DRG RE 012 FOR LOCATION.

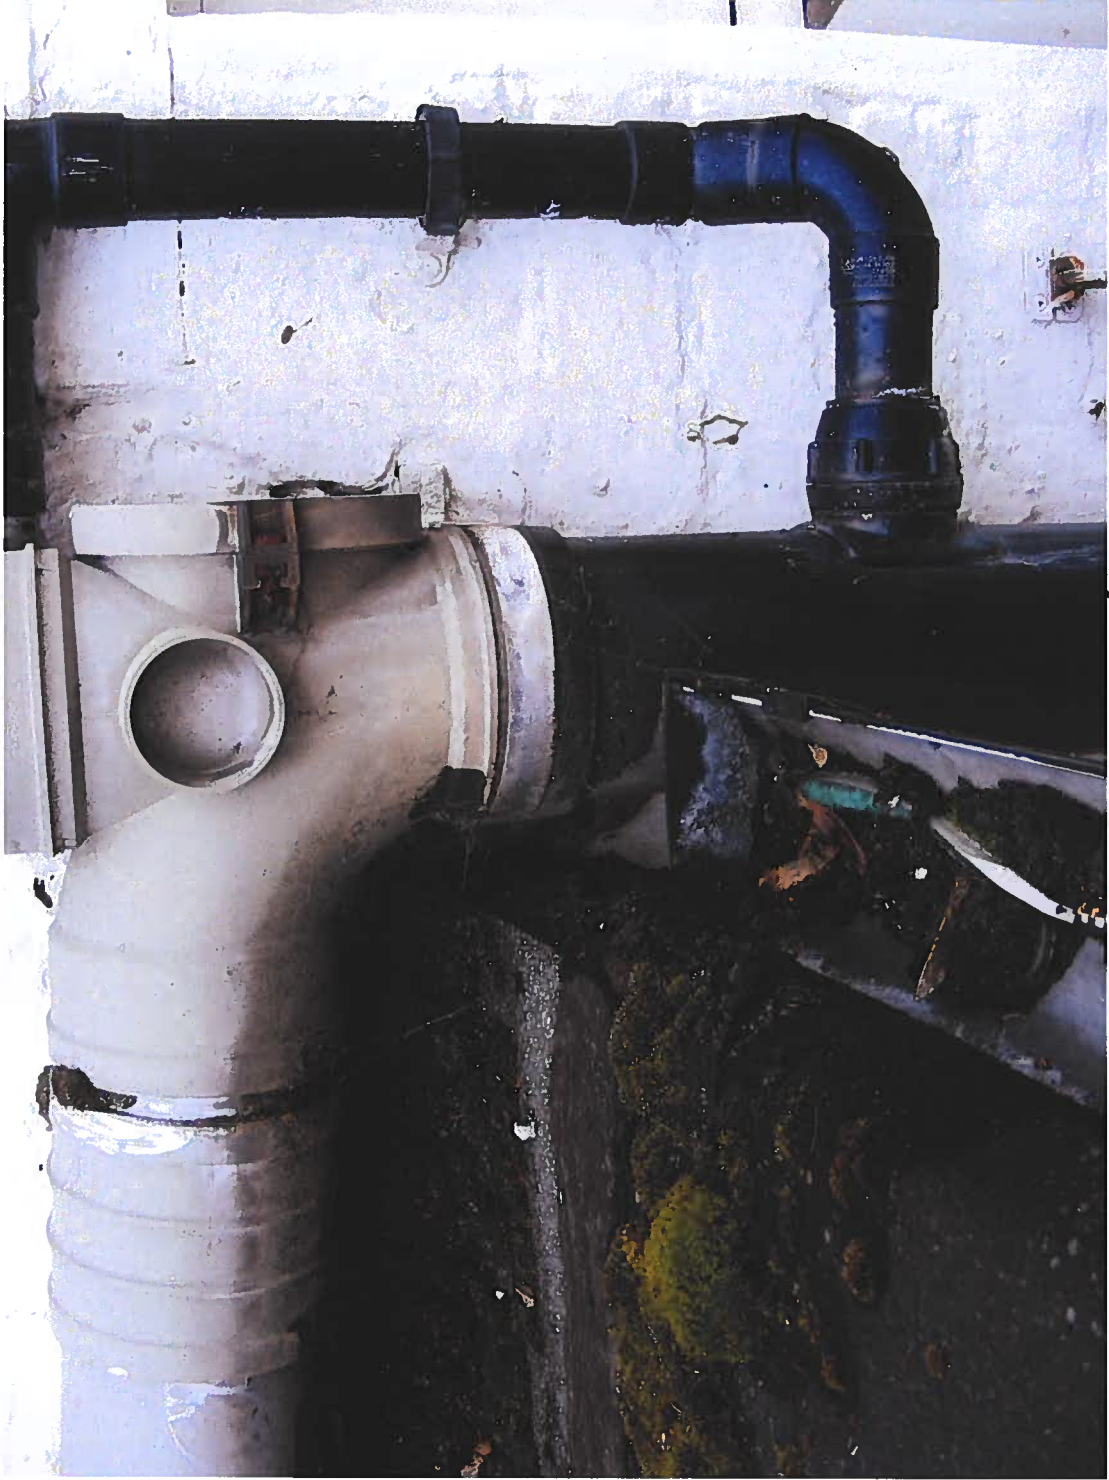
17

CLOSE UP VIEW OF DRAINAGE PIPES / REAR EXTENSION ROOF  
AND GUTTER INTERFACE

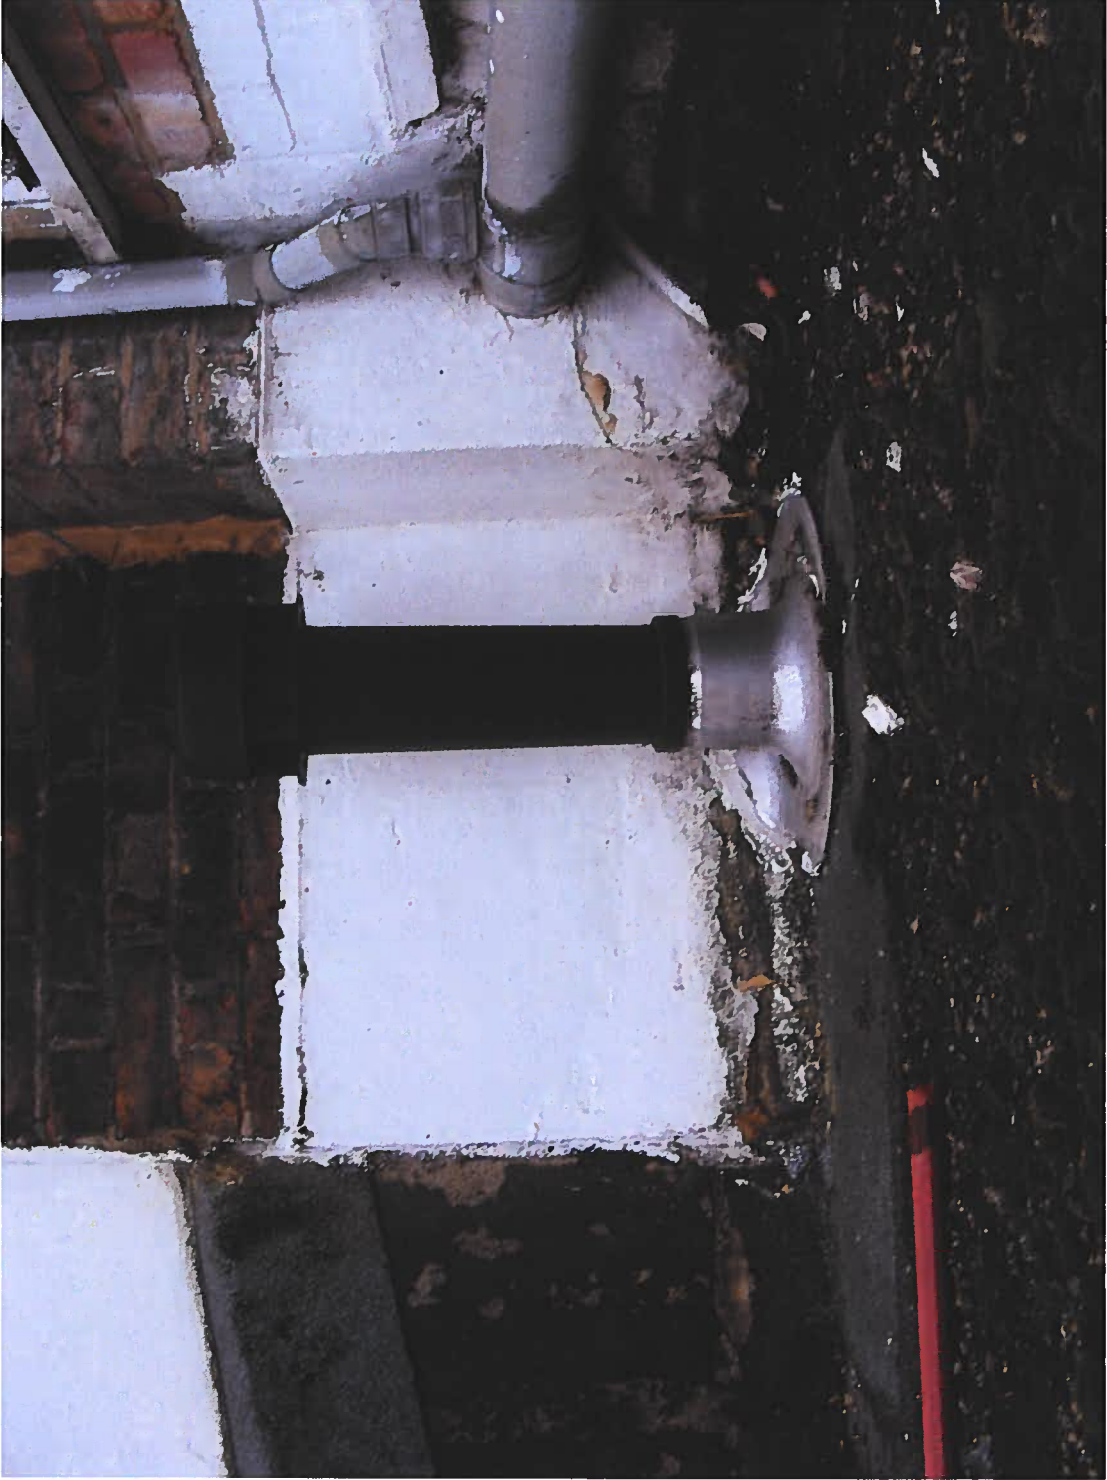
18

CLOSE UP VIEW OF REAR EXTENSION ROOF, WALLS ABOVE,  
BOILER FLUE AND DRAINAGE PIPES.

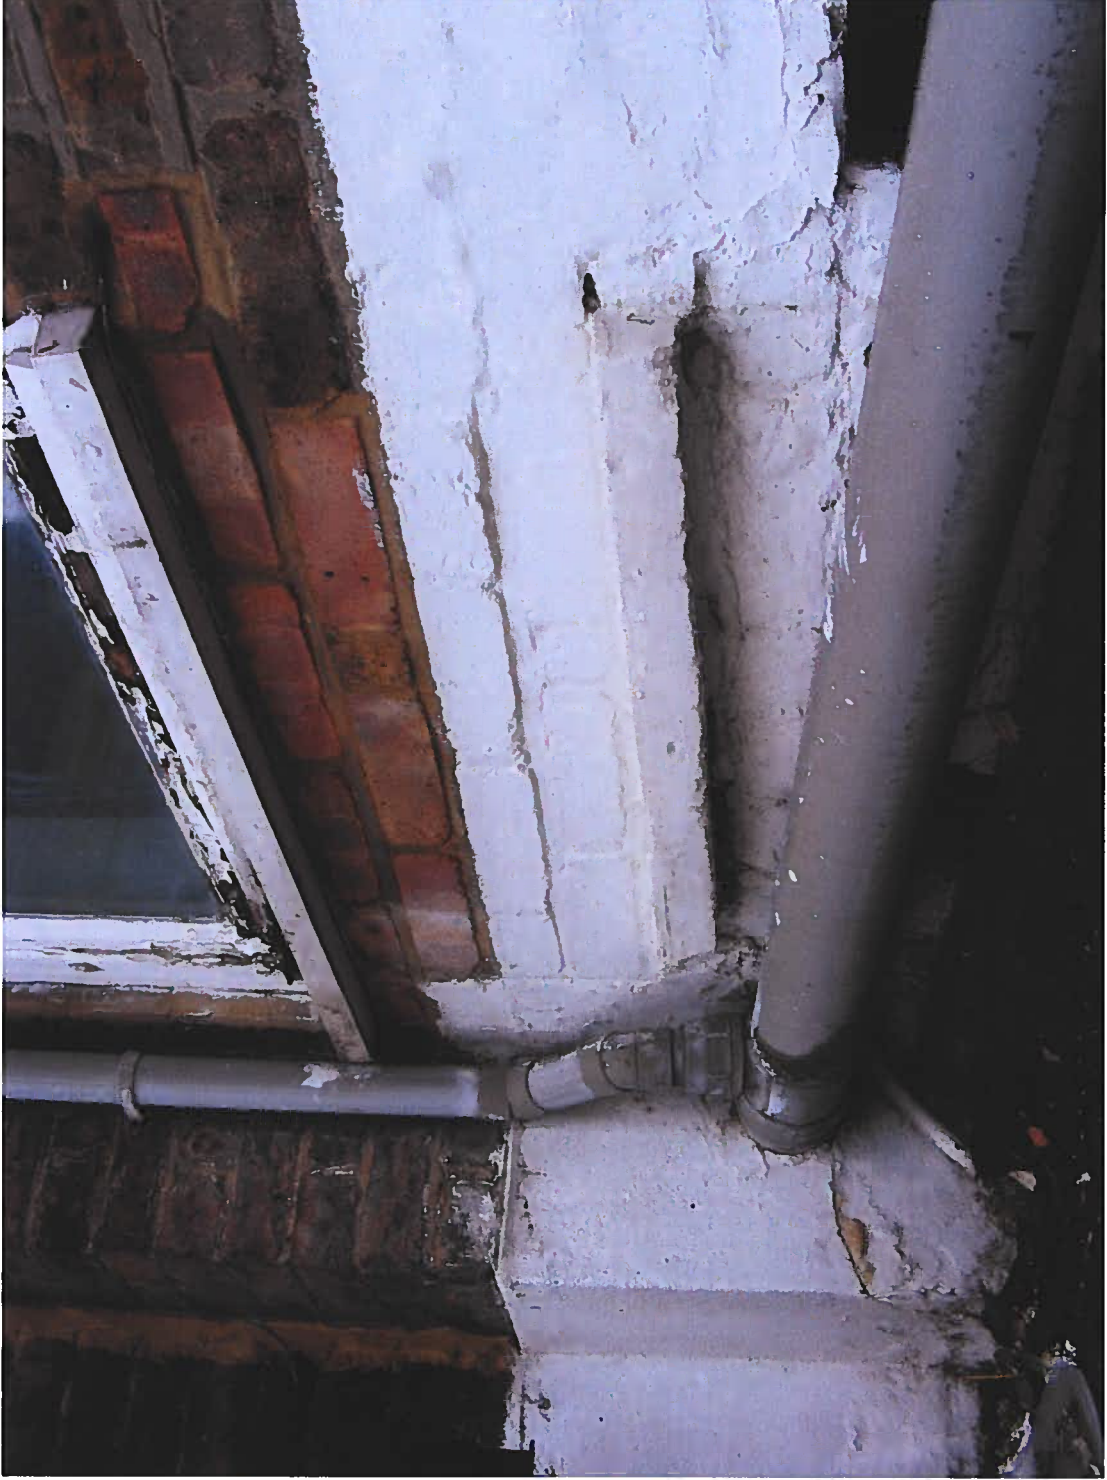
19

CLOSE UP VIEW OF BATHROOM WINDOW, UNPROTECTED  
OPENINGS IN THE WALL BELOW  
NOTE: POOR CONDITION OF WALLS AND ROOF INTERFACE  
PR LOCATION SEE DRG. RE 012

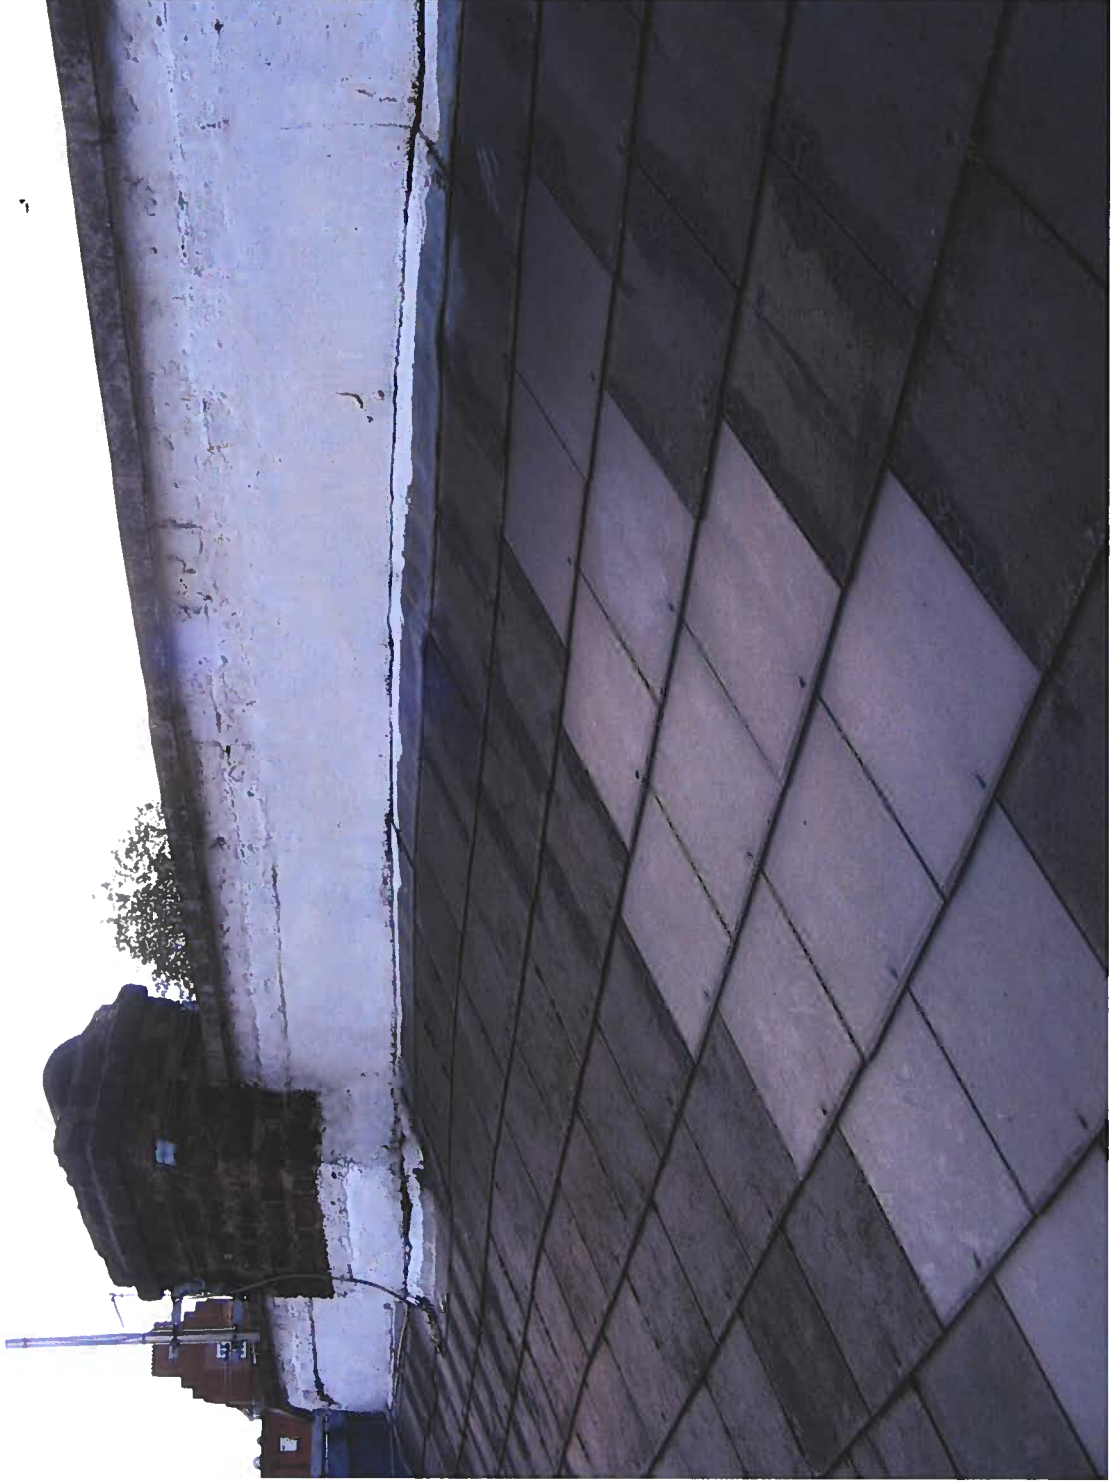
20

GENERAL VIEW OF THE MAIN ROOF SHOWING PATCH REPAIRS  
TO ROOF TILES INCORRECT LEADWORK ETC.  
TYPICAL TO THIS ROOF  
RFR LOCATION SEE DRG RE 013

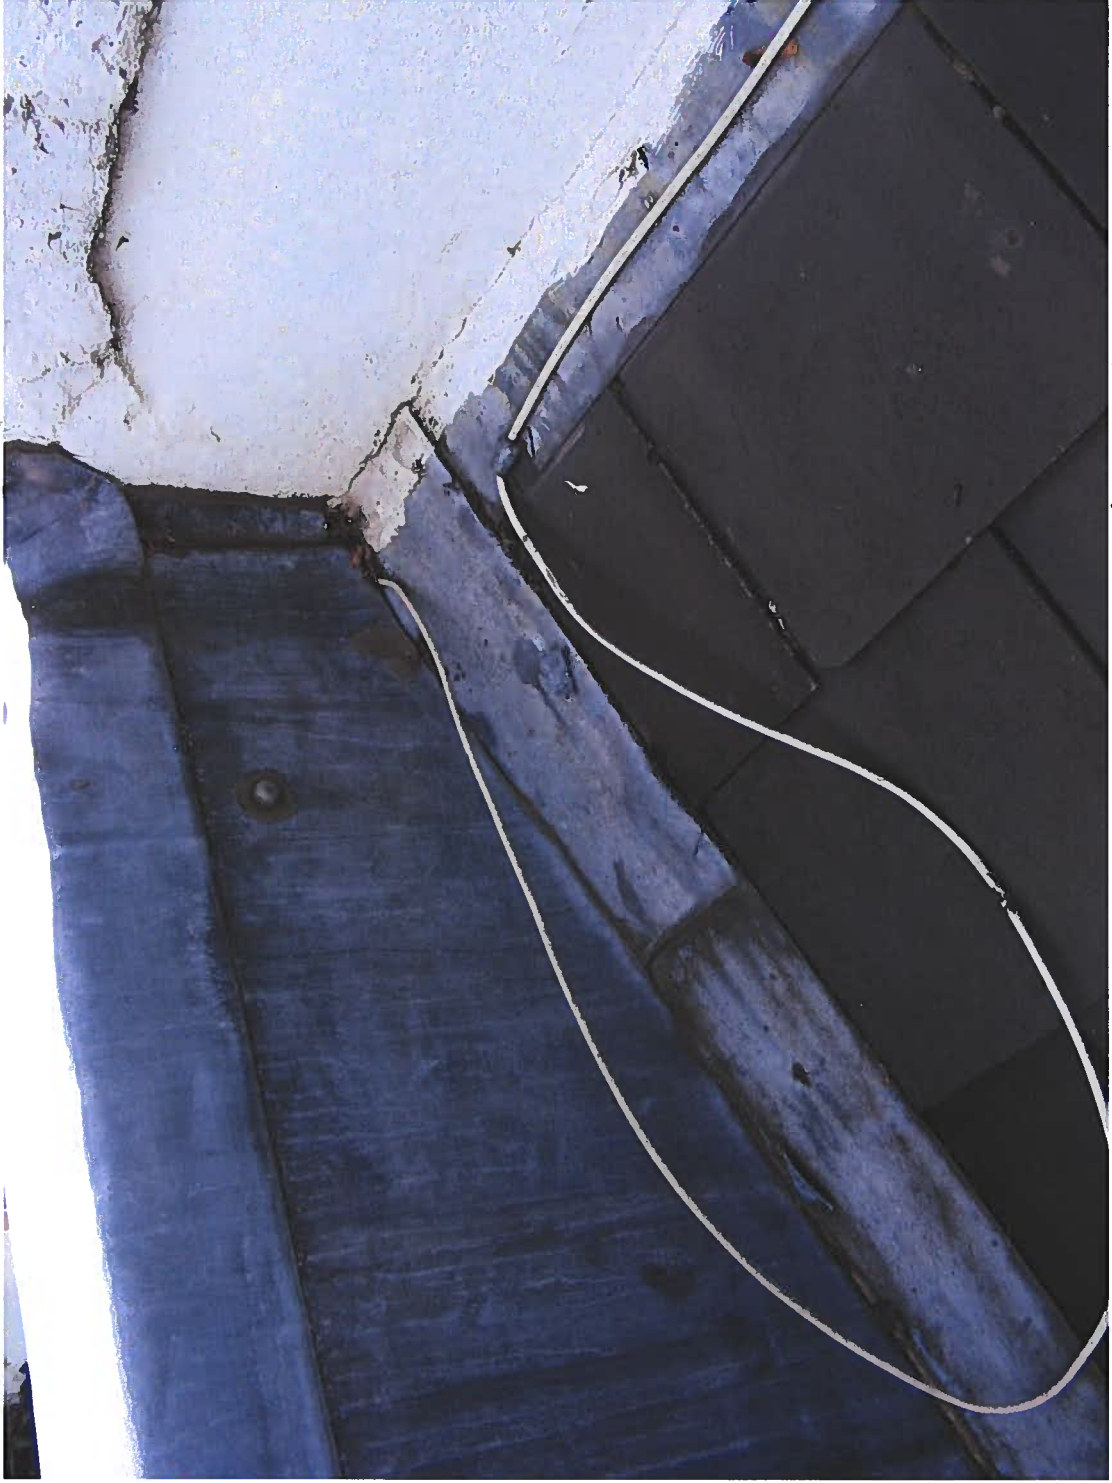
21

CLOSE UP VIEW OF FRONT PARAPET / ROOF / PARTY WALL  
INTERFACE  
FOR LOCATION SEE DRG RE 013

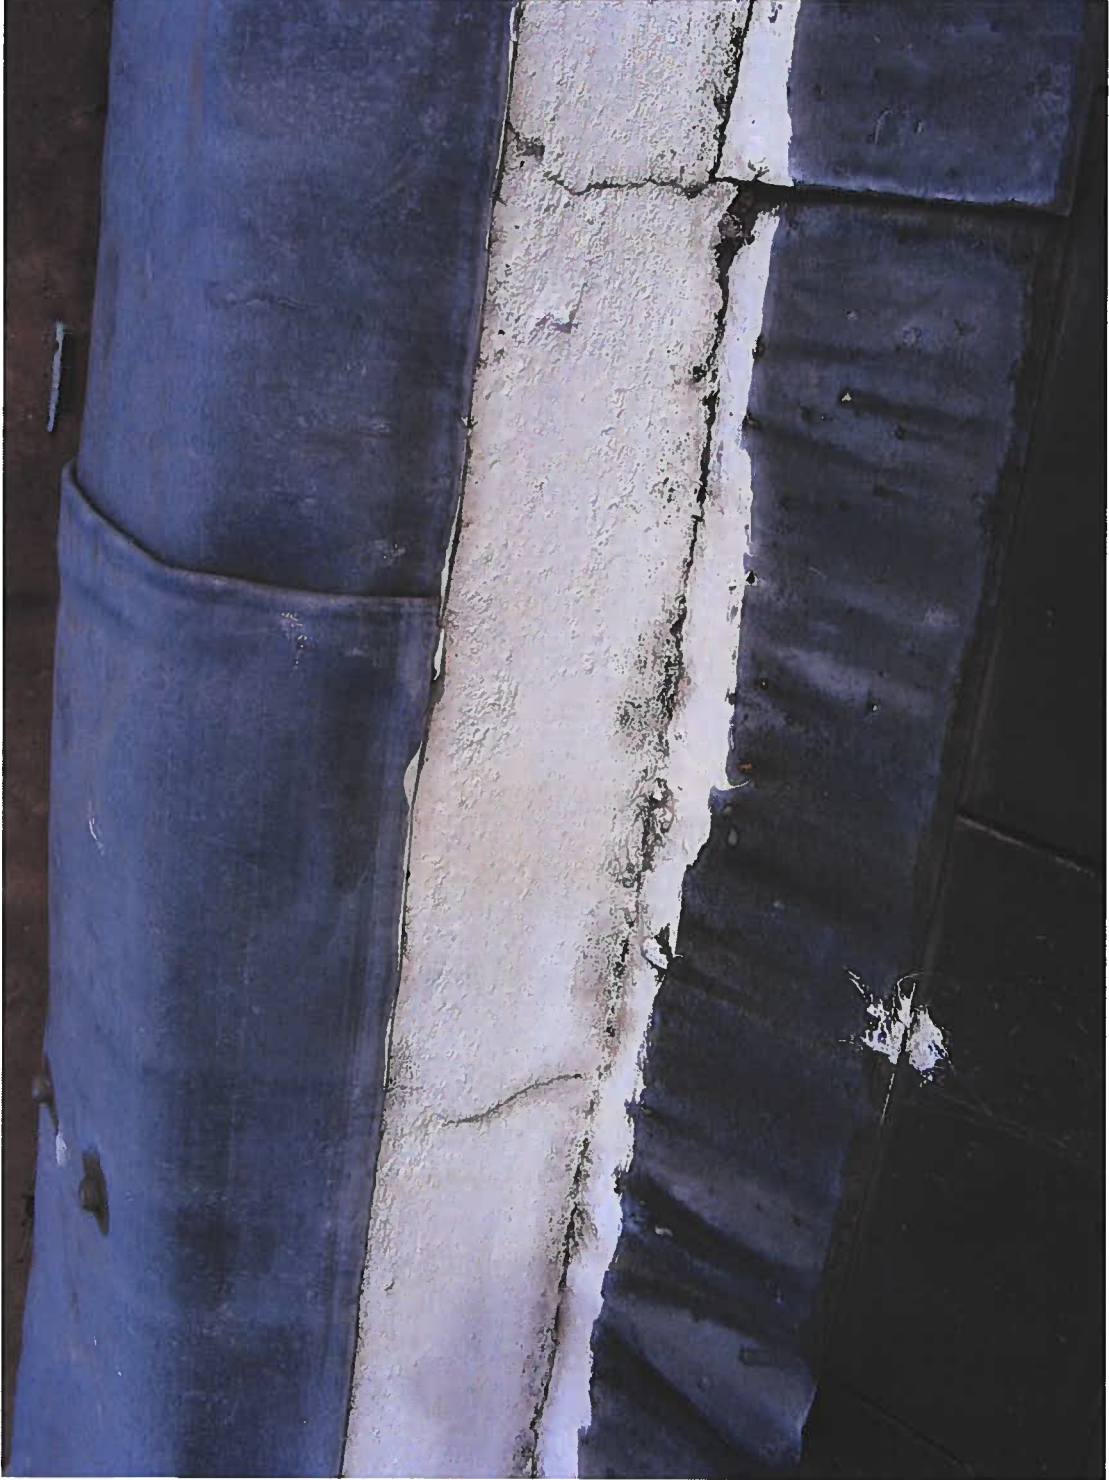
22

CLOSE UP OF ROOF RIDGE DETAIL.  
THIS IS TYPICAL ON THIS ROOF.
