## ***PHASE IV – VALIDATION REPORT CAMDEN COUNCIL APPLICATION NUMBER 2011/2444/P***

***Site at  
3 Augustines Road  
London  
NW1 9RP***

***October 2018  
Report No. 7769***

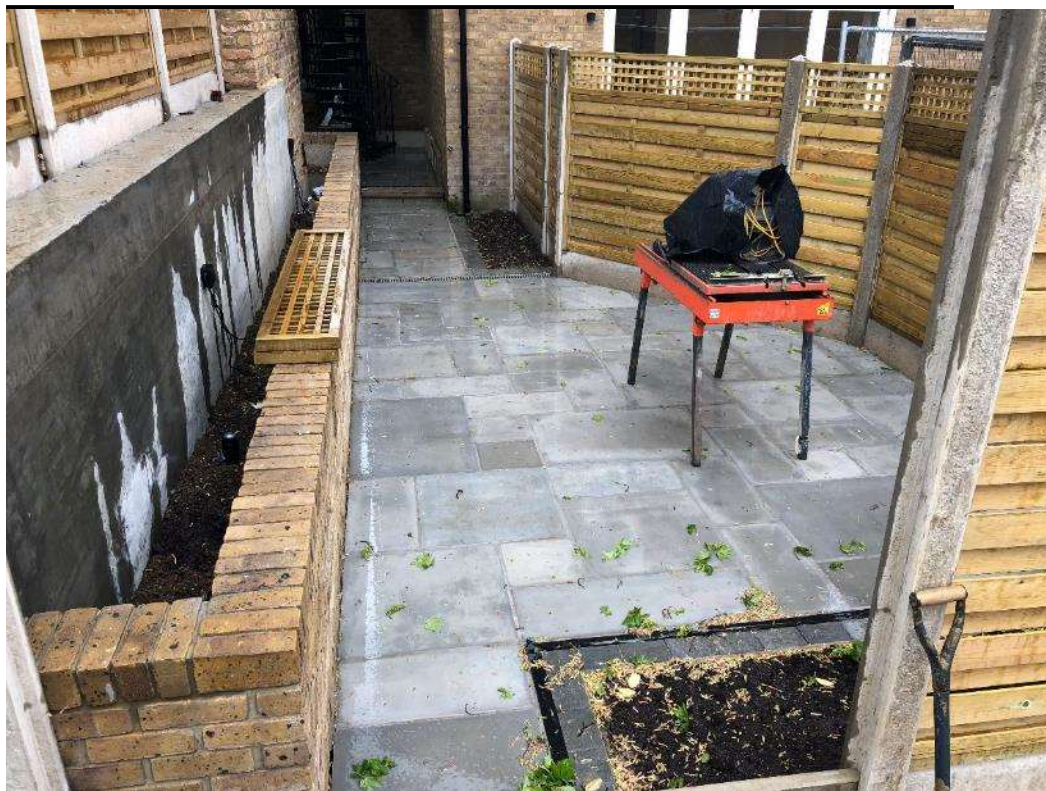
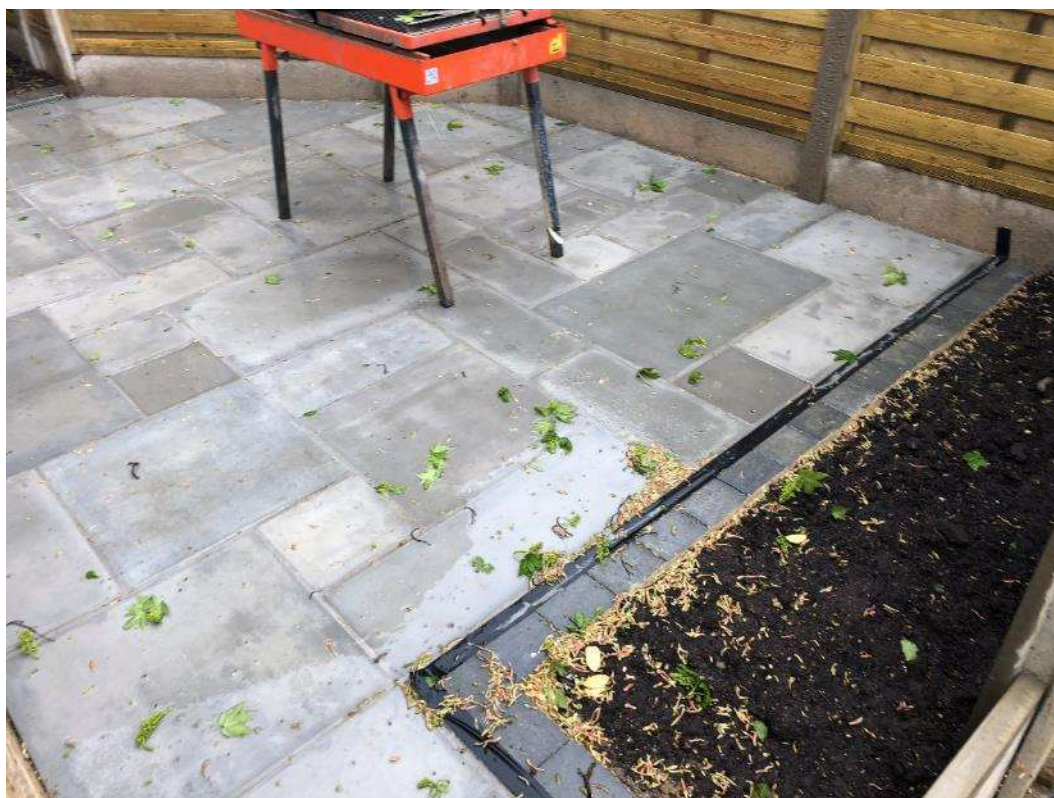
Soft landscaping to rear gardens

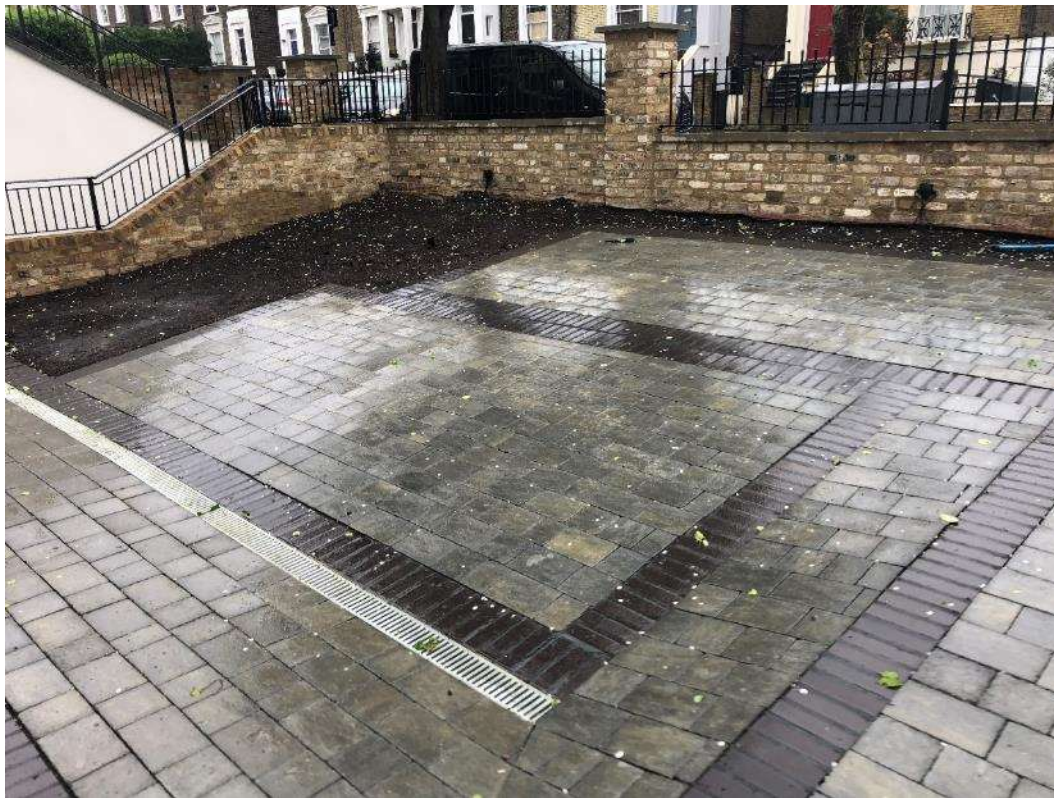
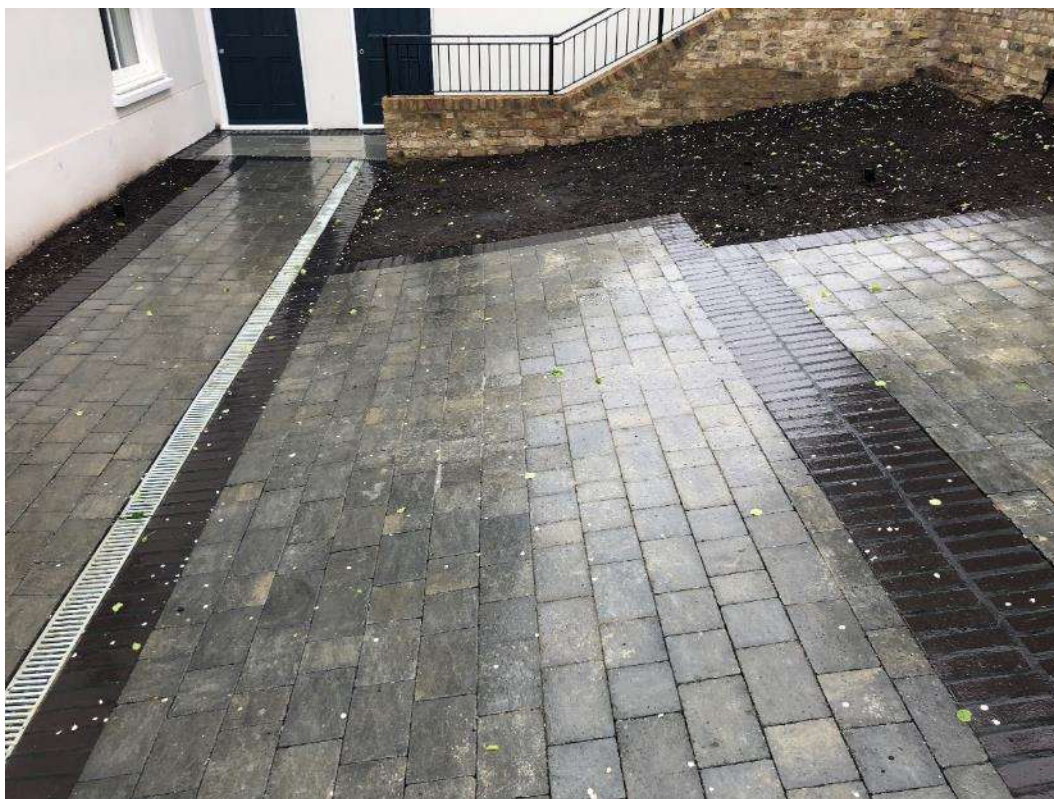
Soft landscaping to front gardens

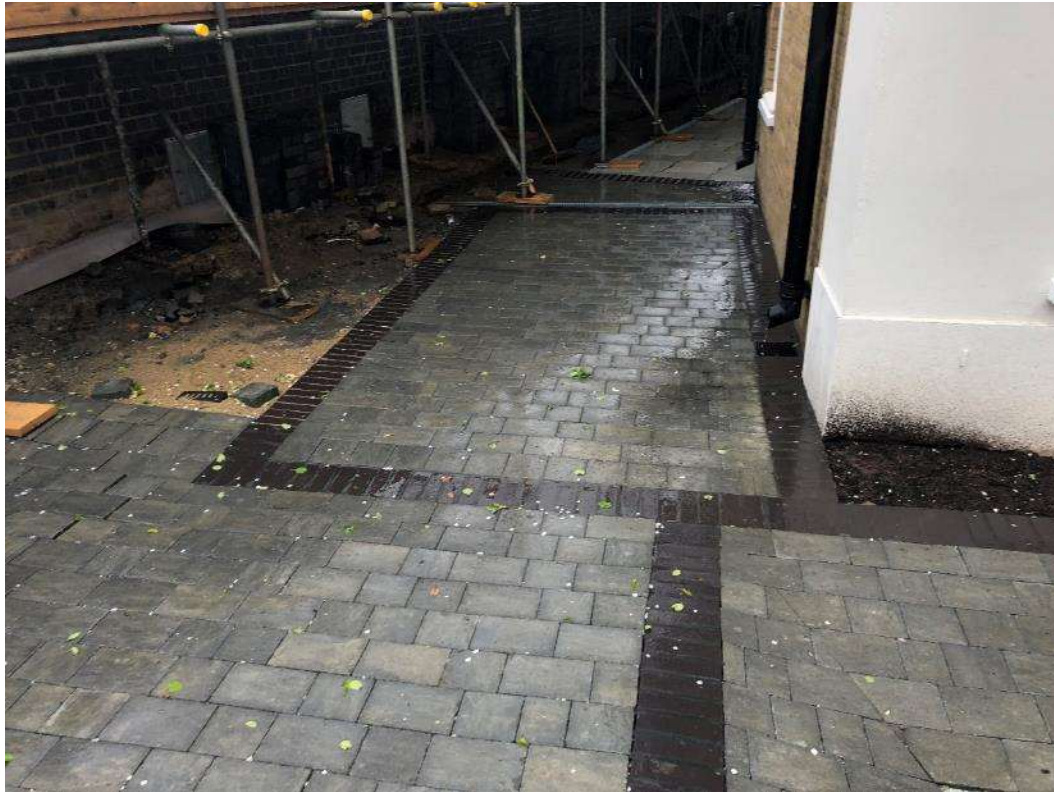
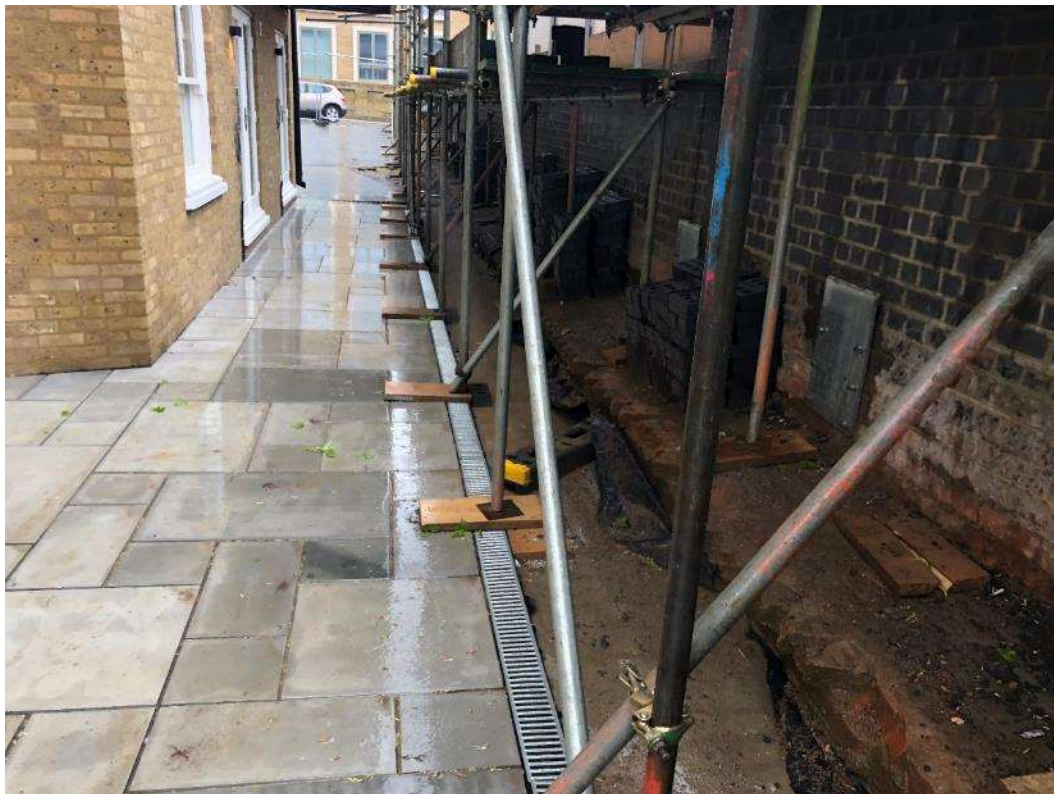
Side hard landscaping
