Project name:
160523

Drawing title:
Bedford Estates

Date:
29/11/2018

Health and Safety Tree Schedule & Works history

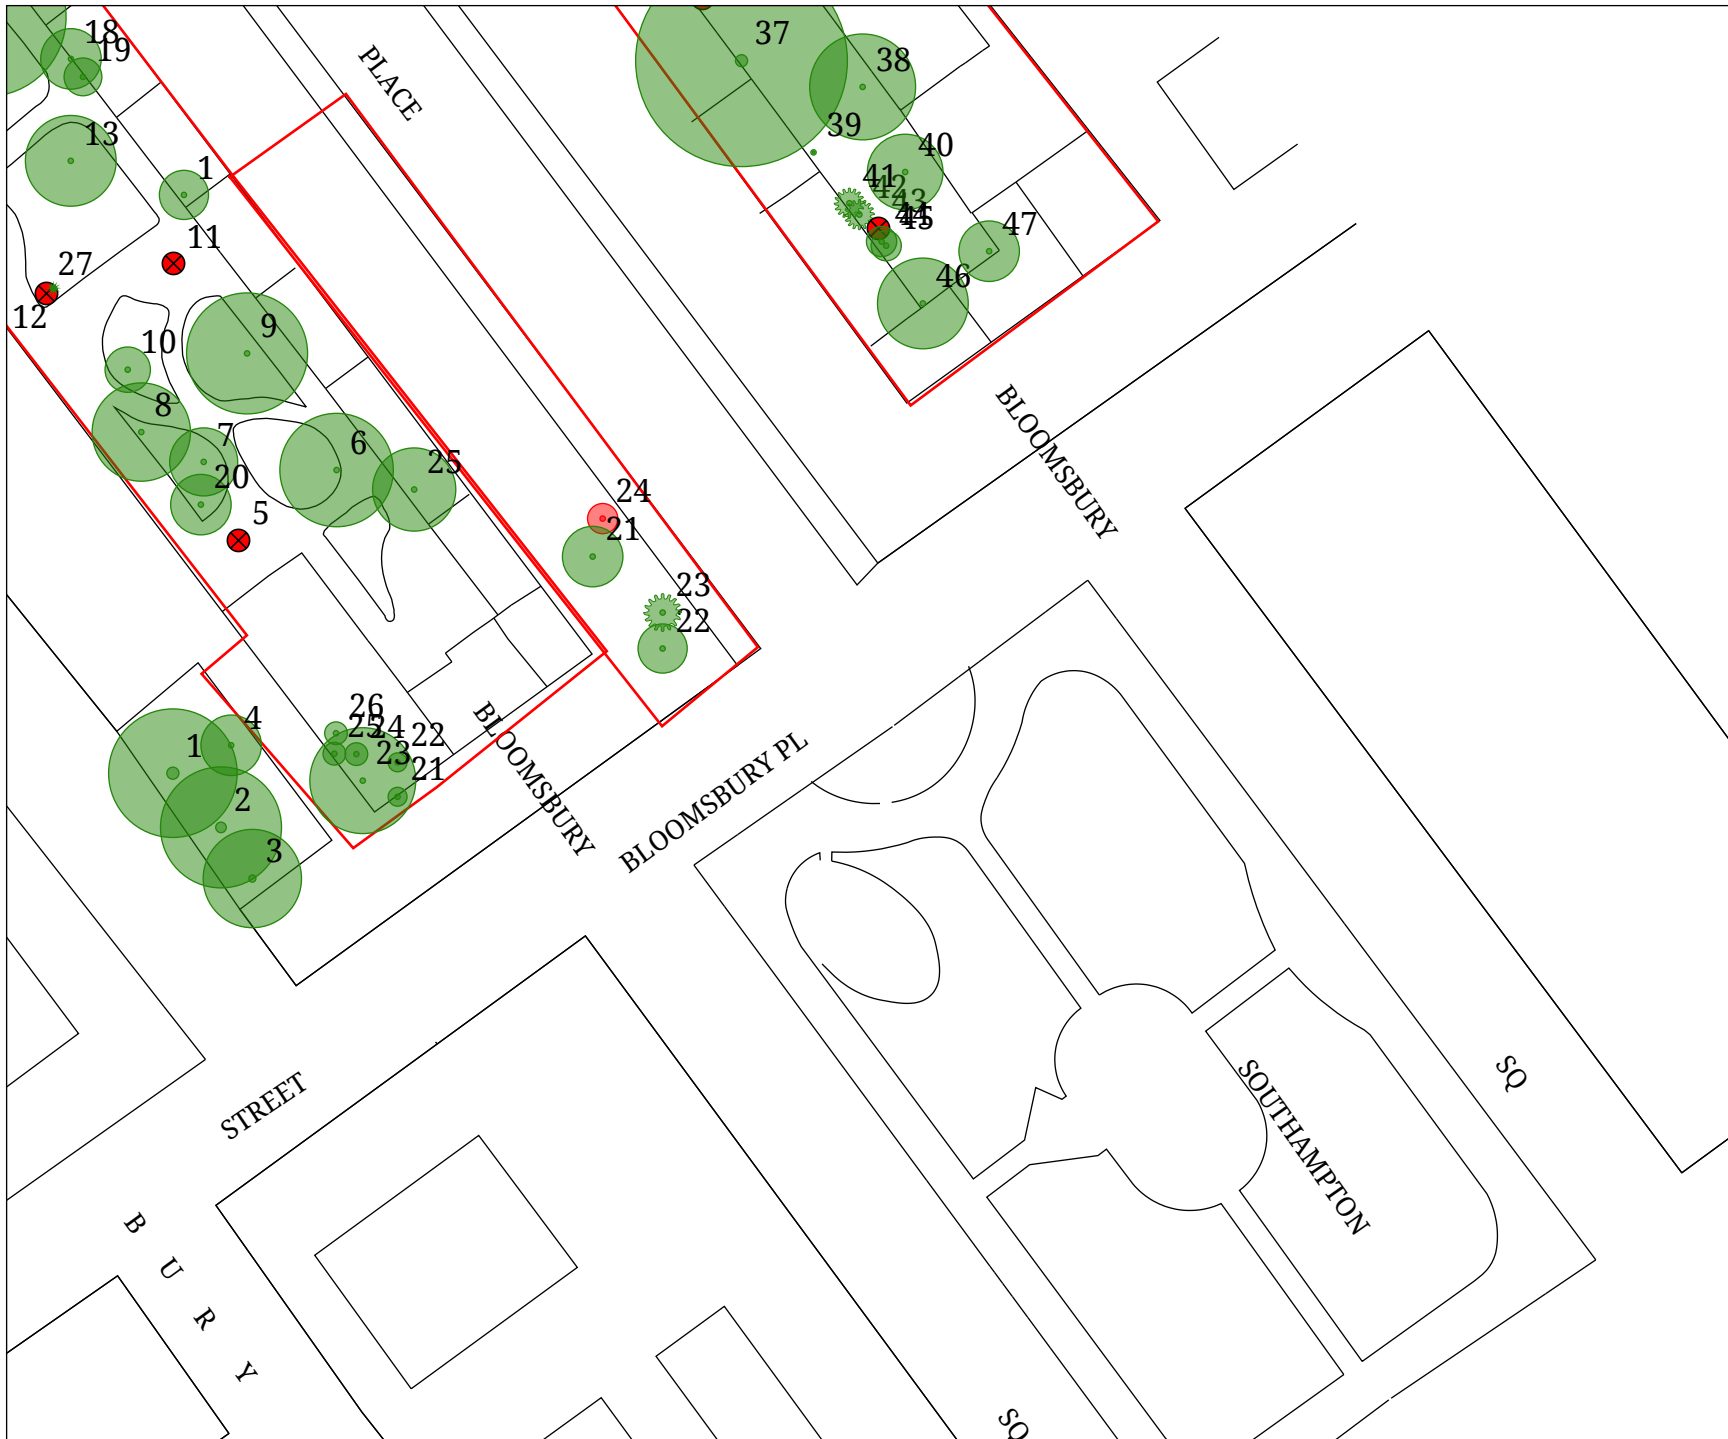
Bedford Place (No. of Trees: 4)

ID	No.	Species name	Height (m)	DBH (cm)	Crown spread(m)	Vitality	Life Stage	Physiological Condition	Structural Condition	Targets	Condition Notes	Recommendations	Status - Safety action date
T24	1	Pittosporum tenuifolium	4.0	7	4.0	Moderate	Early Mature	Fair	Fair	Footpath within crown spread. Tree overhangs neighbouring property.	Epicormic growth - Base / bole / principal stems. Fork - Weak with included bark. Form - Low canopy. Multi-stemmed.	Lift low canopy - Pedestrian clearance lift to 2.5m over footpath and neighbouring property	Proposed - (2019-05-31)

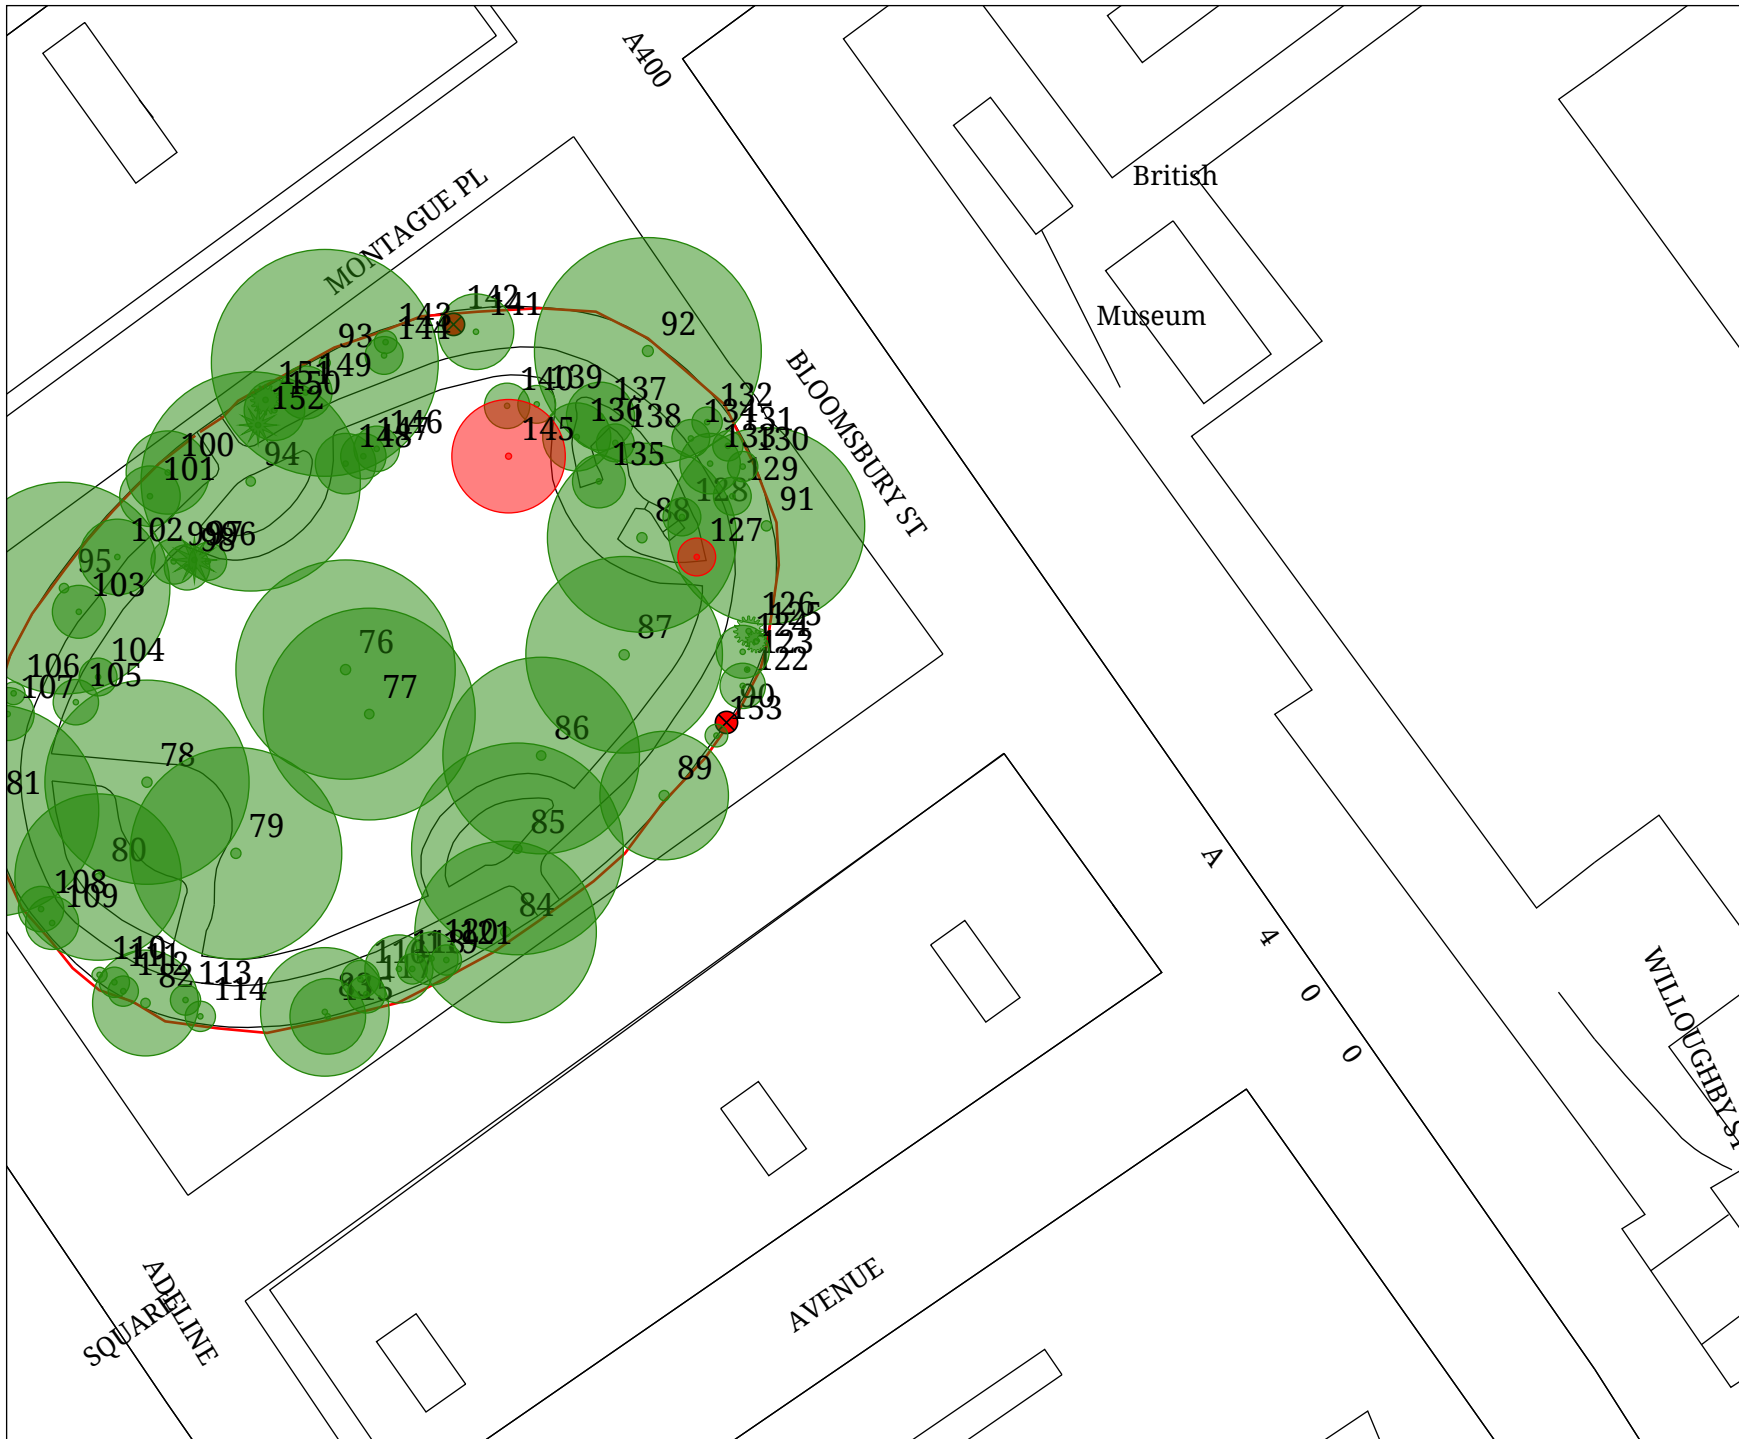
Bedford Square (No. of Trees: 78)

ID	No. Species name	Height (m)	DBH (cm)	Crown spread(m)	Vitality	Life Stage	Physiological Condition	Structural Condition	Targets	Condition Notes	Status - Safety action date
Old tag										Recommendations	
T127	1 Ilex aquifolium Holly	5.0	18	5.0	Moderate	Early Mature	Fair	Fair	Footpath within crown spread.	Arboricultural work - Historic. Form - Low canopy. Leaning trunk - Major. Suppressed crown - Minor. Lift low canopy - Pedestrian clearance to 2.5m over footpath	Proposed - (2019-05-31)
T145	1 Ulmus glabra 'Camperdownii' Camperdown Elm	8.0	80	15.0	Moderate	Late Mature	Fair	Poor	Footpath within falling distance of tree.	Coalesced decay seam - Suspected. Decline - Suspected. Decay / structural defect in crown limb / limbs - Localised. Deadwood - Minor. Decay / structural defect - Extensive. Decay / structural defect - Open cavity / cavities. Decay / structural defect - Bole. Epicormic growth - Base / bole / principal stems. Fungal fruiting body - structural decay suspected. Habitat - High value. Pruning wounds - Historic. Rigidoporus ulmarius bracket at base on north side of stem. Tap tests around base and stem indicate significant hollowing. Reduce crown by - Specified extent lateral branch length by 1-2m to suitable growth points to establish a smaller crown and minimise risk of branch or stem failure, leaving furnishing growth to minimise visual impact	Proposed - (2019-11-26)

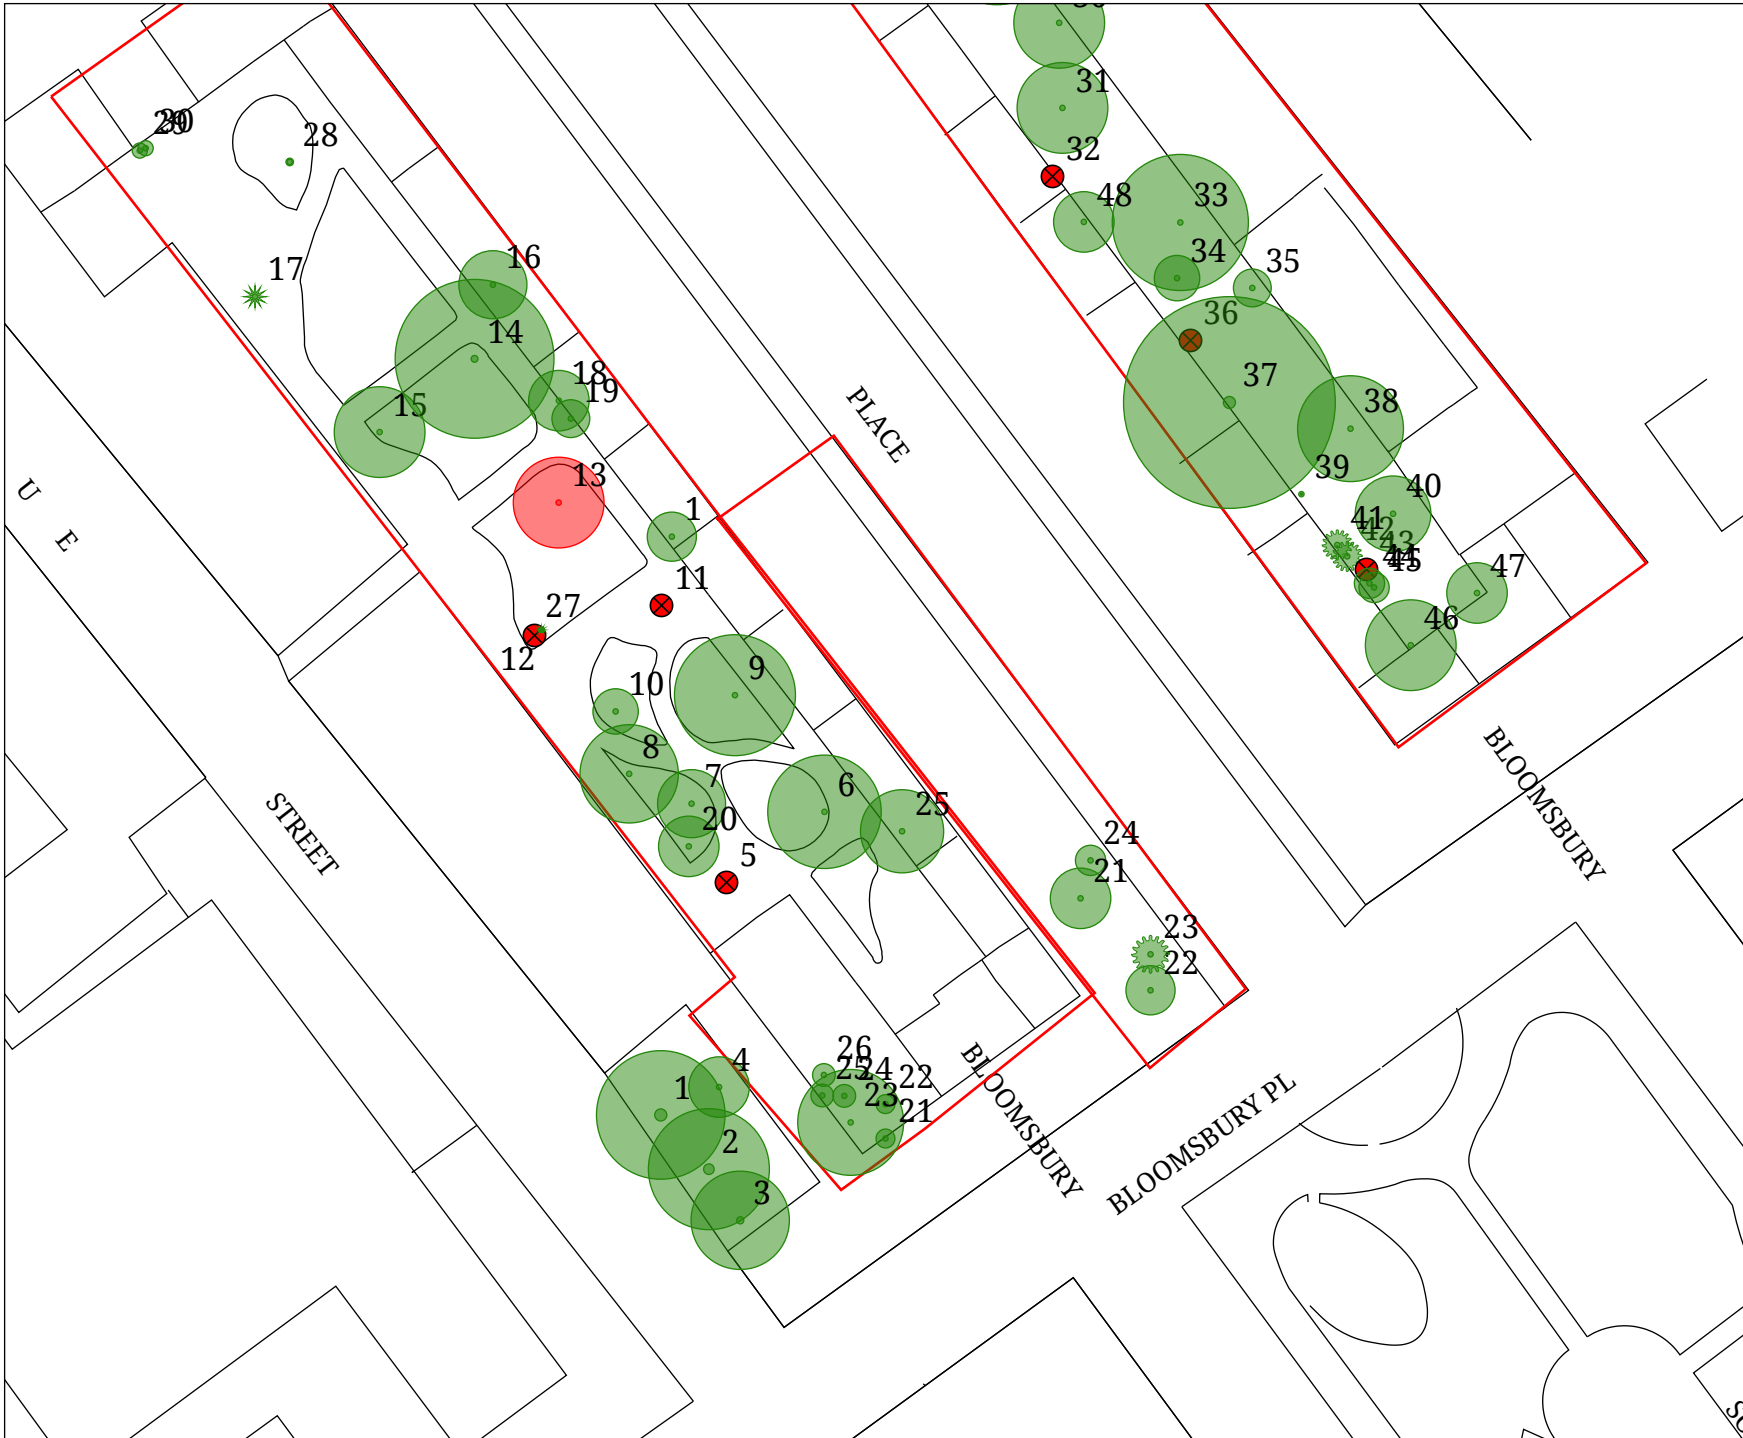
Montague Street (No. of Trees: 30)

ID	No. Species name	Height (m)	DBH (cm)	Crown spread(m)	Vitality	Life Stage	Physiological Condition	Structural Condition	Targets	Condition Notes	Status - Safety action date
Old tag										Recommendations	
T13	1 Robinia pseudoacacia 'Frisia' Golden False Acacia	17.0	45	12.0	High	Mature	Good	Fair	Neighbouring property in falling distance. Footpath within crown spread.	Crown reduction - Historic. Dense crown. Decay / structural defect in crown limb / limbs - Major. Decay / structural defect - Principal stems. Epicormic growth - Crown. Root damage - Mower. Raised surface roots. Shedding limb / limbs - Recent. Reduce crown by - Specified extent to most recent reduction points to minimise risk of branch failure and continue established management	Proposed - (2019-11-26)

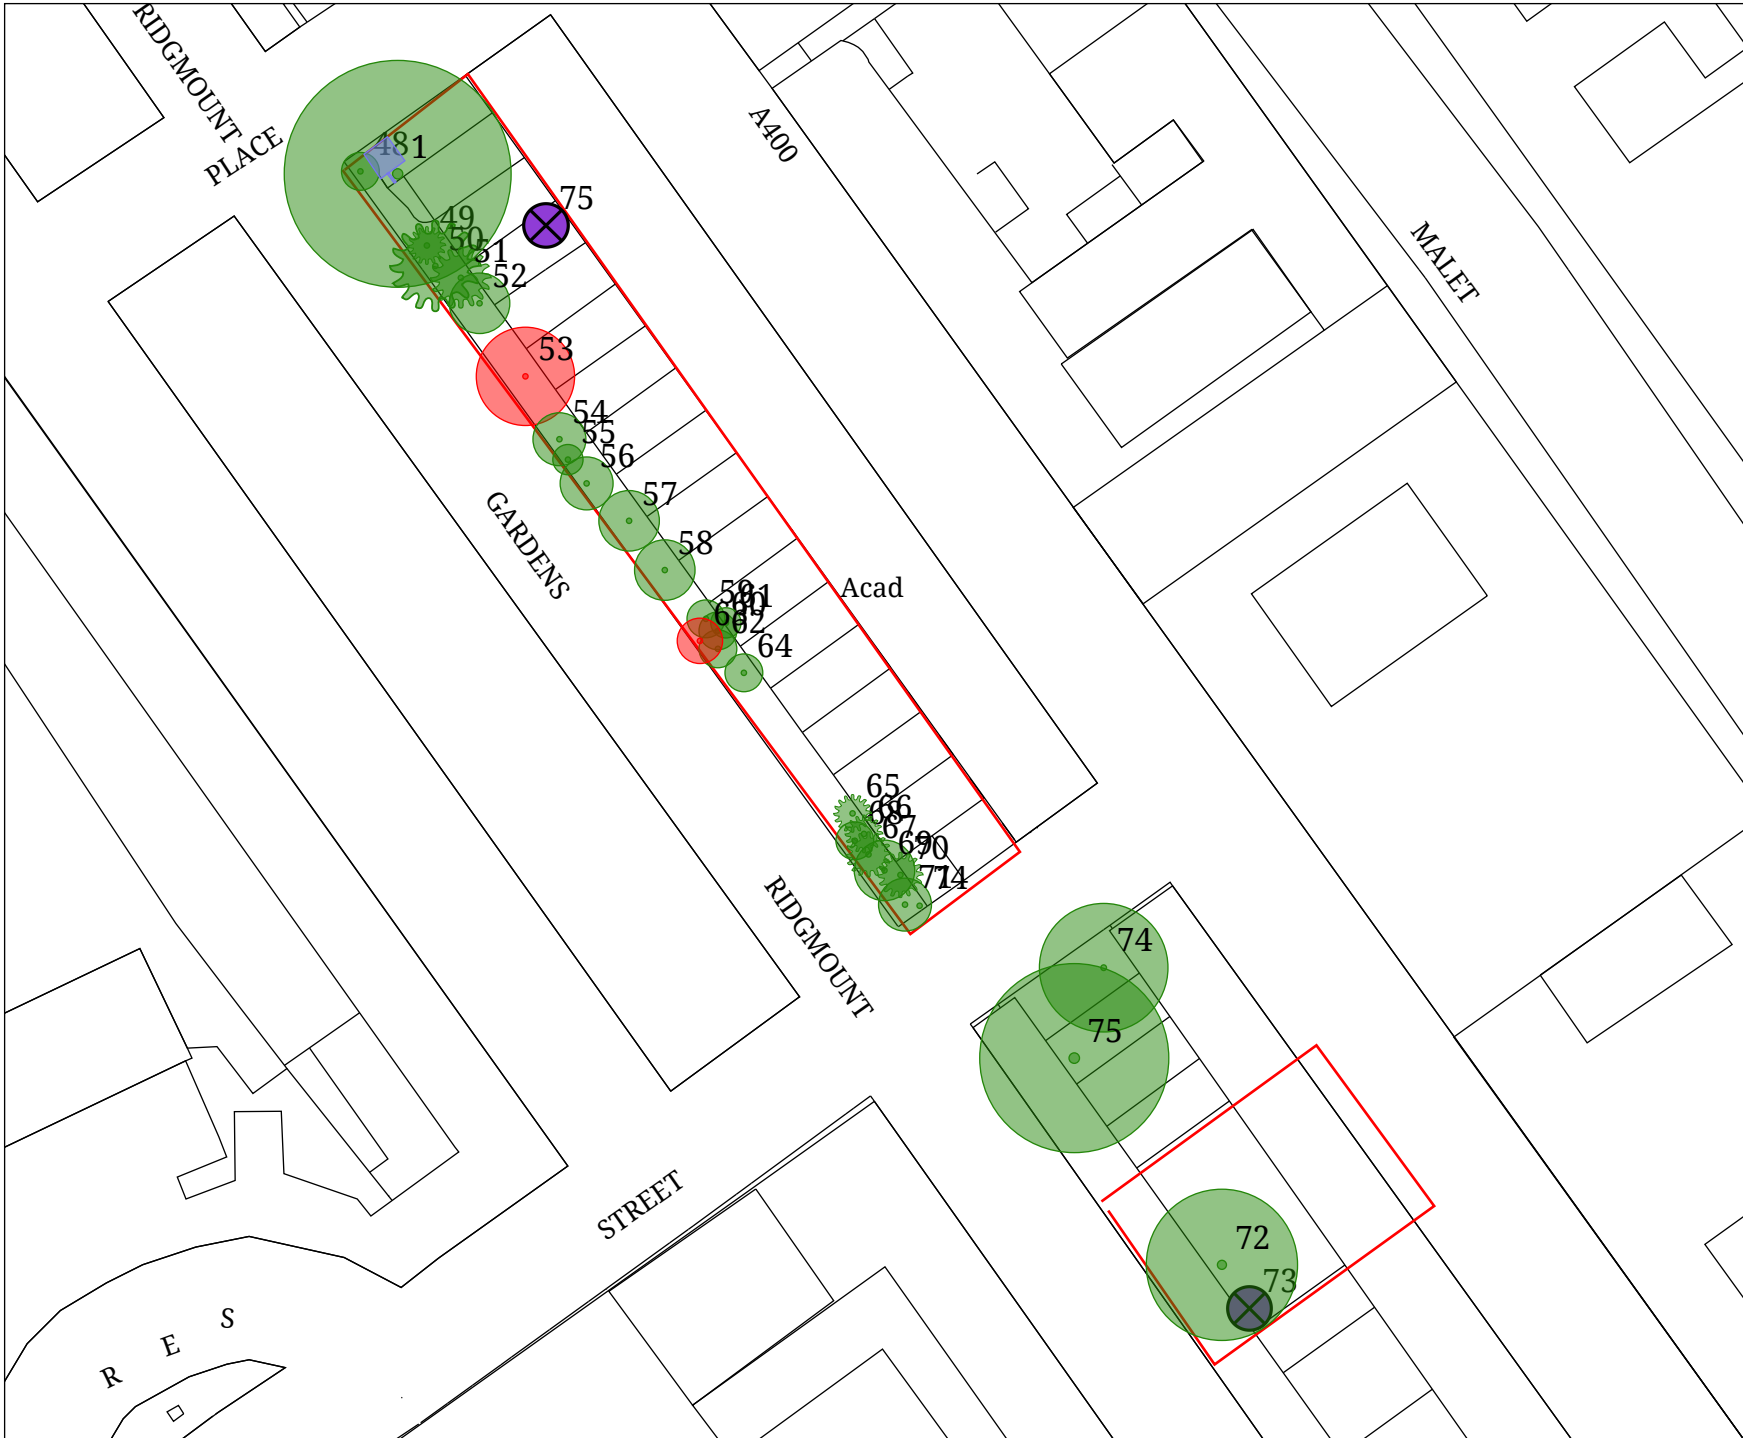
Ridgmount Gardens (No. of Trees: 25)

ID	No. Species name	Height (m)	DBH (cm)	Crown spread(m)	Vitality	Life Stage	Physiological Condition	Structural Condition	Targets	Condition Notes	Status - Safety action date
Old tag										Recommendations	
T53	1 Robinia pseudoacacia 'Frisia' Golden False Acacia	25.0	45	13.0	Moderate	Mature	Fair	Poor	Seating area within crown spread. Car parking within falling distance of tree. Building within falling distance of tree.	Decay / structural defect in crown limb / limbs - Suspected. Epicormic growth - Crown. Foreign object. Reaction wood / Adaptive growth - Stem / stems. possible decay in trunk at 9m Reduce height - Specified extent by 3-4m to suitable growth point to relieve loading above apparently damaged area and minimise risk of crown failure - assess apparently damaged area at 9m and report findings	Proposed - (2019-05-31)
T63	1 Amelanchier lamarckii Snowy Mespilus	6.0	8	6.0	Moderate	Early Mature	Poor	Fair	Car parking within falling distance of tree. Footpath within falling distance of tree.	Access to inspect base - Restricted / obscured. Base / stems obscured - Vegetation. Decline - Suspected. Deadwood - Minor. Multi-stemmed. Dimensions - Stem diameter average of stems. Reduce faulted limb / limbs by - Specified extent remove damaged section of smallest diameter stem to prevent stem failure - using hand tools to avoid damaging remaining stems remove deadwood	Proposed - (2019-05-31)

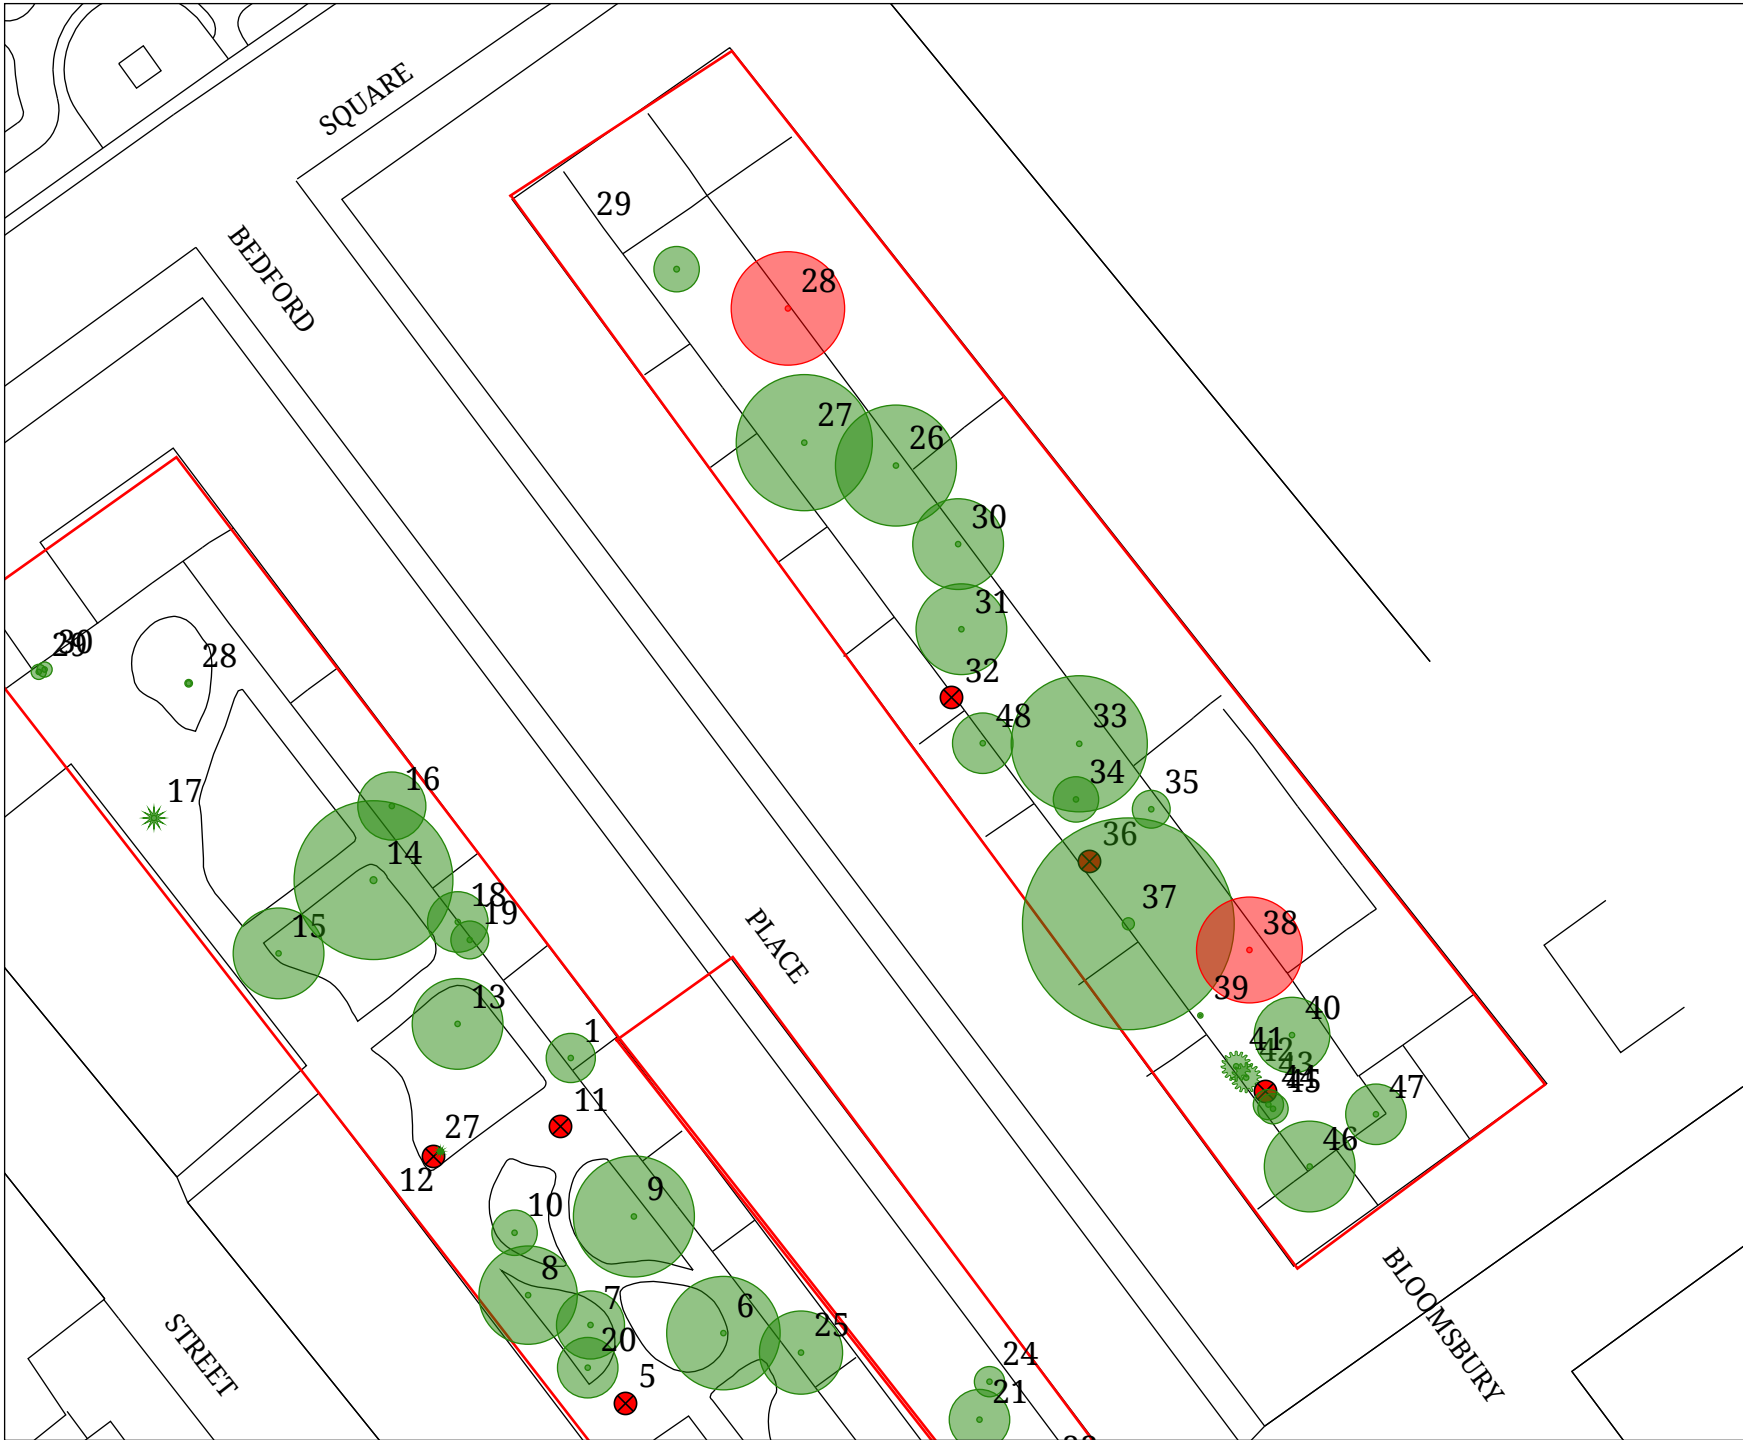
Southampton Row (No. of Trees: 23)

ID	No. Species name	Height (m)	DBH (cm)	Crown spread(m)	Vitality	Life Stage	Physiological Condition	Structural Condition	Targets	Condition Notes Recommendations	Status - Safety action date
T28	1 Tilia cordata Small Leaved Lime	18.0	40	15.0	Moderate	Mature	Fair	Fair	Tree overhangs neighbouring property.	Deadwood - Minor. Eccentric growth. Fork - Suspected structurally sound. Form - Low canopy. Ivy or climbing plant. Rubbing limbs. Reduce lateral limb / limbs by approximately 2m (two lower limbs east over car park, one west over garden) to suitable growth points to relieve loading and minimise risk of branch failure onto car park	Proposed - (2019-05-31)
T38	1 Aesculus hippocastanum Horse Chestnut	14.0	45	14.0	Moderate	Mature	Poor	Fair	Tree overhangs neighbouring property.	Decay / structural defect in crown limb / limbs - Localised. Foliar / bud damage - Insect. Suppressed crown - Major. Unbalanced crown - Major. End-weight reduction - Specified extent approximately 5m from lowest branch (remove lowest, heaviest section to suitable growth point) to relieve loading on cracked (by union with trunk) branch and minimise risk of failure, to prolong useful life of tree	Proposed - (2019-05-31)
