**RE: 84 Compayne Gardens, London, NW6 3RU**

**Tree assessment:**

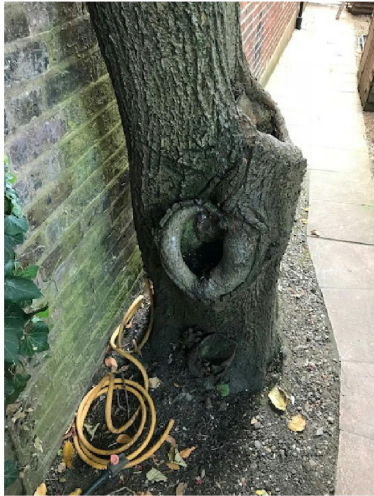
- There are two cavities on the main stem of the tree. One cavity is at 1m on the north side of the stem and the other cavity is at 1.2m on the west side of the main stem. Given how close they are, these cavities are likely to be linked within the stem tissue and in my opinion will act as a 'weak point', and may eventually lead to the failure of this tree. These cavities will also act as an entry point for other pathogens.

*Above: cavities on main stem*

T8: I would recommend T8 is removed and not replaced for the reasons outline above.

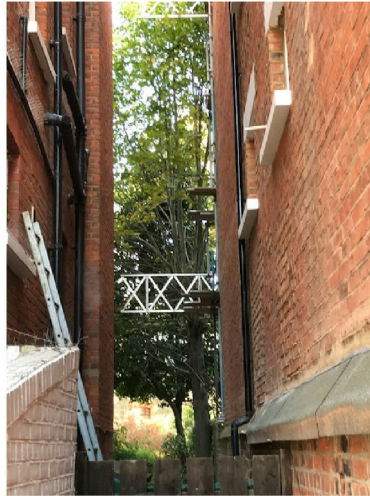
- The tree is located 2m from the rear elevation number 82 and 2.4m from 84; the stem is almost touching the nearby boundary wall. These relationships are unsustainable and I think the tree will cause damage to these structures in the future, especially as it matures further. The tree has been heavily pruned in the past, presumably in an attempt to manage this relationship.
- The tree is of limited visual amenity and is only just visible between the two properties.

*Above: tree location close to nearby houses*
