Asbestos Refurbishment/Demolition Survey for

Evans & Co Ltd

5 Great James Street
London WC1N 3DB
Ground and Basement
(Site Specific)

Project Number: 8064/KB

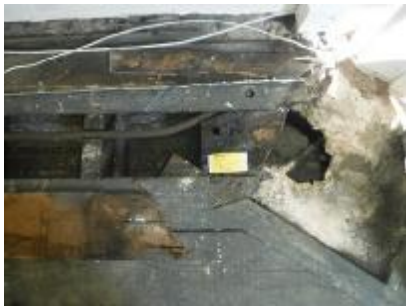
Inspection Date: 03/08/2018 Next Inspection: Not Applicable Survey Type: RDS
Location ID: 44963 Location Ref: Sample 1 Product Type: NADIS

Material Comments:
A sample of dust/debris to floor void was removed for laboratory bulk sampling analysis from the office to rear, ground floor.

Damage: NADIS
Treatment: NADIS
Asbestos Type: NADIS
Identification: Identified
Quantity: Representative Dust/Debris Sample

Action:
No Action Required

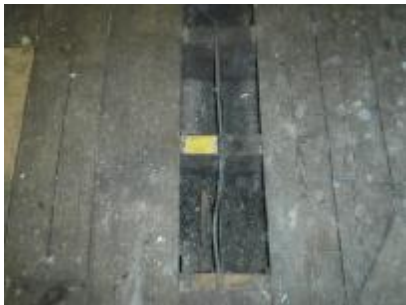
Inspection Date: 03/08/2018 Next Inspection: Not Applicable Survey Type: RDS
Location ID: 44964 Location Ref: Sample 2 Product Type: NADIS

Material Comments:
A sample of dust/debris to floor void was removed for laboratory bulk sampling analysis from the office, ground floor.

Damage: NADIS
Treatment: NADIS
Asbestos Type: NADIS
Identification: Identified
Quantity: Representative Dust/Debris Sample

Action:
No Action Required

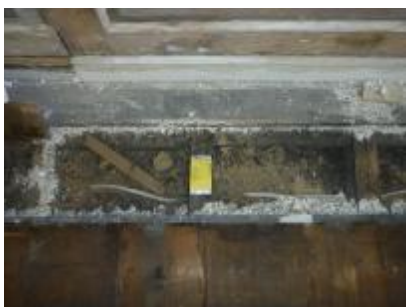
Inspection Date: 03/08/2018 Next Inspection: Not Applicable Survey Type: RDS
Location ID: 44965 Location Ref: Sample 3 Product Type: NADIS

Material Comments:
A sample of dust/debris to floor void was removed for laboratory bulk sampling analysis from the front office, ground floor.

Damage: NADIS
Treatment: NADIS
Asbestos Type: NADIS
Identification: Identified
Quantity: Representative Dust/Debris Sample

Action:
No Action Required

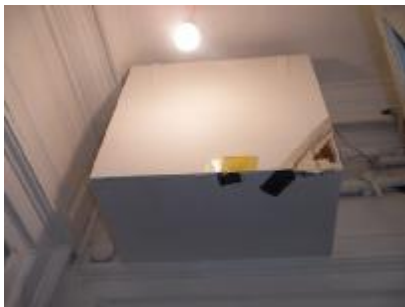
Location Ref: Sample 4

Sample 4 - Board boxing - Office - Ground floor - Removal By Licensed Contractors

Product Type: Asbestos Insulating Board

Damage: Medium damage

Removal By Licensed Contractors

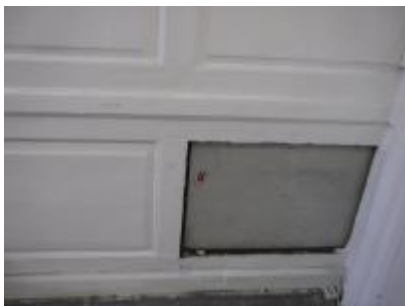
Location Ref: Photo 1

Photos 1 & 2 - Board to wall cavity - Office - Ground floor - Removal By Licensed Contractors

Product Type: Asbestos Insulating Board

Damage: No visible damage

Removal By Licensed Contractors

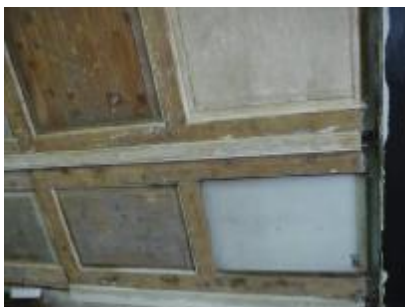
Location Ref: Photo 2

Product Type: Asbestos Insulating Board

Damage: No visible damage

Removal By Licensed Contractors

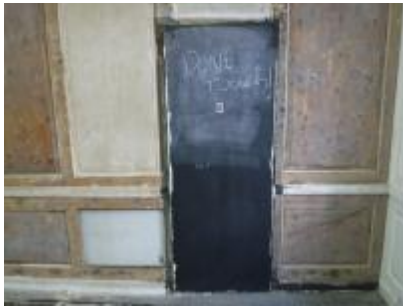
Location Ref: Photo 3

Photo 3 - Door lining board - Office - Ground floor - Removal By Licensed Contractors

Product Type: Asbestos Insulating Board

Damage: Low damage

Removal By Licensed Contractors

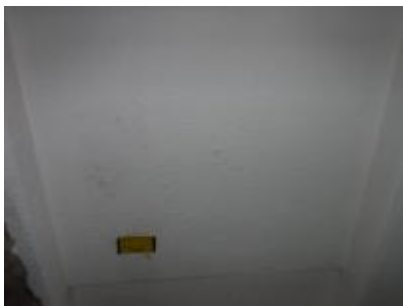
Location Ref: Sample 5

Sample 5 - Board (wall) - Stairs - Ground floor - Removal By Licensed Contractors

Product Type: Asbestos Insulating Board

Damage: No visible damage

Removal By Licensed Contractors

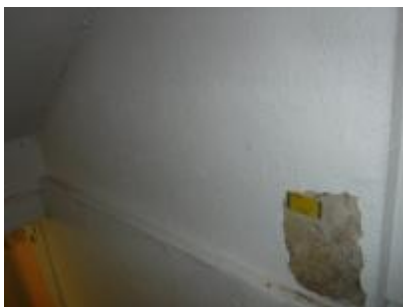
Location Ref: Sample 6

Product Type: NADIS

Damage: NADIS

No Action Required

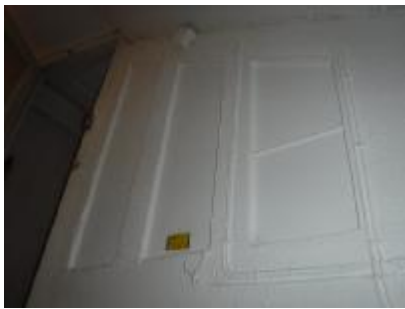
Inspection Date: 03/08/2018 Next Inspection: Not Applicable Survey Type: RDS
Location ID: 44972 Location Ref: Sample 7 Product Type: NADIS

Material Comments:
A sample of board to wall partition was removed for laboratory bulk sampling analysis from the stairs to basement, ground floor.

Damage: NADIS
Treatment: NADIS
Asbestos Type: NADIS
Identification: Identified
Quantity: Approx 4m²

Action:
No Action Required

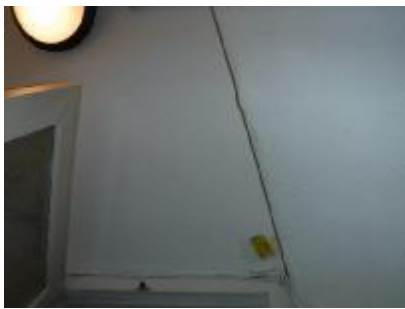
Inspection Date: 03/08/2018 Next Inspection: 02/02/2019 Survey Type: RDS
Location ID: 44973 Location Ref: Sample 8 Product Type: Asbestos Insulating Board

Sample 8 - Board (ceiling) - Stairs - Ground floor - Removal By Licensed Contractors

Material Comments:
A sample of board to ceiling was removed for laboratory bulk sampling analysis from the stairs to basement flat, ground floor level.

Damage: No visible damage
Treatment: AIB painted or encapsulated
Asbestos Type: Amosite
Identification: Identified
Quantity: Approx 3m²

Action:
Removal By Licensed Contractors

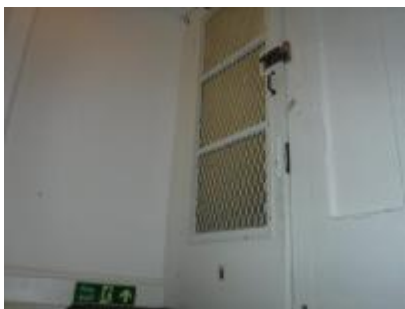
Inspection Date: 03/08/2018 Next Inspection: 02/02/2019 Survey Type: RDS
Location ID: 44974 Location Ref: Photo 4 Product Type: Asbestos Insulating Board

Photo 4 - Door lining board - Stairs - Ground floor - Removal By Licensed Contractors

Material Comments:
A photographic reference of door lining board to stairs to basement flat, ground floor level. Warning label in place.

Damage: Good condition
Treatment: AIB painted or encapsulated
Asbestos Type: Amosite
Identification: Strongly Presumed
Quantity: Approx 1m²

Action:
Removal By Licensed Contractors

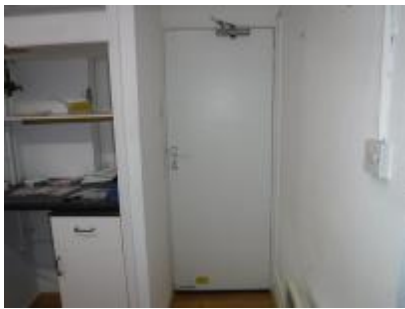
Location ID: 44975 Location Ref: Sample 9 Product Type: Asbestos Insulating Board

Sample 9 - Door lining board - Office - Basement - Removal By Licensed Contractors

Basement, Office	Asbestos Insulating Board	Door Lining Board	Approx 2m ²	Easy Accessibility	Good condition	AIB painted or encapsulated	Amosite	Identified	Sample 9	5	N/A

Damage: Good condition

Action:
Removal By Licensed Contractors

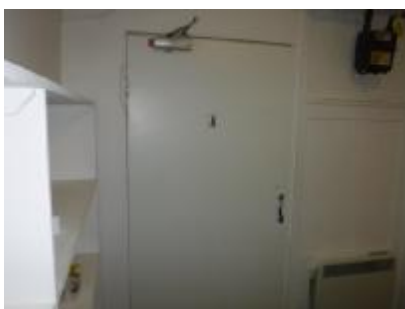
Location ID: 44976 Location Ref: Photo 5 Product Type: Asbestos Insulating Board

Photo 5 - Door lining board - Corridor - Basement - Removal By Licensed Contractors

Damage: Good condition

Action:
Removal By Licensed Contractors

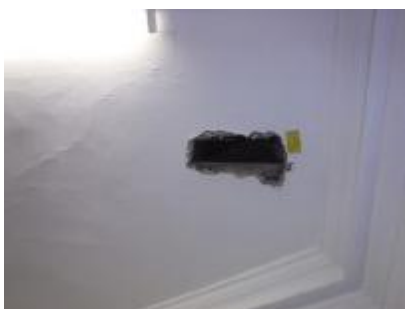
Location ID: 44977 Location Ref: Sample 10 Product Type: NADIS

Damage: NADIS

Action:
No Action Required

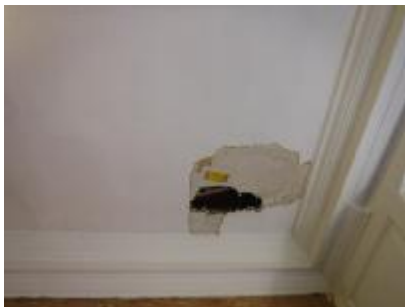
Location ID: 44978 Location Ref: Sample 11 Product Type: NADIS

Material Comments:
A sample of plaster ceiling was removed for laboratory bulk sampling analysis from the front office, ground floor.

Damage: NADIS

Action:
No Action Required

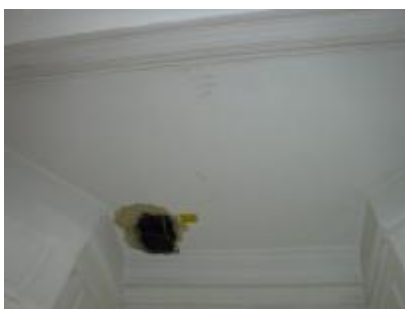
Location ID: 44979 Location Ref: Sample 12 Product Type: NADIS

Material Comments:
A sample of plaster ceiling was removed for laboratory bulk sampling analysis from the front office, ground floor.

Damage: NADIS

Action:
No Action Required

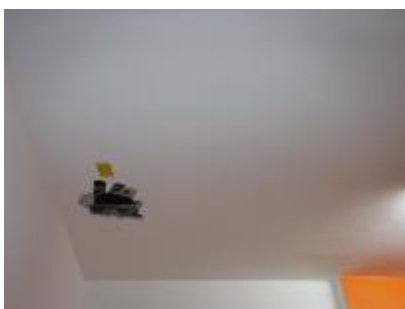
Location ID: 44980 Location Ref: Sample 13 Product Type: NADIS

Material Comments:
A sample of plaster ceiling was removed for laboratory bulk sampling analysis from the office to rear, basement level.

Damage: NADIS

Action:
No Action Required

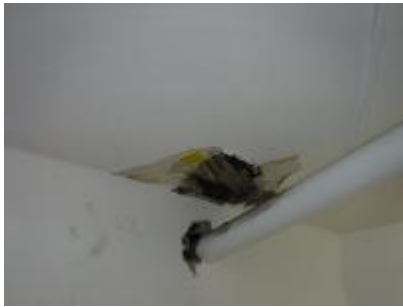
Location Ref: Sample 14

Product Type: NADIS

Damage: NADIS

No Action Required

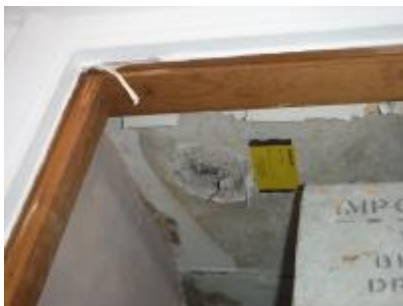
Location Ref: Sample 15

Product Type: NADIS

Damage: NADIS

No Action Required

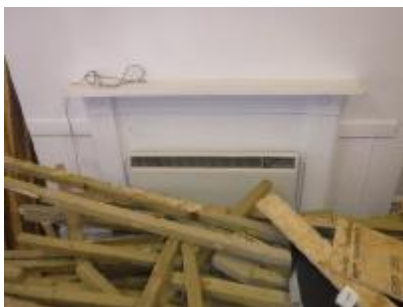
Location Ref: Photo 6

Photo 6 - Fire places - Office - Ground/basement - Do Not Disturb - Contractors to be Aware

Product Type: Ropes and woven textiles

Damage: No visible damage

A photographic reference of fire places presumed only to contain asbestos i.e enclosed rope seals. Noted to ground floor and basement level.

Do Not Disturb - Contractors to be Aware

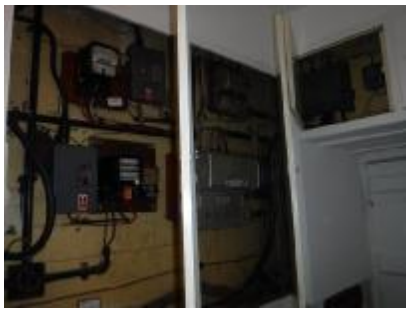
Location ID: 44991 Location Ref: Photo 7 Product Type: Ropes and woven textiles

Photo 7 - Electrical boxes - Office - Basement - Do Not Disturb - Contractors to be Aware

Damage: No visible damage

Action:
Removal By Licensed Contractors
