Kingsway Residential Limited
42 Kingsway Opening-up of Brickwork

Rear (East) Elevation

1:50 @ A1 GA-200 D

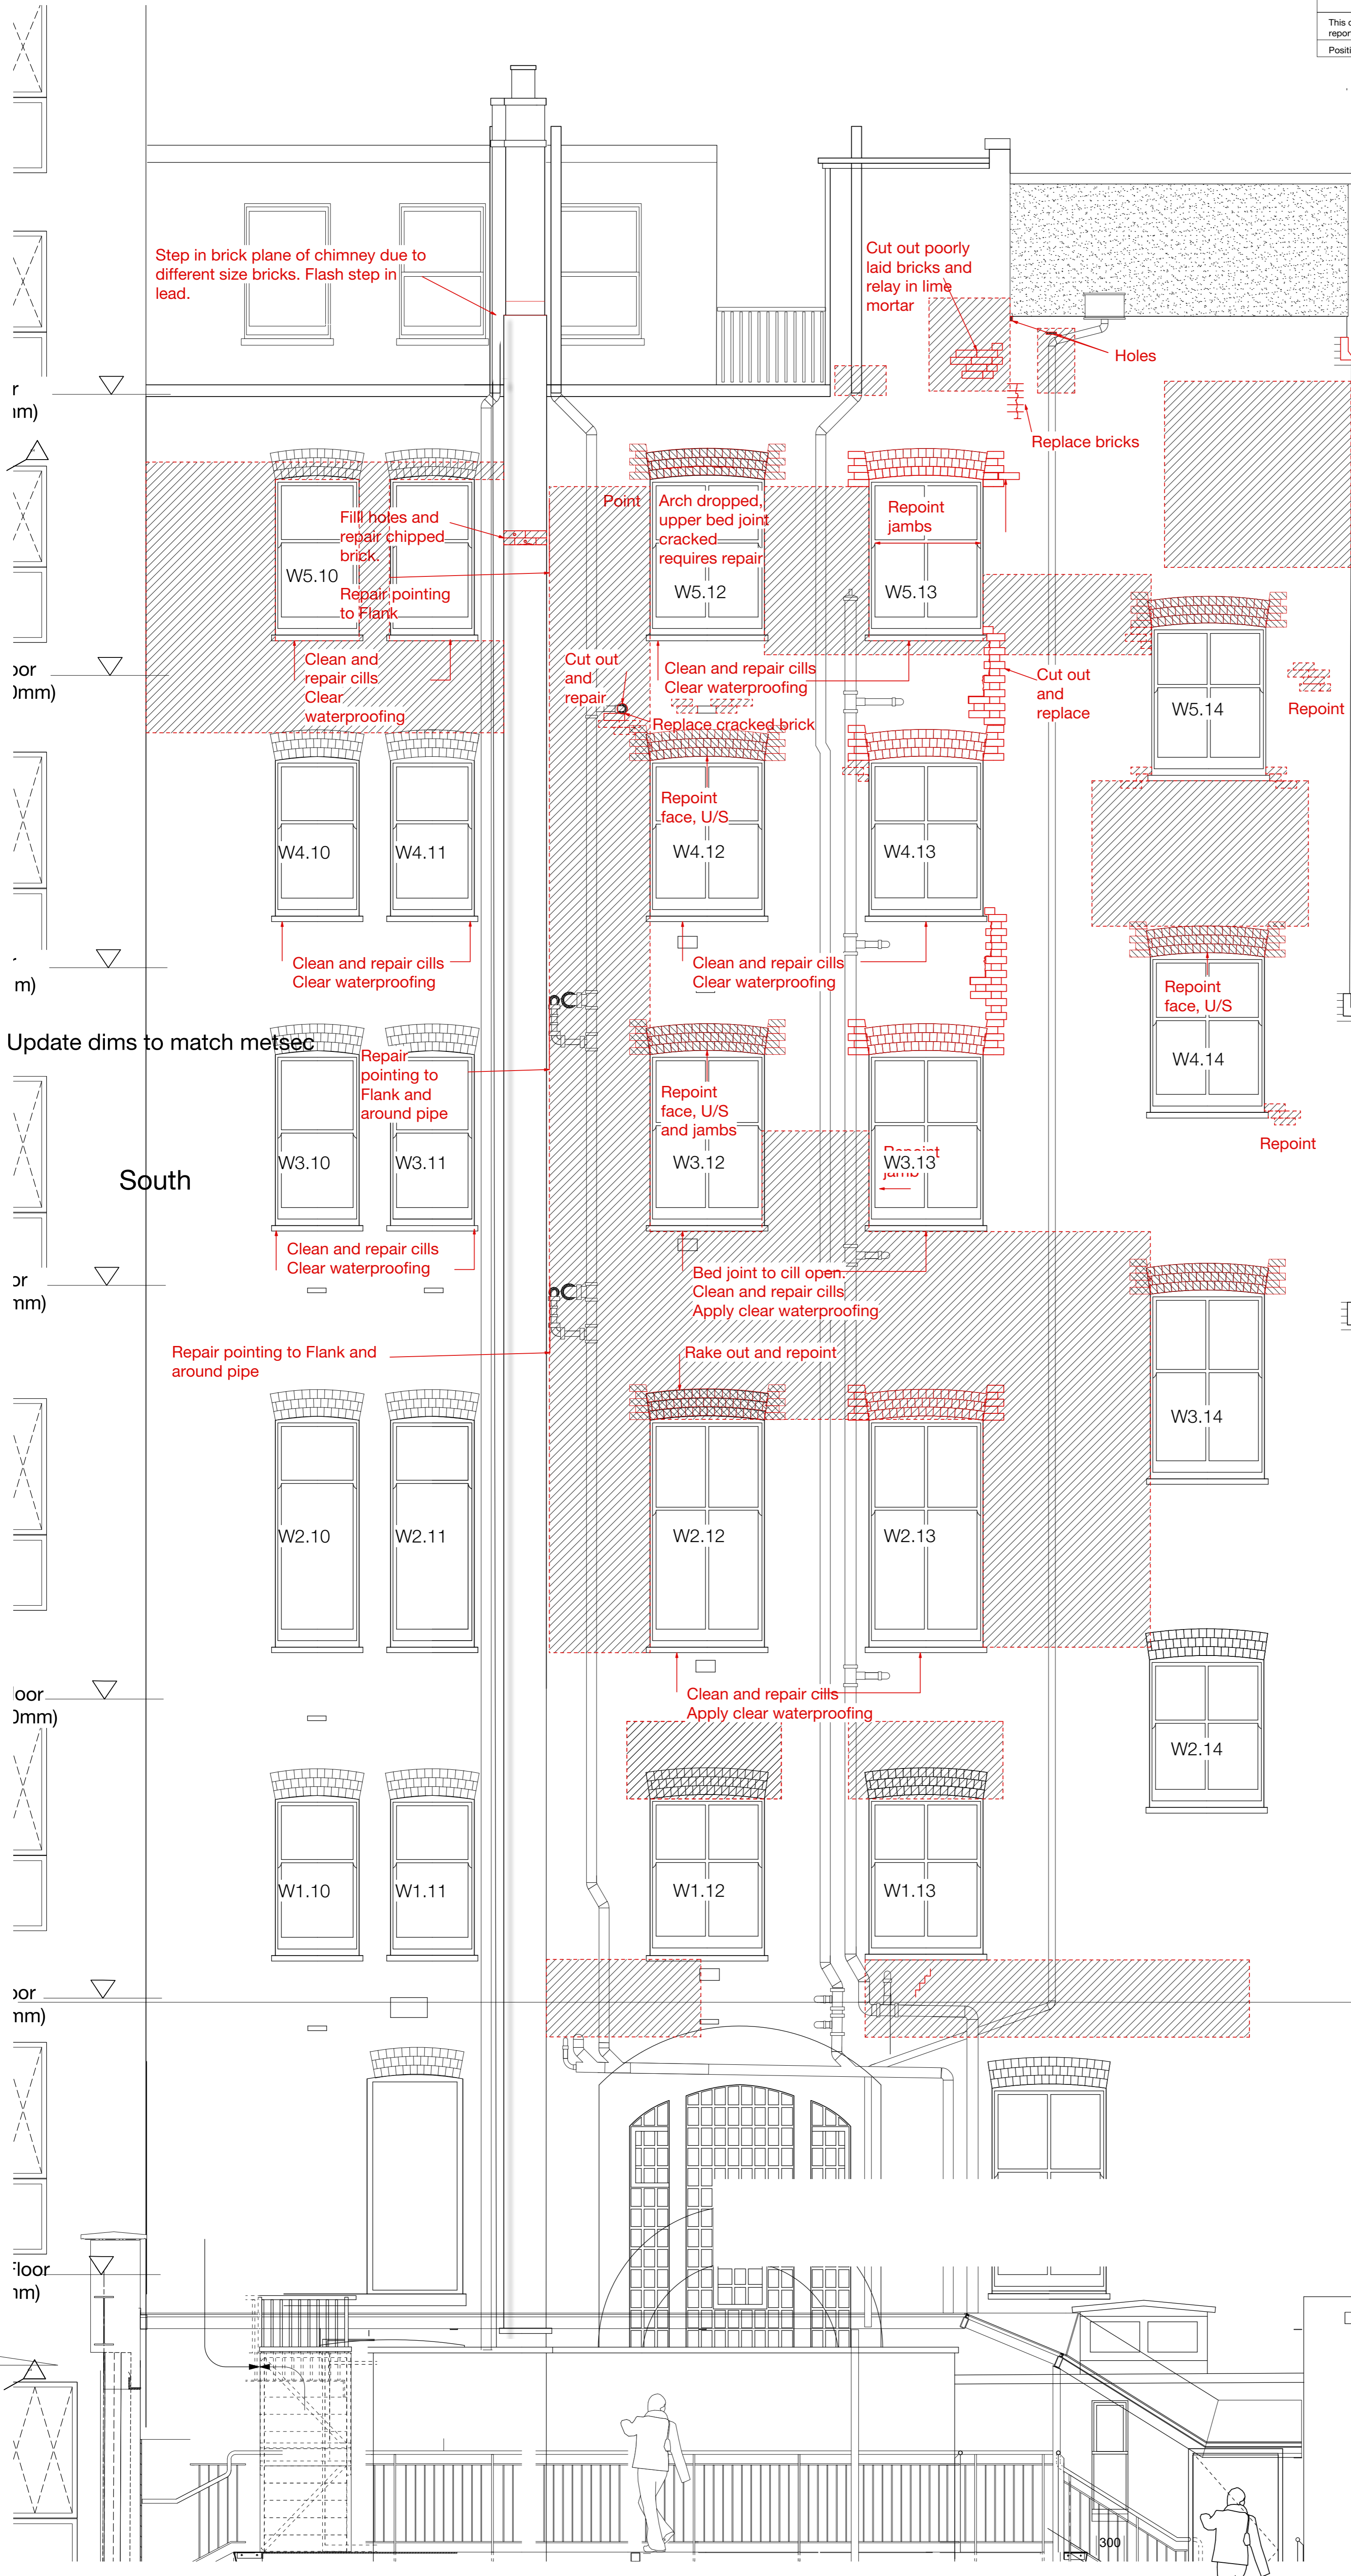
Aproximate area of brickwork requiring the joints to be repointed/pressure filled

Replace missing flashing

Remove brickwork repair/replace outer and inner lintels
-

Areas of repointing shown hatched
-

Areas of brickwork to be replaced outlined in solid red line
-

Possible further investigation with a view to repair/replace outer and inner lintels as necessary
