INVESTIGATION OF FLOORBOARDING TO ASCERTAIN AGING OF 16-18
CHENIES STREET FOR 18 MAY 2017, JOB NO. 147.17

RADA

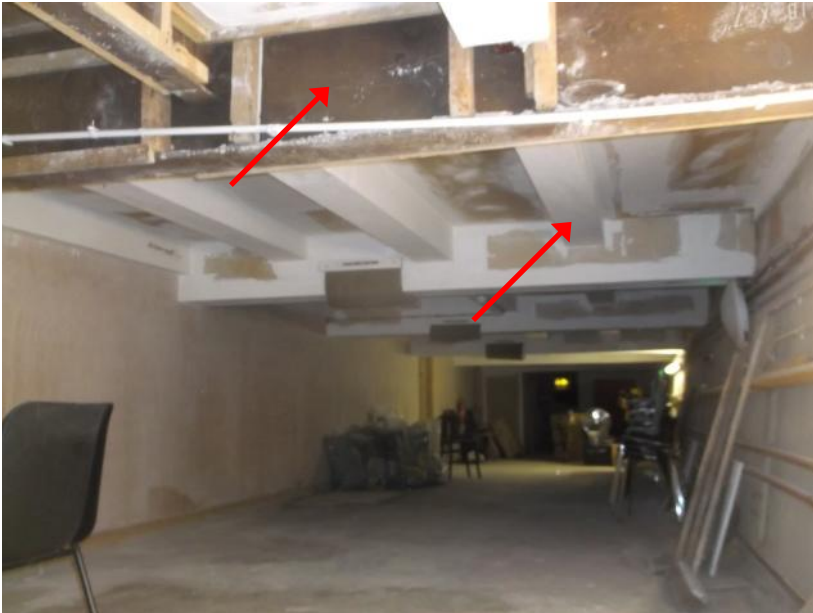
Fig 1:

Basement; showing an overall view to the north indicating the large steel primary bridging beams which may post-date the period of original construction. Downstands enclosing secondary steel beams between the primary beams indicated by the arrow were of smaller cross-sectional size and some were of contemporary origin

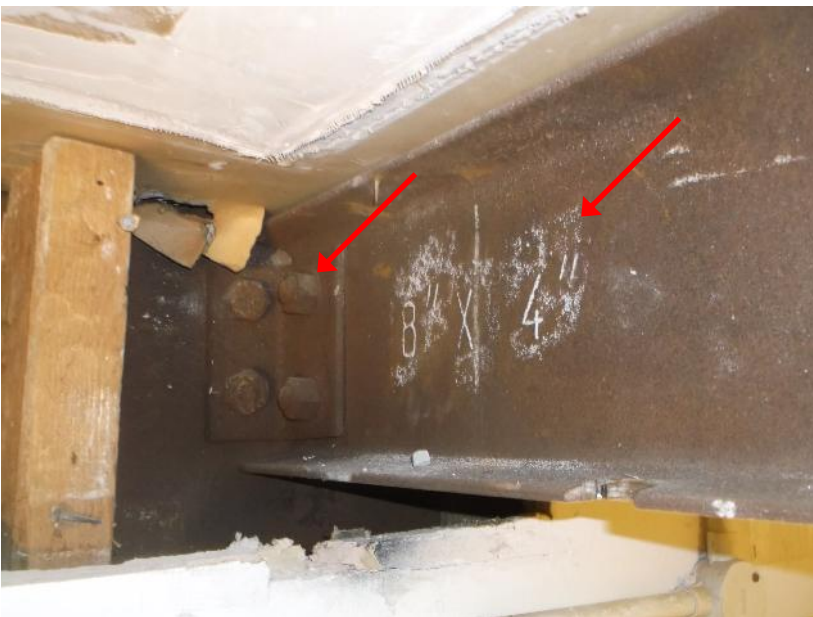
Fig 2:

Basement; showing the bolted connection of one of the imperial measurement secondary beams connected to the large cross-sectional sized bridging beam along the south wall of the basement. The secondary beam indicated may post-date the period of original construction

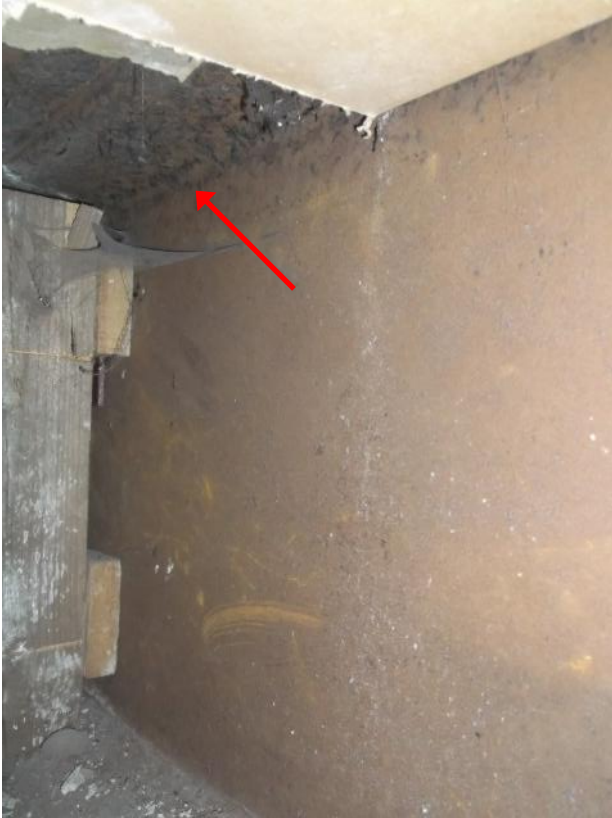
Fig 3:

Basement; showing the riveted large cross-sectional sized beam running along the south side of the basement. This may be original

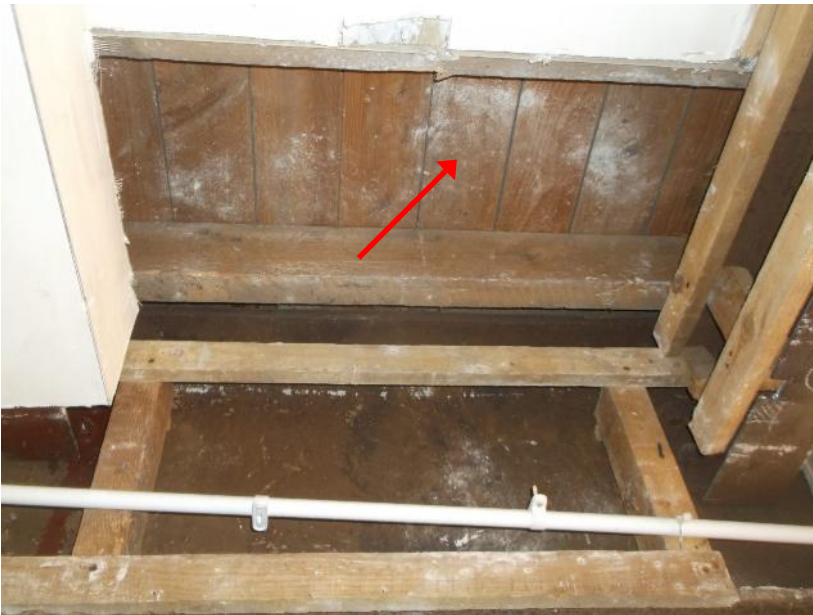
Fig 4:

- 4 Hatch 4: Floorboards were of a tongue and groove nature and of softwood measuring approximately 20 x 115mm. As viewed from beneath adjacent to the hatch, the sheen to the underside of the floorboards indicated that they were of relatively recent origin possibly replacing fire damaged boards

Basement, Hatch 4; showing the smaller cross-sectional sized tongue and groove floorboards which appeared to be of more recent origin than the period of original construction, and possibly replaced those significantly damaged by fire in this area of the basement

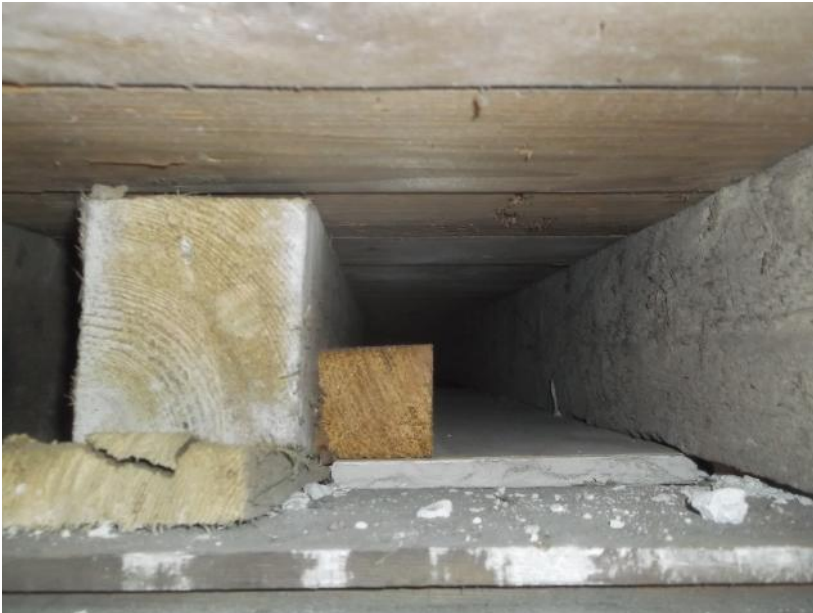
Fig 5:

Basement, Hatch 4; showing the smaller cross-sectional sized tongue and groove floorboards which appeared to be of more recent origin than the period of original construction, and possibly replaced those significantly damaged by fire in this area of the basement. Note the plasterboard attached to the underside of the possibly original joists, and also the partnering joists, noggins and packing pieces within the floor dating back to the last major refurbishment

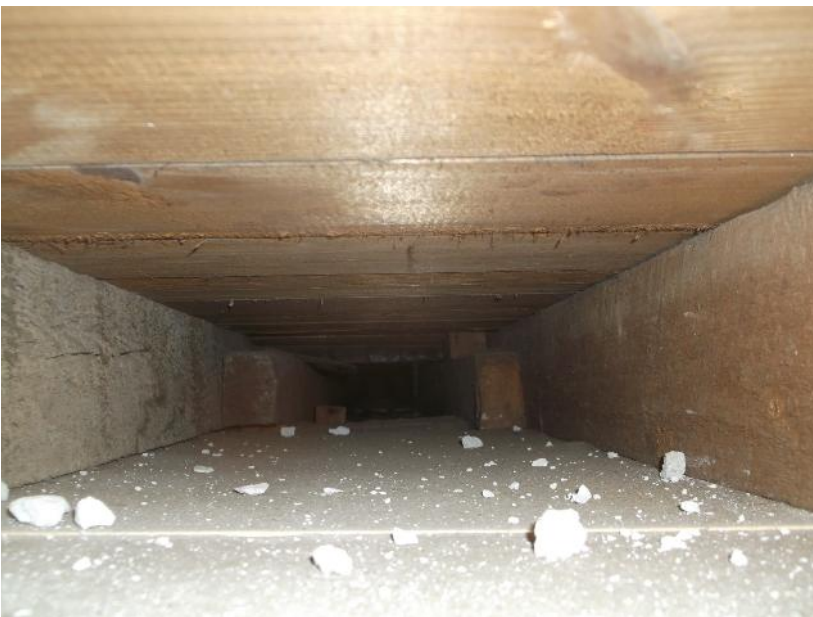
Fig 6:

Basement, Hatch 4; showing the smaller cross-sectional sized tongue and groove floorboards which appeared to be of more recent origin than the period of original construction, and possibly replaced those significantly damaged by fire in this area of the basement. Note the plasterboard attached to the underside of the possibly original joists, and also the partnering joists, noggins and packing pieces within the floor dating back to the last major refurbishment

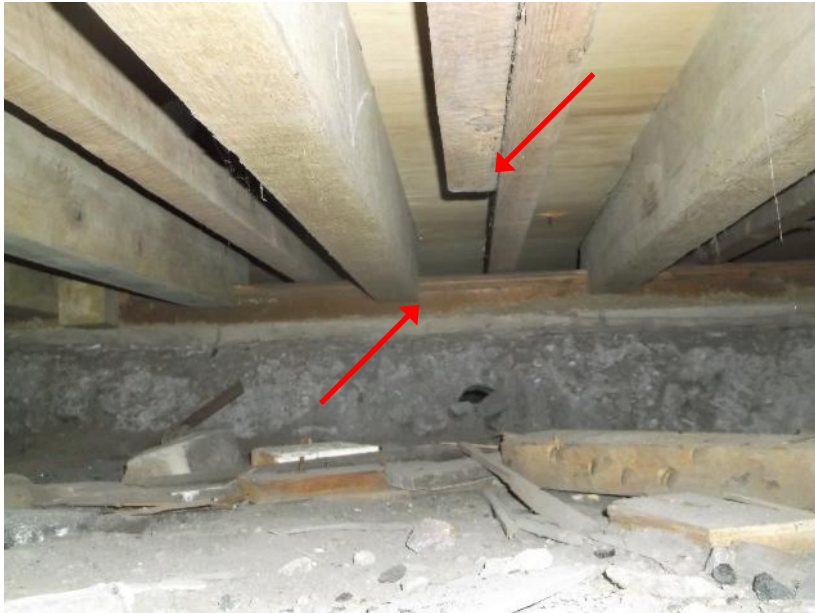
Fig 7:

The likely original joists had been extensively fire damaged with a significant loss of cross sectional size in some locations
- 2 Hatch 2: Floor joists measured on average 110 x 50mm at 370mm centres and were partnered with newer elements where extending beyond the dividing wall at basement level to that area generally to the east over the void extending beneath the theatre above. The likely original joists appeared to have been partnered with contemporary softwood joists of large cross sectional size, typically 150 x 80 at 400mm centres, supported over plate seated on an even mortar bed on concrete sleeper walls. Off-cuts and other debris littered the oversite and were all of new timber dating back to the repair and replacement work in this location

Basement, Hatch 2; showing a view beyond the wall head upstand at basement level extending beneath the theatre area above. Note the almost wholly new floor construction in this location with some original floor joists indicated by the arrow. Joists were seated on possibly original plate on a concrete sleeper wall. Note the off-cuts and other debris all dating back to the last major refurbishment. The floor structure in this location had been largely replaced with plywood replacing the floorboards themselves, as also illustrated in figs. 41-44

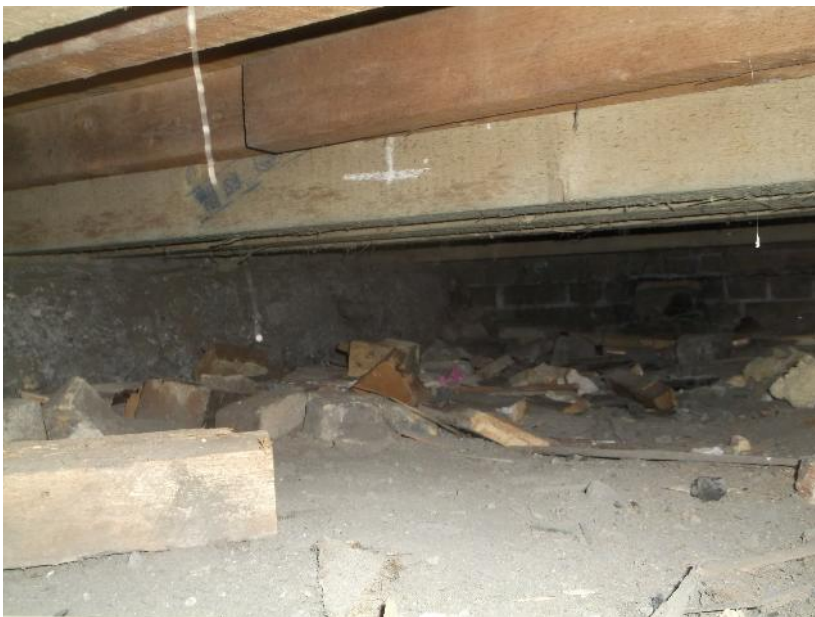
Fig 8:

Hatch 2; showing a view beyond the wall head upstand at basement level extending beneath the theatre area above. Note the almost wholly new floor construction in this location with some original floor joists indicated by the arrow. Joists were seated on possibly original plate on a concrete sleeper wall. Note the off-cuts and other debris all dating back to the last major refurbishment. The floor structure in this location had been largely replaced with plywood replacing the floorboards themselves, as also illustrated in figs. 41-44

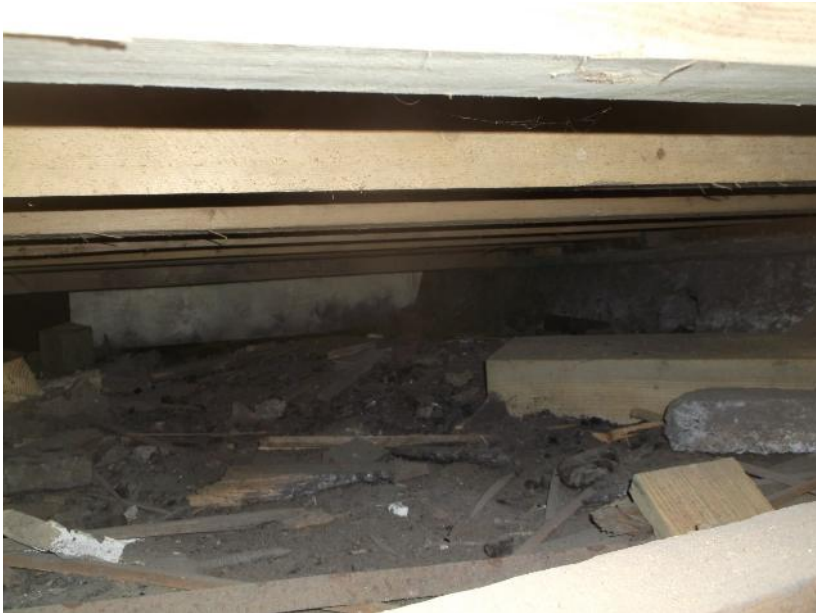
Fig 9:

Basement, Hatch 2; showing a view beyond the wall head upstand at basement level extending beneath the theatre area above. Note the almost wholly new floor construction in this location with some original floor joists indicated by the arrow. Joists were seated on possibly original plate on a concrete sleeper wall. Note the off-cuts and other debris all dating back to the last major refurbishment. The floor structure in this location had been largely replaced with plywood replacing the floorboards themselves, as also illustrated in figs. 41-44

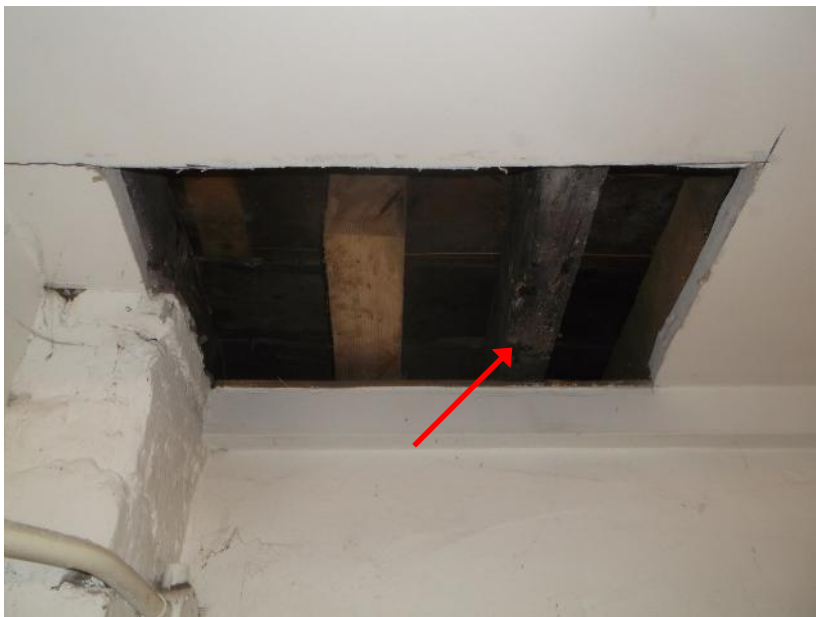
Fig 10:

- 1 Hatch 1: Likely original floorboards were of softwood of a tongue and groove pattern measuring approximately 30 x 150mm. They were significantly charred as a result of fire damage. Some were cupped as a result of the significant damp penetration that had occurred in the past and also possibly because they were of poorer quality flat sawn nature
- 2 Hatch 2: Plywood sheets overspanned the floor joists and no floorboards were visible
- 3 Hatch 3: Floorboards were of a tongue and groove nature and of softwood measuring approximately 20 x 115mm. As viewed from beneath adjacent to the hatch, the sheen to the underside of the floorboards indicated that they were of relatively recent origin possibly replacing fire damaged boards

Basement, Hatch 1; showing an overall view. Note the fire-damaged original joist indicated by the arrow partnered with new later large cross-sectional sized timber elements, detailed with a timber yard grade stamp. The overlying floorboards were fire-damaged but are likely to be original

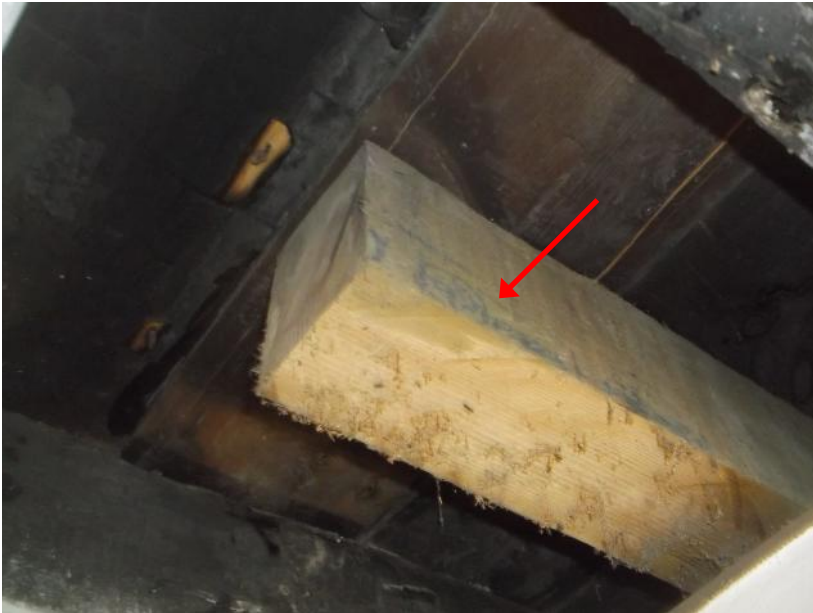
Fig 11:

Basement, Hatch 1; showing an overall view. Note the fire-damaged original joist indicated by the arrow partnered with new later large cross-sectional sized timber elements, detailed with a timber yard grade stamp. The overlying floorboards were fire-damaged but are likely to be original

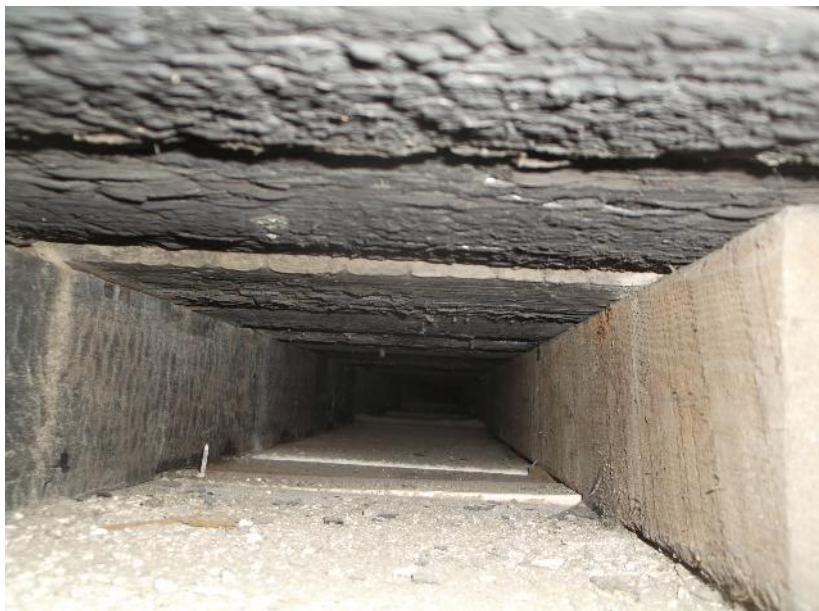
Fig 13:

Basement, Hatch 1; showing an overall view. The overlying floorboards were fire-damaged but are likely to be original. It is likely that the floorboards have been lifted and re-laid in this location as part of the post-fire refurbishment

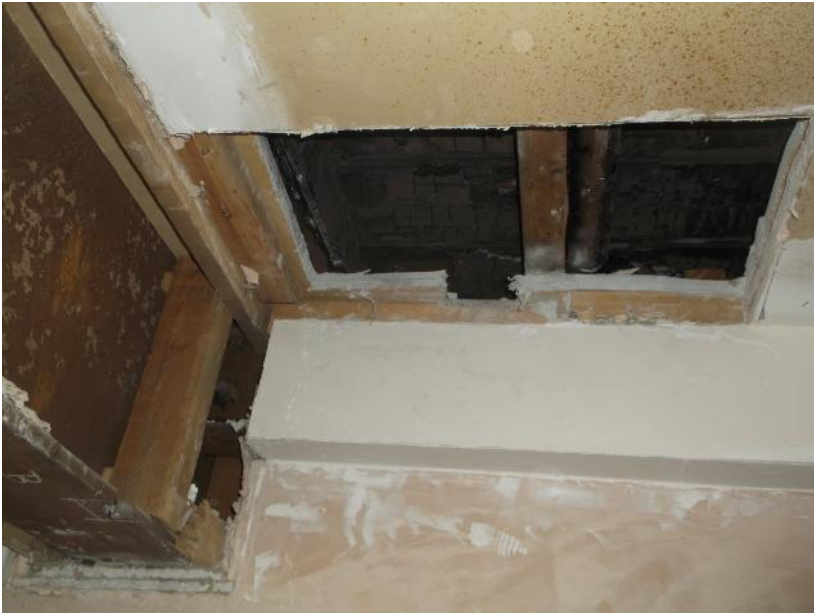
Fig 15:

- 3 Hatch 3: Floor joists measured approximately 110 x 50mm at 370mm centres and appeared to date back to the period of original construction. They had been partnered with later large cross sectional sized elements over the intermediate steel beams. Noggins and packing pieces had been inserted. Superficial fire damage had occurred to the joists

Basement, Hatch 3; showing the fire and smoke damaged boards in this location. The boards are likely to be original. Note the fire-damaged original joist partnered with newer large cross-sectional sized elements, dating to the post-fire refurbishment. It is highly likely that the floorboards would have been lifted and re-laid in this location

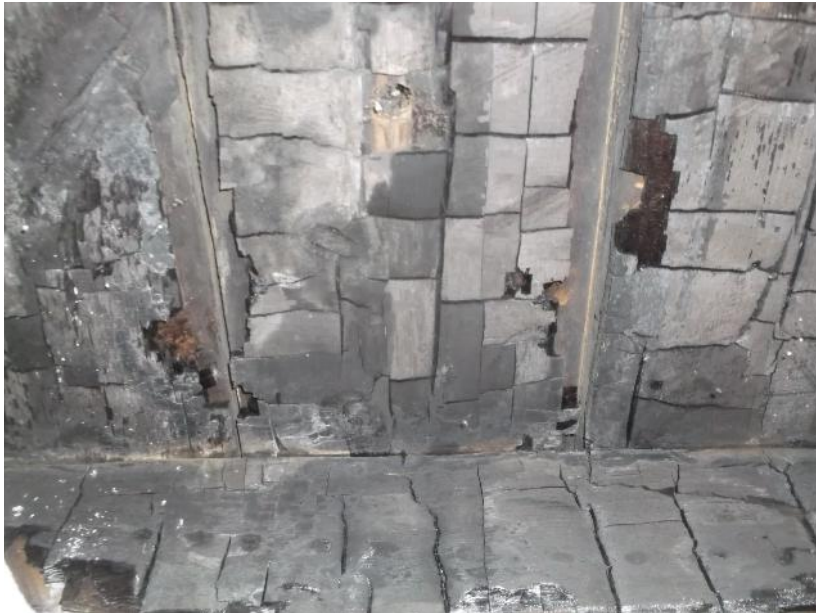
Fig 17:

Basement, Hatch 3; showing the fire and smoke damaged boards in this location. The boards are likely to be original. It is highly likely that the floorboards would have been lifted and re-laid in this location

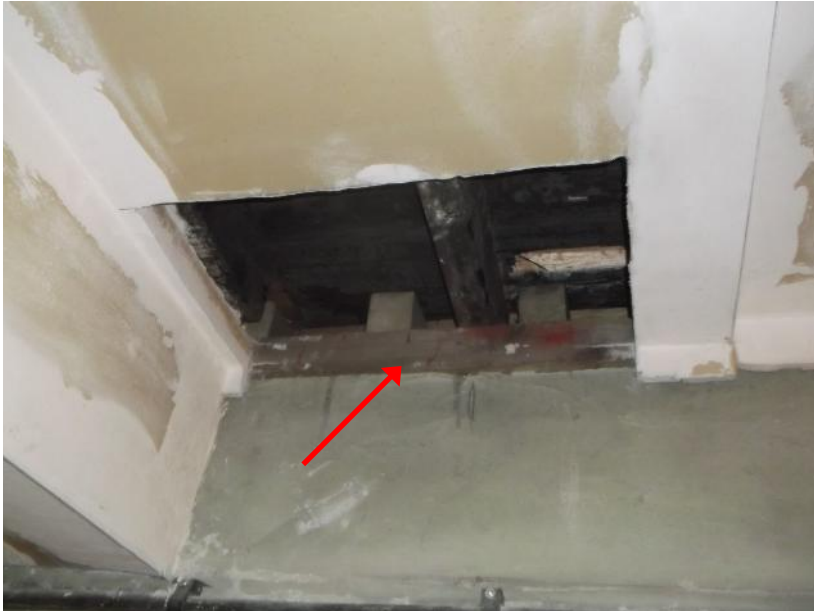
Fig 19:

- 5 Hatch 5: Floor joists measured approximately 115 x 60mm at 370mm centres and were partnered with later larger cross sectional sized timber joist elements, as viewed within the void to the east extending beneath the theatre area above. Joists were supported on what appeared to be original plate seated on an even mortar bed over a concrete sleeper wall. New timber plate travelled along the dividing wall to the void to the east indicative of repair and replacement work generally

- 5 Hatch 5: Likely original floorboards measured 30 x 170mm and appeared to be of a tongue and groove nature. There was extensive evidence of fire and smoke damage to the boards and new replacement floorboards extended beyond the wall head at basement level and under the area of the theatre staging above

Basement, Hatch 5; showing fire and smoke damaged floor joists and floorboards overspanning the new joist plate on the wall head upstand at basement level. The joists had been partnered with new large cross-sectional sized timber elements dating to the post-fire refurbishment and the floorboards beyond that area indicated in the photograph were new replacements extending beneath the theatre area

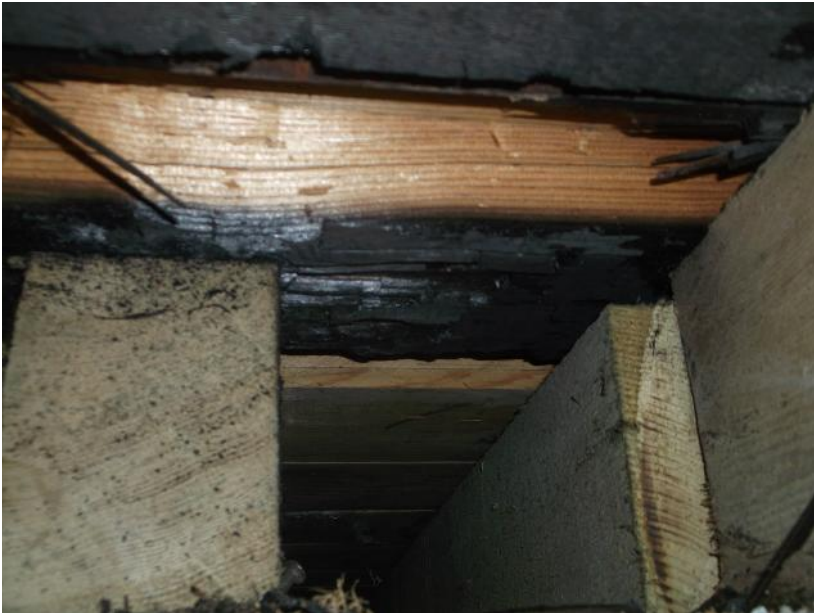
Fig 21:

Basement, Hatch 5; showing fire and smoke damaged floor joists and floorboards overspanning the new joist plate on the wall head upstand at basement level. The joists had been partnered with new large cross-sectional sized timber elements dating to the post-fire refurbishment and the floorboards beyond that area indicated in the photograph were new replacements extending beneath the theatre area

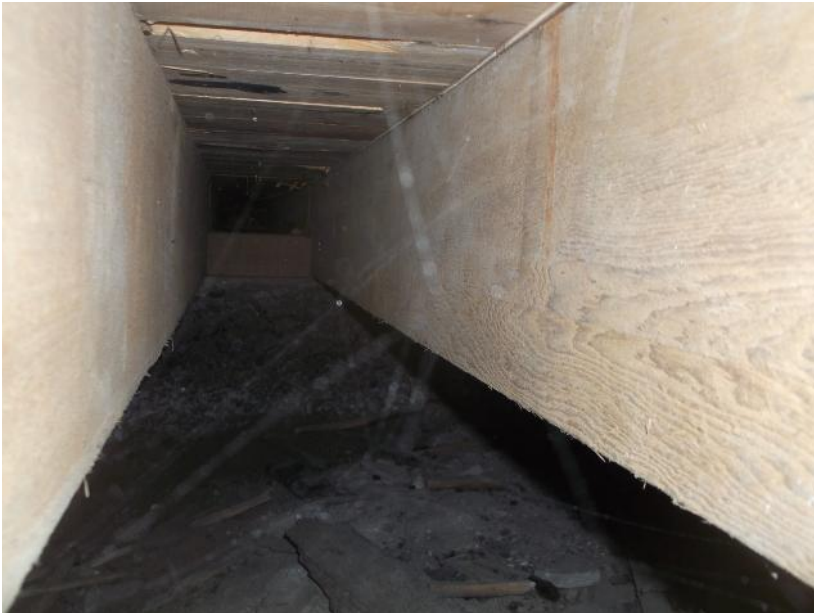
Fig 23:

Basement, Hatch 5; showing new floor joists and floorboards

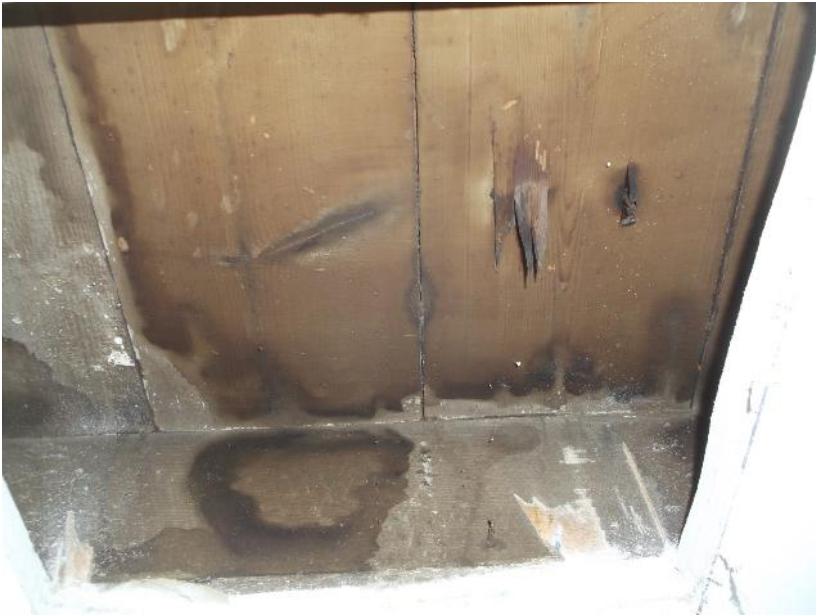
Fig 25:

- 6 Hatch 6: Floor joists measured approximately 110 x 60mm at 370mm centres and appeared to date back to the period of original construction. No fire damage was evident extending to this location

Basement, Hatch 6; showing likely original floorboards and joists in this location fixed with squared shanked nails. There was no evidence of fire or smoke damage. However, it is still likely that the floorboards would have been lifted and re-laid in this location since the period of original construction

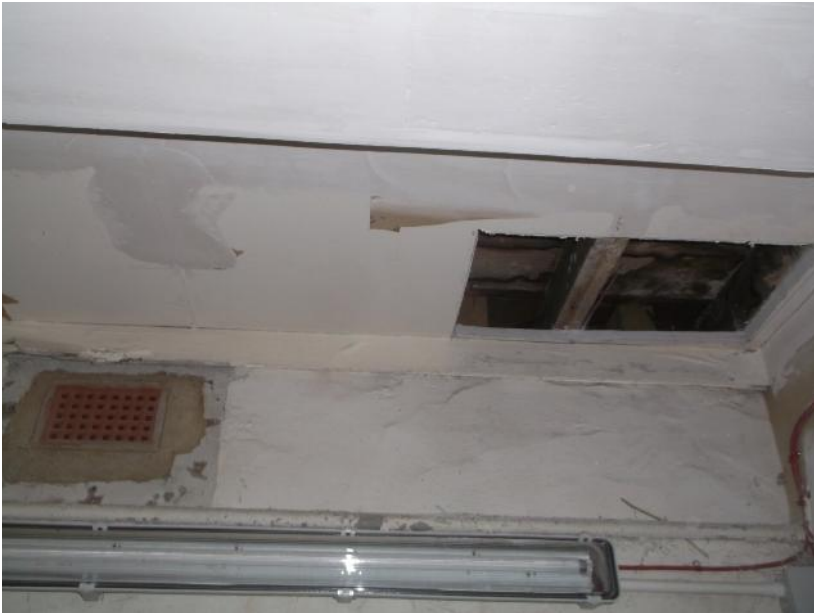
Fig 27:

- 7 Hatch 7: Floor joists measured approximately 110 x 60mm at 370mm centres and appeared to date back to the period of original construction. No fire damage was evident extending to this location

Basement, Hatch 7; showing one of the relatively newly inserted airbricks dating back to the last major refurbishment providing some and through circulating ventilation beneath the theatre floor above. There was no evidence of fire or smoke damage to the timbers. However, it is likely that the floorboards would have been lifted and re-laid since the period of original construction

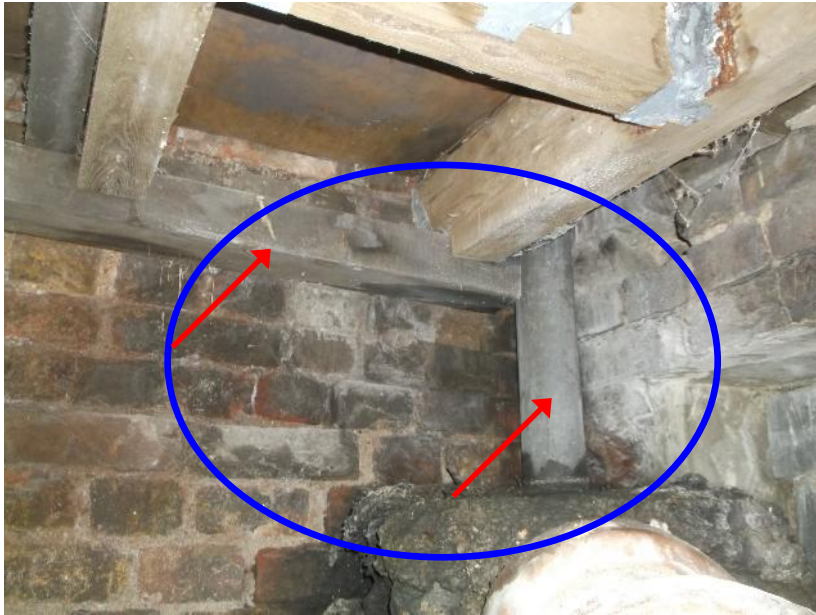
Fig 29:

- 8 Hatch 8: Floor joists measured approximately 110 x 60mm at 370mm centres and appeared to date back to the period of original construction. No fire damage was evident but structurally significant timber decay had occurred as a result of water services failing. Although extensive repair and replacement had occurred, there was a high risk of progressive decay. Most of the likely original joists in this location had been partnered with new larger cross sectional timber elements with timber yard grading stamps

- 8 Hatch 8: Likely original tongue and groove floorboards were of softwood measuring 30 x 120mm. This is smaller than the others. Some smoke staining was evident. Extensive structurally significant decay had occurred in this location and approximately 6m² of floorboards had been replaced with plywood

Basement, Hatch 8; showing the area of significant repair and refurbishment as a result of failure to the pipework indicated by the arrow. The blue ring indicates saturated masonry putting at risk of decay the plate indicated by the arrow and the joist bearing ends. Floorboards had been extensively replaced by plywood in this location

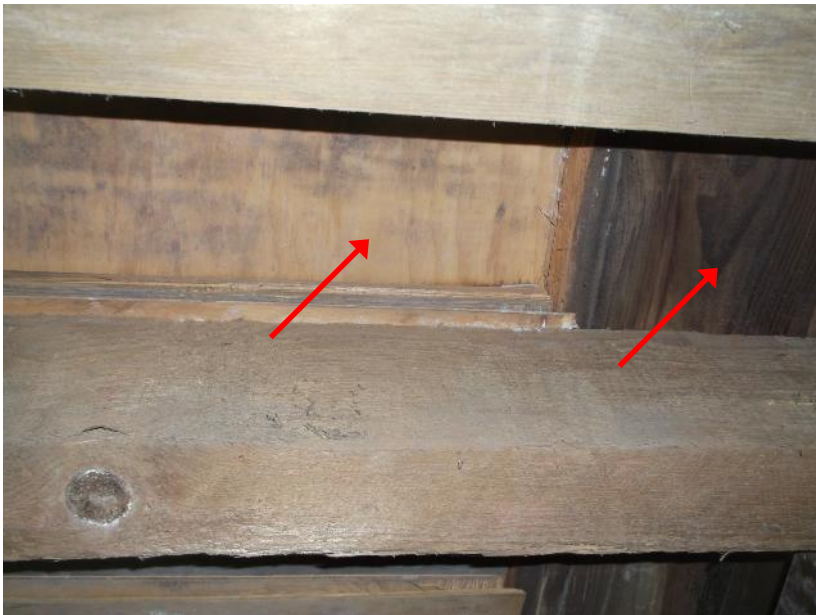
Fig 30:

Basement, Hatch 8; showing a view of the combination of plywood and older likely original floorboards

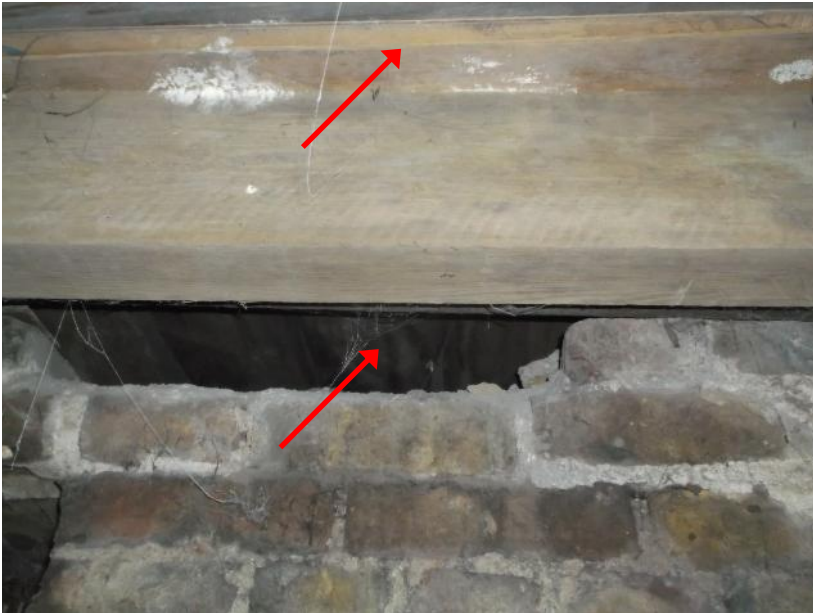
Fig 31:

Basement, Hatch 8; showing a view of the combination of plywood and older likely original floorboards

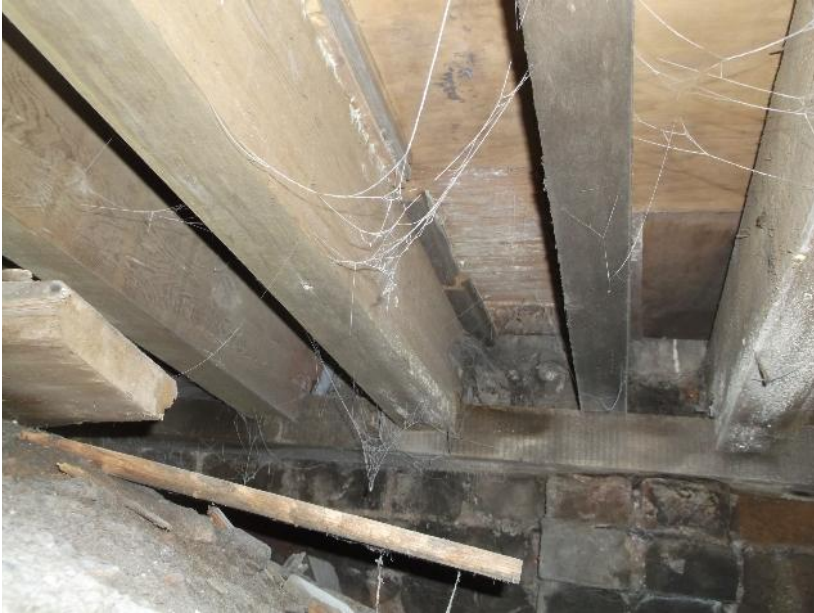
Fig 33:

Basement, Hatch 8; showing the extensive use of plywood replacing the original floorboards along the western side of the area

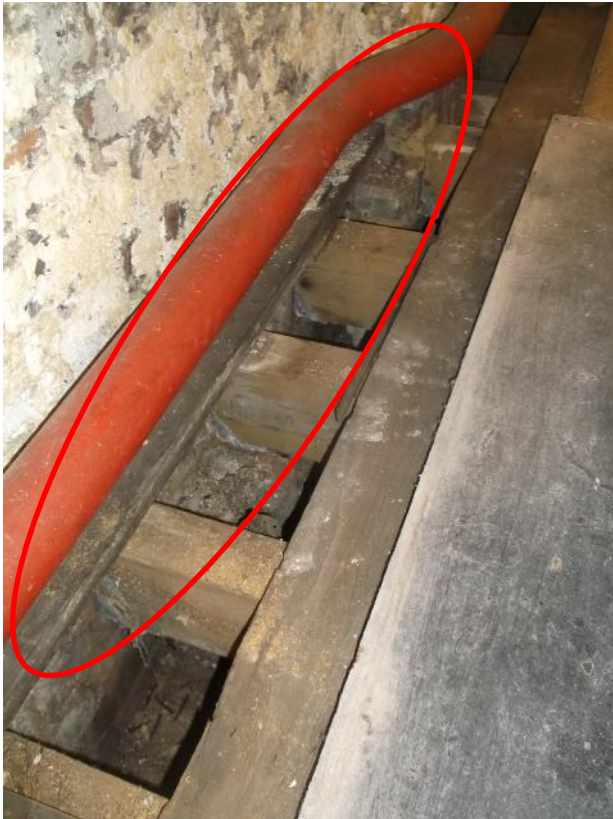
Fig 35:

- 1 Hatch C1: Floor joists post-dating the period of original construction spanned east to west supported on galvanised hangers to their west bearing ends to the external wall masonry. Joist bearing ends were highly vulnerable to structurally significant decay as a result of being in contact with saturated masonry
- 2 Hatch C2: Likely original floor joists spanned east to west partnered with new large cross sectional sized elements supported at their bearing ends on old plate measuring approximately 100 x 100mm running along the damp affected external wall. Both the joist bearing ends and the underlying plate would be vulnerable to structurally significant decay in this location

- 1 Hatch C1: Likely original floorboards measuring approximately 35 x 170mm had been lifted and re-laid over the floor joists beneath. Floorboards were in a fragmentary and partially decayed condition and were finished with 35mm thick plywood sheeting
- 2 Hatch C2: The likely original floorboards had been lifted and largely replaced and re-cut to act as furring pieces beneath the new 35mm thick ply. The extent of the replacement could not be easily ascertained but is likely to extend to approximately 5m² in this location

Western corridor, Hatch C1; showing an overall view. Plywood overlaid the likely original floorboards which had been lifted and re-laid over the floor joists which had been replaced in this location. The replacement joists were supported in hangers and were highly vulnerable to the decay at their bearing ends, being in contact with damp affected masonry

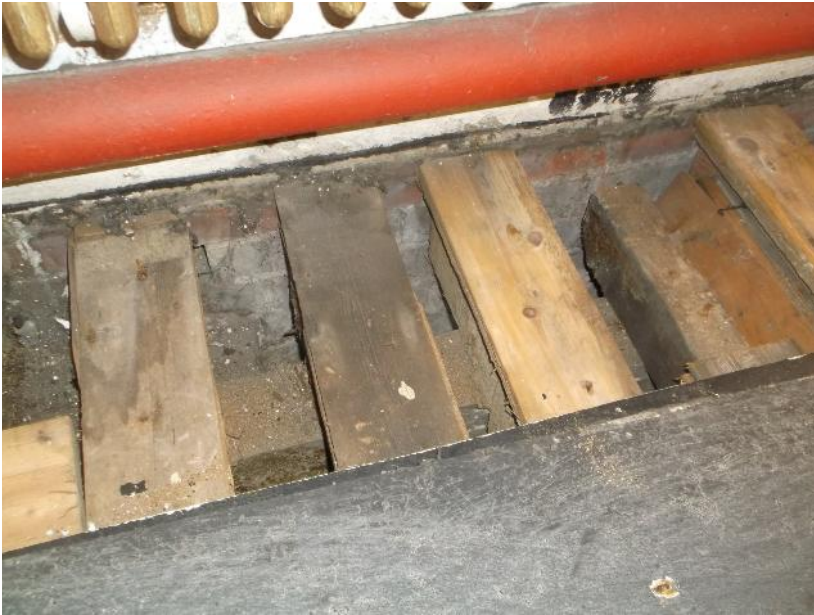
Fig 39:

Western corridor, Hatch C2; showing the exposed original joists in this location which were highly vulnerable to decay being in contact with damp affected masonry. The likely original floorboards had been lifted, cut and re-laid as furring or packing pieces over the joists

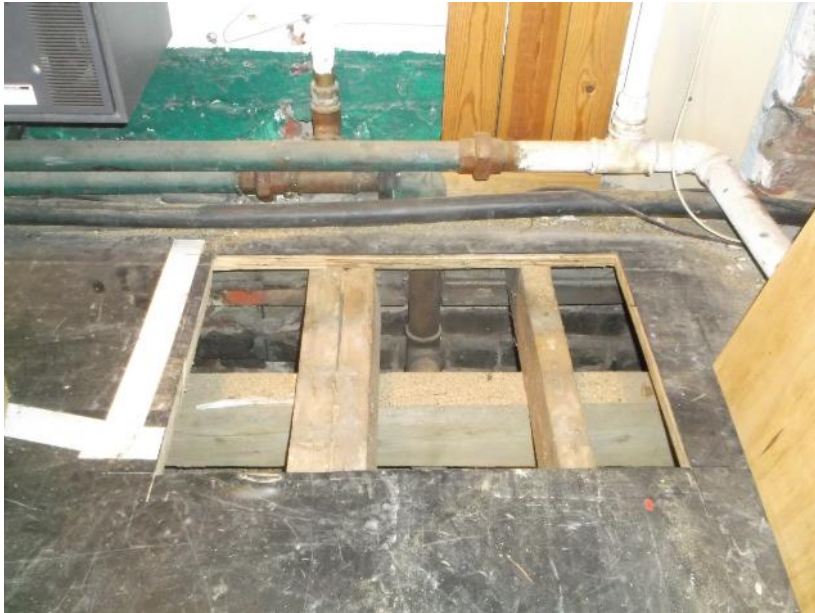
Fig 41:

- 9 Hatch 9: Floor joists spanned east to west and were partnered with new large cross sectional sized joists supported on original plate along the external wall to the east. New secondary joists spanned north to south between the partnered elements apparently providing some lateral support to the structure in this location, which appeared to have been subject to decay and remedial action in the past. Some of the new floor joists acted as primary large cross sectional sized joists providing principal support

- 9 Hatch 9: Floorboards had been replaced with 35mm plywood laid directly on the joists in an area extending to at least 12m² from the south-east corner of the Drill Hall

Drill Hall, Hatch 9; showing the plywood sheeting replacing the original floorboards and extensive repair and replacement work to the original underlying joists. Providing support to the joists was new trimmed timber plate supported in hangers onto the large cross-sectional sized primary joists. It appeared that supporting plate seated on the concrete sleeper walls was not original

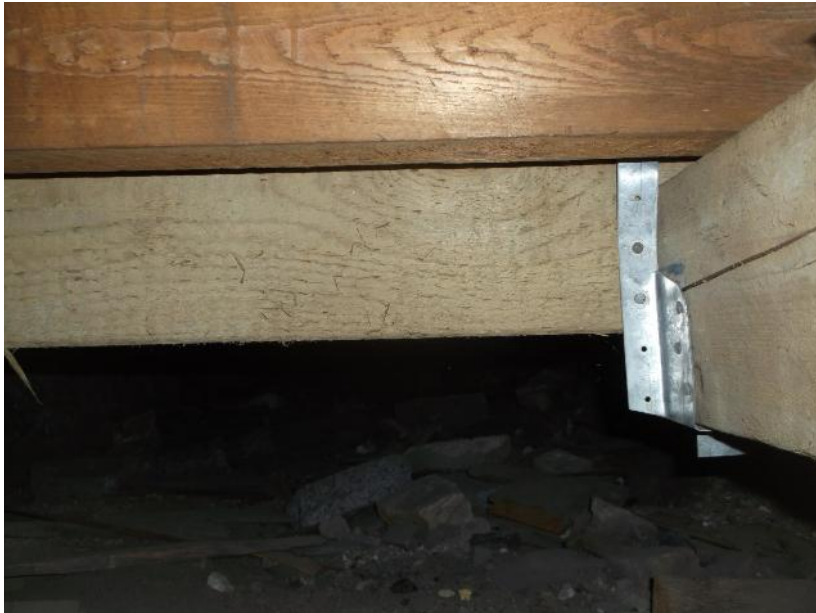
Fig 43:

Drill Hall, Hatch 9; showing the plywood sheathing replacing the original floorboards and extensive repair and replacement work to the original underlying joists. Providing support to the joists was new trimmed timber plate supported in hangers onto the large cross-sectional sized primary joists. It appeared that supporting plate seated on the concrete sleeper walls was not original

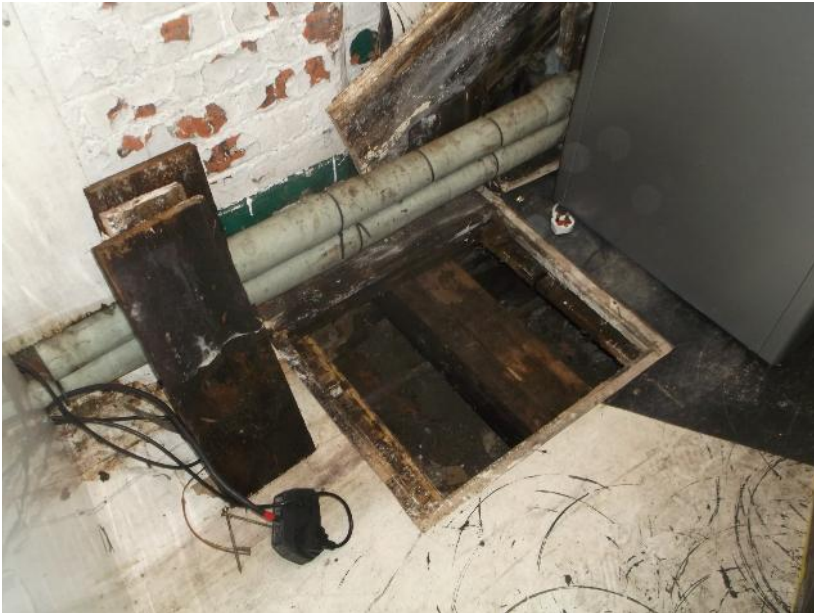
Fig 45:

- 10 Hatch 10: Likely original floor joists spanned east to west housed into masonry pockets to their east bearing ends. structurally significant wet rot decay had occurred to the built-in bearing ends in an area of saturated masonry as a result of failure to the white goods above. The floor was inadequately supported in this location. Partnering had occurred in the past to strengthen the floor but these elements were also decayed

- 10 Hatch 10: 35mm plywood sheets had been laid over the older floorboards which measured approximately 35 x 170mm. Floorboards appeared to be rebated or lap jointed as opposed to tongue and groove in this location, and were extensively decayed by wet rot as a result of failure to the white goods within the bar storage area

Drill Hall, Hatch 10; showing original joists partnered with later elements as a result of progressive wet rot decay in this location. Decay was occurring to built-in bearing ends. Remnants of likely original floorboards remained but were structurally significantly decayed

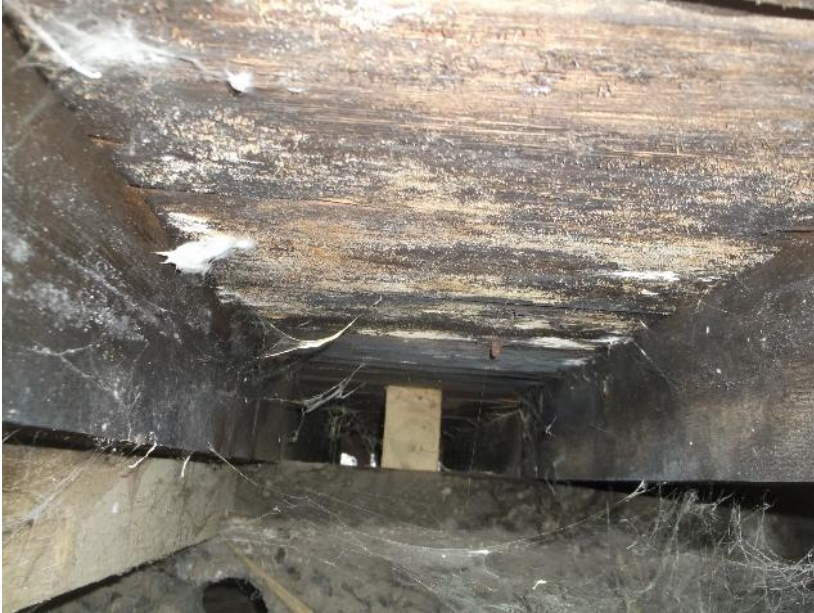
Fig 47:

Drill Hall, Hatch 10; showing original joists partnered with later elements as a result of progressive wet rot decay in this location. Decay was occurring to built-in bearing ends. Remnants of likely original floorboards remained but were structurally significantly decayed

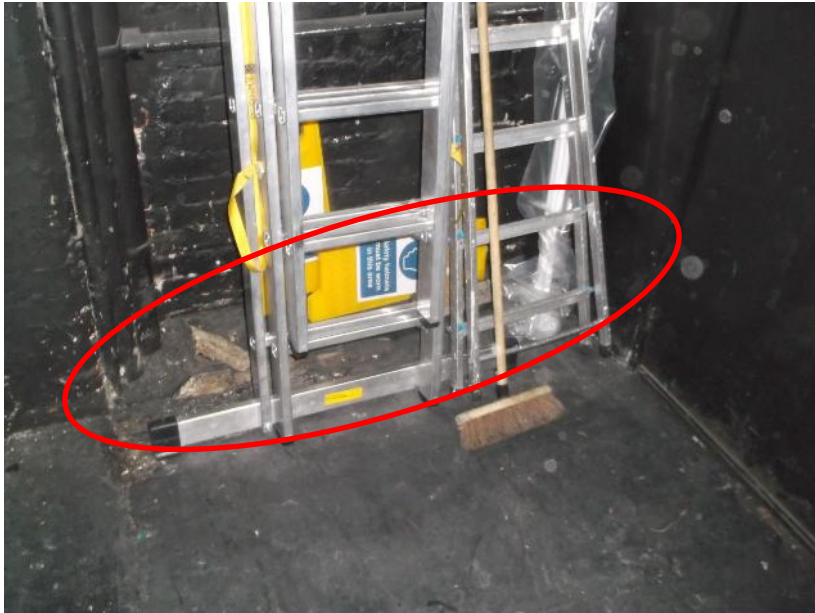
Fig 49:

Drill Hall entrance threshold; showing the area of significant damp and decay adjacent to that area illustrated in fig. 45 as a result of water leaks from the white goods and also failure to the pipework and possibly also washing activities of the floor

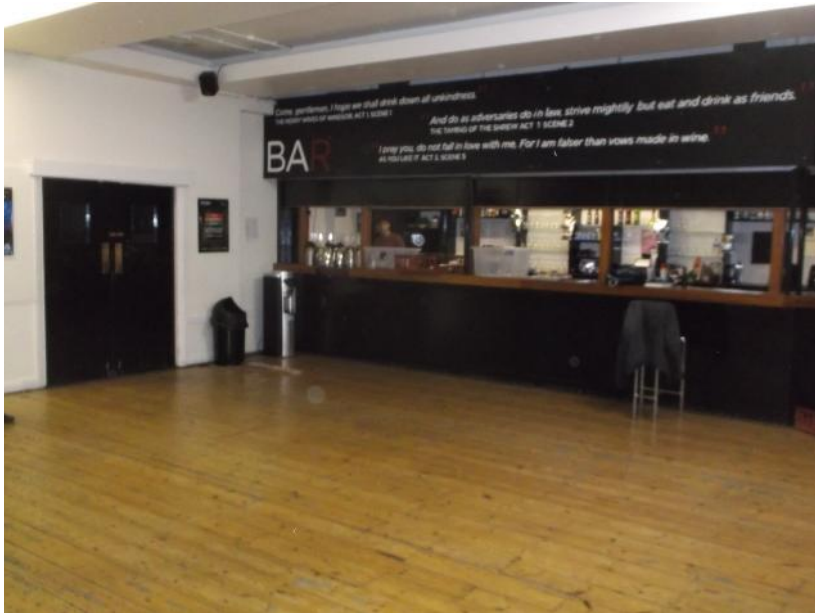
Fig 51:

The floorboards to the approximate 78m² Bar area had been heavily sanded and were nail fixed with squared nails to the underlying floor joists. The use of similar squared shanked nails died out during the 1960s. There was evidence of heavy patch repair and replacement to the Bar floorboards in localised areas. In H+R's opinion, none of the floorboards within the Bar area date back to the period of original construction

Bar; showing an overall view of the sanded floor finish. In H+R's provisional opinion, none of the floorboards in the bar area dated back to the period of original construction

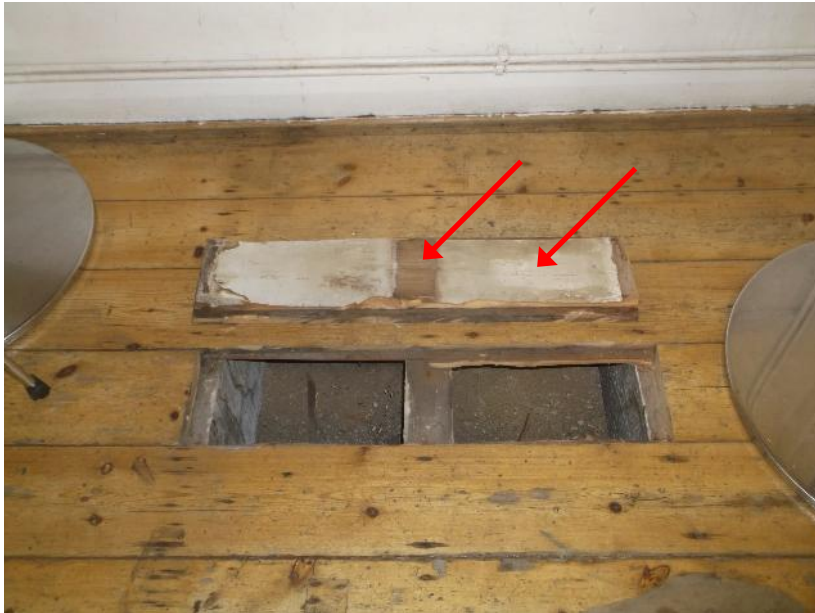
Fig 53:

Bar Hatch B2; showing floorboards painted with a limewash after they had been secured to the joists beneath. This was likely to have been applied as a preservative treatment against wood boring insect infestation and died away in the 1960s as a methodology. The underlying floor joists are likely to be original, but the floorboards are likely to date to the post WW2 refurbishment. The floorboards were rebated at their joints and were flat sawn and of a poorer quality than those likely original boards to the adjacent Drill Hall area

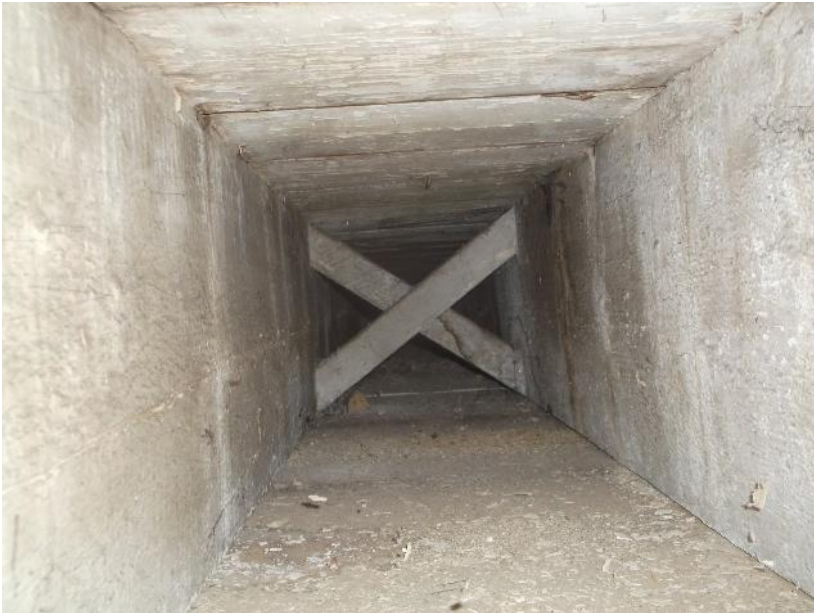
Fig 55:

Bar Hatch B2; showing herringbone strutting for lateral support

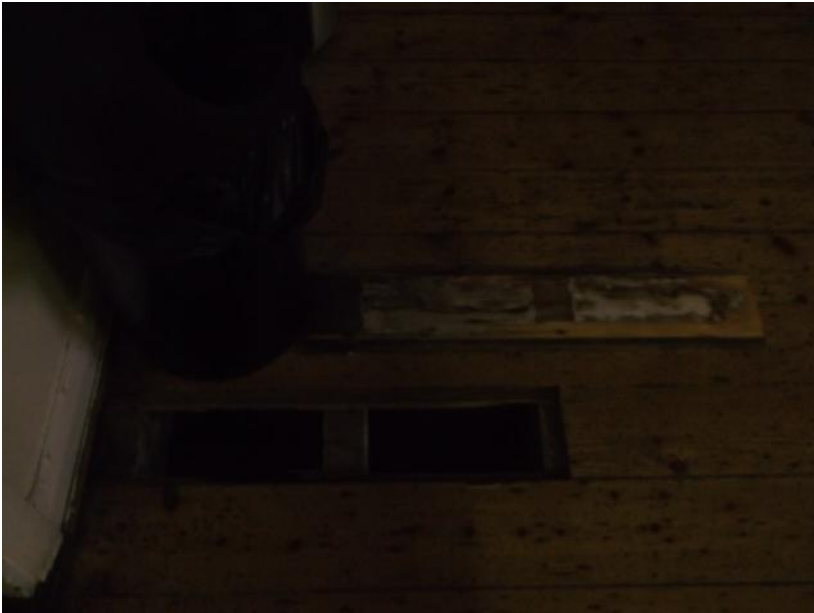
Fig 57:

Bar Hatch B3; showing a floorboard painted with limewash similar to that illustrated in fig. 53. Floorboards had been laid on a metal furring piece or tongue generally to the western half of the bar area. Judging by the nature of the metalwork, the boards were likely to have been laid using this methodology in the 1950s and 1960s

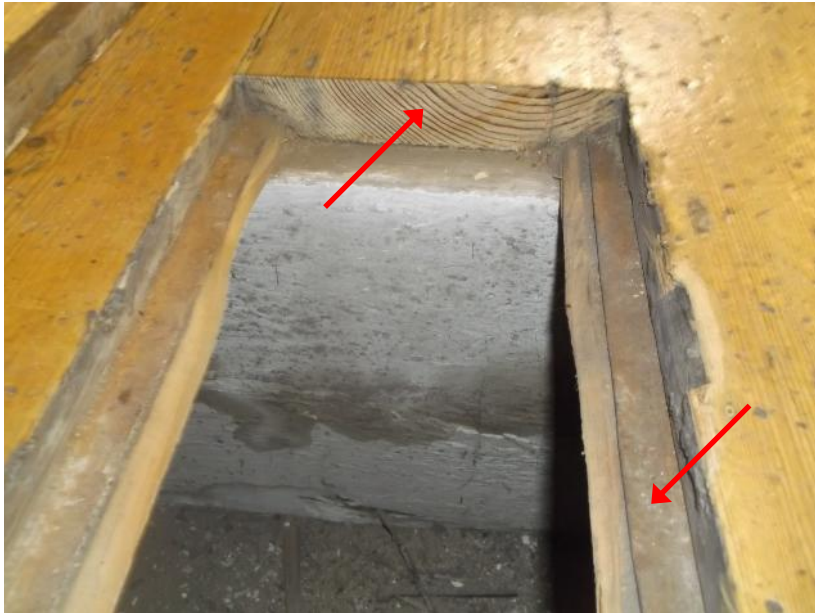
Fig 59:

Bar Hatch B3; showing a detail of the metal furring pieces or tongues and also the poorer quality flat sawn grain to the boards, indicating later origin
