INVESTIGATION OF FLOORBOARDING TO ASCERTAIN AGING OF 16-18
CHENIES STREET FOR 18 MAY 2017, JOB NO. 147.17

RADA

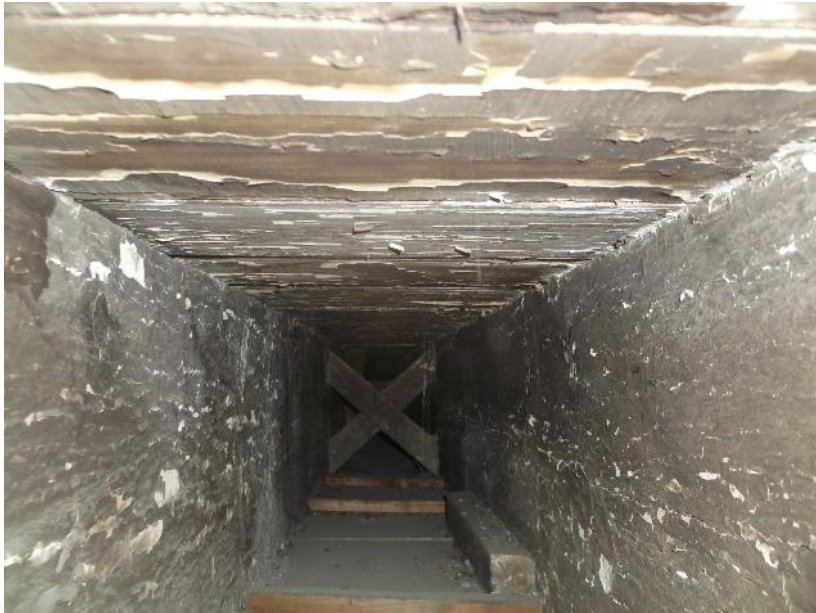
Fig 61:

- 4 Hatch B4: The floorboards were rebated. They post-dated the period of original construction. The floorboards were smoke damaged to the underside possibly as a result of a fire resulting from mismanagement of the adjacent fireplace

Bar Hatch B4; showing some possible smoke damage to the joists but also limewash to the underside of the floorboards and herringbone strutting

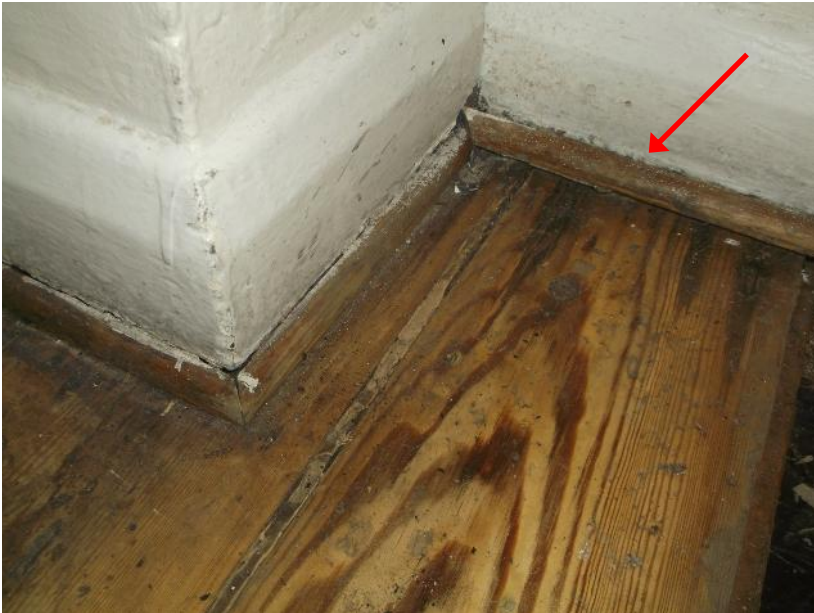
Fig 63:

The beading around the perimeter of the floor at the junction with the plaster skirtings masks a gap. Such a gap would not have been countenanced on original construction and is a further indication that the boards are replacements

Bar Hatch B5; showing the timber beading at the foot of the plaster skirting masking the gap in this location. Such a gap would not have been countenanced on original specification

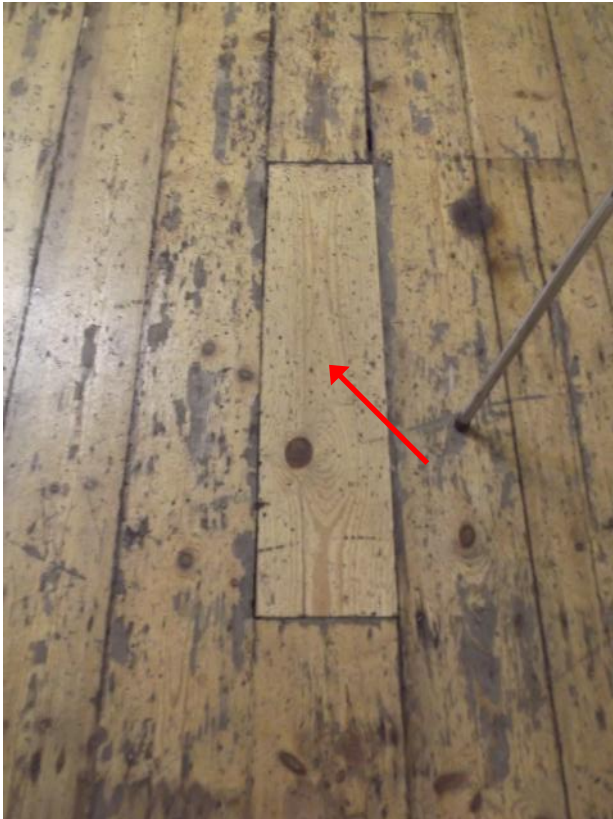
Fig 65:

Bar; showing a typical area of localised replacement of floorboards

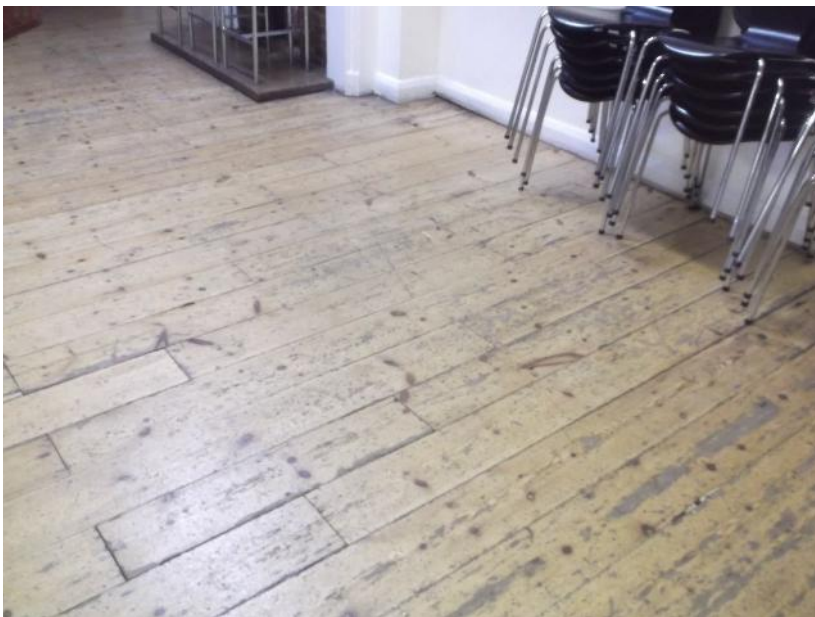
Fig 66:

Bar; showing a typical area of localised replacement of floorboards

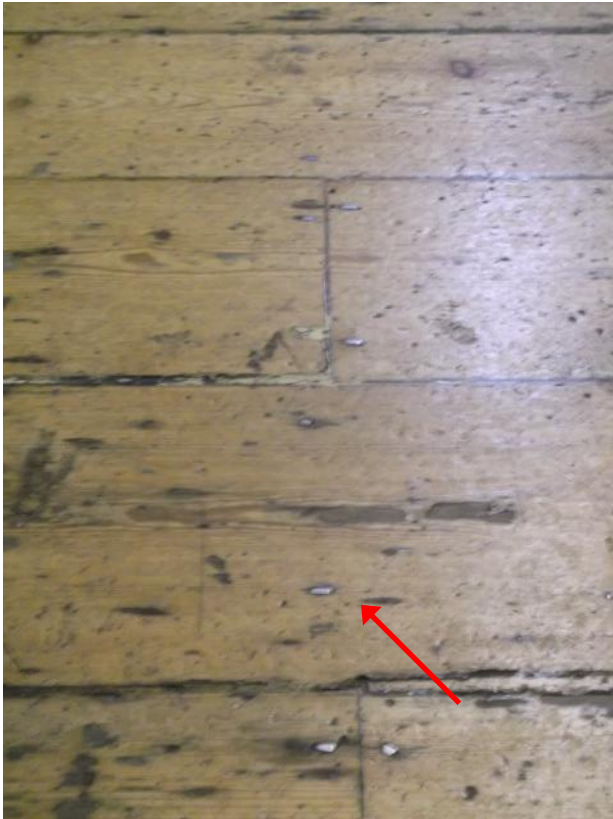
Fig 67:

Bar; showing the use of squared shanked nails for fixing throughout. The use of such nails died away in the 1960s
