SITE INVESTIGATION REPORT

Name of Insured: [REDACTED]
Address of Insured: Cleve House, Cleve Road, LONDON, NW6 3RN
Situation of Damage: Cleve House Freehold Limited, Cleve Road, LONDON, NW6 3RN

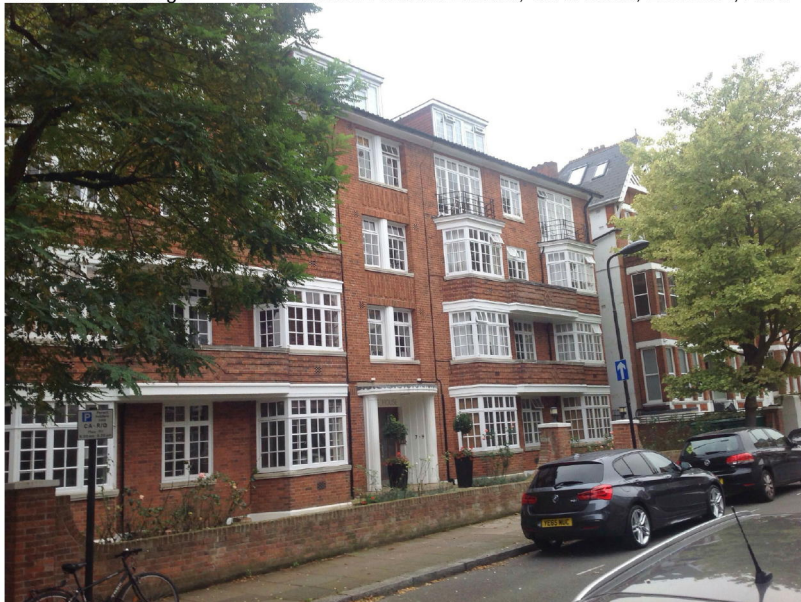
The claim is primarily concerned with damage to the front right hand bay.

Based on the information detailed above, we are of the opinion that damage has occurred due to clay shrinkage subsidence. This has been caused by variations in the moisture content of the clay subsoil, resulting in volume changes, which in turn have affected the foundations.

We have not yet decided on the final type of repair required, but have produced an outline of the most likely requirements. This involves undertaking partial demolition, rebuilding and redecoration. This decision has been taken based on our knowledge and experience of dealing with similar claims. In addition the results of the Site Investigation, laboratory testing and monitoring have been taken into account.
