Highgate  
Newtown  
Community  
Centre, 25  
Bertram  
Street,  
London,  
N19 5DQ

## Endoscope Survey Brief

December  
2018

Ref: 18-4442

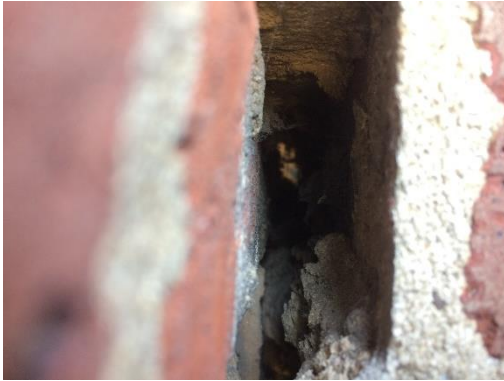
- 4.4 The crack/recess that runs along the joining wall for the gymnasium and the wood workshop (known as building 3 in the PEA Report, October 2018), noted little to no potential crevice potential. Some of the ingress points extended through to the room on the opposite side resulting in the internal area filled with light from the windows on the either side of the building rendering it unsuitable for use as daytime roosts. The majority of the crack ingress points found cobwebs suggesting no recent disturbance. Two of the ingress points did lead to dead ends

providing some suitability for use by single roosting bats, however no signs of bats in the form of marks, stains, droppings and or debris was noted. The wall space was solid with no internal wall cavity available for use by roosting bats.

visible light noted during inspection of the crack in wall

- 5.1 The results of the endoscope inspection of the joining wall for the gymnasium and wood workshop (building 3) has confirmed likely absence of a bat roost and no further bat surveys are recommended for this building. It is recommended that precautionary measures are in place for the demolition of this building and the crack/recess section of the building undergoes soft demolition. Should demolition works be delayed beyond the 1<sup>st</sup> May 2018, then a further endoscope survey will be required, to inform the mitigation measures.

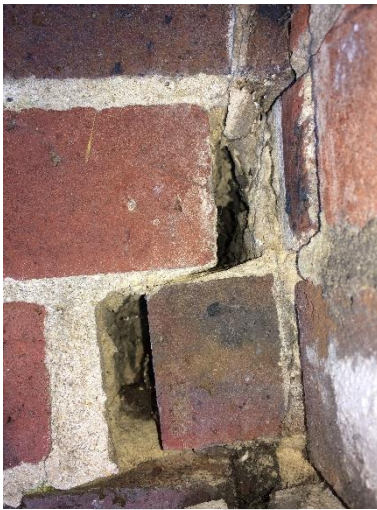
ingress with cobwebs noted

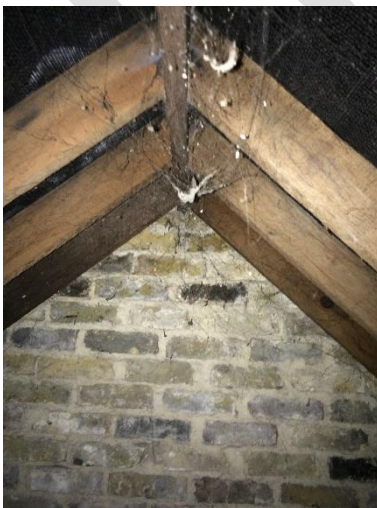
- 4.5 The ridge tile on the community centre roof (building 2) was not accessible to the surveyors due to health and safety reasons.
- 4.6 Building 1's soffit boards noted limited to no crevice roosting spaces and no further endoscope survey was required. The internal loft space of the building noted three areas of potential access and crevice spaces, these were inspected and nesting debris, likely from house sparrow were noted in one of the sections of sagged felt. No signs of bats in the form of marks, stains, droppings and or debris was noted.

loft space of building 1 – heavy cobwebs within ridge space

- 5.2 The loft space of building 1 found potential access points and crevice spaces. The detailed endoscope inspection of the potential areas has found no evidence of bats and it can be assumed that the spaces are unlikely to support roosts, however in the absence of a dusk/dawn survey to confirm likely absence, mitigation measures will be required. The ecologist must be on site for the demolition of the building and a soft strip will be required of the roof space.

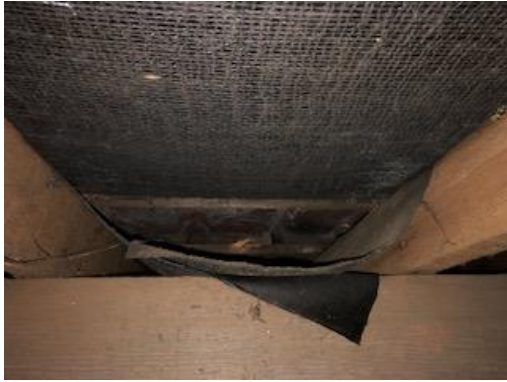
sag in felt with visible light – no signs of bats noted during inspection of area

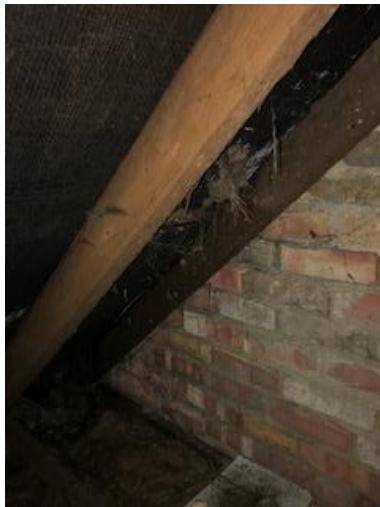
nesting debris noted in torn/sag felt area in loft (building 1)

- 5.5 Building 1's roof space had a remnant nest site, likely to be house sparrow. This building must be demolished outside of the nesting bird season (generally March to August inclusive), unless first checked by a suitably qualified ecologist.
- 5.6 As mentioned in the PEA Report, the nest boxes on site must be removed prior to the nesting bird season. Site clearance of vegetation must be carried outside of nesting bird season (March to August inclusive) or unless first checked by a suitably qualified ecologist.
- 5.7 The loss of the likely house sparrow nest site within building 1 will require compensation. It is recommended that (2) WoodStone Build-in House Sparrow Nest Boxes are incorporated into eastern walls, at a height of at least three metres.

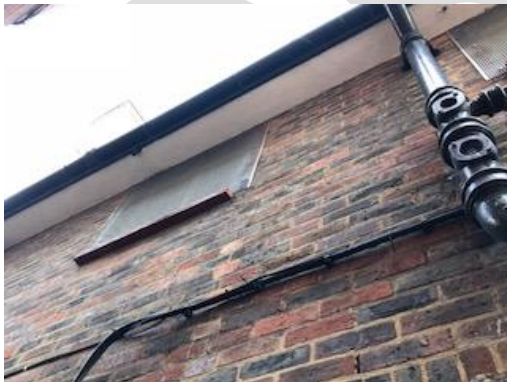
- 4.2 In summary, the former caretaker is a detached derelict building (referred to as building 1 in the PEA Report, October 2018). With access obtained to the surveyor, the gaps noted during the October survey at a distance, now noted that the gaps between the brick wall and soffits were less than 15mm and considered unlikely to support crevice potential. The walls were in a good state of repair with no notable holes, gaps or cracks noted.

limited gaps noted between brick wall and soffit boards in building 1
