Pic. 1 Front Elevation & Main Entry

Roof Coverings Condition Report

Paul's House, Huntley Street

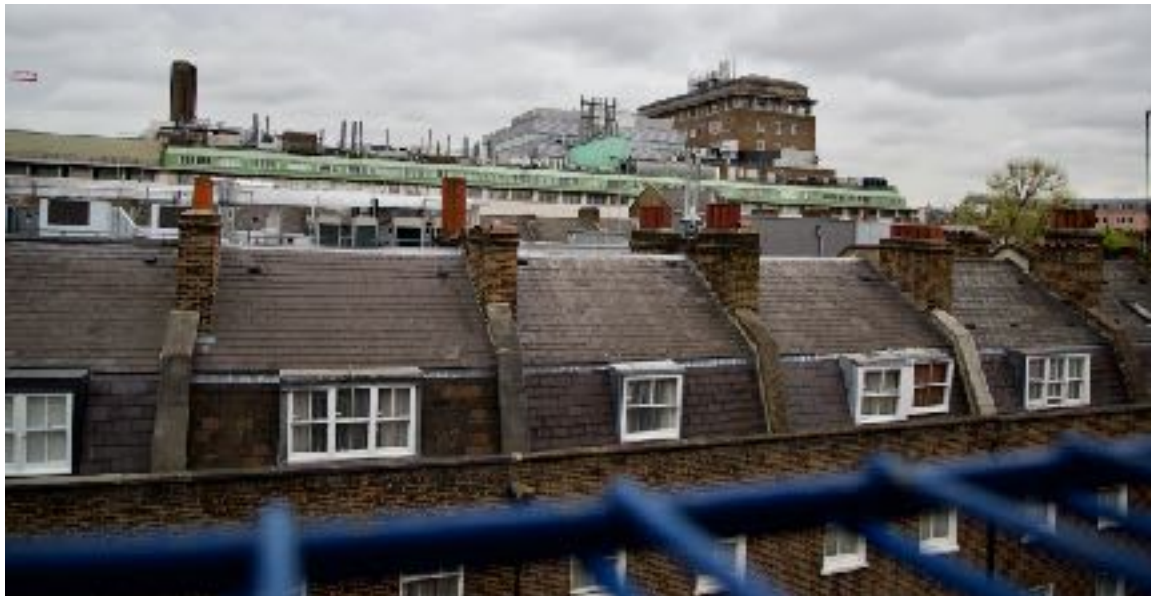
Pic 2 General view of front elevation roofs

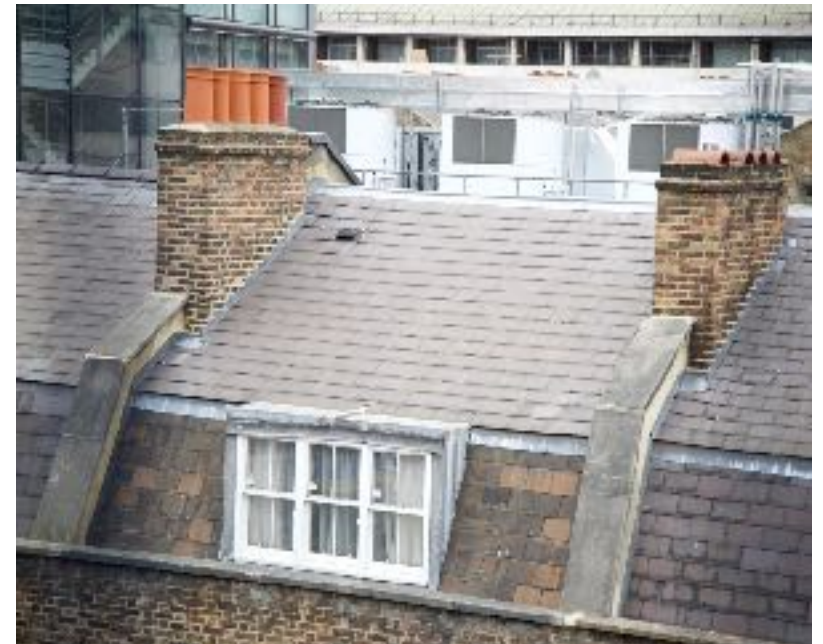
The lower, steeper roof slope to the front elevation of 66 Huntley Street, has slates of a different colour indicating that they have been replaced in this location.

Pic 3 View of front elevation to 66 Huntley Street

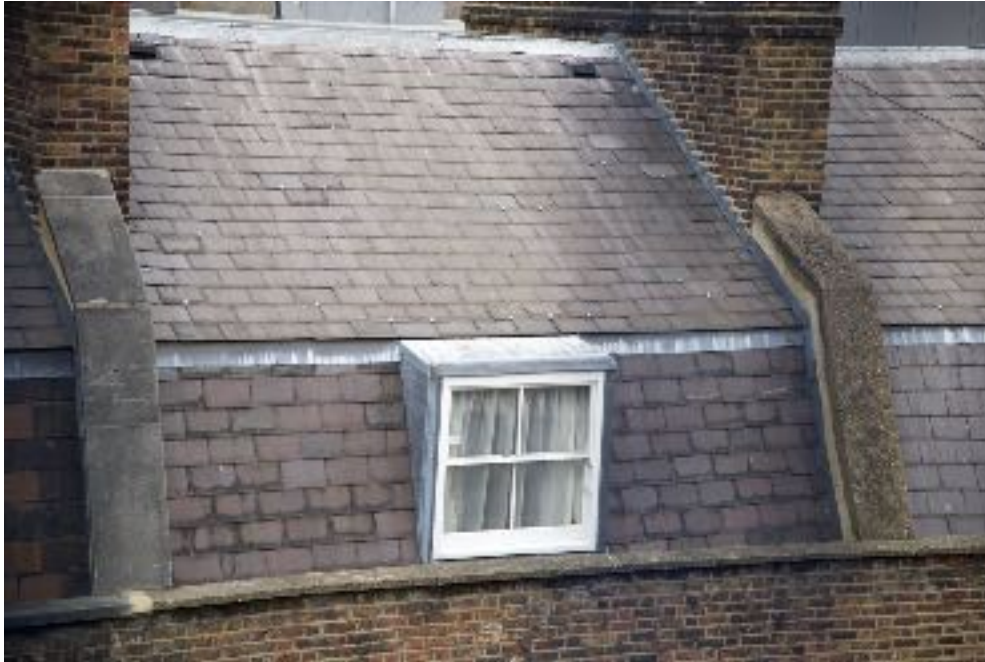
Pic 4 View of front elevation to 64 Huntley Street

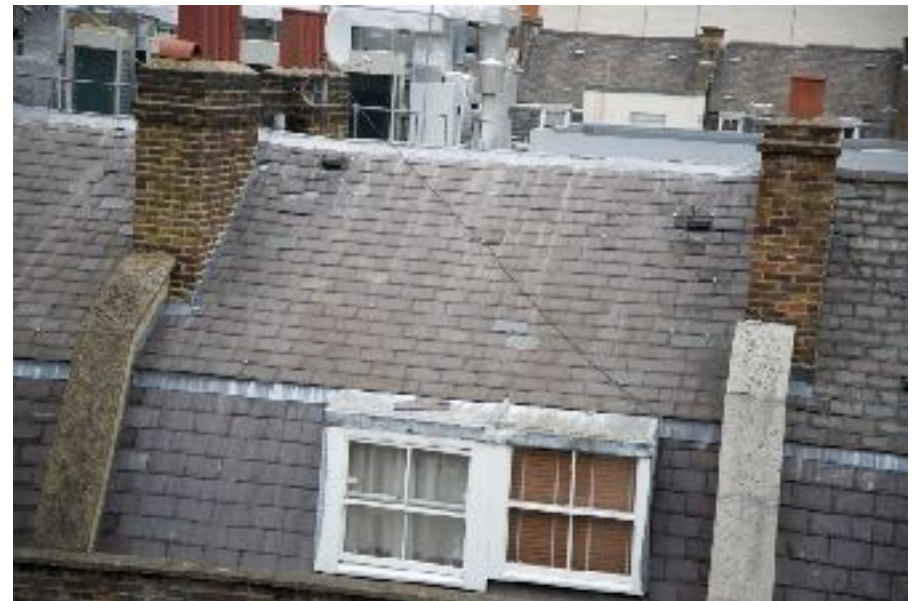
Pic 5 View of front elevation to 62 Huntley Street

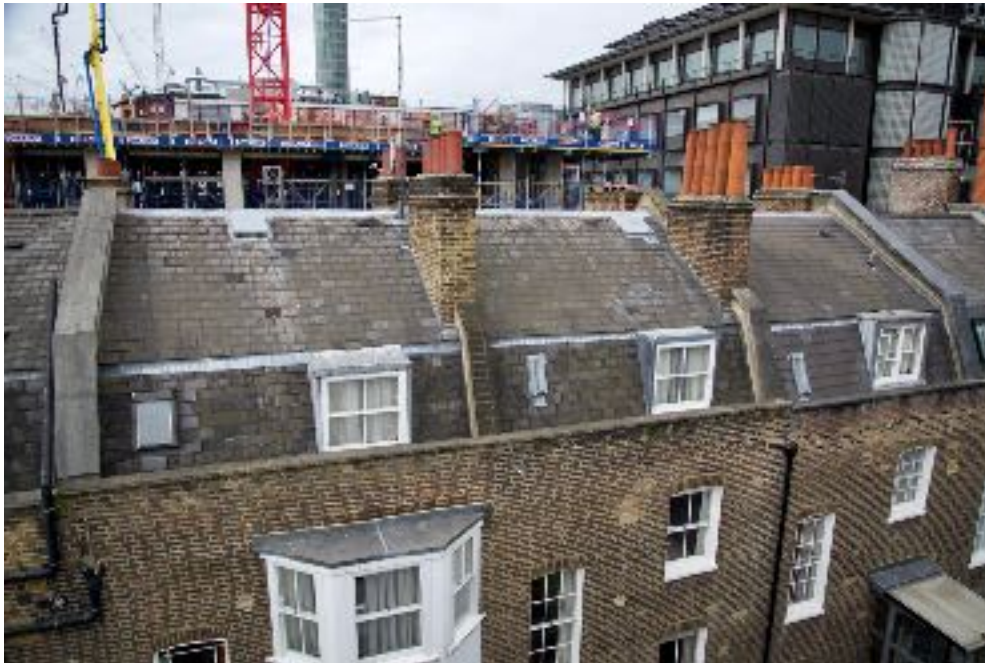
Pic 6 General view of rear elevation roofs

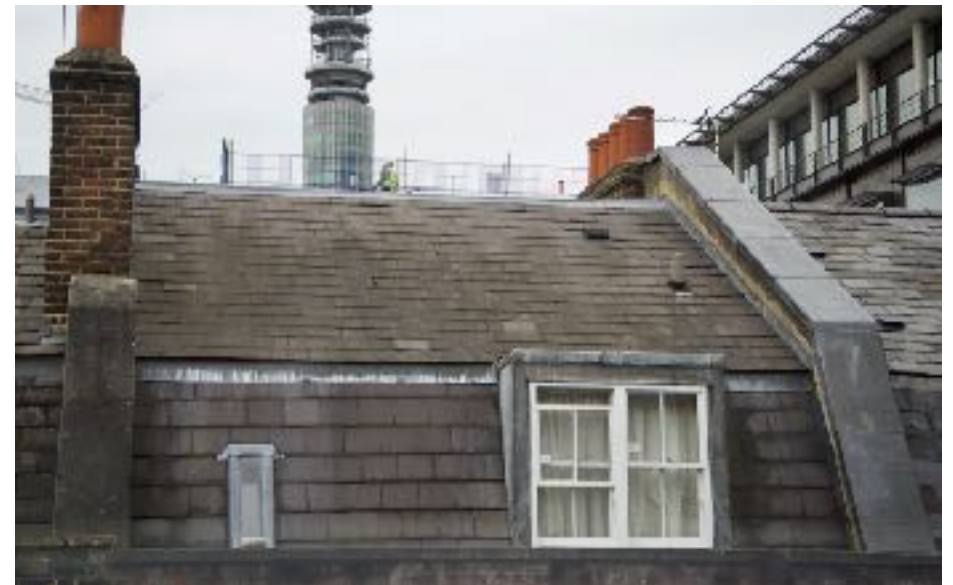
The roofs to the properties are covered with natural slates with the exception of the rear elevation to number 66 which has artificial slates.

Pic 7 View of rear elevation to 66 Huntley Street

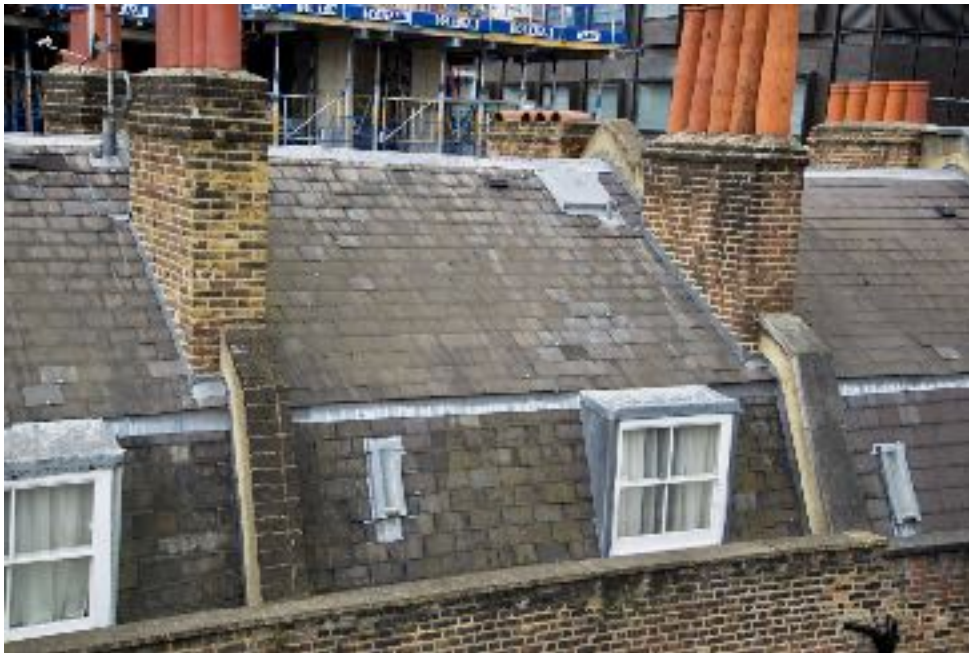
Pic 8 View of rear elevation to 64 Huntley Street

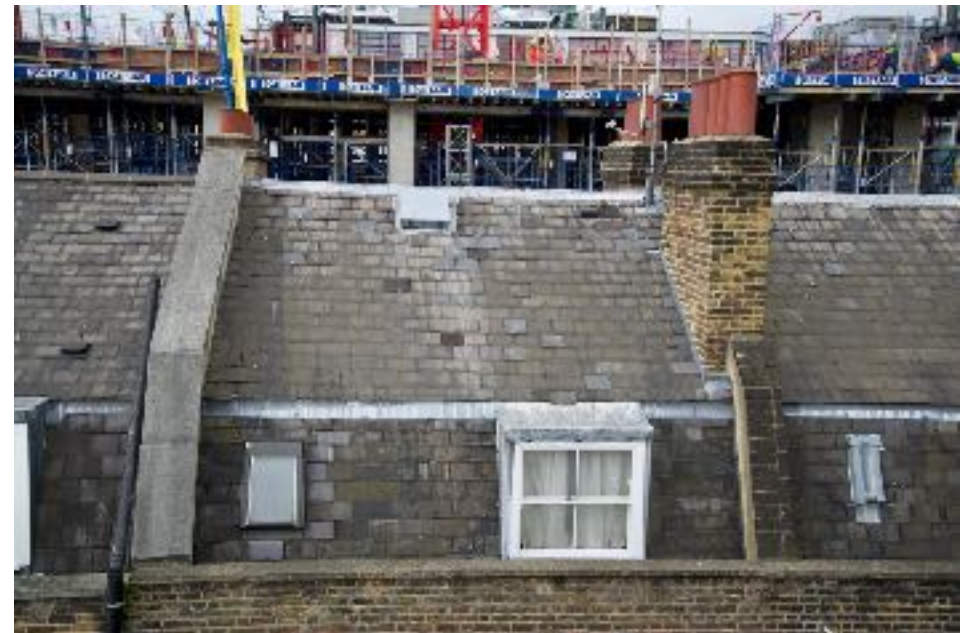
Pic 9 View of rear elevation to 62 Huntley Street

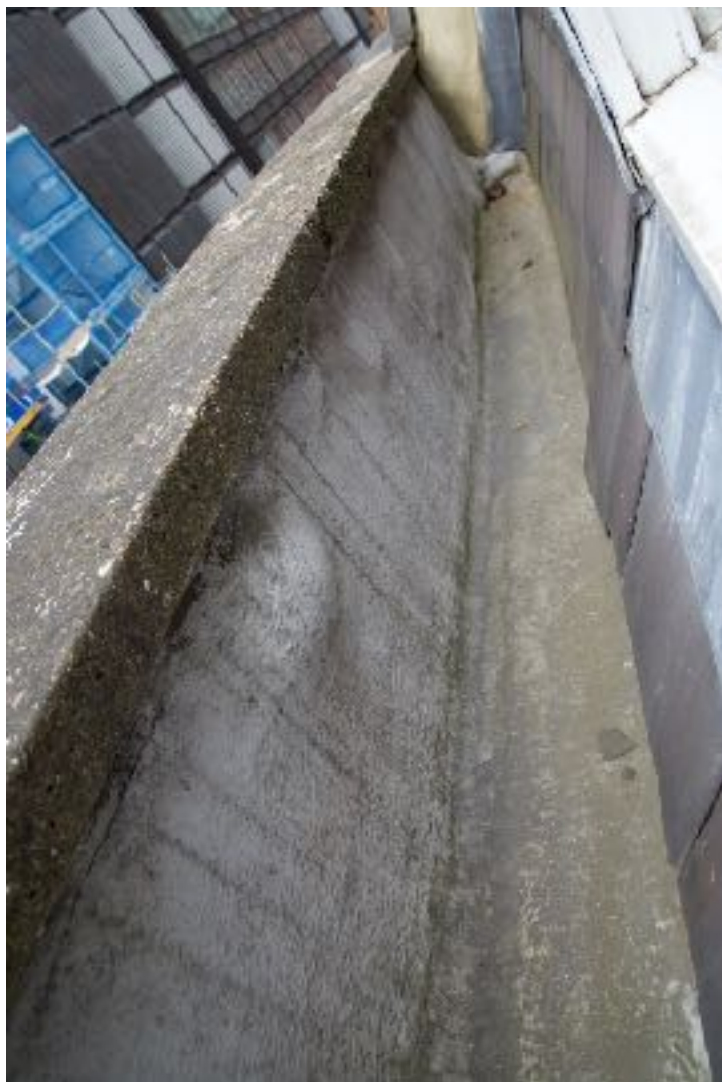
It was noted that the asphalt has slumped and blistered to some gutters, in particular to number 64. A small amount of debris and standing water was noted to some of the gutters.

Pic 10 View of parapet gutter indicating slumping asphalt

Repairs should be undertaken to the waterproofing within the parapet gutters, were found to be defective, together with clearing any debris to ensure free flowing.

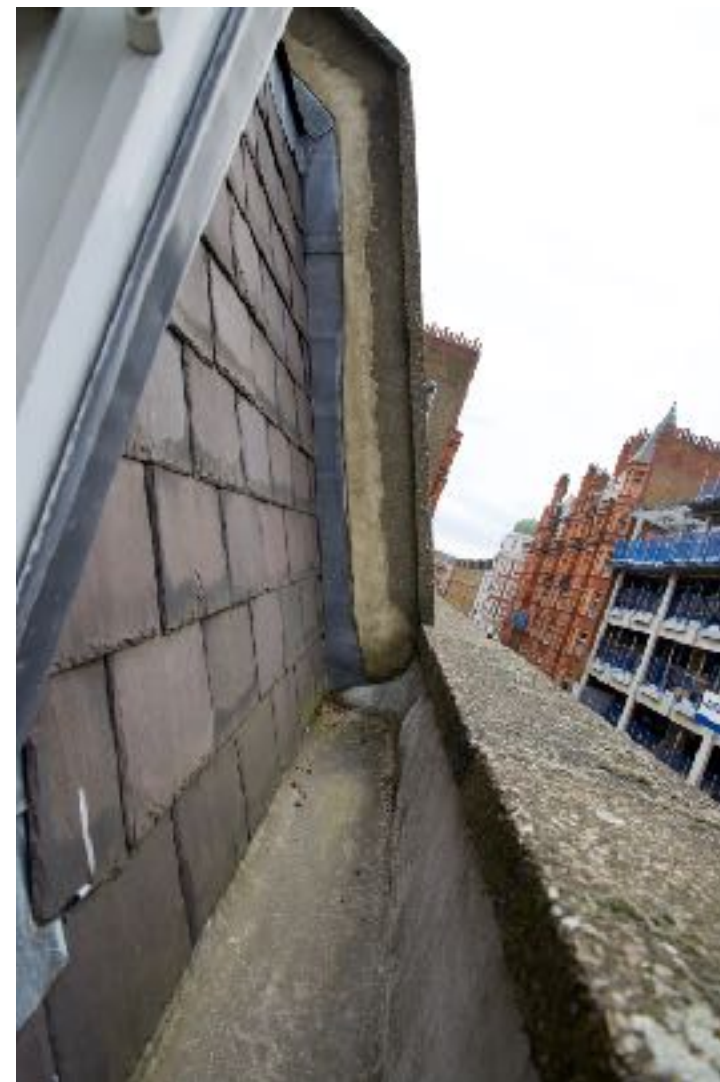
The upstand walls are finished with sand : cement render in all cases. The condition of the render varies from good to poor. On the rear elevation, notably, the render is patchy where new lead flashings have been installed.

Pic 11 Parapet gutter and upsand wall with patchy render

The Party Wall upstands should be re-rendered following the replacement or reinstatement of the stepped flashings.

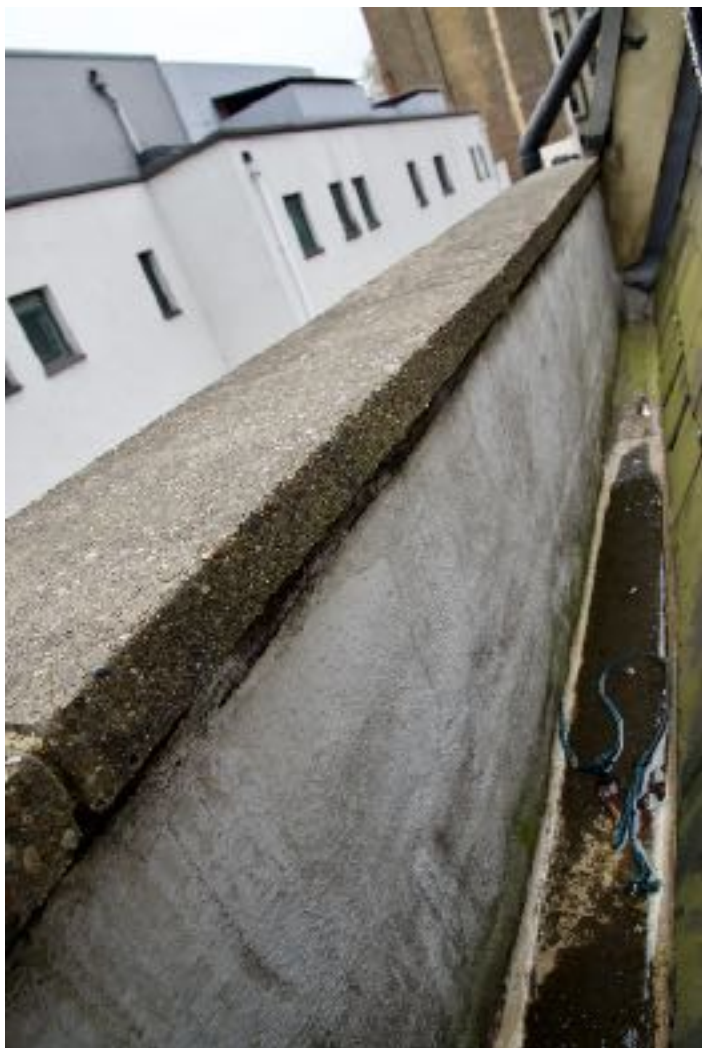
Pic 12 Standing water noted on one parapet gutter

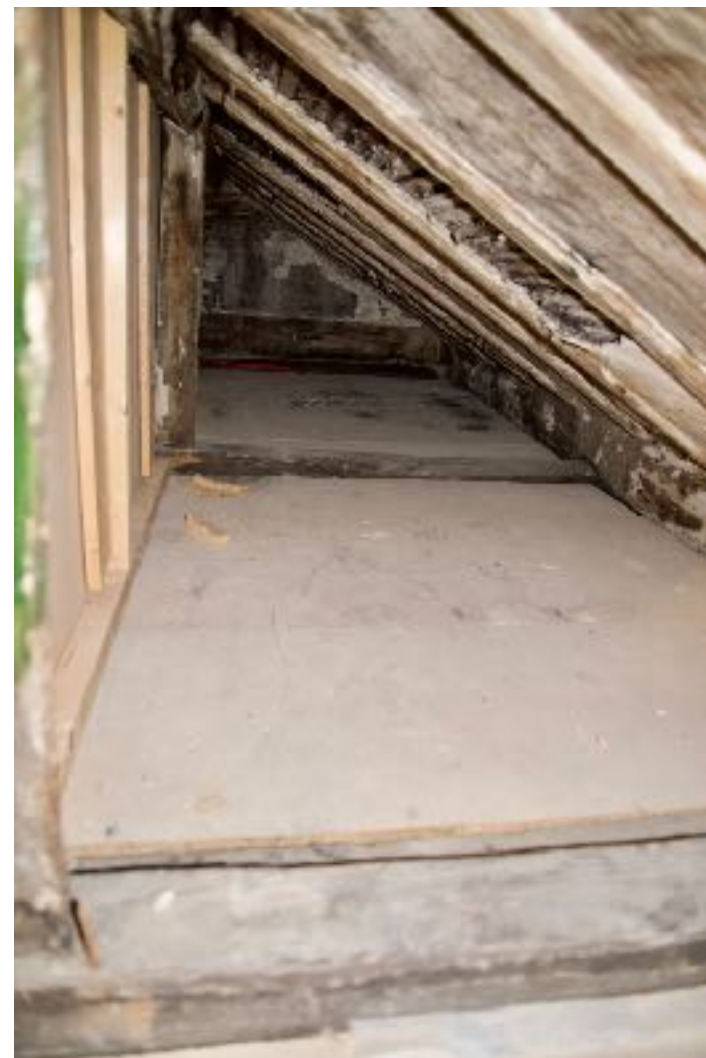
The roof timbers seen were in reasonable condition with minor timber deterioration, although generally heavily water stained which would indicate previous leaks.

Pic 13 View of loft space over 62 Huntley Street
indicating stained roof timbers

Provisional allowance should be made to replace roof timbers should defects be discovered upon stripping the roofs.
