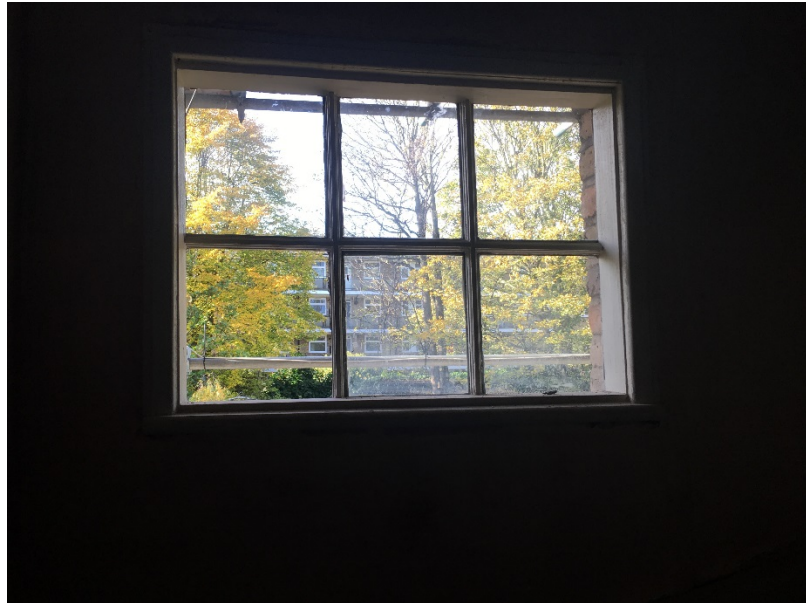
Photograph 11.1 – Existing window (internal view)

11. Replacement Stair Window (Proposed)

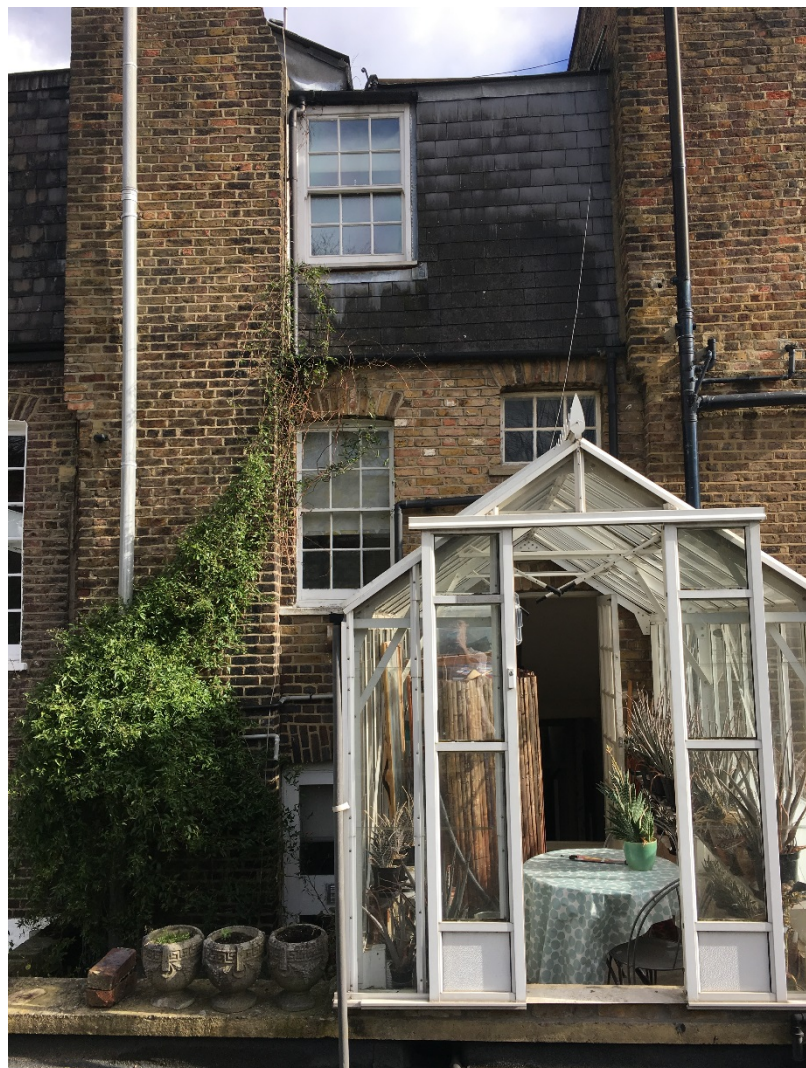
Photograph 11.2 – Existing window (external view)

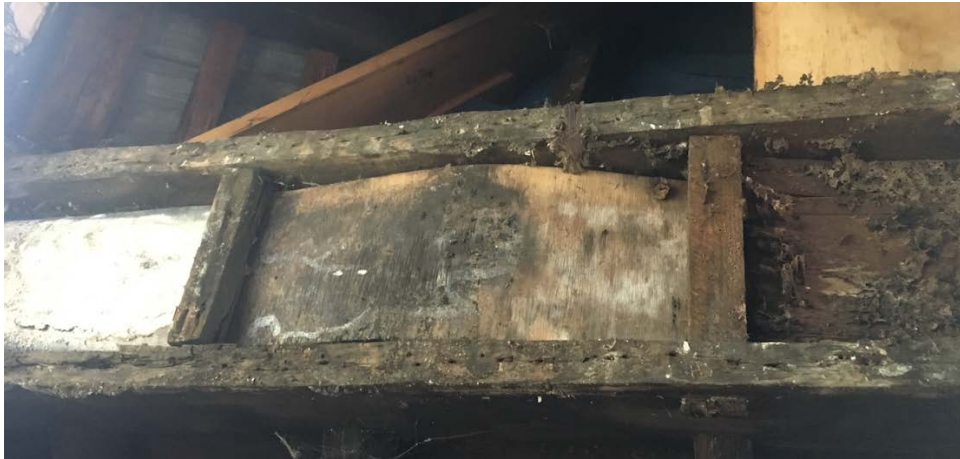
Photograph 12.1 – Rotten timbers and leaking leadwork

12. Replacement beams (Retrospective)

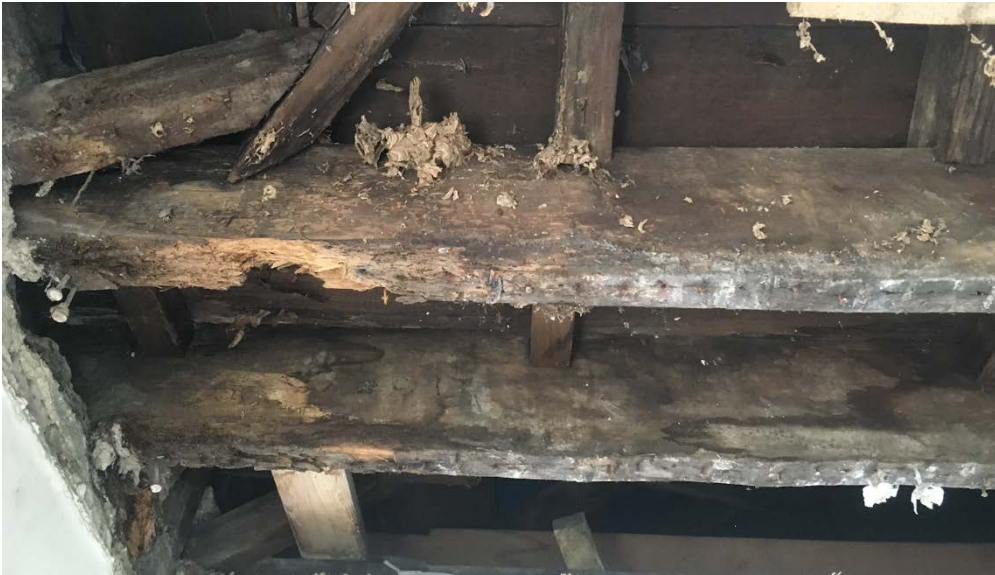
Photograph 12.2 – Rotten timbers where new supports were attached either side

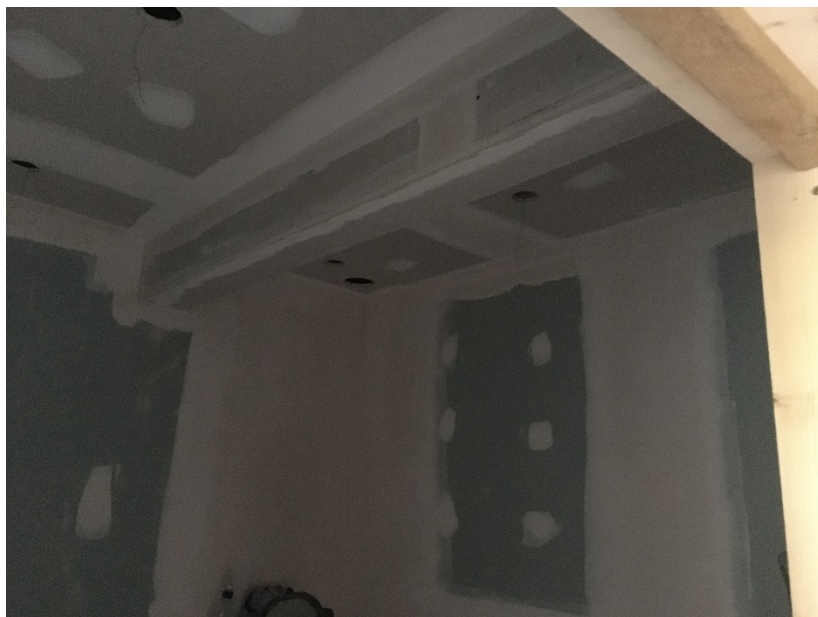
Photograph 12.3 – Ceiling covering the completed works

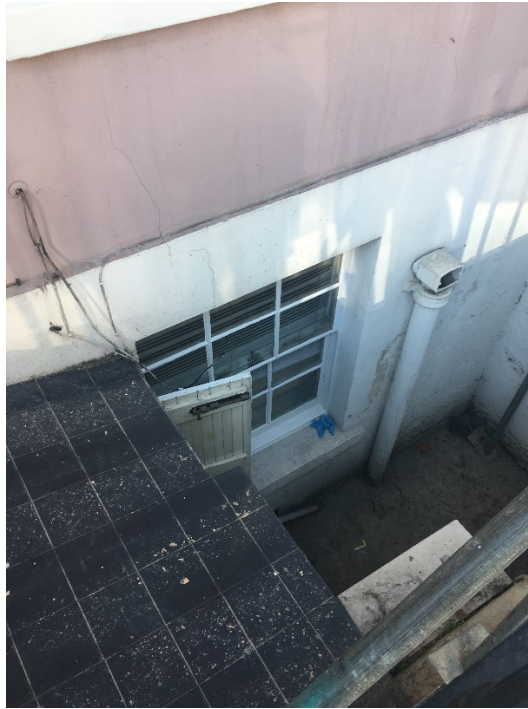
Photograph 15.1 – Damaged render on front elevation

15. Repair & re-render front elevation (Proposed)

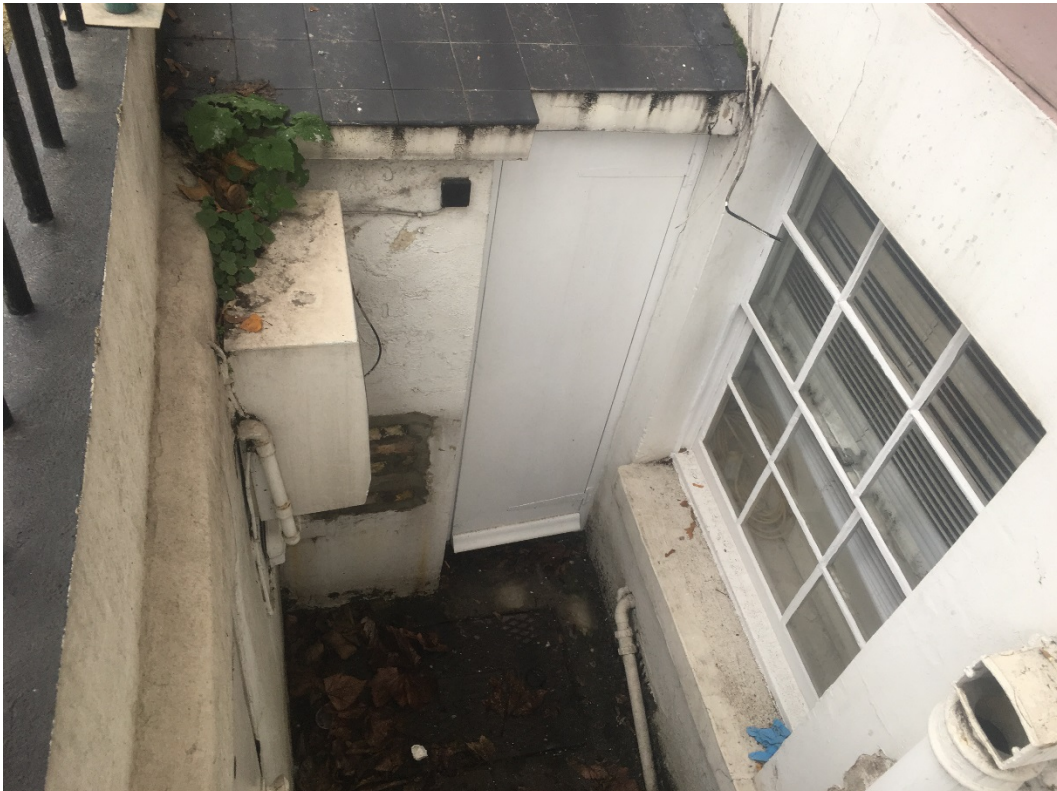
Photograph 16.1 – Proposed location of boiler extractor. To be positioned between door and electric box

16. Installation of boiler extractor

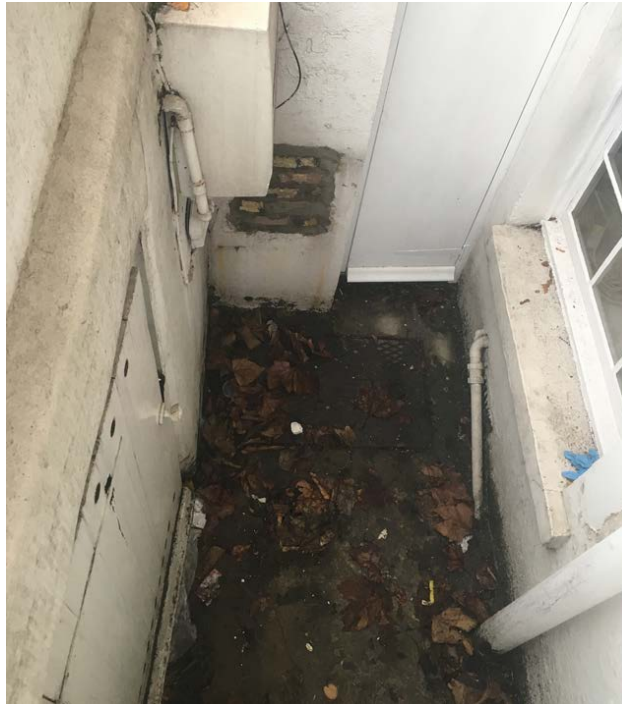
Photograph 17.1 – Hole from previous extractor which has been repaired.

17. Repair hole from former extractor fan (Proposed)

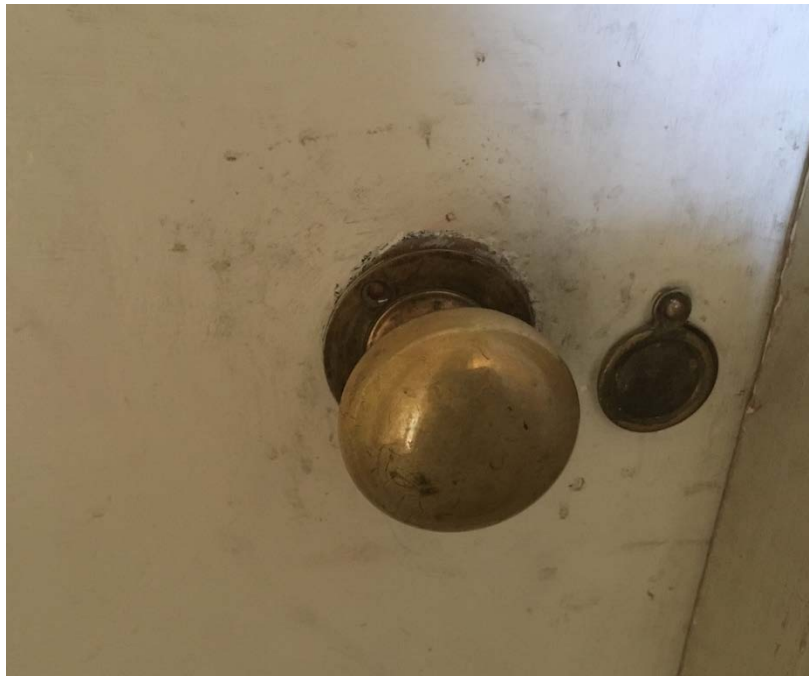
Photograph 18.1 – Existing non-original door handles.

18. Replacement door furniture (Proposed)

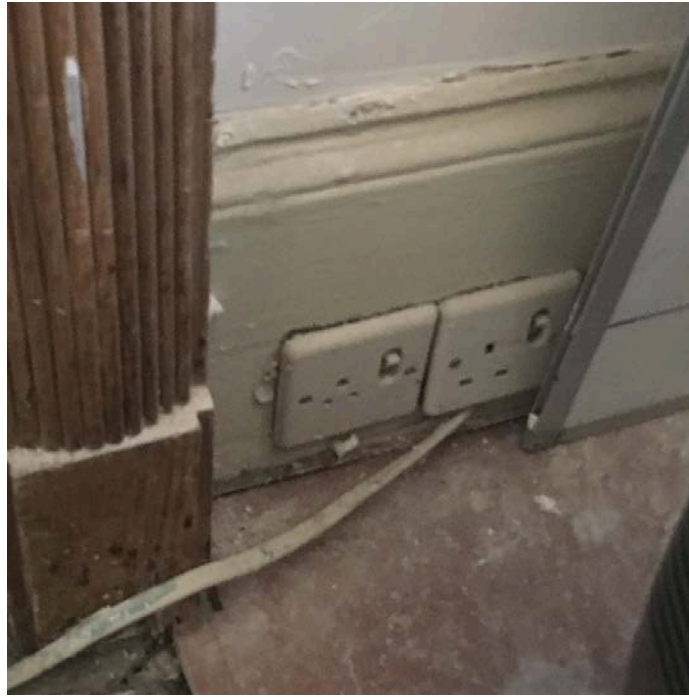
Photograph 20.1 – sockets which has been removed and have left holes within the skirting board.

20. Skirting board infills (Proposed) – N/A
