project no 897	sheet no REP002_5DMS
date 22.11.2017	by RK

St Giles - Zone 3 - Visual Structural Inspection of No5 Denmark Street

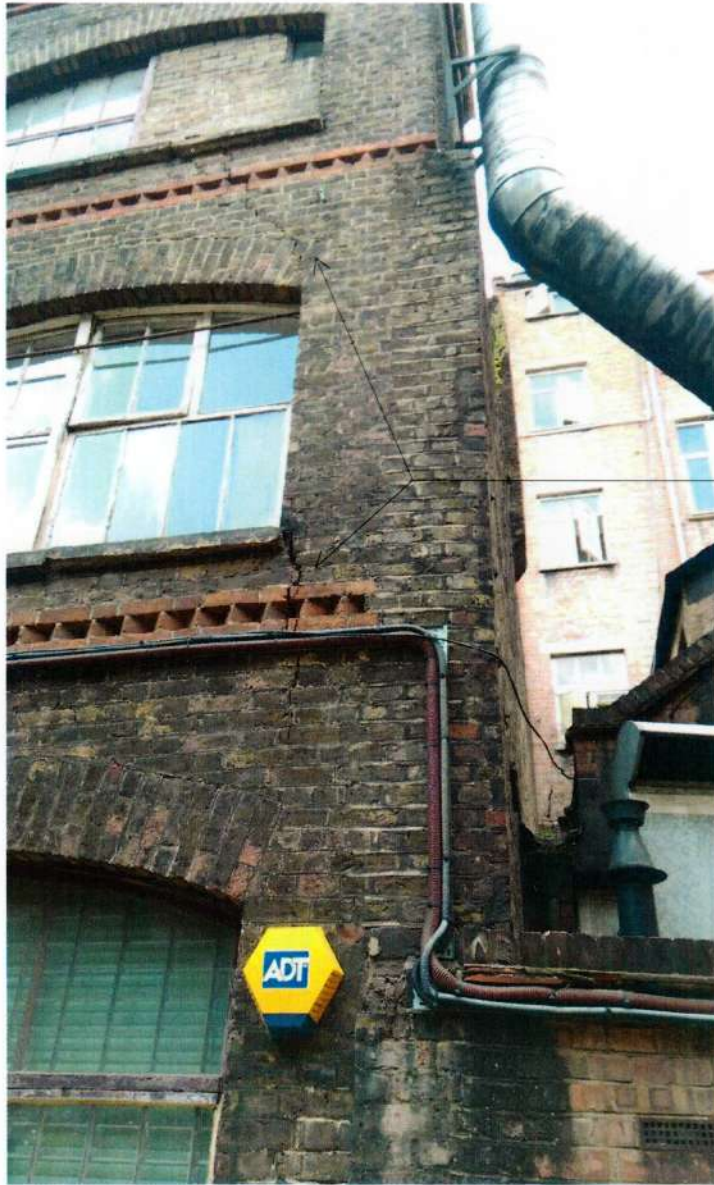
Figure 9 - Rear Elevation

Significant cracking to masonry around window openings

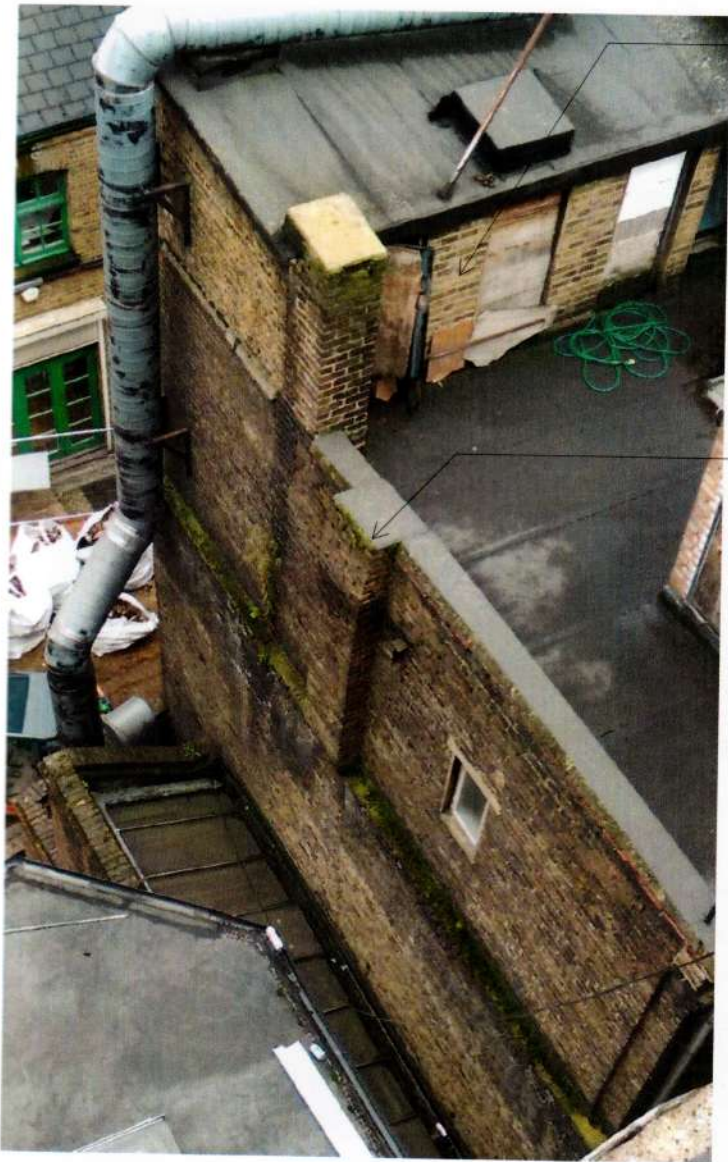
Figure 10 - Flank Wall To No4 Denmark Street

Roof top additions

Visible movement of parapet line and masonry wall below

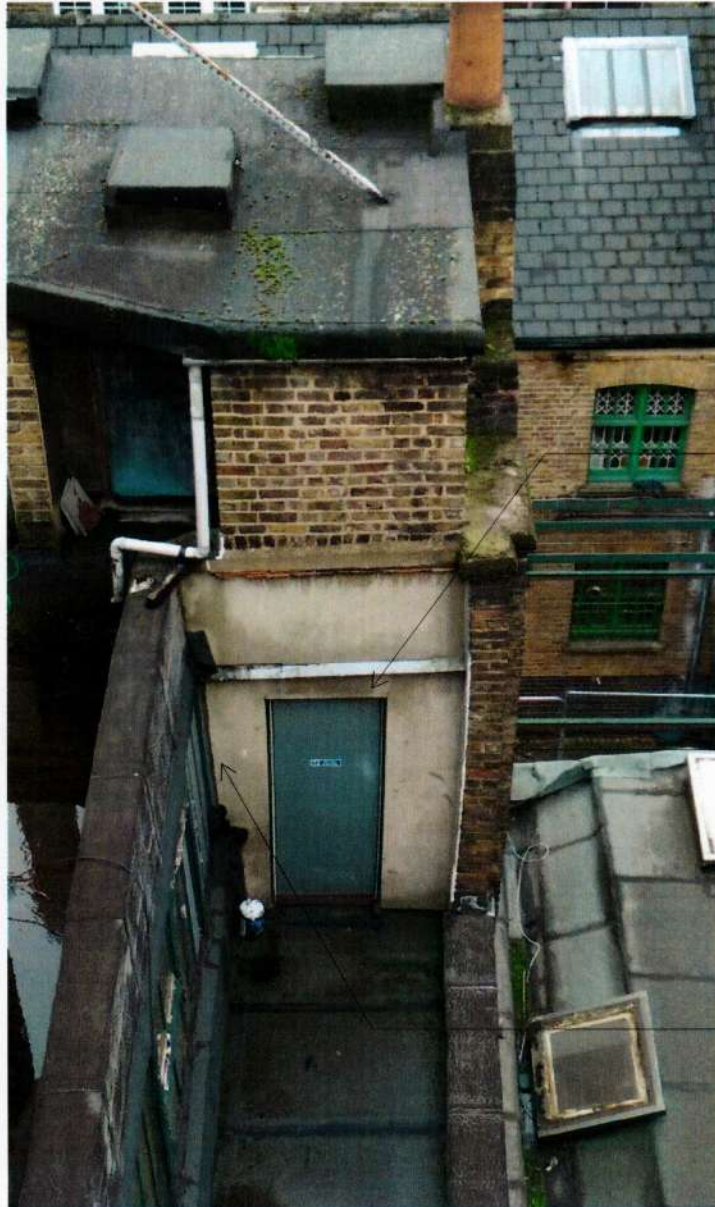
Figure 11 - Flank Wall To No6 Denmark Street

Cracking to corners of doorway

Flank wall bowing significantly towards No6 Denmark Street

Wall line leaning away from flank wall

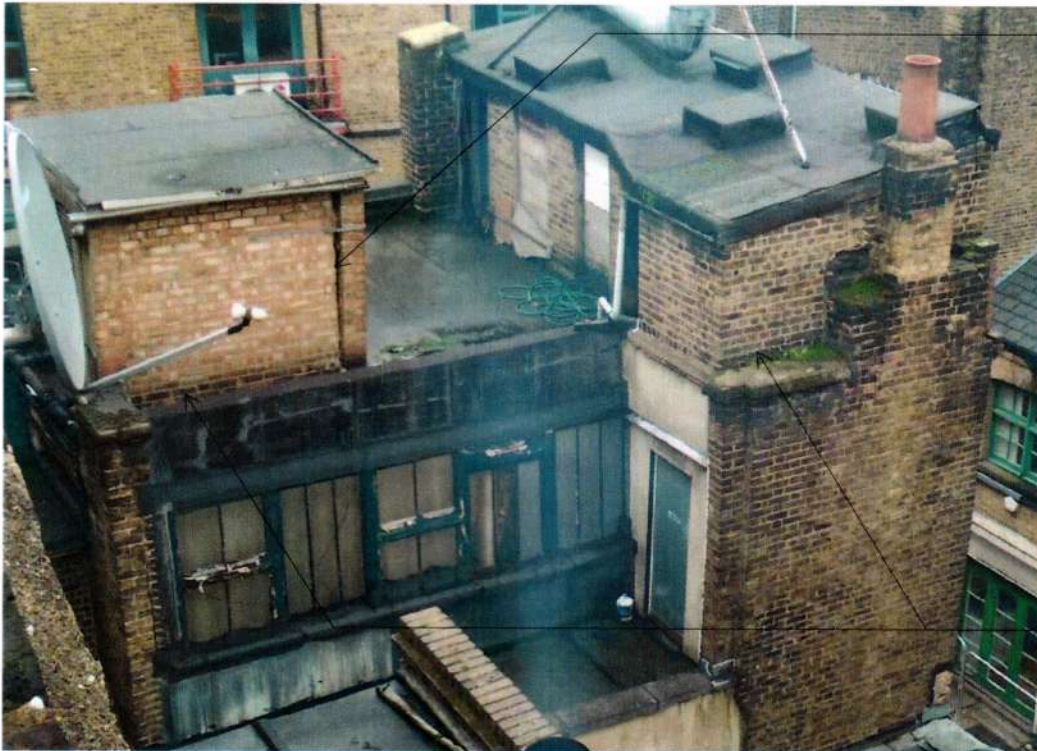
Movement to masonry walls and remedial strapping

Masonry walls do not align with walls below - no visible transfer/supporting structure to underside of ceiling below
