Arboricultural Survey
& Report

35a Buckland Crescent
London
NW3 5DJ

31st December 2018

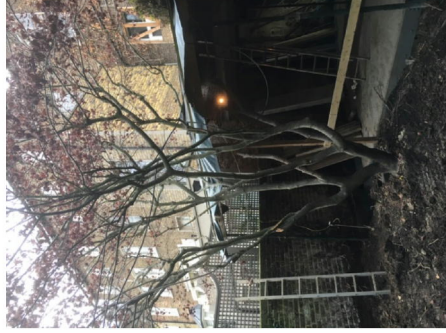
4.11 Tree T4 is a mature Japanese Maple sited within 1.5m of the implemented development at the rear of the property. The tree is recommended for removal in order to implement final landscape works and provide an appropriate ornamental planting for the long term. The removal of the tree will not impact upon amenity value or canopy cover within the rear garden and wider landscape and proposed planting is recommended with one of the following species to provide direct replacement:

Tree T4, Japanese Maple as viewed in a north westerly direction

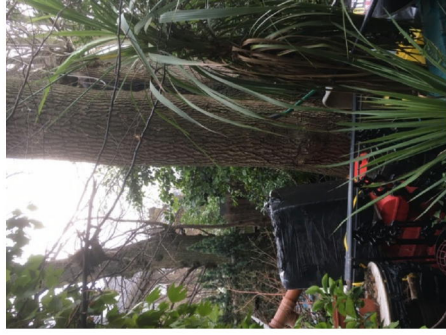
Main stem of Ash tree, T1 and Lime T2 also as viewed in a southerly direction

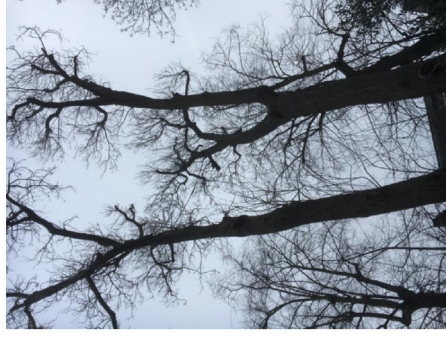
- Reasonable root flare at base
- Main union at 1.8m sound but with collection of water
- Previously reduced tree (approx 3 years ago) with limited re-growth and poor extension growth for size and species
- *Inonotus hispidus* fruiting bracket at 8-10m on eastern main stem from significant cavity
- Further cavities on main stems from significant historic crown lifting to 10m

Previously reduced mid-upper canopy of Ash tree T1, with limited regrowth

4.6 The Ash tree is a dominant feature within the rear garden area and wider landscape also. However taking account of close proximity to surrounding properties and overall structural condition, the tree is recommended for a heavy pollard which will reduce over-extended weighting in relation to cavities and obvious decay in the main eastern stem.

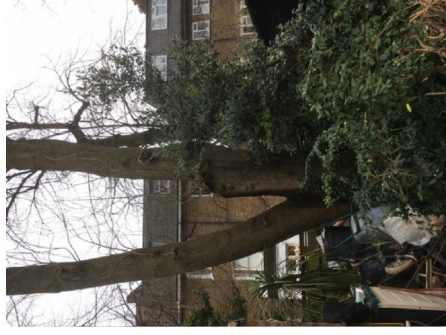
Main stem of tree T1 showing main union at 1.8m as viewed in a southerly direction

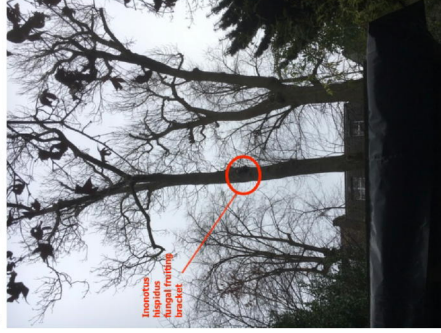
Overall view of tree T1 Ash - showing point of fungal fruiting bracket

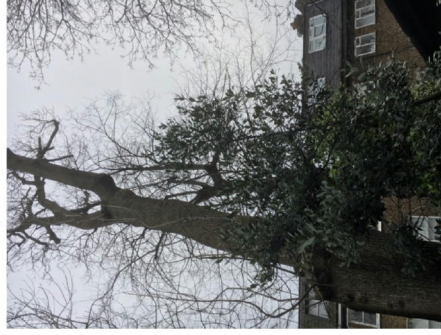
Westerly stem of tree T1, as viewed in a south westerly direction

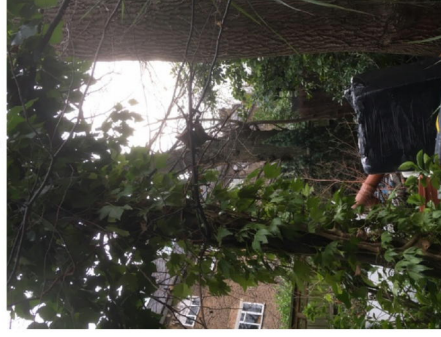
Main stem of Ash tree, T1 and Lime T2 also as viewed in a southerly direction

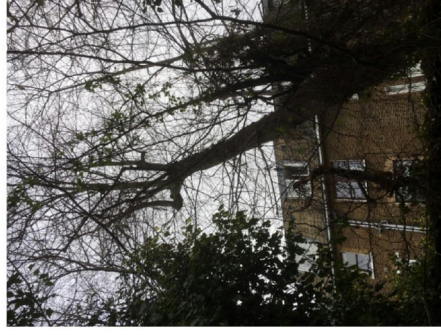
- Tree T2 suppressed with a light lean to the west
- Tree T3 suppressed with a heavy lean to the east (unable to fully inspect base due to debris)
- Trees overhanging and cyclically reduced over neighbouring property 9 Adamson Road
- Low growth retained fro screening
- Mid to upper canopy light pruning history recently; historically pollarded / reduced at 10-12m

Tree T3 as viewed in an easterly direction with lean due to suppression from Ash

4.10 The trees are recommended for crown reduction works to manage over-extended form in relation to rear boundary location and to provide more compact and balanced shape. In addition with significant crown reduction works to the Ash tree T1, the works are recommended to establish lower crown shape in the altered environment and removal of suppressing canopy above both trees.
