JM PARTNERSHIP
(SURVEYORS) LTD

FLAT 1, 15 GREENAWAY GARDENS, NW3 7DH

LON/18/023391

Wednesday, 9 January 2019

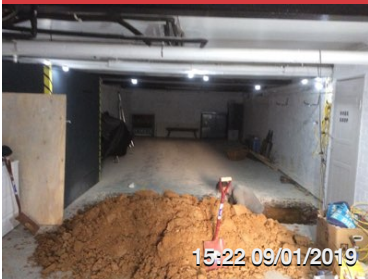
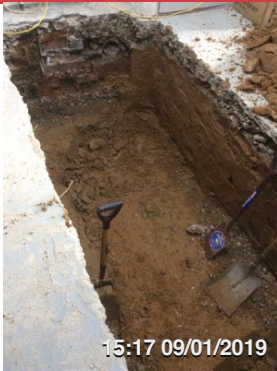
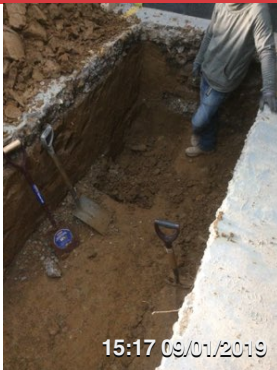
GARAGE

A 3.65 x 1.20 x 1.45 meters strip foundation is almost dug in sandy clay at the time of the inspection.

There is no presence of relevant roots within the trench.

There is a drainage clay pipe within trench foundation which is not in use and has been removed.

Site manager has stated that strip foundation will be poured up to 1 meter and then box frame bottom beams will be installed on top.

* Agreed with site manager that bottom beams will be wrapped in mesh D49

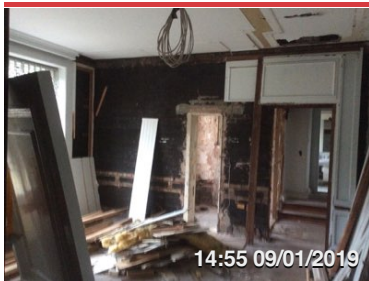
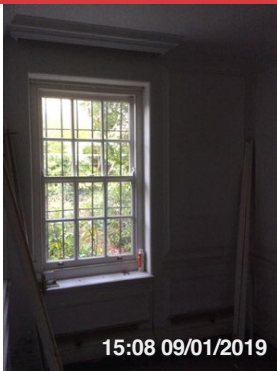
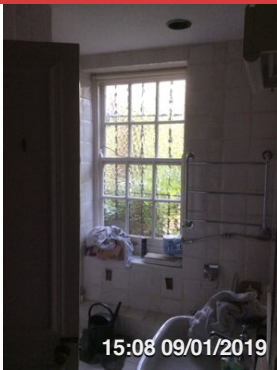
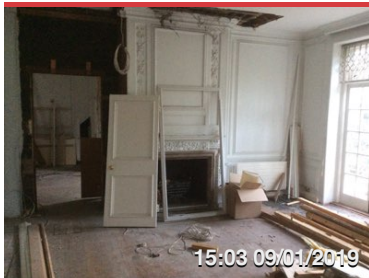
FLAT 1

Site manger stated that asbestos has been found within the flat so they are waiting to be removed. Bedroom where asbestos are located remains locked.

*I have informed site manager for future references that presence of asbestos must be notified to JMP in advance before an inspection is booked . JMP surveyors should not be carrying out an inspection if asbestos has not been removed and all subsequent tests have been undertaken.

* JMP to be informed whether asbestos has been removed and next inspection should not be booked until this has been addressed on site.

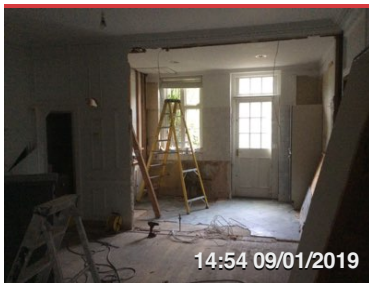
FLAT 1

Kitchen will be separated from hall with double fire door

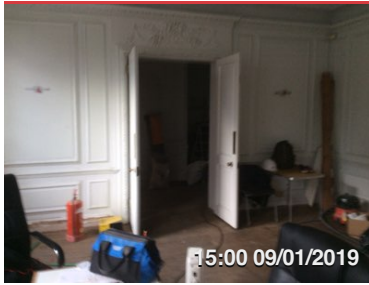
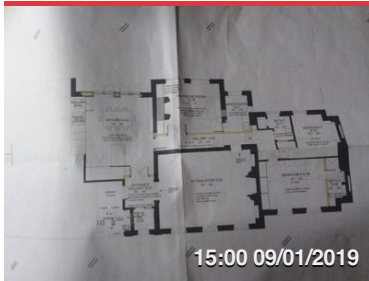
SITTING ROOM DOORS

*Drawings show that living room will be opened to hall which is not the current situation. Hall is part of mean of escape and should be enclosed. Please clarify if existing doors will remain or not.
