### 1.0 Introduction

- 1.1 Mr Raphael Skerratt was commissioned to complete a BSS5837 Tree Survey, Arboricultural Impact Assessment, Method Statement and Tree Protection Plan in support of an application to demolish a garage and store and replace these with a studio annex in the rear garden of 144 Mill Lane.
- 1.2 My instructions are to revise the arboricultural impact assessment and method statements prepared by Mr Skerratt.
- 1.3 Mr Skerratt produced two reports, a copy of his second report is appended. (Appendix F) It should be read in conjunction with this document.
- 1.4 This report also addresses an error made in the second of Mr Skerratt's reports.

# **Arboricultural Impact Analysis**

144 Mill Lane London NW6 1TF

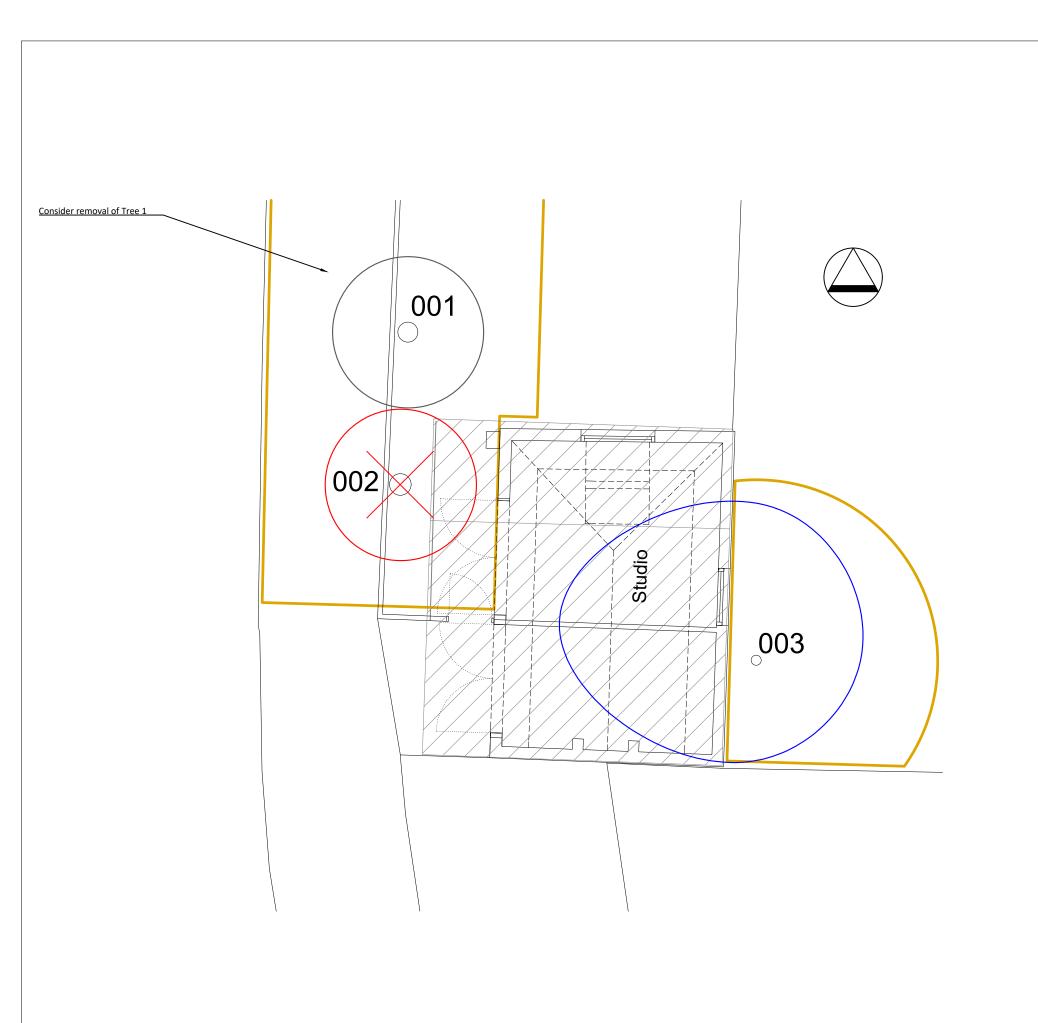
SR2 - Tree Removal

- 4.1.1 Mr Skerratt produced two reports, the first proposed the removal of Tree 002 and the retention of Tree 001. This report supported a planning application which was refused. The refusal was appealed and overturned. The planning inspector referred to Mr Skerratt's report. He did not object to the removal of Tree 002.
- 4.1.2 Following appeal, the planning application was resubmitted to the planning authority. In support of the resubmission, Mr Skerratt provided the second report appended to this one. In this report, he erroneously showed Tree 002 as being retained throughout and

beyond development. His error led to the planning authority granting planning permission on the misunderstanding that the tree was to be retained. This misunderstanding requires correction. The planning permission needs to align with the inspector's findings. The error was not made by the planning authority. Mr Skerratt's report makes several conflicting statements about Tree 002. These are highlighted in his appended report.

- 4.1.3 In my opinion consideration should also be given to the removal of Tree 001. This is a poor-quality specimen which provides little amenity benefit. The tree could be replaced with another species whose mature height is smaller than a Lime tree's and therefore more in scale with the local environment.
- 4.1.4 A small section of the garden boundary fence must be removed to provide construction access. This fence is heavily clad in ivy which will also be removed. The removal of the fence does not affect any shrubs or trees.
- 4.15 The appended Tree Removal Plan SR2 shows the locations of the trees to be removed. (Appendix A)

5.3.1 Tree 001, (subject to consent) and 002, shall be removed before other site work begins. Their locations are shown on the tree removal plan (Appendix A). The work shall accord with BSS 3998:2010 Recommendations for Tree Work. It shall be carried out by an appropriately qualified arboriculturalist. Arisings shall be removed to an approved tip. Stumps may be ground or dug out.

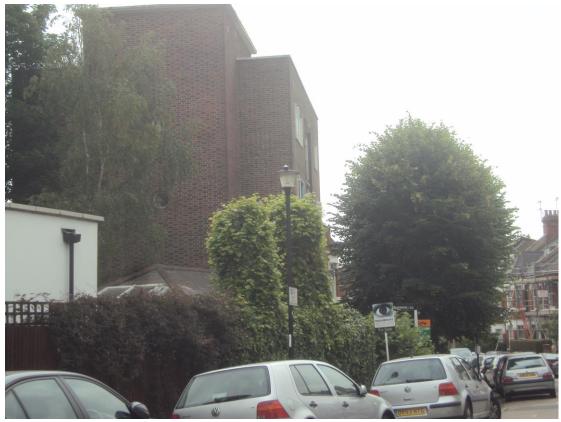
- 3.3.5 Such an approach would enhance the visual amenities of the locality in the short-to-medium term.
- 3.3.6 The successful establishment of a row of young Limes on the Holmdale Road frontage of the adjacent apartments immediately to the east of the proposed development site also renders the continued retention of Trees 001 and 002 less critical than it might at one time have been (see **Photograph 1** in **Appendix b**).

Photograph 1: Limes 001 and 002 in foreground, Birch 003 on left edge of image, young Limes in Holmdale Road behind

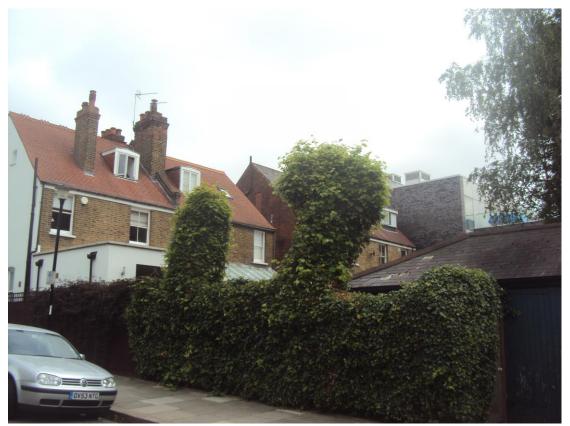
- 3.1.2 In the case of Limes 001 and 002, the crowns of these trees have been very severely reduced in the past on a regular basis and as a result their stems are disproportionately large in relation to the crowns that they support.

Photograph 2: Trees 001 and 002 (2013)
