**JM PARTNERSHIP**  
(SURVEYORS) LTD

# **FLAT 1, 15 GREENAWAY GARDENS, NW3 7DH**

LON/18/023391

Wednesday, 9 January 2019

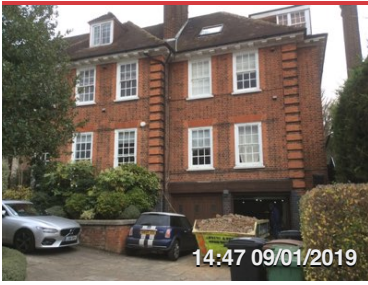
## **BUILDING FRONT ELEVATION**

Site visit arranged with contractor Mike( 07771771467) to inspect foundation at garage level.

Site manger stated that asbestos has been found within the flat and they are waiting for asbestos to be removed.

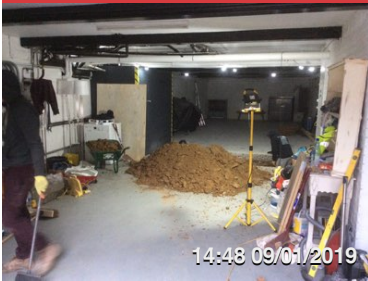
## **GARAGE**

A 3.65 x 1.20 x 1.45 meters strip foundation is almost dug in sandy clay at the time of the inspection.

There is no presence of relevant roots within the trench.

There is a drainage clay pipe within trench foundation which is not in use and has been removed.

Site manager has stated that strip foundation will be poured up to 1 meter and then box frame bottom beams will be installed on top.

\* Agreed with site manager that bottom beams will be wrapped in mesh D49

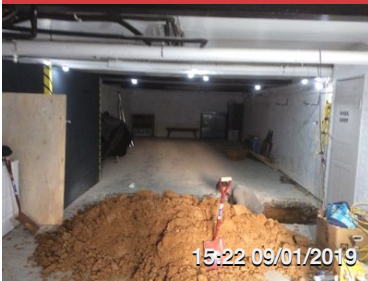
## **GARAGE**

Following previous item

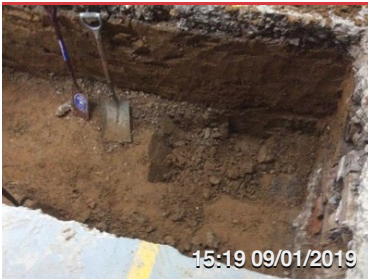
## **TRENCH FOUNDATION**

Following previous item

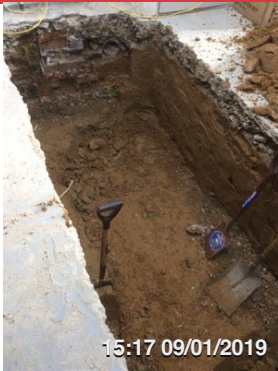
### **TRENCH FOUNDATION**

Following previous item

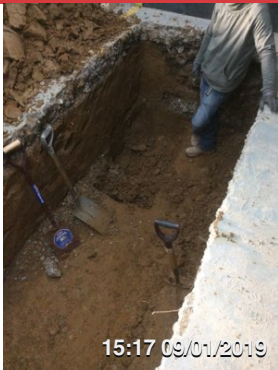
### **TRENCH FOUNDATION**

Following previous item

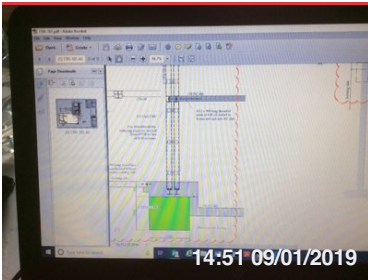
### **DESIGNED FOOTING AND BOX FRAME**

Following previous item.

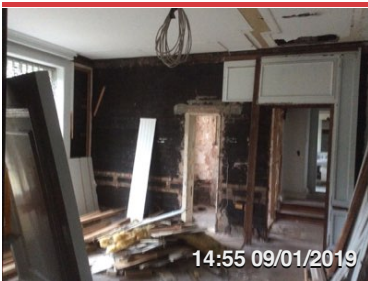
### **FLAT 1**

Site manger stated that asbestos has been found within the flat so they are waiting to be removed. Bedroom where asbestos are located remains locked.

\*I have informed site manager for future references that presence of asbestos must be notified to JMP in advance before an inspection is booked . JMP surveyors should not be carrying out an inspection if asbestos has not been removed and all subsequent tests have been undertaken.

\* JMP to be informed whether asbestos has been removed and next inspection should not be booked until this has been addressed on site.

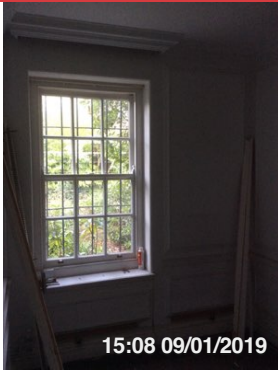
**FLAT 1**

Following previous item

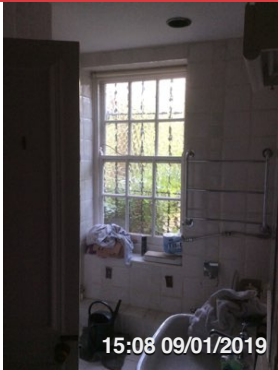
**FLAT 1**

Following previous item

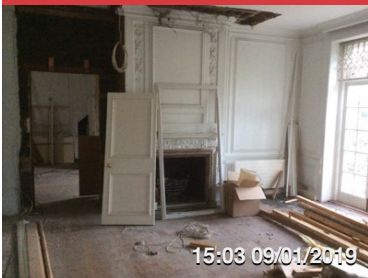
**FLAT 1**

Following previous item

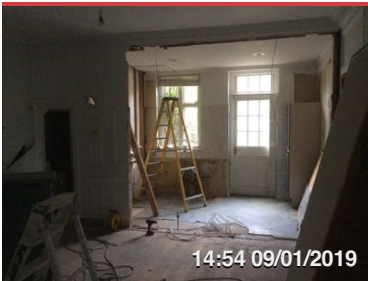
**FLAT 1**

Kitchen will be separated from hall with double fire door

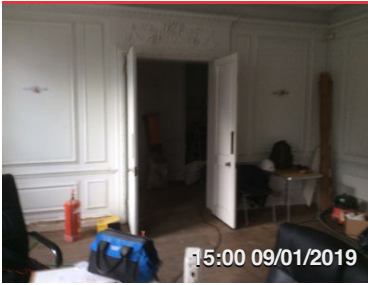
### **SITTING ROOM DOORS**

\*Drawings show that living room will be opened to hall which is not the current situation.Hall is part of mean of escape and should be enclosed.Please clarify if existing doors will remain or not.
