## Arboricultural Consultancy for Lloyds Bank

### 1. Case Details

Insured		Address	50 Patshull Road, London, NW5 2LD	
Client		Contact		Claim No.
		Consultant		Contact No.
Report Date	11/12/2018

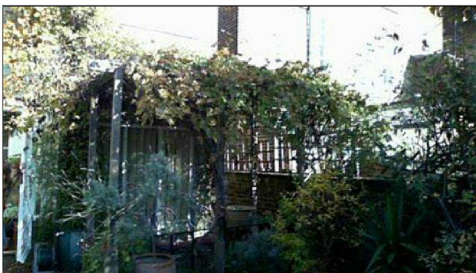
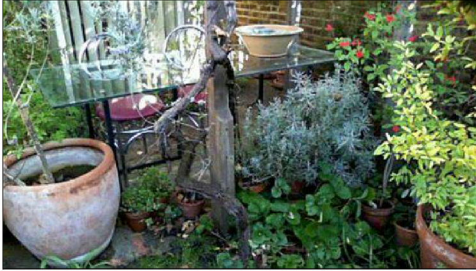
C1 - Vine

Tree No.	Species	Age Cat	Approx. Height (m)	Distance to Building (m) *	Ownership	Action	Requirement
C1	Vine	1	4.4	2.6	C - Insured	Action to avoid future risk	Do not allow to exceed current dimensions by way of regular pruning.
C2	Hydrangea (Climbing)	1	3	0.1	C - Insured	Action to avoid future risk	Do not allow to exceed current dimensions by way of regular pruning.
S1	Aucuba	1	2.4	0.2	C - Insured	Action to avoid future risk	Do not allow to exceed current dimensions by way of regular pruning.
SG2	Mixed species shrubs: Pyracantha, Viburnum and Hypericum.	1	2.1	4	C - Insured	Action to avoid future risk	Do not allow to exceed current dimensions by way of regular pruning.
T2	Birch	1	3.3	9	C - Insured	Action to avoid future risk	Do not allow to exceed 6m max height / spread by way of regular pruning.
T3	False Acacia	1	11.7	1.85	C - Insured	Action to avoid future risk	Do not allow to exceed current dimensions by way of regular pruning.

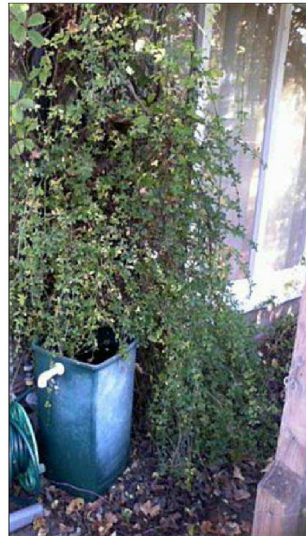
SG1 - Mixed species climbers

Based on our observations on site and with due regards to species profile, the Mixed Species Climbers (SG1) and Apple (T1) are the most likely source of the recovered root material and accordingly we have identified them as the principal cause of the subsidence damage.

Tree No.	Species	Age Cat	Approx. Height (m)	Distance to Building (m) *	Ownership	Action	Requirement
SG1	Mixed species climbers: Includes jasmine and clematis.	1	1.8	0.1	C - Insured	Remove	Remove close to ground level and treat stumps to inhibit regrowth.
T1	Apple	1	4.5	6.5	C - Insured	Remove	Remove close to ground level; do not treat stump due to translocation risk. Where such a risk exists, we advise that any emergent regrowth is removed annually.

Removal of SG1 and T1 will offer the most certain and reliable arboricultural solution likely to restore long-term stability.
