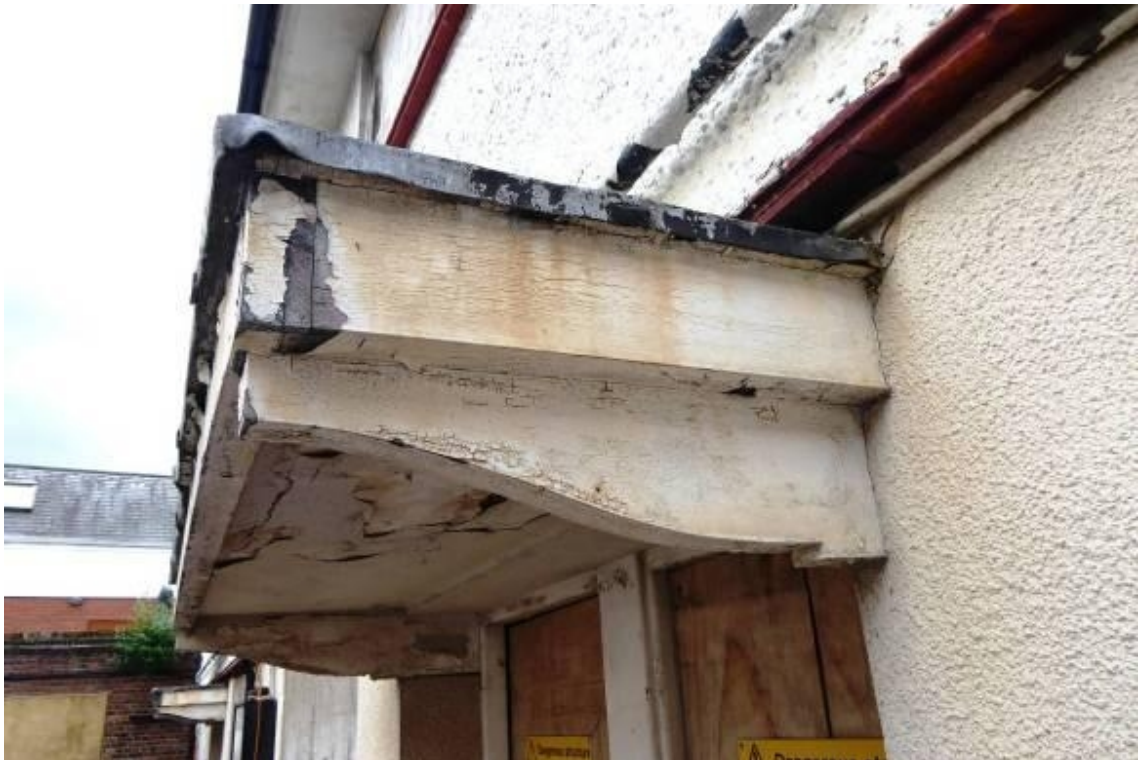
Fig 3.4.2: Front porch

- 3.4.2 Over the front doors are flat roofed canopies spanning both sets and is timber framed with a top covering of lead sheet with welted joints. These are supported

by single painted timber brackets that project out from the sides of the door openings.

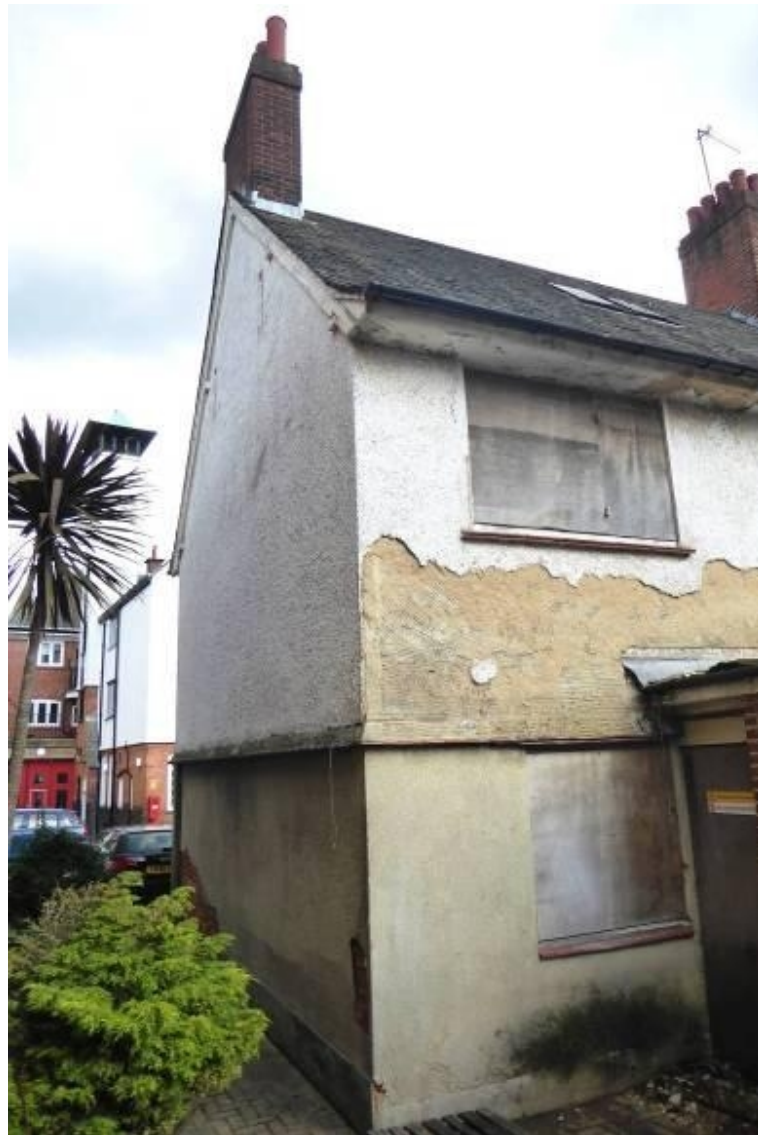
Fig 3.5.1: External wall of cottages

- 3.5.1 The external walls to the main house are all apparently of solid construction and are approximately one and a half bricks thick. These have facings in two distinct sections with the division being a line at ground floor window head height where there is a horizontal tile creasing band all the way around the building that appears to have been painted historically.

- 3.5.2 The section above head height is apparently of solid construction and is finished with heavily over painted pebbledash render that extends up from a bell mouth drip at the bottom above the creasing course.

- 3.5.3 The walls below the tile creasing are now finished in a hard cement spatter dash type render that has used a coloured mortar over a plain cement type rendered base that has failed all around the building and is coming off. Where it has been lost it exposes the underlying wall structure which is orangey coloured brickwork that is laid in English bond using a fairly hard lime mortar with a joint width of approximately 4 mm. This was originally pointed with a white cement type mortar finished with a struck joint to create a heavily defined, but narrow joint.

- 3.5.8 Because of the application of the hard cement render to the lower part of the building there is much evidence of brick spalling and loss of the face of the brickwork from ground level up to approximately 1.2 m above ground level. This is likely to be due to a combination of condensation, general moisture entrapment and frost action resulting from this modern applied surface coating.
