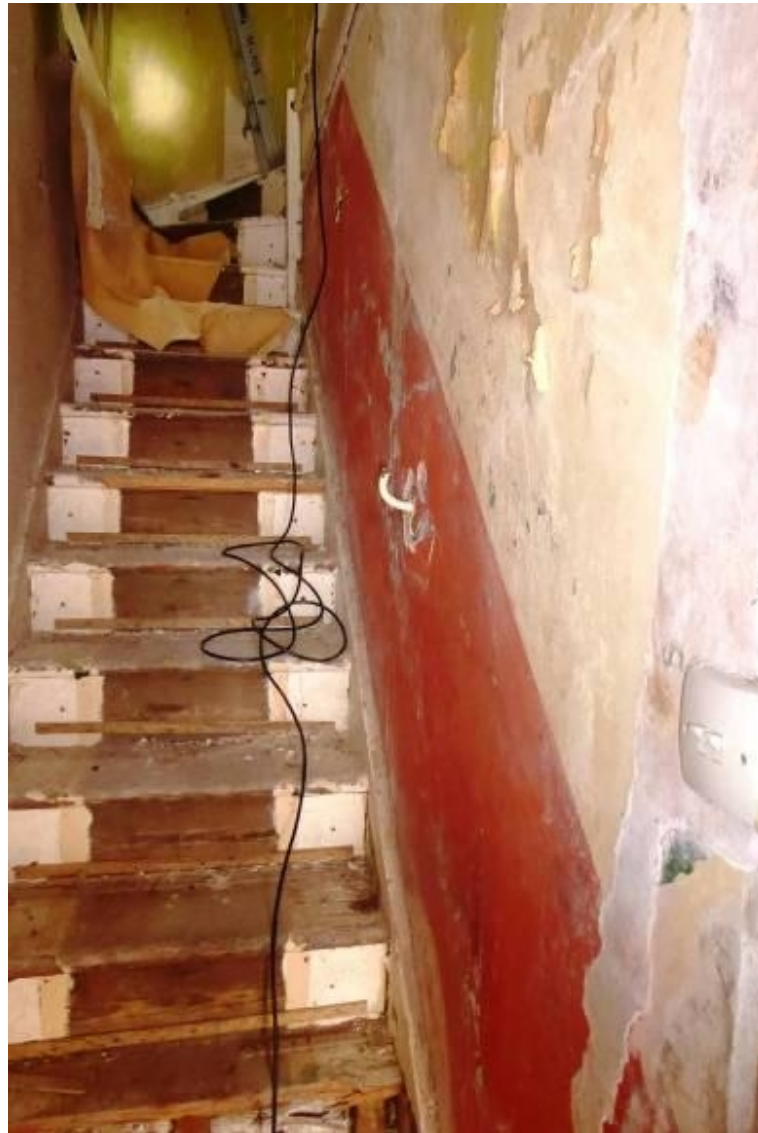
Fig 4.6: Ground to first floor stairs

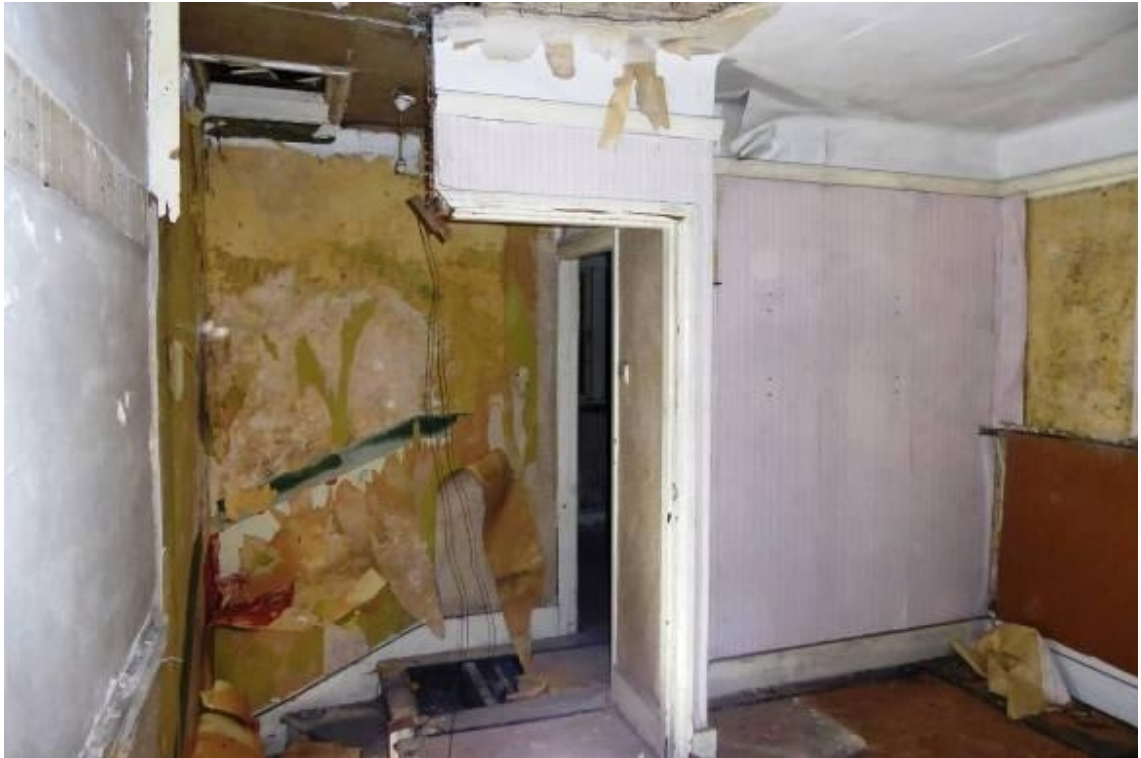
- 4.7.2 The remains of a short timber balustrade could be seen by the sawn off base of a square newel post and sockets in the landing edge for the balusters. It guarded the open side of the landing and extended to the sidewall, which was missing, to the front bedroom adjacent to its door position.

Fig 4.7: Landing from front bedroom through removed wall

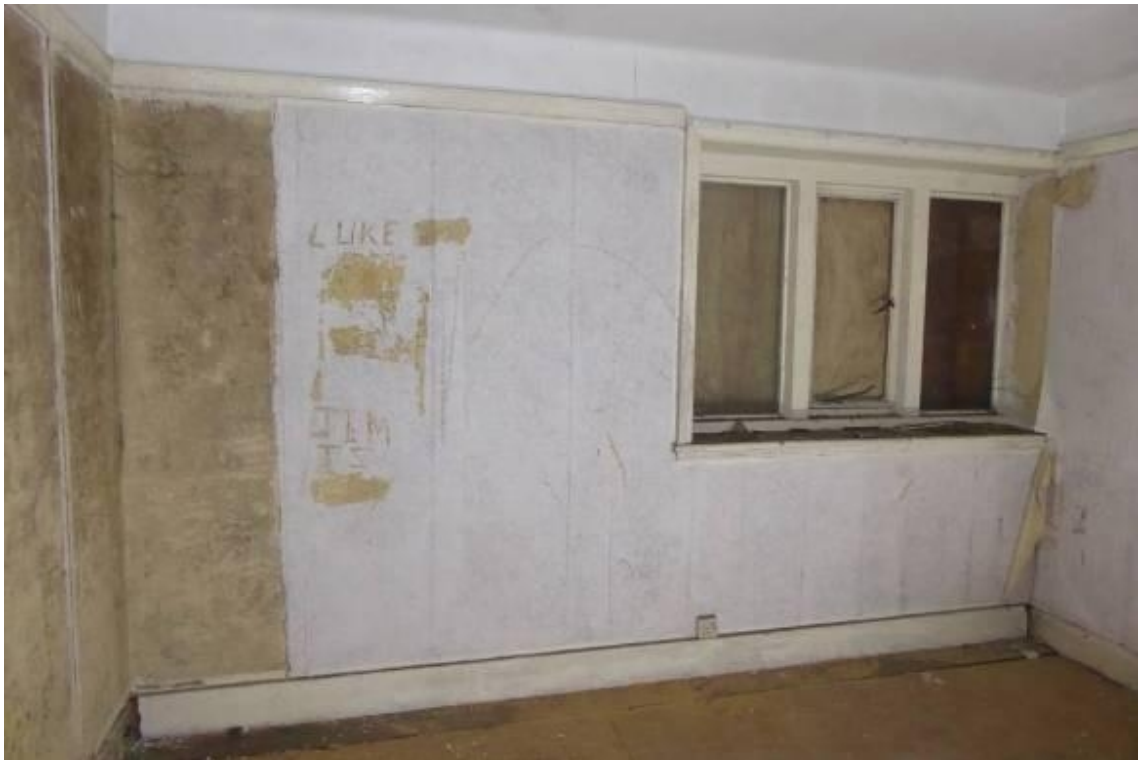
- 4.8.1 The floor is largely Stirling board or similar, which is a large timber particle or flake board, but there is still evidence of softwood boarding as that for the landing still remaining in some locations.

Fig 4.8: Front bedroom
