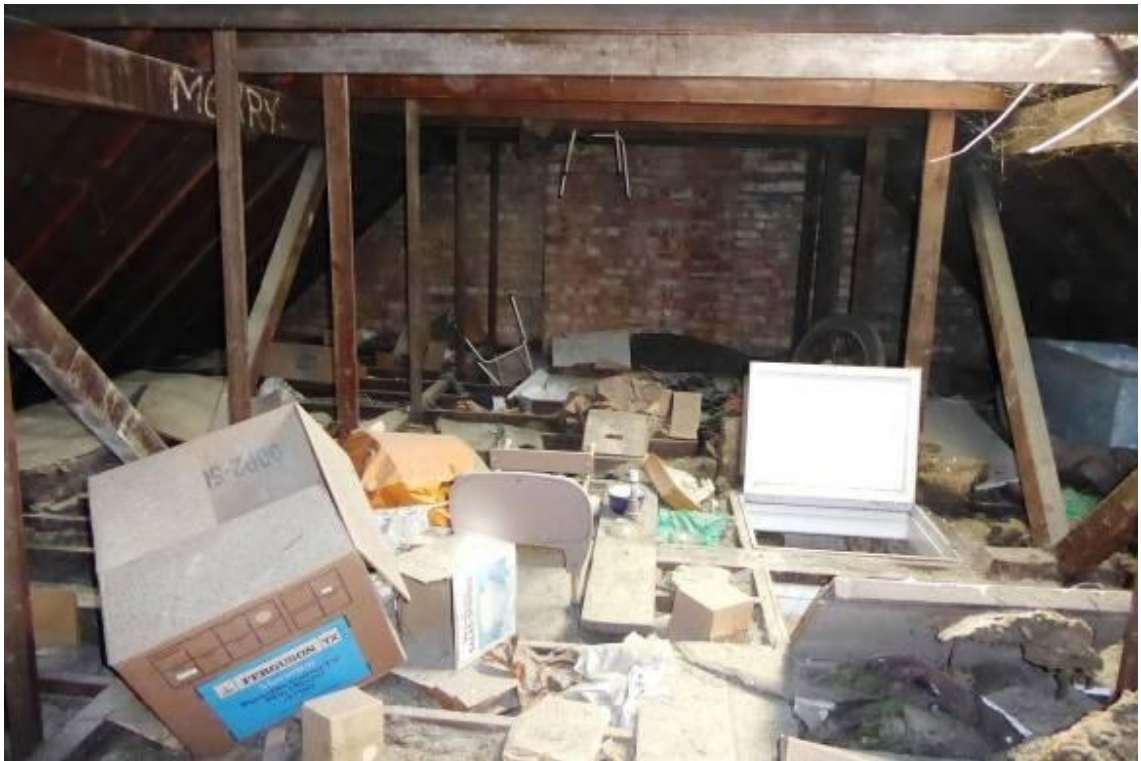
The rafters span from the wall heads, over the purlins to a ridge board at the top. At high level over the purlin collars connect to the roof structure and these are on every other rafter for the length of the roof.

Fig 4.10: Roof space from north gable
