5 OTHER COTTAGES

5.1 Second Cottage from the North

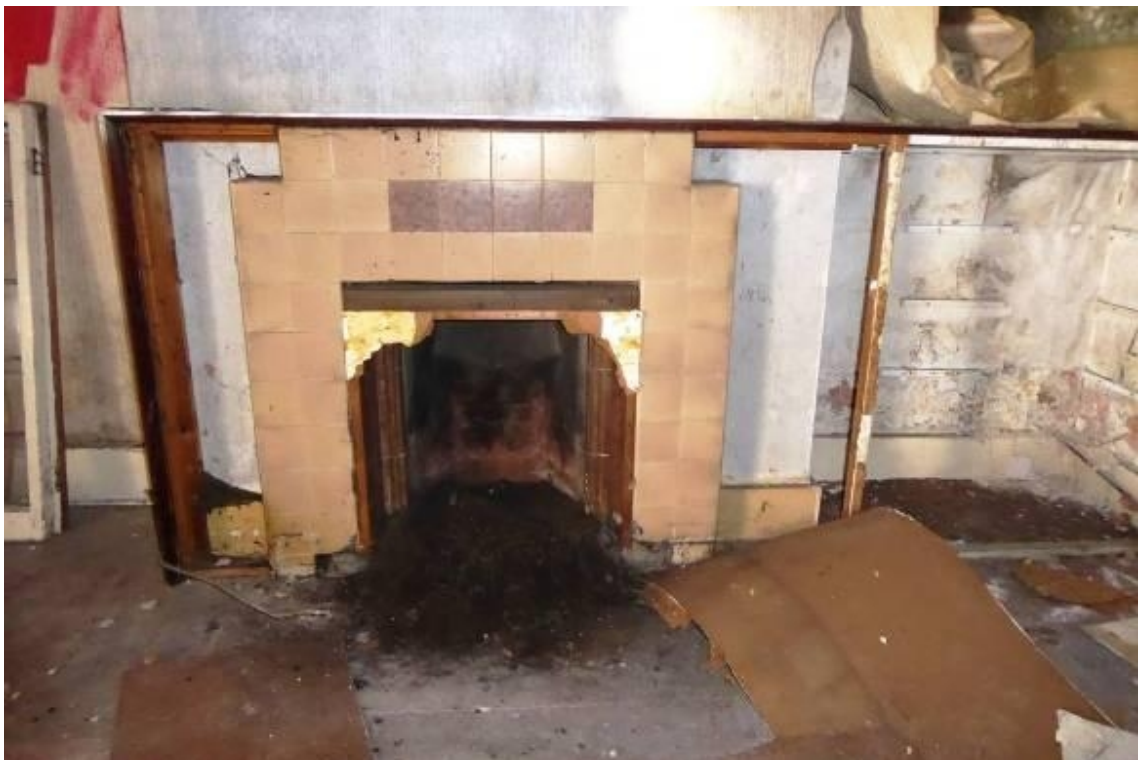
Fig 5.1.3: Sitting room fireplace

- 5.1.1 This is generally as described from the north cottage, but the staircase is more complete.
- 5.1.2 The four panel door from the entrance lobby to sitting room is possibly the original that has been painted and faced on the entrance side with hardboard or similar, possibly to help make this a fire resistant. The panels on the back have some form of texturing applied
- 5.1.3 Within the sitting room the fireplace appears to be the original as it has a glazed tile surround with an inner set of glazed tiling and a hearth that corresponds with the hearth seen elsewhere. However, the general style of the present surround is more of a style of the 1930's.

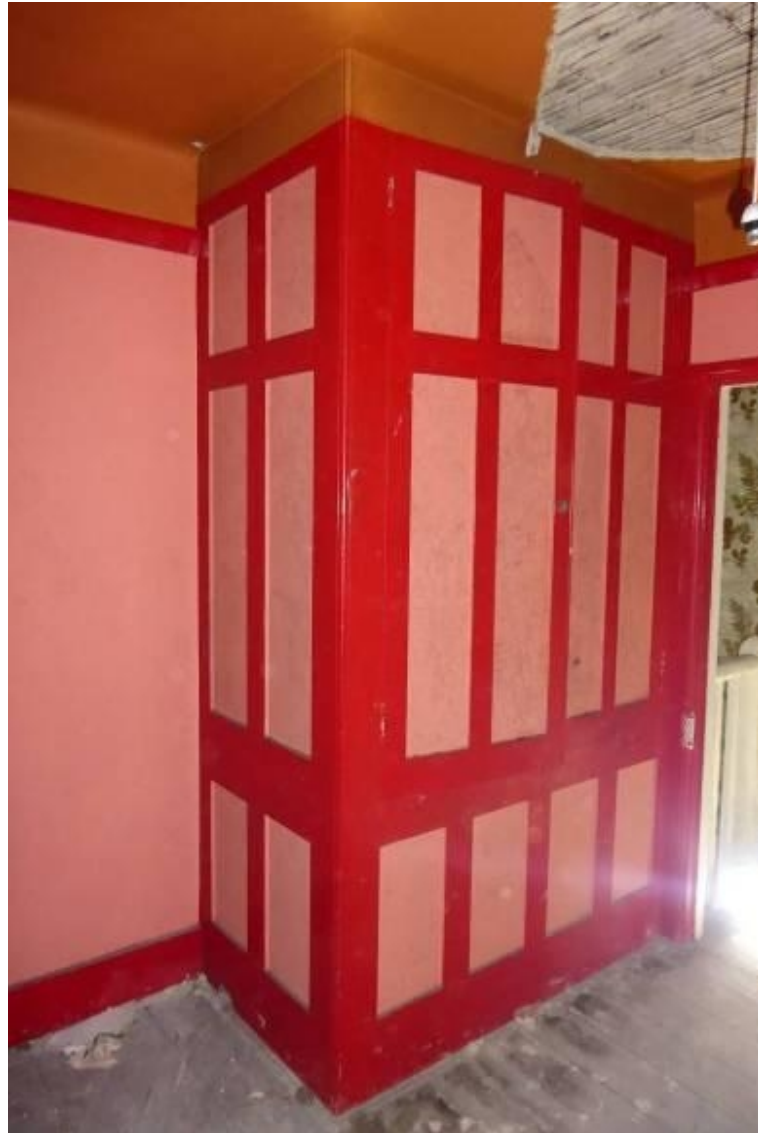
Fig 5.2.10: Over stairs cupboard in front bedroom

5.2.10 The built in cupboard over the staircase to the front bedroom appeared to be in almost original condition, being fully panelled all the way around.

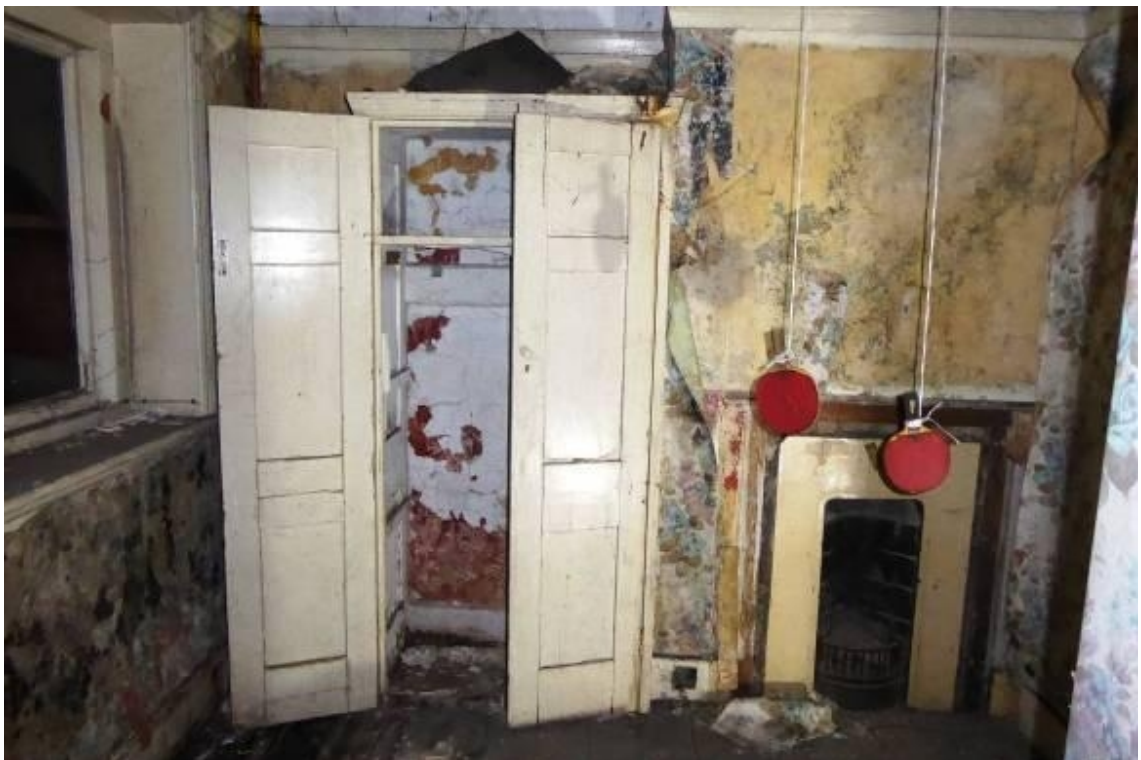
Fig 5.2.14: Rea bedroom cupboard

- 5.2.12 Access and therefore inspection within the rear bedroom was curtailed due to a structurally unsafe floor.
- 5.2.13 The bottom of the chimneybreast in the rear bedroom still has a burning basket and the inner face to fireplace, but the outer face and surround was missing.
- 5.2.14 In the rear bedroom in the left side of the chimneybreast is a fitted wardrobe with a pair of three panel doors to the front and similar panels on the outer side. Its overall style and form could suggest a dating to the 1930's.
