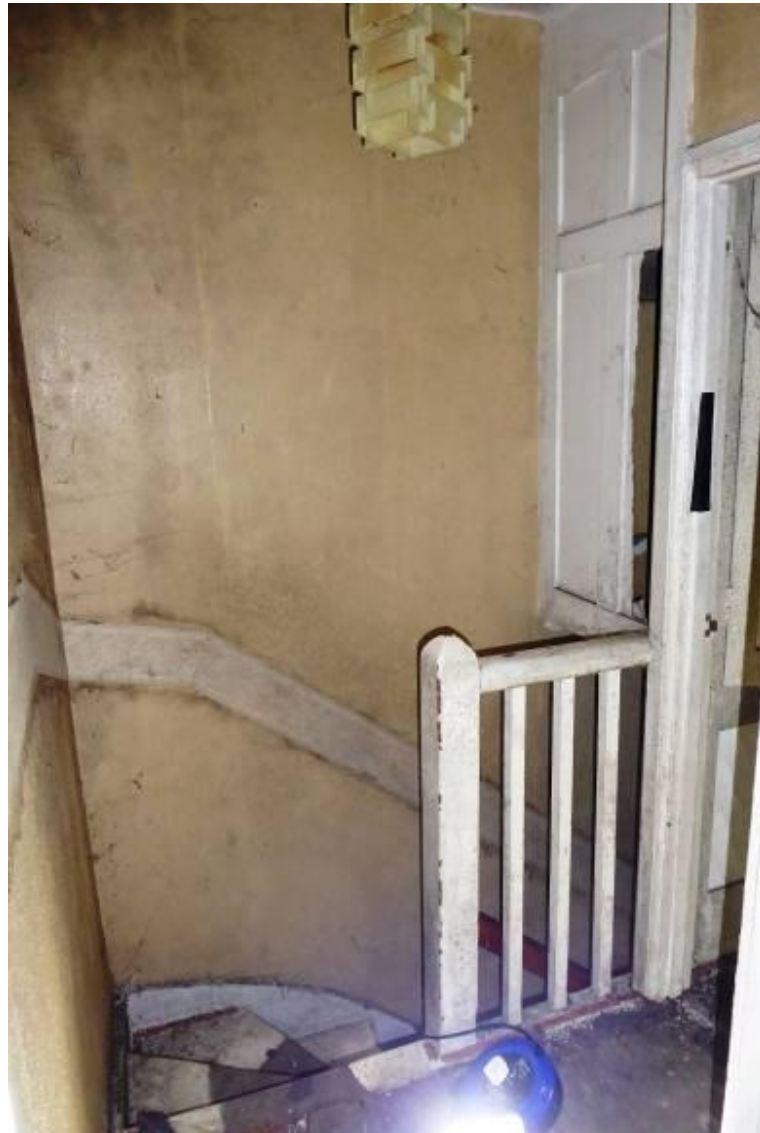
- 5.3.10 The ceiling over the bathroom is of varnished timber boarding over battens fixed through the plasterboard ceiling above.
- 5.3.11 The stairs and landing are generally as that described for south central cottage including the un-boarded balustrade to the head.

Fig 5.3.11: Landing with balustrade at door to front bedroom
