Picus: London Highgate

Tree species: Cedar of Lebanon

Road: The Bank

Number of tree: 1

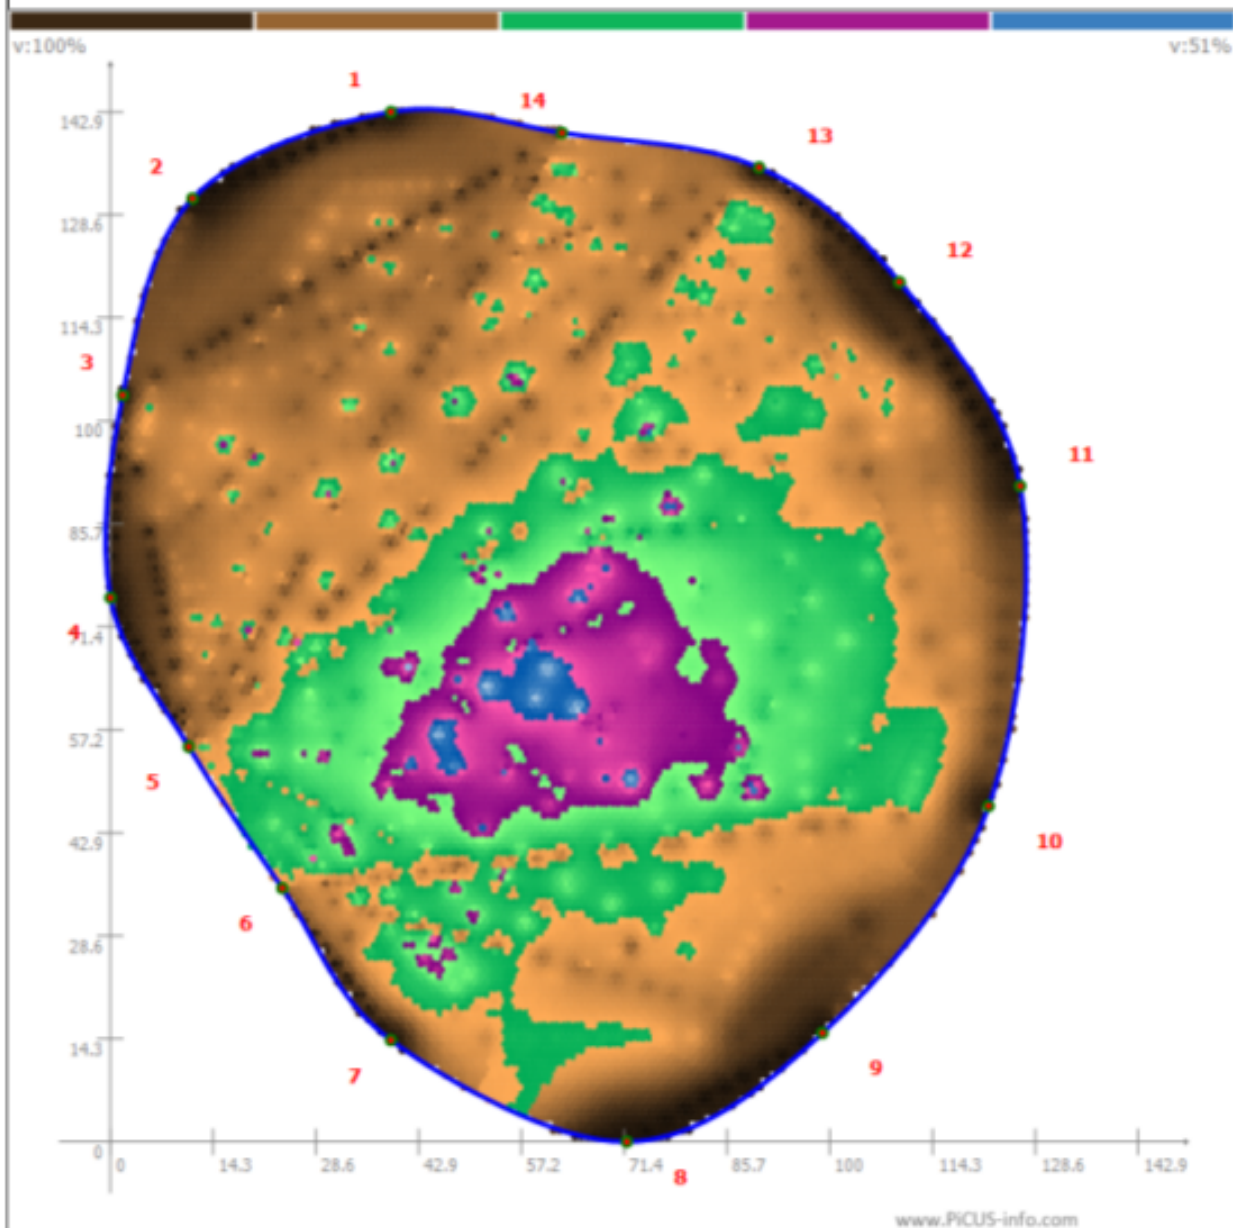
Structural condition (Sonic tomography) – Tomography was carried out at 3.25m above ground, just below the opening and in the region of hollow mallet sounds described above. North is at Measuring Point 1 (MP1); the opening was above MP6 & 7. The scan revealed the presence of decay in the approximate location of the secondary stem union and aligned with it. A wide area of 'incipient decay' was found to extend around the decay representing wood infected by the fungus and likely to become significantly degraded in the foreseeable future. The average of all maximum sound velocities (1767ms⁻¹) was normal though at the upper end of the range for softwood indicating that the tomography data is of good quality. The difference between 'good' and 'decayed' wood velocities was 49%, again indicating data reliability.

Interpretation – Taken together, the visual and tomographic observations indicate that a progressive brown rot decay is present which has produced a substantial weakening of the SW secondary stem union. Brown rot decay is unpredictable: affected limbs and unions can fail without warning. The likely primary mode of failure is therefore separation of the SW secondary stem from the main bole at approx. 4m above ground. The failing part of the tree can be expected to be 12m long, placing the sports courts and forest school within target range. No significant obstacles to limb descent were observed.

Threat category: 6, SERIOUS. Close target area and remediate within 7 days.

4. Reluctantly, I have to conclude that the only viable means of abating the risk from T1 is removal of the entire crown to the level of the main unions at 4m above ground. Because the stem itself is apparently sound, the remaining standing trunk could be retained with habitat spaces created in it artificially. Alternatively, it could be transformed into a sculpture thus retaining some value for decades to come.
