J. B. WARD & SONS

8 Woburn Walk, Nepenthes And Sons Ltd

REPORT

No D 72044

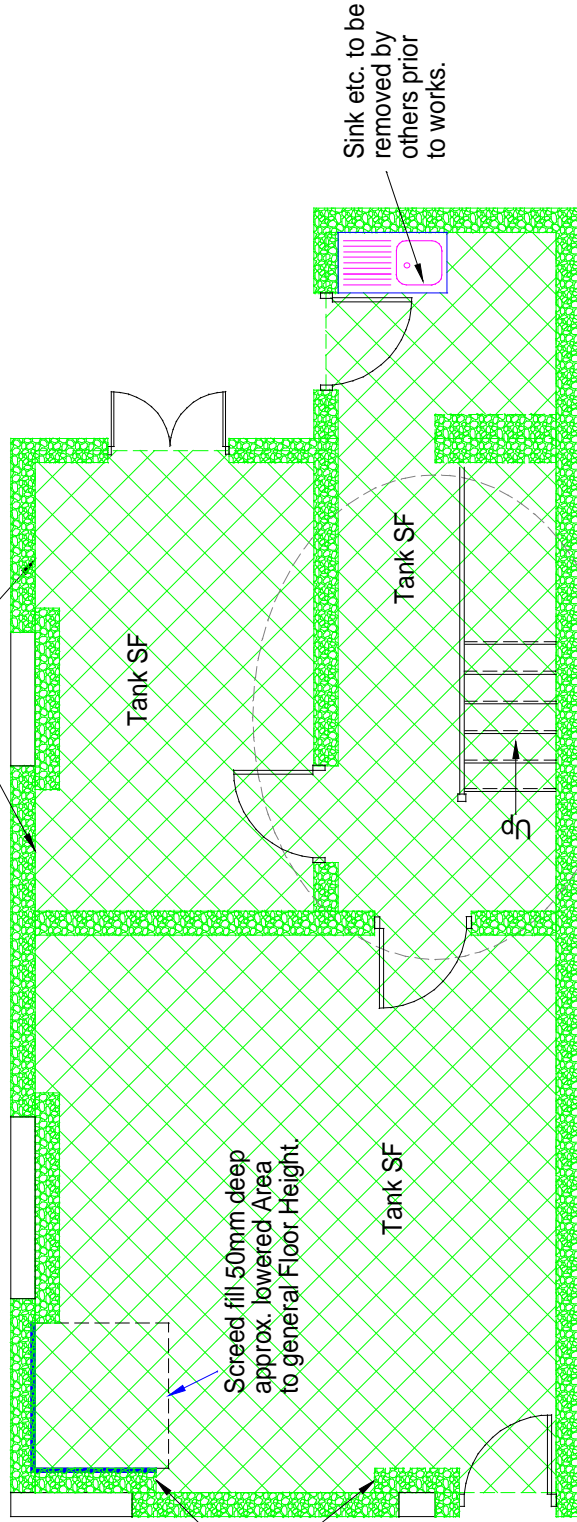
Section A

Modern ply linings are damp. To be removed by others prior to works.

Window Reveal Bases are Rotting require removal by other Contractors prior to works.

Door Frame & Staircase Bases tracking Subfloor Moisture with early Rot visible. Others to create Bridging Gaps &/Or protect with membrane leaving 20mm exposed for JB Wards to lap Floor Membrane.

130sm of Cavity Drainage Membrane to Floor & full height of Walls.

Screed fill .50mm deep approx. lowered Area to general Floor Height

Sink etc. to be removed by others prior to works.
