## The Hope Project – Site Visit Report No.10

### 1. Dome roof truss investigations

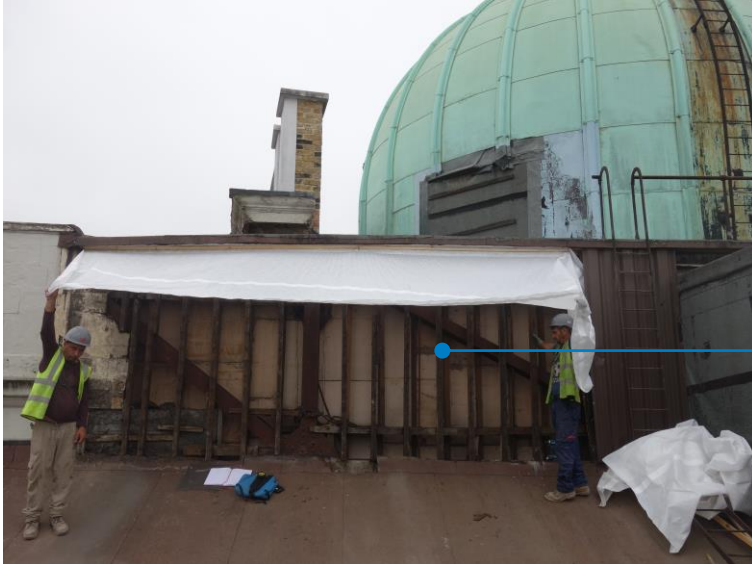
1.1 TD have exposed the southern end of the existing steel roof truss that supports the dome.

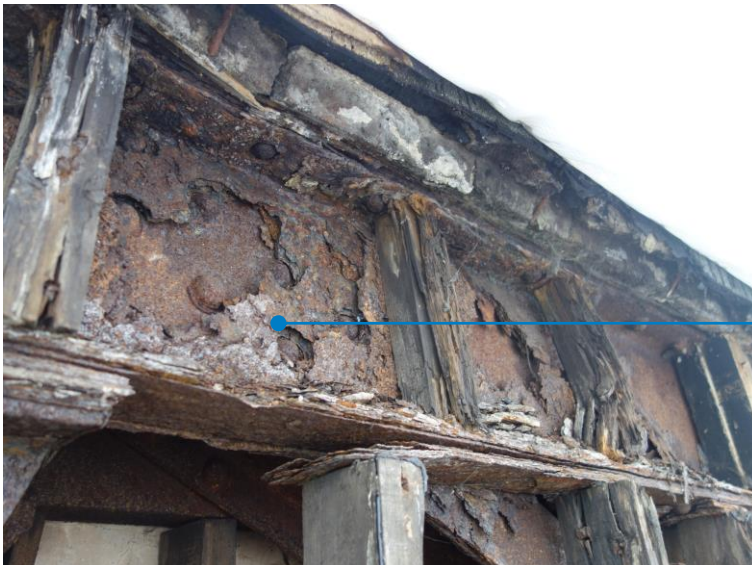
1.2 Severe deterioration/delamination of the truss top chord was observed, likely caused by water ingress during the life of the building. Delamination has caused a reduction in effective steel area will consequently reduce the capacity of the existing truss.

HTS have measured the existing member sizes and will carry out an analysis to estimate the capacity of the truss to inform the client of any potential collapse risk.

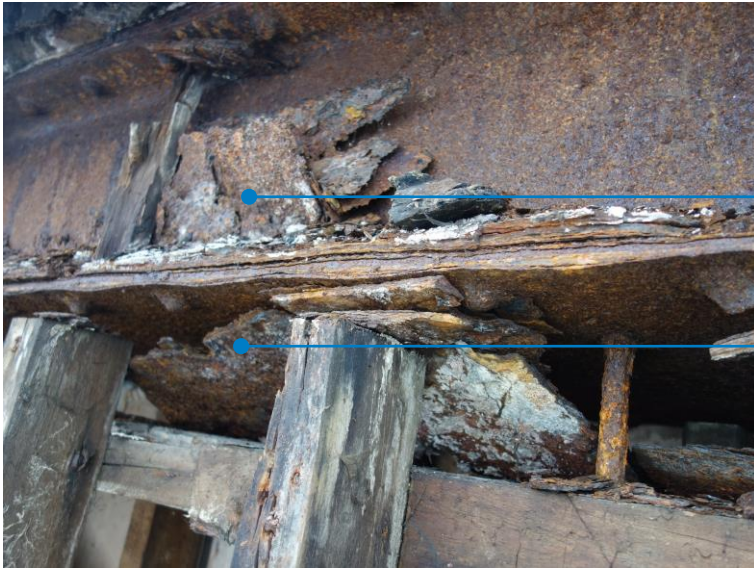
1.3 Delamination of existing steel truss top chord.

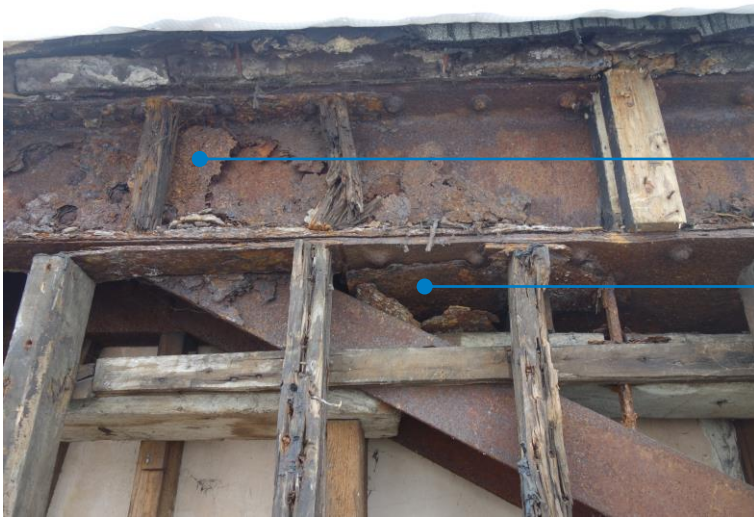
1.4 Delamination of existing steel truss top chord.

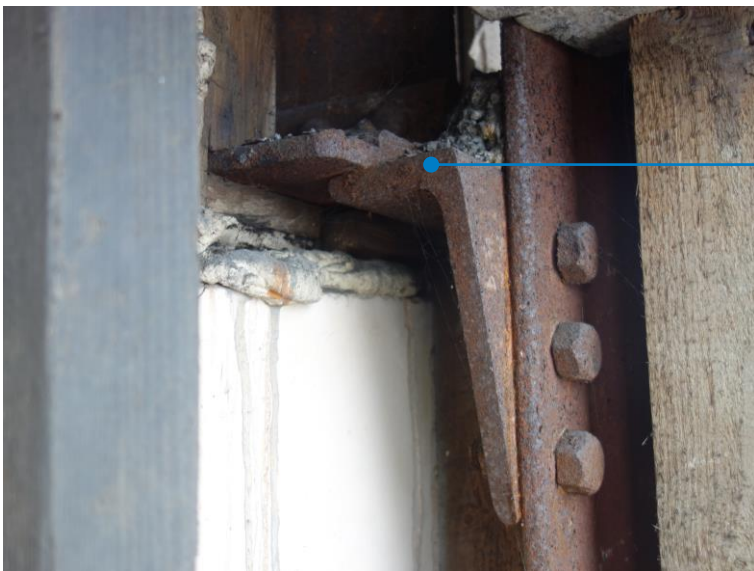
1.5 The connection of the existing roof beam to the truss vertical was observed below the brick parapet.

The existing connection appears to be a bearing connection (approx. 30mm) on a 200x90x15 angle connected to the truss bottom chord with 6no. bolts (30mm hex bolt head).
