7<sup>th</sup> and 9<sup>th</sup> August 2018

Ref: 1444

### KOKO – Site Visit Report No.11

#### 1. Truss Remedial Works

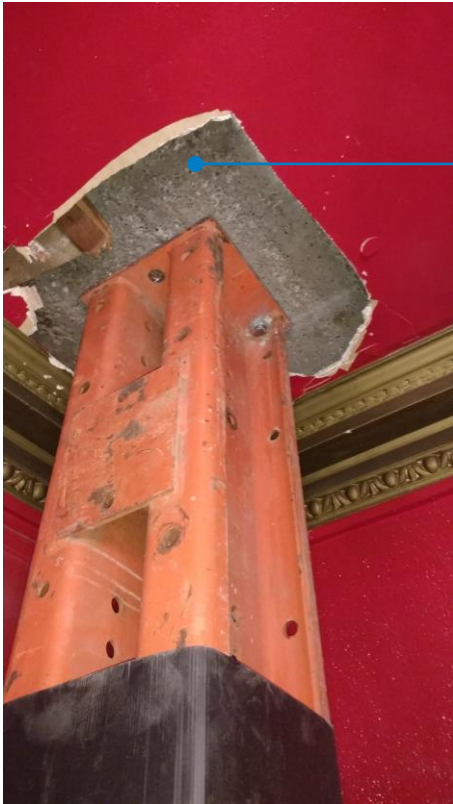
##### 1.1 Positioning of props.

We note that prop locations do not appear to line up between storeys. In the best-case scenario these provide no support, in the worst-case this may cause failure of the slabs / beams set between the misaligned props. We recommend that this is resolved and documented, potentially with the aid of a position survey.

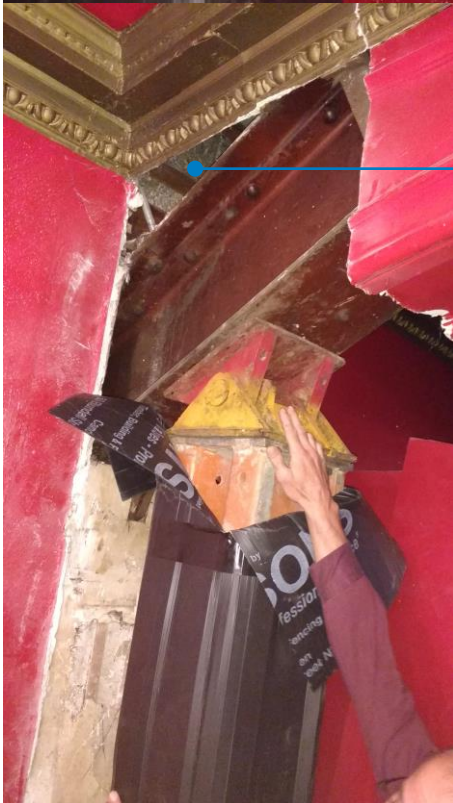
##### 1.2 Load path through existing structure.

As in this image, there is no clear load path through the existing structure with there being a gap between steel beam and slab above. Please provide calculations to show that the prop loads can be accommodated through all existing structure.

Has the existing structure been determined and justified?

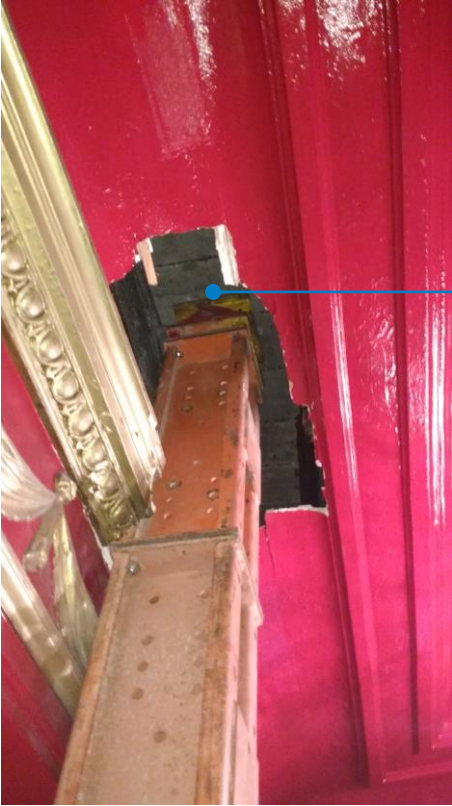
### 1.3 Fixing of props.

Some props seem not to be fixed at all to the existing structure while others appear to be nominally connected with a single bolt or anchor. Has this been approved by the temporary works engineer?

### 1.4 Number of props.

It was our understanding that double mega-shores would be required (at least in the outermost locations) to carry the loads from the existing truss. Has the single prop solution been justified and signed off by the temporary works engineer?

If not, we strongly recommend that this is remedied as soon as possible as we do not believe that the truss can safely carry the load imposed on it.

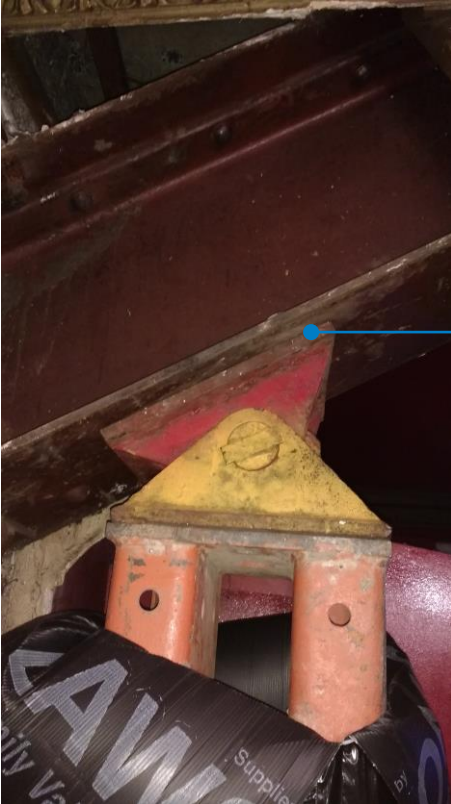
### 1.5 Connection through rivetted steel.

The depiction shows a shore connected with a single bolt through a rivetted beam. There is a gap between the bearing surface and the flange due to the rivets, and this had not been packed or shimmed. Has this been checked / approved by the temporary works engineer?

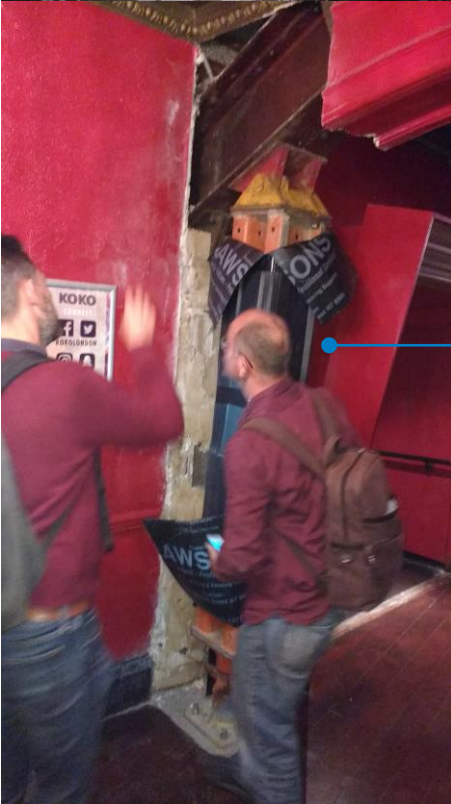
### 1.6 Angle of props

Tower Demo's drawing shows a 5° angle to the shores at their highest level and no angle below, In practice there appear to be significant angles to all shores, has this been signed-off? Have the lateral forces into the existing diaphragms been justified?

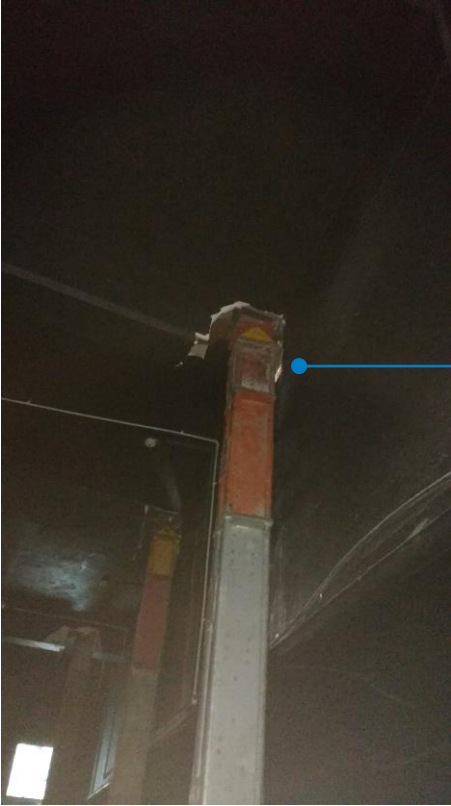
### 1.8 Weatherproofing.

Daylight can be seen through the openings where secondary beams meet the truss. Please ensure that a robust weathering strategy is in place to avoid damage to structure and internal finishes as well as ingress of damp into the building fabrics.

For the future remedial works on the truss, it is likely that a full weathered and secured perimeter will need to be formed around the structure.

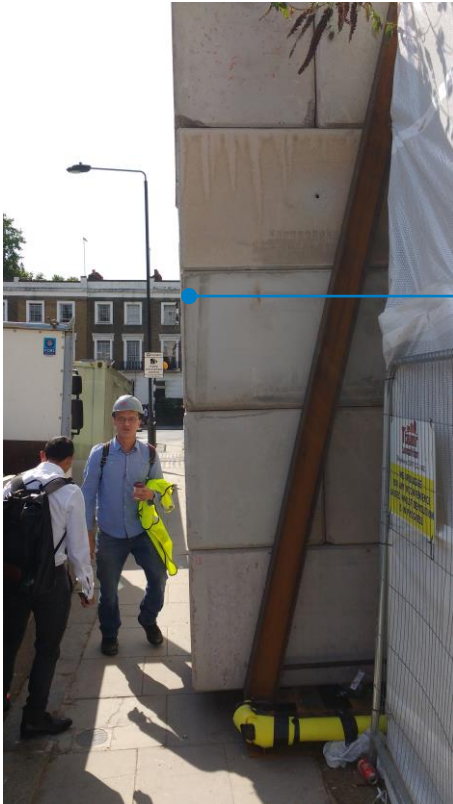
2.1 As per the picture, the Kentledge 'Lego' blocks are at an angle to the vertical. From discussions with Tower Demo, we understand that this can be accommodated in their design, but note that it may cause pavement access restrictions?

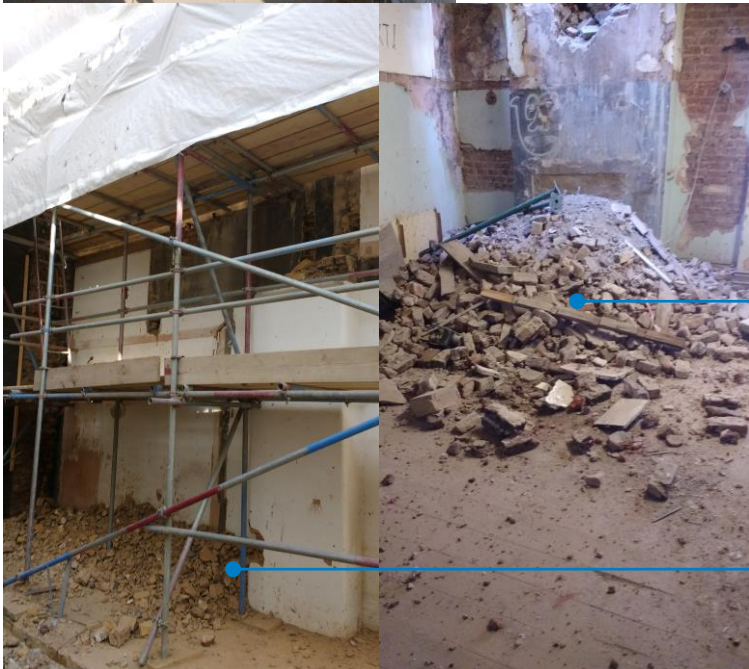
2.2 There are piles of old stone and brick loading the existing structure. Tower Demo noted that this has been allowed in their design, but we have not seen any calculations justifying this.

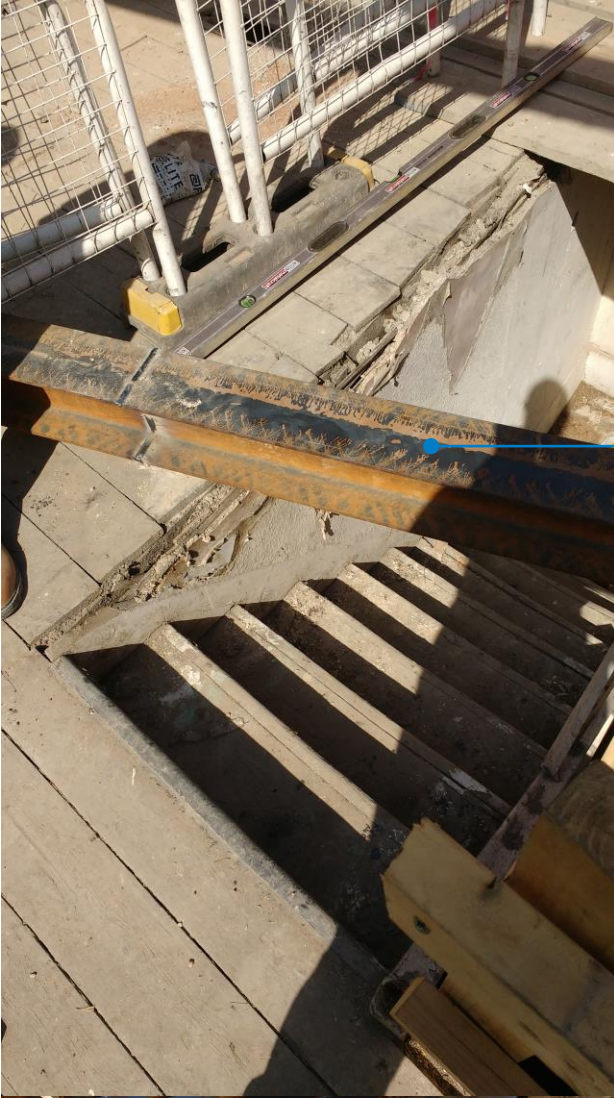
2.3 The access route to the top storey of the structure being demolished was blocked by an active flying shore. It was noted that the access would be redirected the next day. This is a H&S risk, and we ask that safe access / escape is ensured and monitored in future.

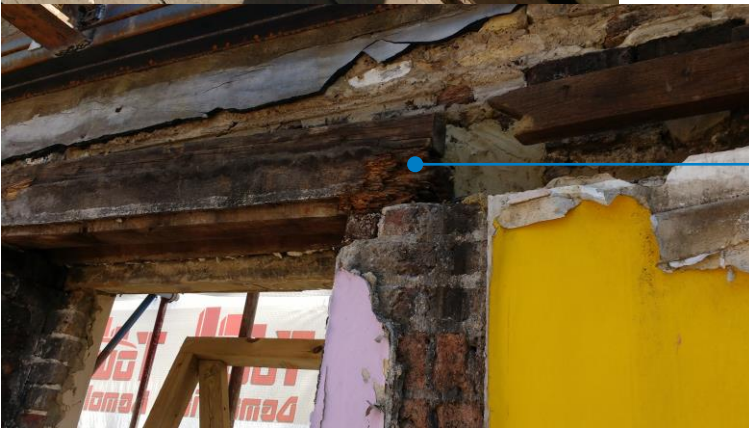
2.4 We note that single leaf timber lintels appear to have rotted and will likely need to be replaced / remedied for retained facades.

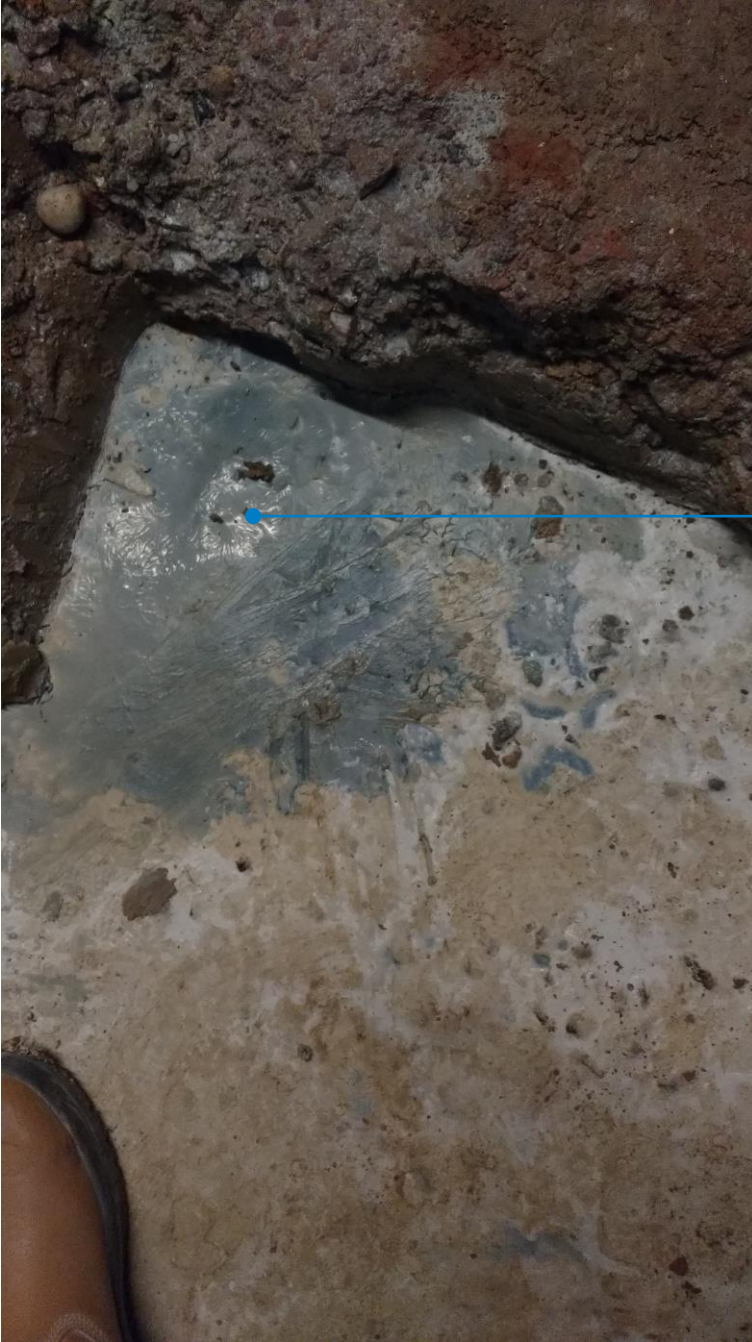
2.5 With water-ingress into thrust blocks, the concrete mix appears to have split, creating a solid, translucent topping. This may affect the capacity of the thrust blocks. Please confirm that these have sufficient capacity prior to activating / using the blocks.

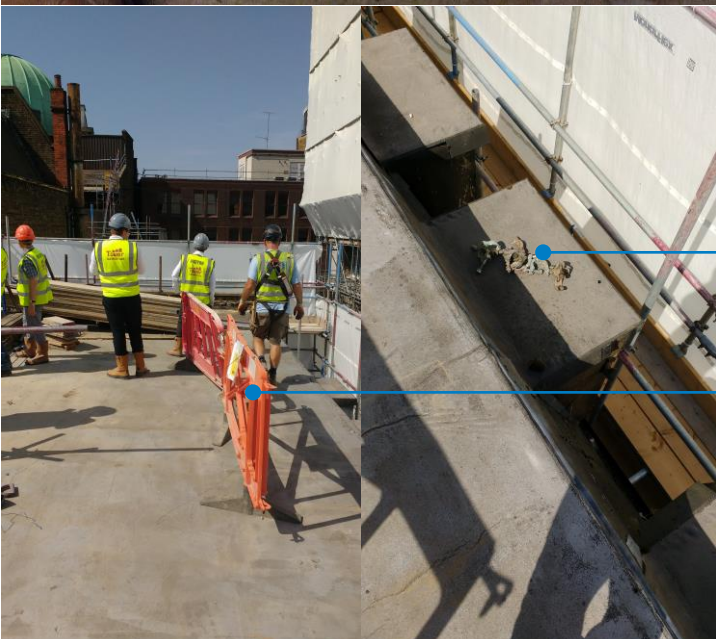
2.6 The edge protection on the roof of Bayham Place is unclear and seems to be ignored (with evidence of tools stored on a window frame below). Please ensure that a clear, safe perimeter is enforced throughout the works.

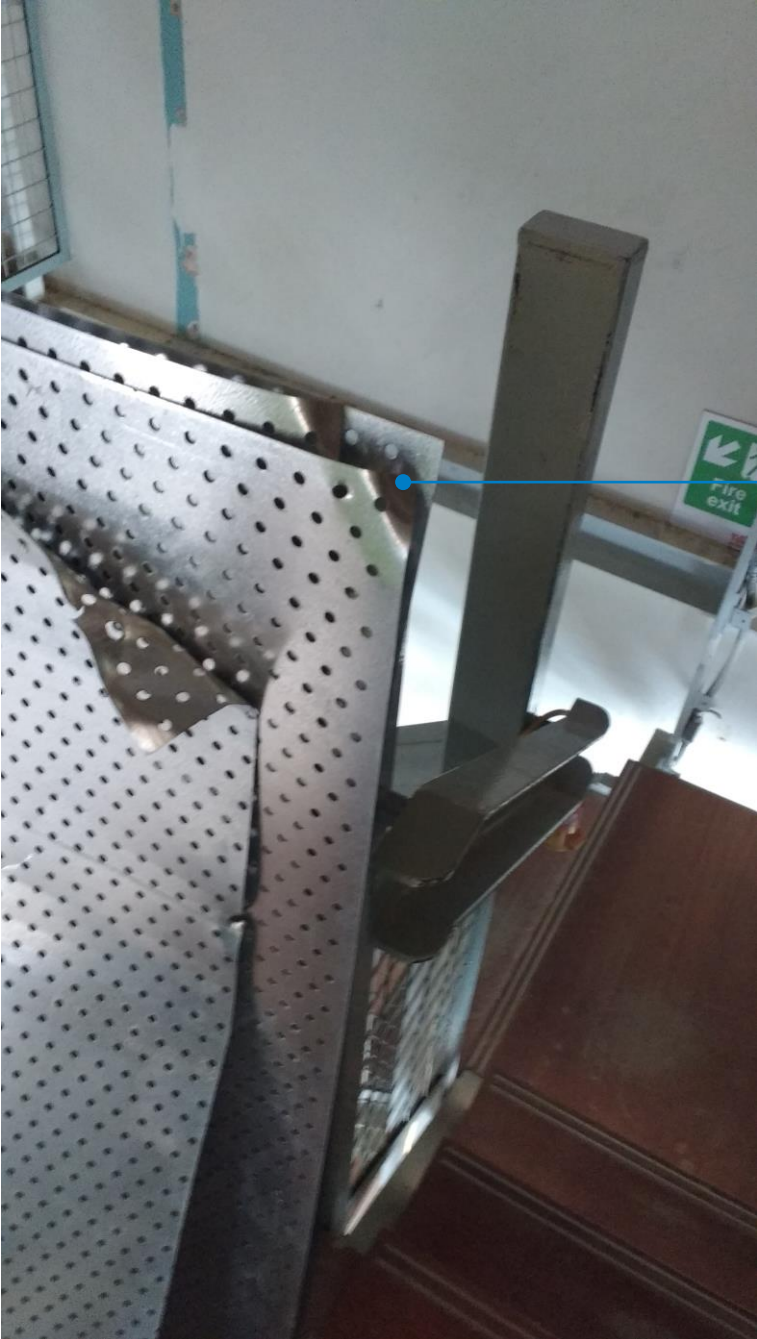
2.7 Sharp metal sheets are stored adjacent to an access stair, and there is a risk of injury to personnel. Please store material in a safe location.
