**TECHNICAL REPORT ON A SUBSIDENCE CLAIM**

**24 Langbourne Avenue  
London  
N6 6AL**

**SUBSIDENCE CLAIM**

DATE 22 January 2019

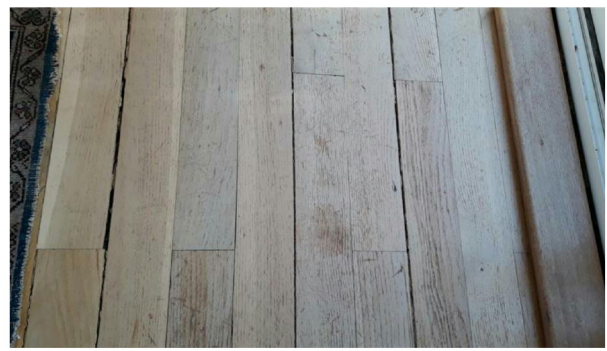
Cracking in rear side utility room

Distorted wooden flooring in rear extension

Distortion of door/window openings of the patio doors to rear extension. A section of the wooden flooring in the extension room is being pulled away leaving a gap beneath the patio window and doors. In addition minor cracking, less than 1mm, was noted in some of the areas of the rear extension room and side rear utility room.

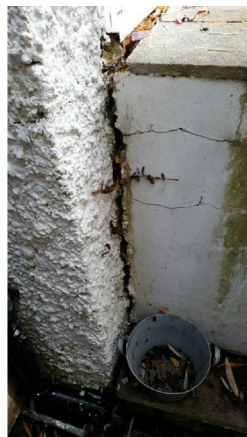
12mm crack where raised patio area pulling away from rear extension

Where the raised patio area meets the rear extension is a 12mm wide vertical crack. In the pebbledash wall of the rear elevation below the patio doors and window are diagonal cracks up to 6mm wide. There is a large 10-12mm wide crack running horizontally the full width of the external supporting wall to the raised patio area. There is a large 20mm wide vertical crack in an external wall at right angles to patio area. Overall, the raised patio area is slipping slightly down the rear sloping back garden away from the main house.

The cause of the movement needs to be dealt with first. We have completed a Soil Risk Analysis (VISCAT Assessment) and we are satisfied that your willow tree is the source of the damage.

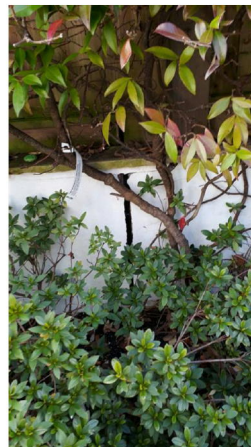
20mm crack in garden wall on right of patio area when viewed from rear garden

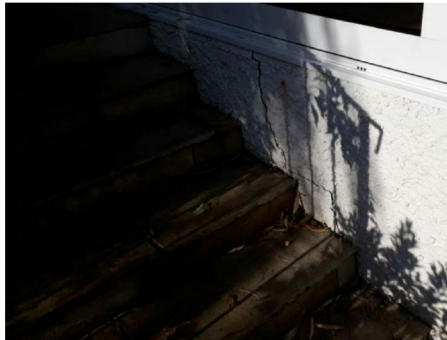
6mm cracks underneath rear extension  
patio doors and window

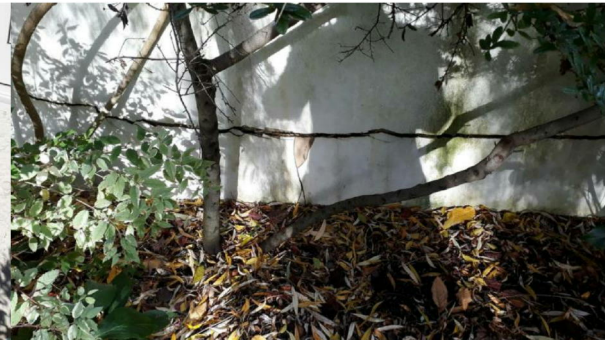
Close up of 10-12mm horizontal cracks in  
rear wall of raised patio area

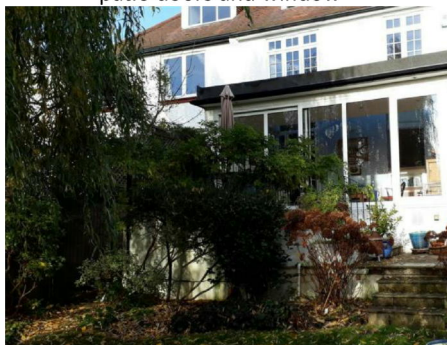
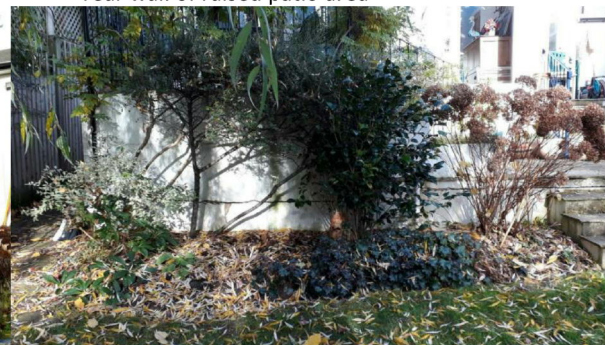
Close up of 10-12mm horizontal cracks in  
rear wall of raised patio area

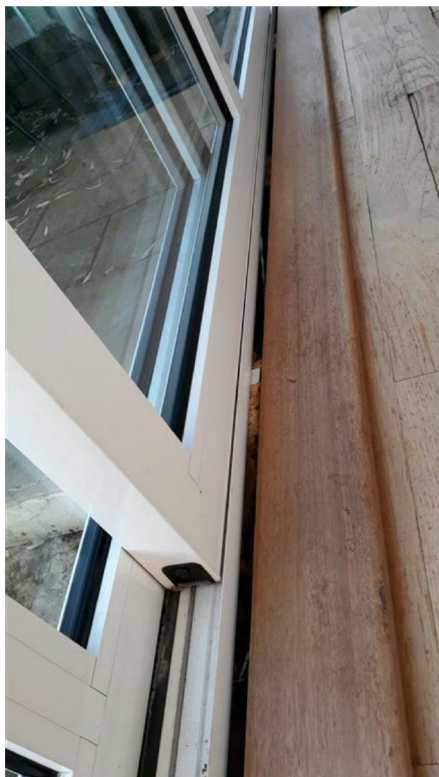
Patio doors and windows pulling away as seen by gap in floor edge

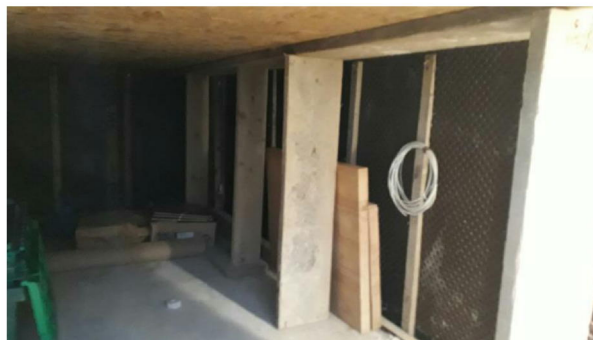
Storage area below rear single story extension-- No damage noted
