# 1.0 Introduction

Following improved access to the rear of 26 Denmark Street and the East Gable of 22 Denmark Place, we have identified a number of discovery item issues that are addressed in the corresponding application drawings as well as summarised within this document.

Application Reference: 2015/6937/L

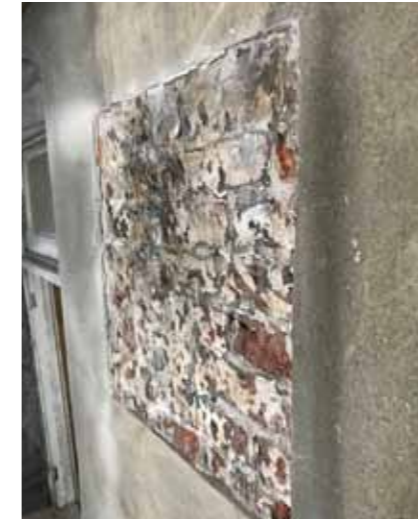
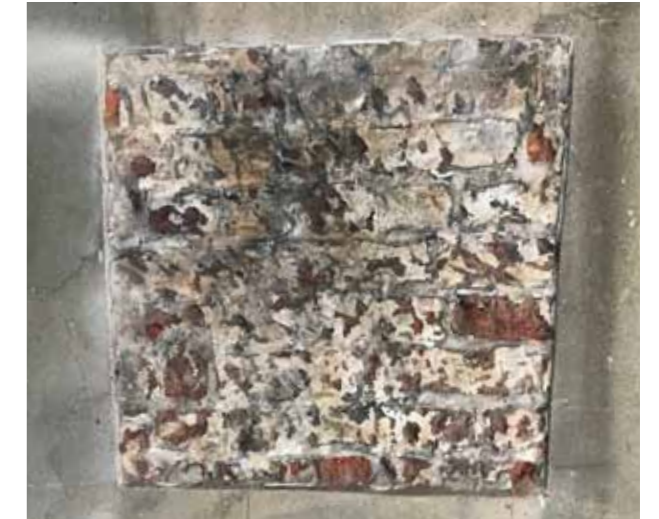
1

This has revealed masonry of varying quality. It is assumed that historically the facing brickwork has been scabbled to provide a key for the render.

As a result the brickwork below the existing render is not of quality to expose, without substantial cutting out and replacement of existing brickwork, which would significantly affect the existing building fabric.

We propose to finish the existing scabbled brickwork with a lime render finish to replace the existing cementitious render.

We propose a lime render in order to protect the existing friable scabbled brickwork from weather damage, whilst also providing a more period appropriate finish than the existing cementitious render.

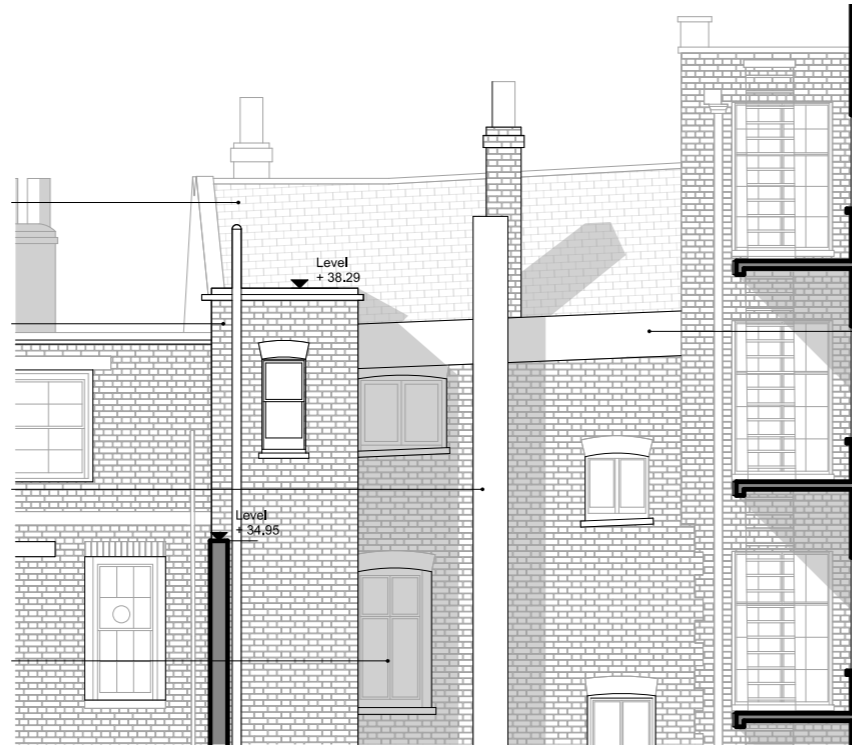
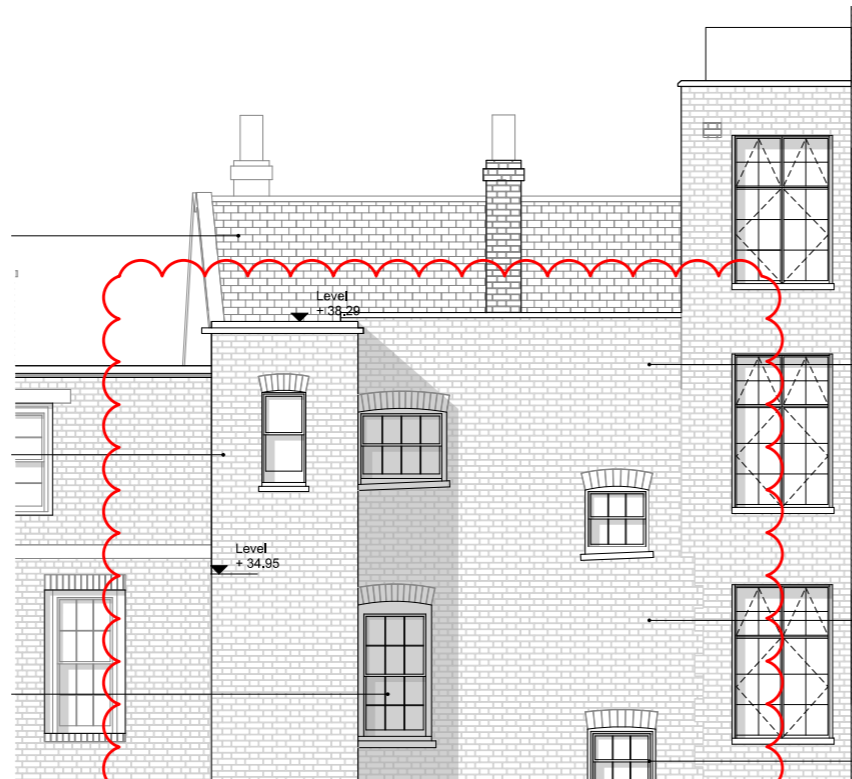
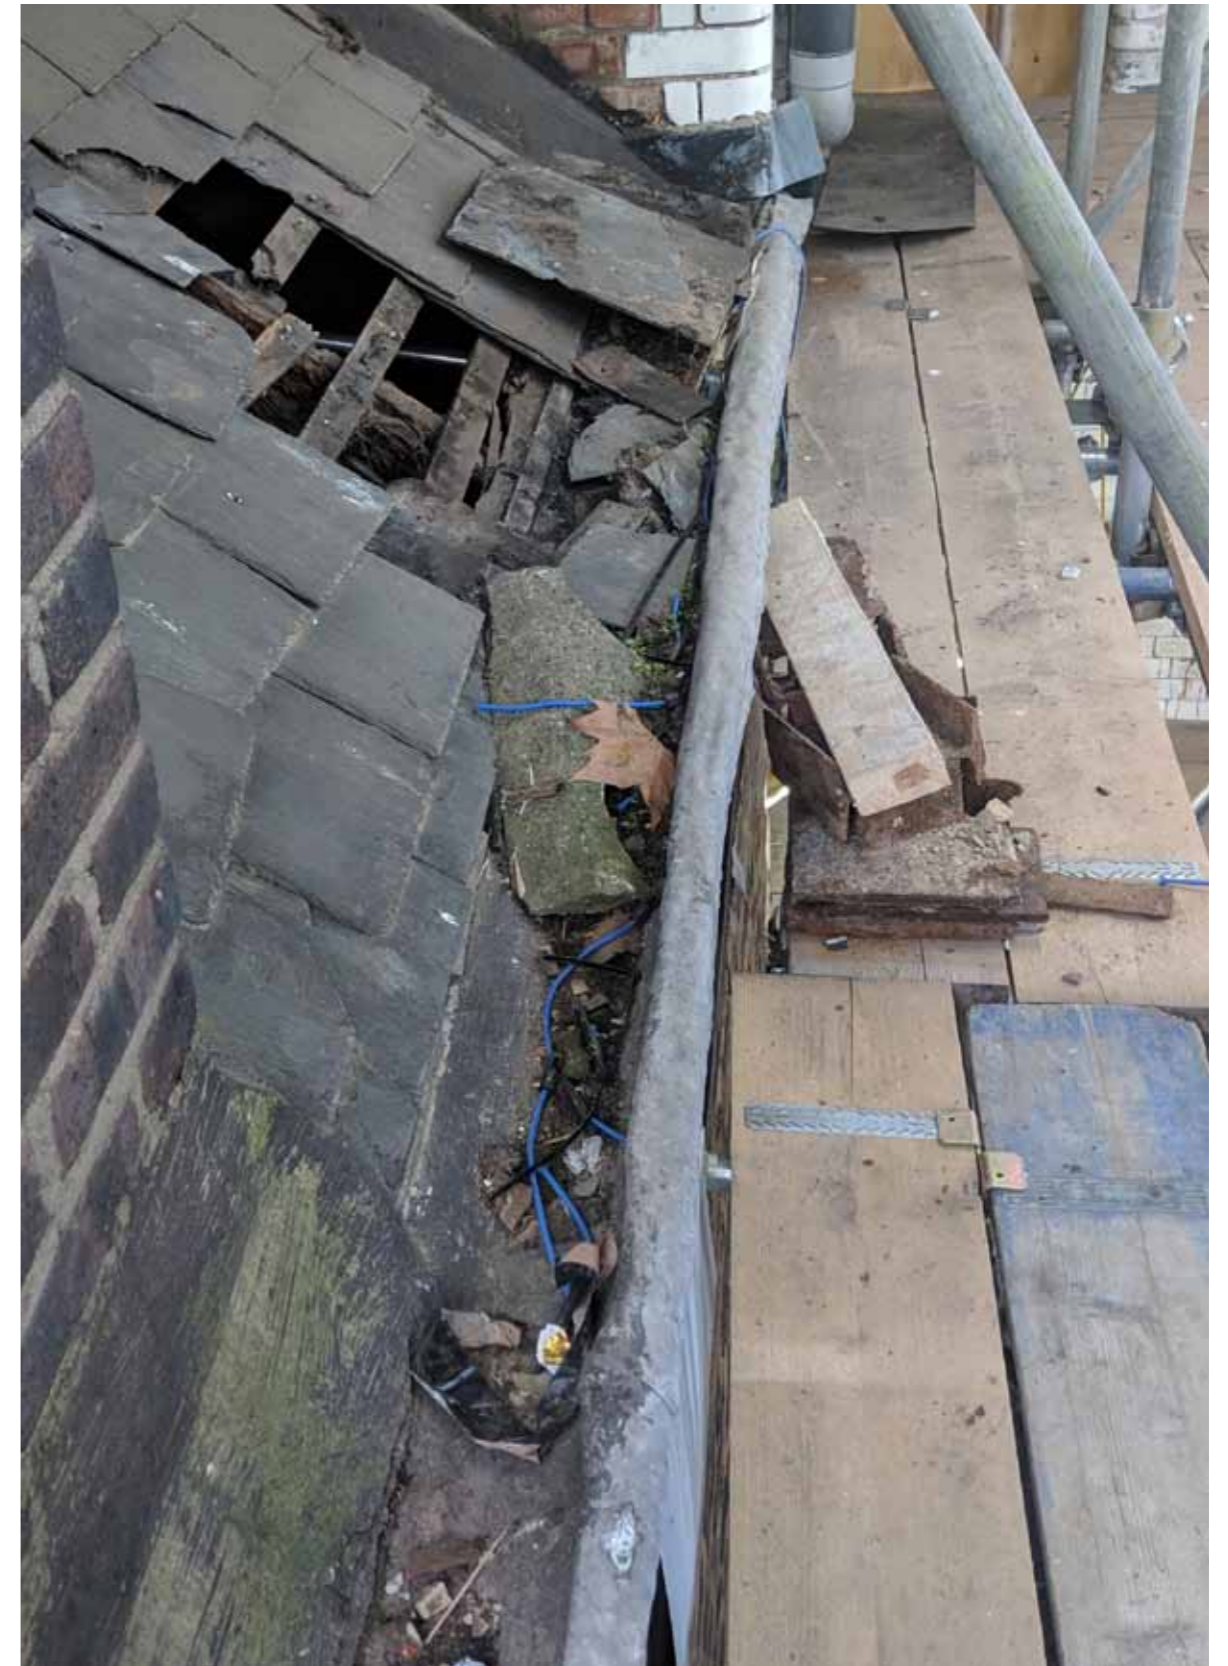
The existing roof arrangement prevents a brick parapet with box gutter being installed due to the current arrangement.

To achieve the detail as originally consented we would need to reset the roof structure to accommodate the box gutter behind the new brick parapet.

We propose removing the existing metal parapet and rebuilding with brick to the existing joist level.

We propose installing a heritage profile gutter affixed to a fascia board. A lead scupper will flash into the gutter at the junction between the closet wing and rear of 26 DMS.

This heritage profile gutter will feed into a downpipe to drain the rear section of the roof.

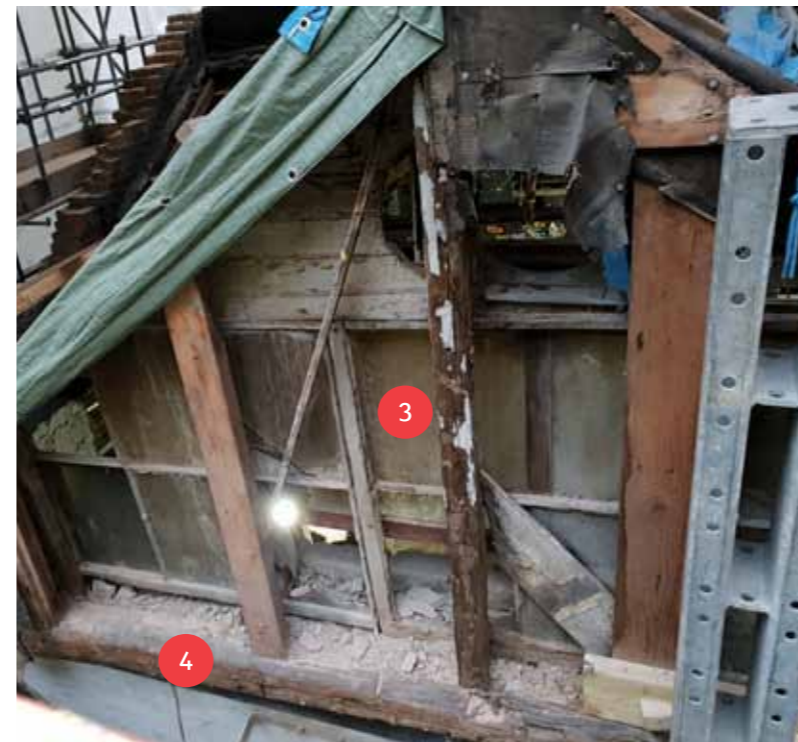
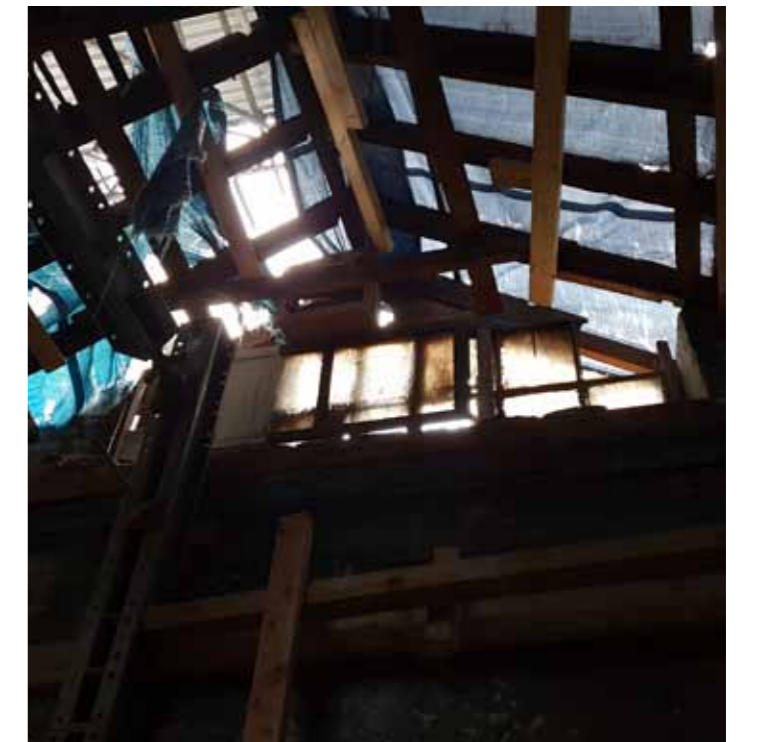
Photographic record following removal of existing felt tiles

3 The existing window appears to be not have been originally for the building - this is evident from the window frame being cut at corners to fit the existing roof profile

The removal of the felt tiles has revealed that there is no facing masonry above the existing, as previously expected. Present is tongue and groove timber boarding

4 The removal of the existing felt tiles has revealed a embedded timber, spanning across the elevation

- 3 New timber framed window with infill tongue and groove timber boarding above to reflect the existing arrangement

- 4 The existing embedded timber will be retained in place and repaired/refurbished.

This retention of the embedded timber is subject to specialist contractor assessment to whether this can be retained. In the event that the beam is irreparable the beam will be replaced to match the existing.

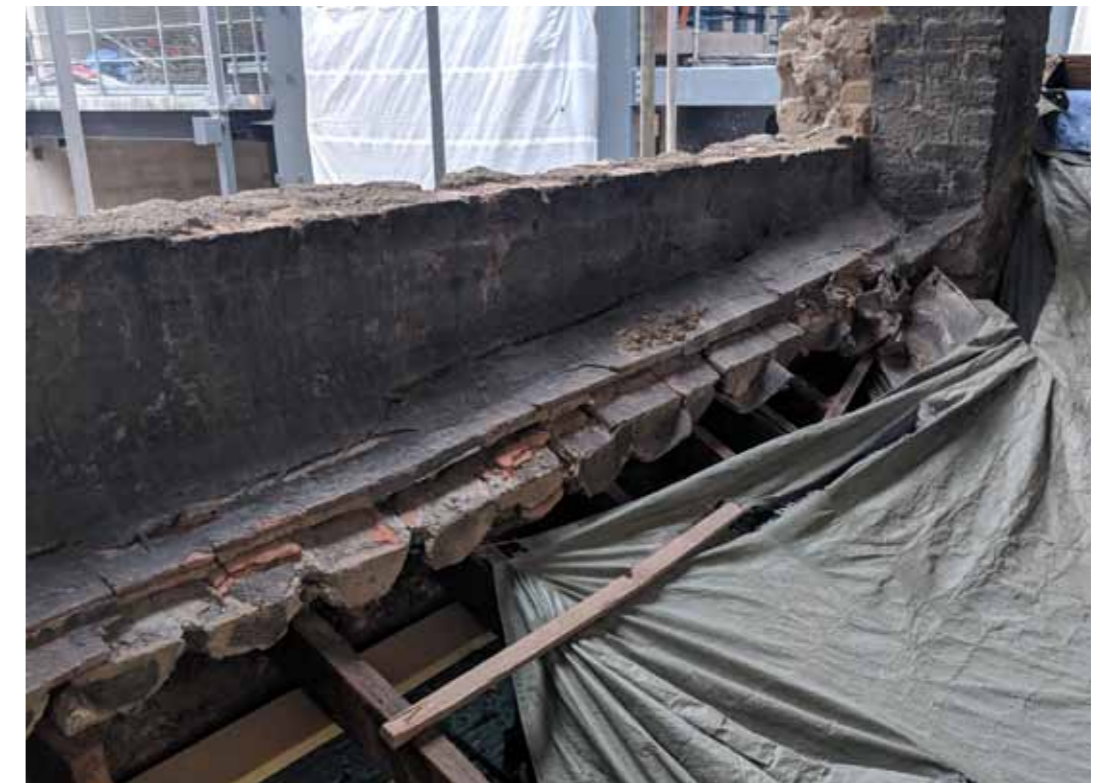
Photo of remaining existing tiles

Following the consented removal of the existing roof finishes, it was revealed that the existing roof tiles were not slate but a red clay pan tile.

In response to this and the proposed works to 26 Denmark Street we propose to match the existing red clay pan tiles for like for like replacements.
