# Structural Inspection Report

**Fire Fighters Cottages**  
**325 West End Lane, West Hampstead. London NW6**  
**Structural Inspection Report**

Version V.01 (24/10/2018)  
Version V.02 (01/11/2018)  
Version V.03 (18/12/2018)  
Version V.03A (21/12/2018)

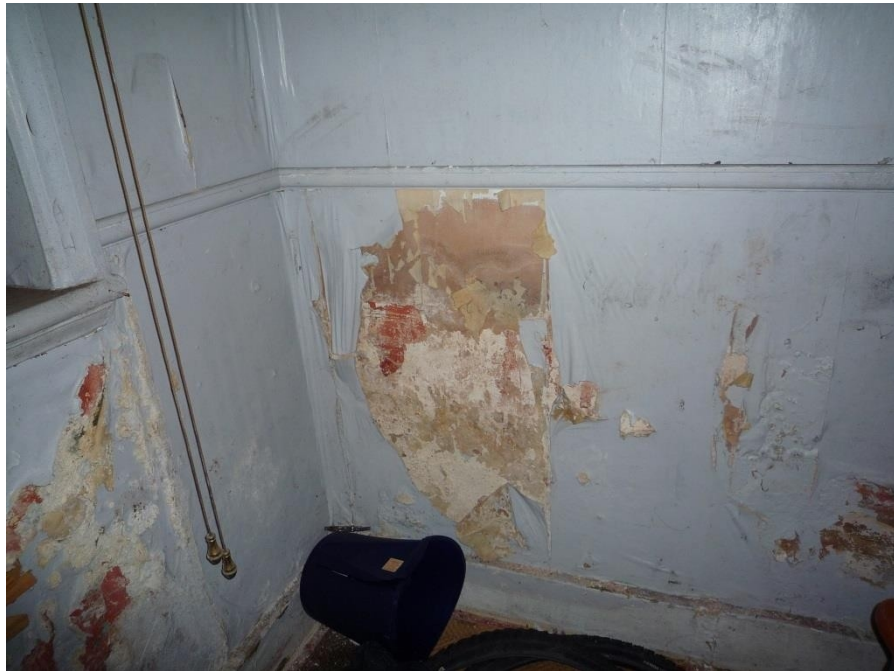
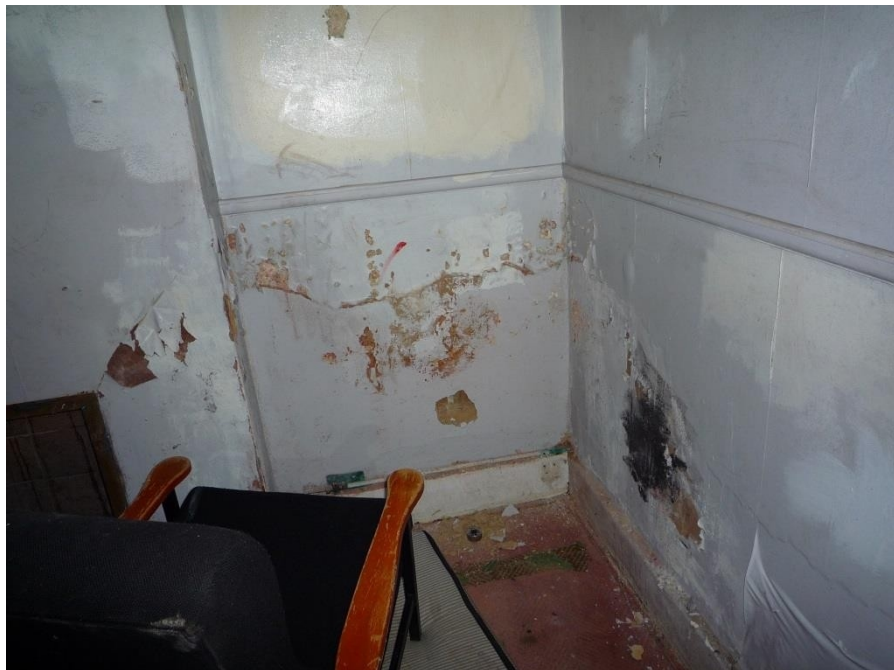
| Symptoms of Distress | Possible Cause(s) | Further Investigation | Principles of Repair | Likely Consequence of Inaction |
|---|---|---|---|---|
| House 1 living room, severe dampness in low levels of external walls.<br><b>Photos 1&amp;2</b> | Trapped moisture trying to escape the building fabric.<br>Improper, impervious render<br>Possible penetrating damp or interstitial condensation.<br>Missing or too low level DPC | <u>All areas of water ingress in this table shall be investigated to locate source(s) of damp.</u> | To be agreed | Continued trapped dampness, further degradation of plaster, render and brickwork |

Picture 1 – House 1, Severe damp in ground floor living room

Picture 2 – House 1, Severe damp in ground floor living room

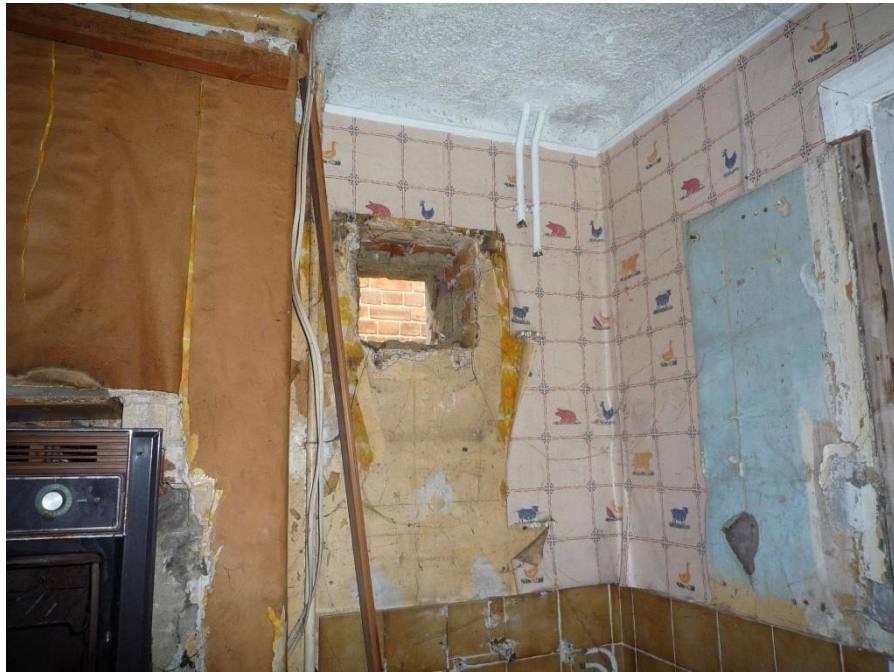
| Symptoms of Distress | Possible Cause(s) | Further Investigation | Principles of Repair | Likely Consequence of Inaction |
|---|---|---|---|---|
| House 1 kitchen, missing vent grills allowing rain and access into the property and general dampness.<br><b>Photo 3</b> | Vandalism or removal and not replaced | No | Replacement of grills and sealing against weather ingress | Continued weather ingress, and degradation of internal plasterwork and brickwork |

Picture 3 – House 1, large open vent in kitchen

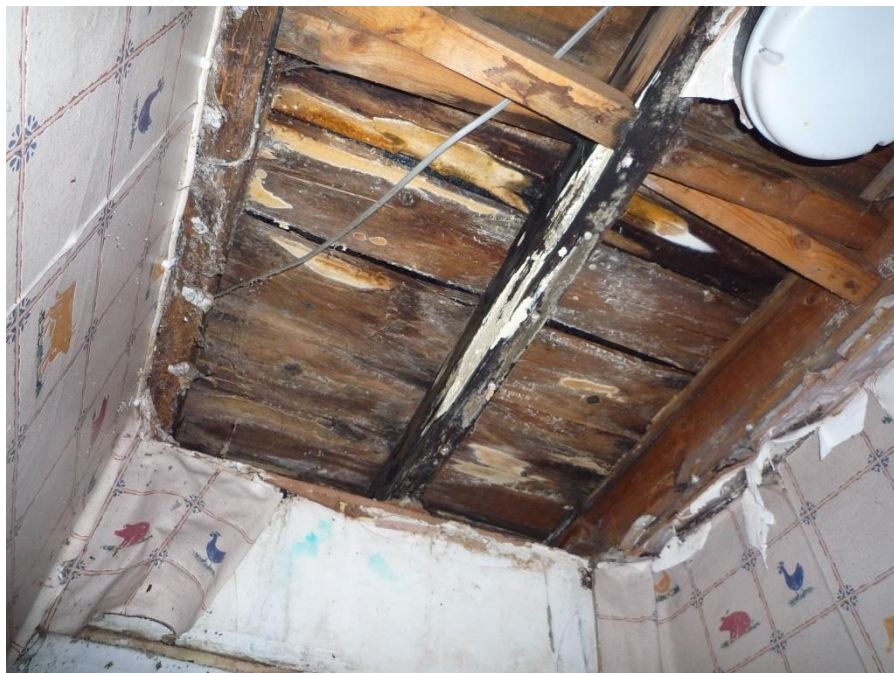
| Symptoms of Distress | Possible Cause(s) | Further Investigation | Principles of Repair | Likely Consequence of Inaction |
|---|---|---|---|---|
| House 1 bathroom, Severe wet rot in flat roof timber construction.<br><b>Photo 4</b> | Leaking felted roof | Fully expose timbers and wall plates to establish extent of repairs | Replacement of timber roof and wall plates and new waterproofing, reinstatement of internal finishes | Continued water ingress and eventual collapse of roof, and further damage to internal finishes |

Picture 4 – House 1, Wet rot in rear extension roof timberwork

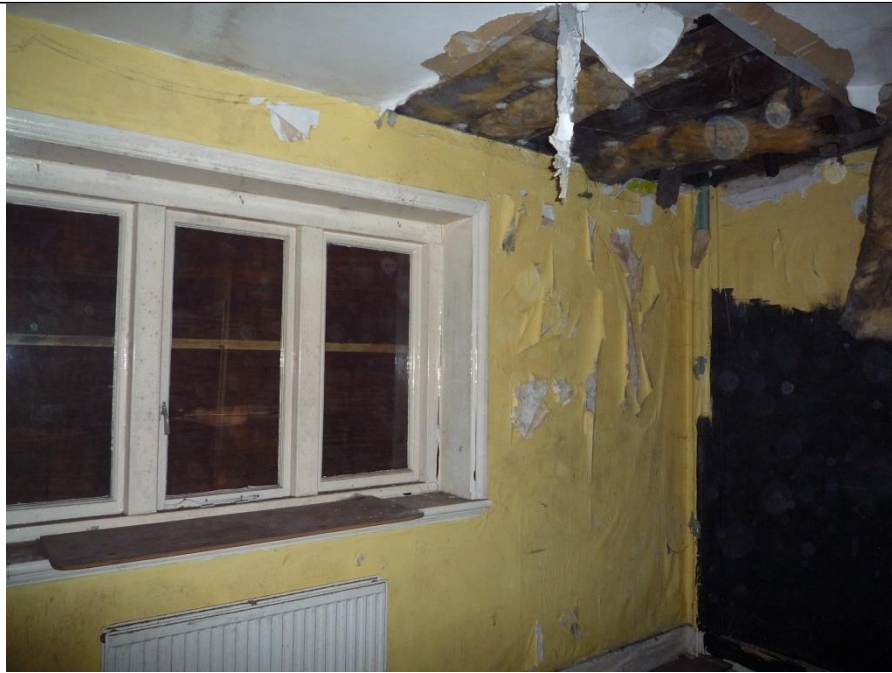
| Symptoms of Distress | Possible Cause(s) | Further Investigation | Principles of Repair | Likely Consequence of Inaction |
|---|---|---|---|---|
| House 1 bedroom 2, General dampness in external walls and partial ceiling collapse.<br><b>Photo 5</b> | Missing render on external walls and damp affected plasterwork | Check external render for extent of defects, and similar with ceiling and wall plasterwork | Replacement of external render and internal debonded or missing ceiling and wall plaster | Continued dampness and further damage to render, brickwork and internal plasterwork |

Picture 5 – House 1, Damp and ceiling plaster down in bedroom 2

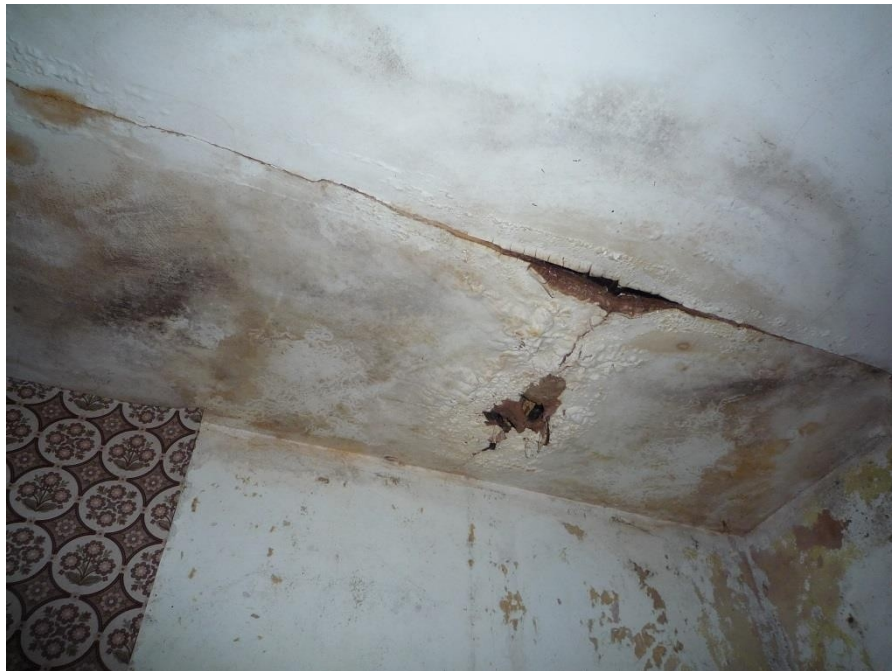
| Symptoms of Distress | Possible Cause(s) | Further Investigation | Principles of Repair | Likely Consequence of Inaction |
|---|---|---|---|---|
| House 2 bathroom, Water ingress through flat roof, probable wet rot in timber roof construction and partial ceiling collapse.<br><b>Photo 6</b> | Leaking felted roof | Fully expose timbers and wall plates to establish extent of repairs | Replacement of timber roof and wall plates and new waterproofing, reinstatement of internal finishes | Continued water ingress and eventual collapse of roof and further damage to internal finishes |

Picture 6 – House 2, Wet and probable joist rot in ceiling to rear addition

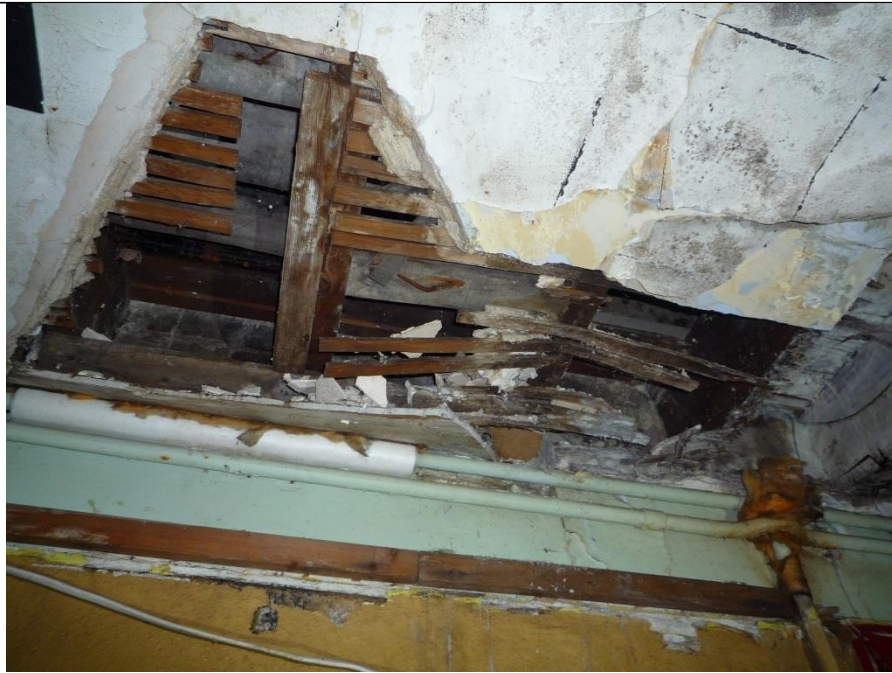
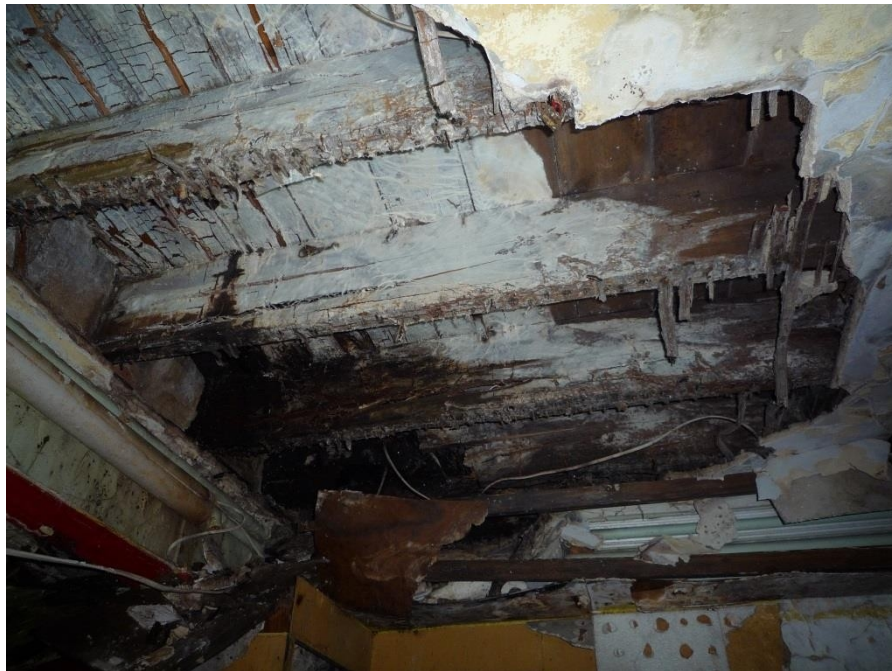
| Symptoms of Distress | Possible Cause(s) | Further Investigation | Principles of Repair | Likely Consequence of Inaction |
|---|---|---|---|---|
| House 2, Severe dry rot in timber floor joists and boarding over kitchen, ceiling collapse.<br><b>Photos 7 &amp; 8</b> | Plumbing or pitched roof leaks | Investigate wall plates over whole area and check for dry rot | Replacement of all affected timberwork, specialist treatment to brickwork and local retained timberwork, reinstatement of internal finishes | Collapse of timber floor and spread of dry rot to other unaffected areas |

Picture 7 – House 2, Severe dry rot in timber floor over kitchen

Picture 8 – House 2, Severe dry rot in timber floor over kitchen

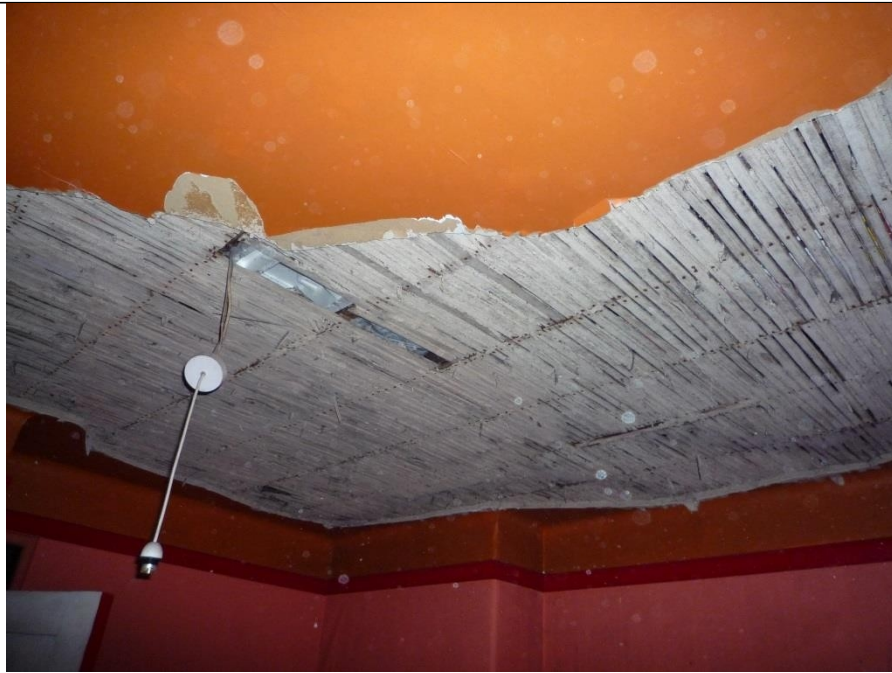
| House 2, Partial ceiling collapse in bedroom 1.<br><b>Photo 9</b> | Debonding of plaster from supporting timber lathes resulting from age and dampness | Check whole ceiling area for debonding and security of lathes | Replace missing plasterwork and secure retained areas | Complete collapse of ceiling |

Picture 9 – House 2, Ceiling plaster down in bedroom 1

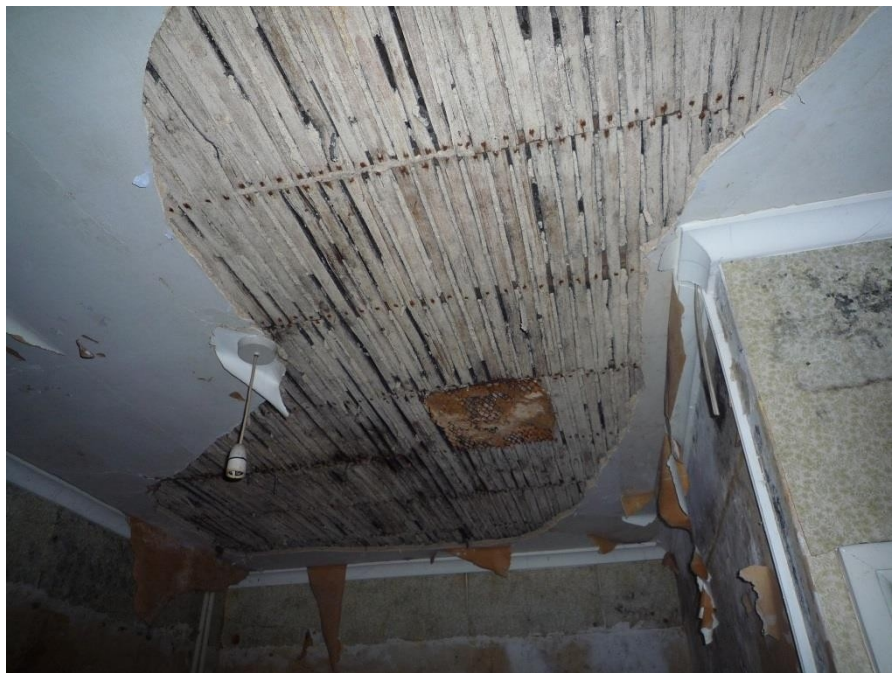
| House 2, Partial ceiling collapse in bedroom 2.<br><b>Photo 10</b> | Debonding of plaster from supporting timber lathes resulting from age and dampness | Check whole ceiling area for debonding and security of lathes | Replace missing plasterwork and secure retained areas | Complete collapse of ceiling |

Picture 10 - House 3, Ceiling plaster down in bedroom 2

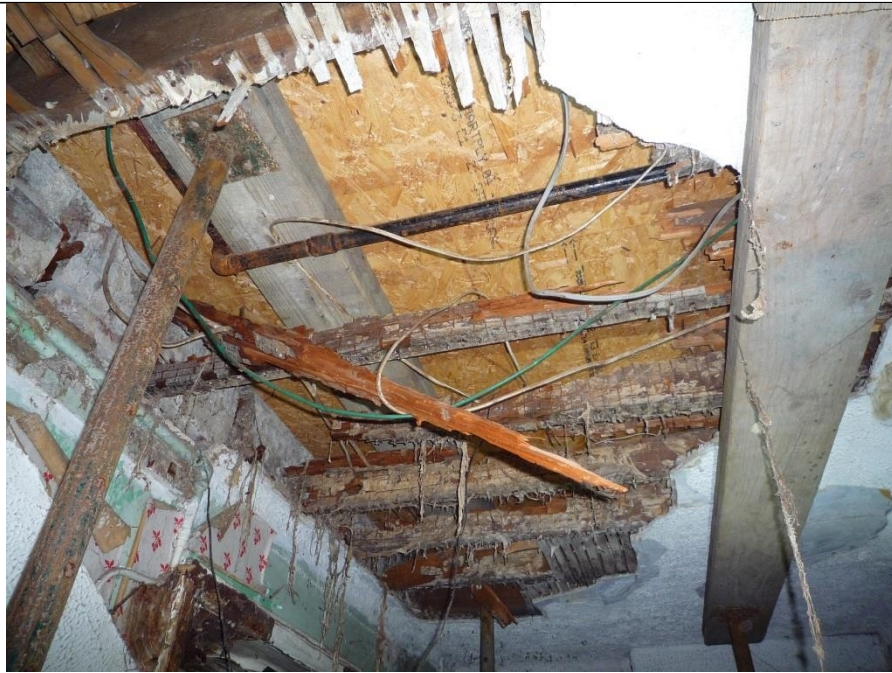
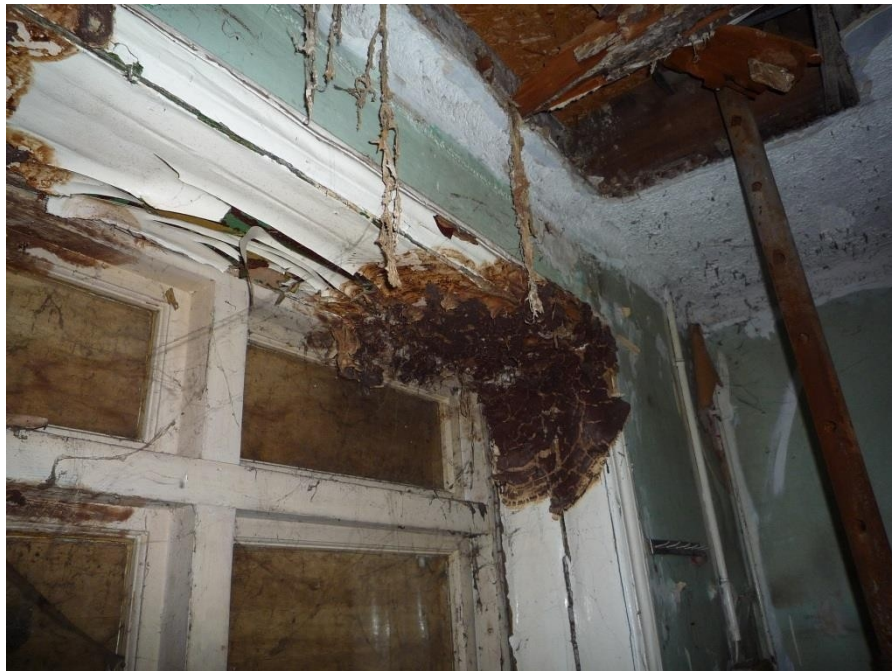
| House 4 kitchen, severe dry rot in timber floor joists, boarding and window timberwork, ceiling collapse.<br><b>Photos 11 &amp; 12</b> | Plumbing or pitched roof leaks | Investigate wall plates over whole area and check for dry rot | Replacement of all affected timberwork, specialist treatment to brickworks and local retained timberwork, reinstatement of internal finishes | Collapse of timber floor and spread of dry rot to other unaffected areas |

Picture 11 - House 4, Severe dry rot in timber floor over kitchen

Picture 12 - House 4, Severe dry rot in window timber in kitchen

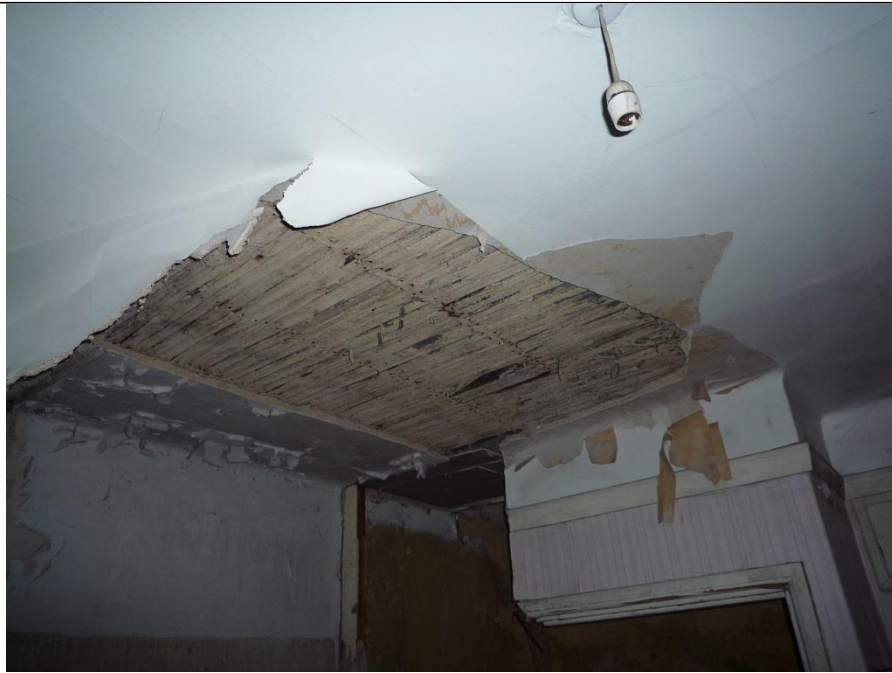
| House 4 bedroom 1, partial ceiling collapse, similar in living room.<br><b>Photo 13</b> | Debonding of plaster from supporting timber lathes, resulting from age and dampness | Check whole area for debonding and security of lathes | Replace missing plasterwork and secure retained areas | Complete collapse of ceiling |

Picture 13 – House 4, Ceiling plaster down in bedroom 1, similar in living room

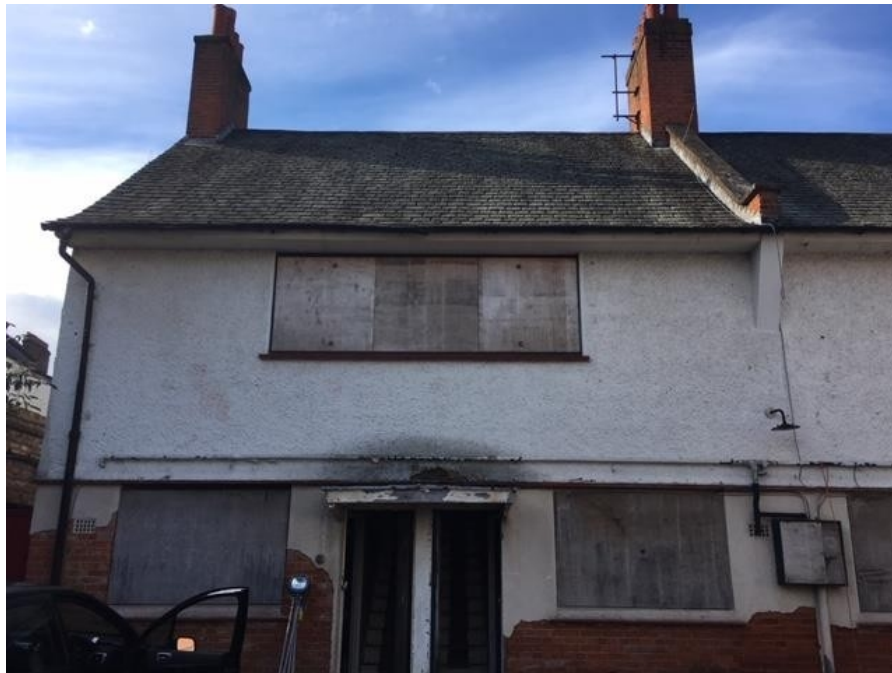
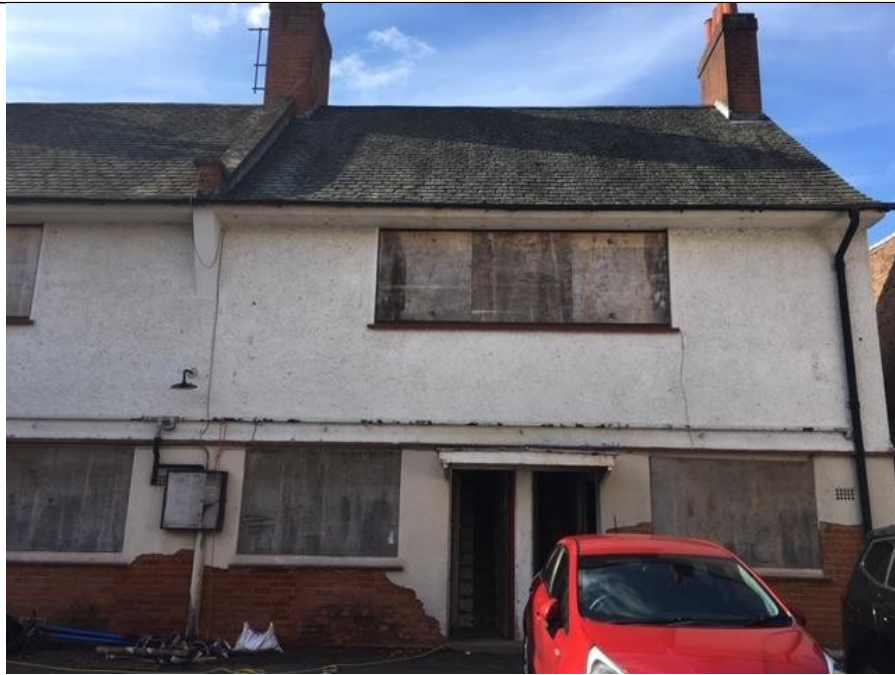
| Front elevation, large patches of L/L render fallen away.<br><b>Photos 14 &amp; 15</b> | Improper, impervious render and/or penetrating damp or interstitial condensation in brickwork causing delamination of the brickwork at low level | Arrange for a specialist to check all L/L render for soundness, the sources of damp and suitability of the brick base for re-rendering | To be agreed | Continued falling away of render, deterioration of exposed brickwork, and further internal damp problems |

Picture 14 – Houses 1 & 2, front elevation with l/l render coming away

Picture 15 – Houses 3 & 4, front elevation with l/l render coming away

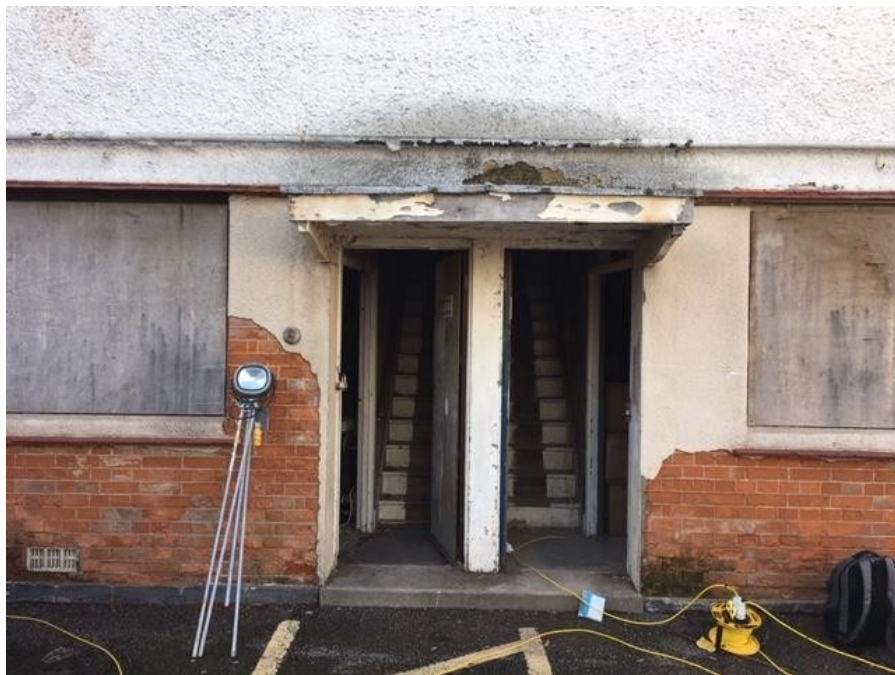
| Houses 1 & 2, timber porch leaking with probable wet rot in structure.<br>Houses 3 & 4 similar<br><b>Photo 16</b> | Leaking roof, wet rot in timber, and lack of maintenance | No | Replace timber structures and re-roof | Continued deterioration and eventual collapse |

Picture 16 – Houses 1 & 2, front doorways and dilapidated timber porch

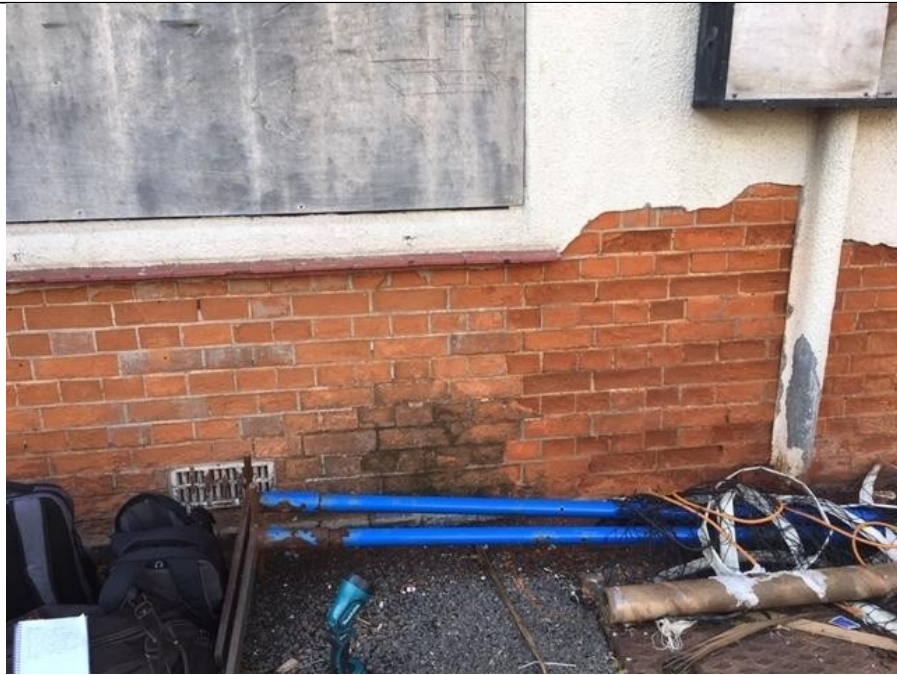
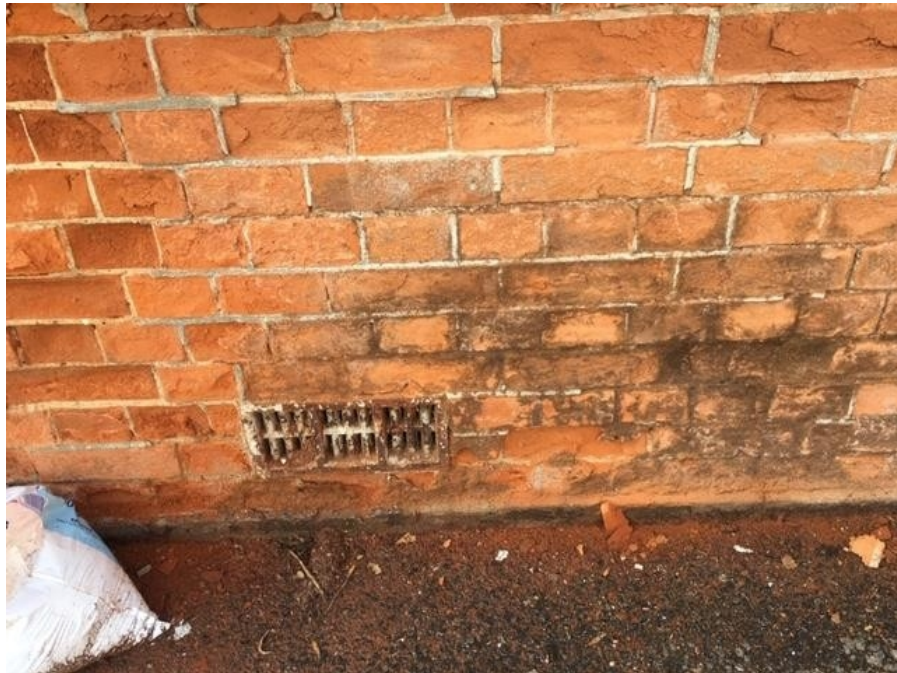
| Front elevation, large areas of L/L render fallen away, exposing dusting and unstable faces of soft red brickwork<br><b>Photos 17 &amp; 18</b> | Improper, impervious render and/or penetrating damp or interstitial condensation. causing delamination of the brickwork at low level | Arrange for a specialist to check all L/L render for soundness, and suitability of the brick base for re-rendering | To be agreed | Continued falling away of render, deterioration of exposed brickwork, and further internal damp problems |

Picture 17 – House 2, low level brickwork face powdering and delaminating on front elevation where rendering has come away.

Picture 18 – House 3, low level brickwork face powdering and delaminating on front elevation where rendering has come away.

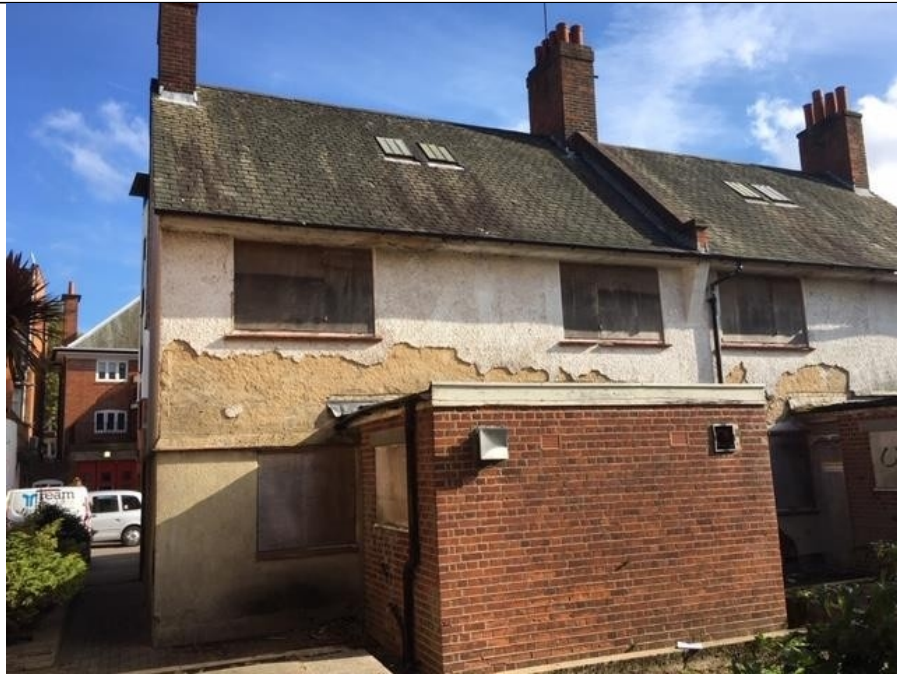
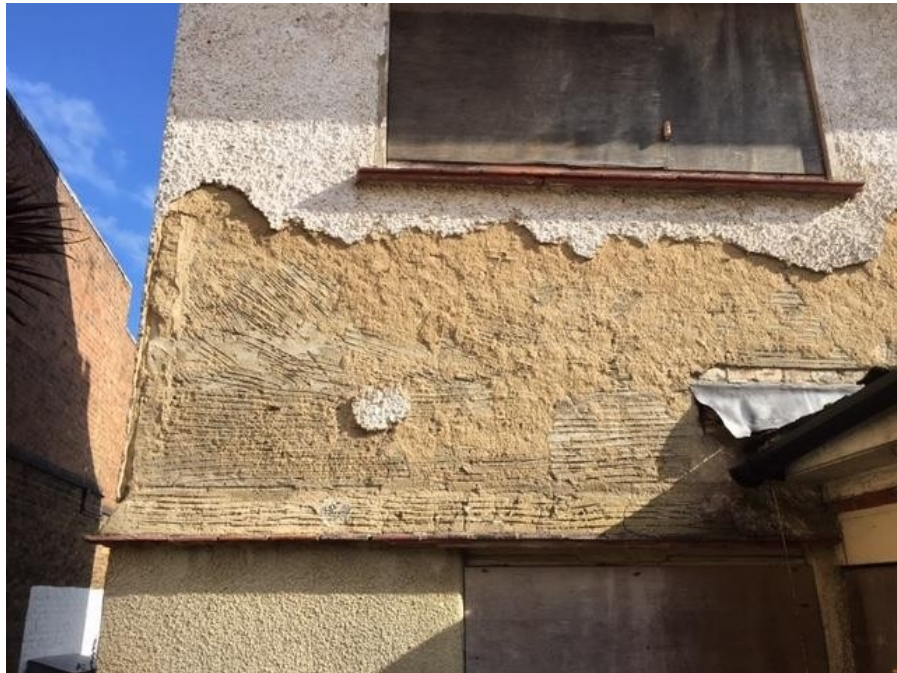
| House 4, Rear elevation with missing render at high and low levels, poor pointing on rear addition.<br><b>Photos 19 &amp; 20</b> | Improper, impervious render and/or penetrating damp at low level causing delamination of the brickwork. General wear and tear of aged render and pointing | Arrange for a specialist to check all L/L render for soundness, and suitability of the brick base for re-rendering | Low level problem and repair to be agreed. High level render repairs. Pointing repairs to rear addition | Continued falling away of render and pointing, deterioration of exposed brickwork, and further internal damp problems |

Picture 19 – Houses 3 & 4, rear addition and main house elevation with large areas of render coming away.

Picture 20 – House 4, main house rear elevation with large areas of original render coming away.

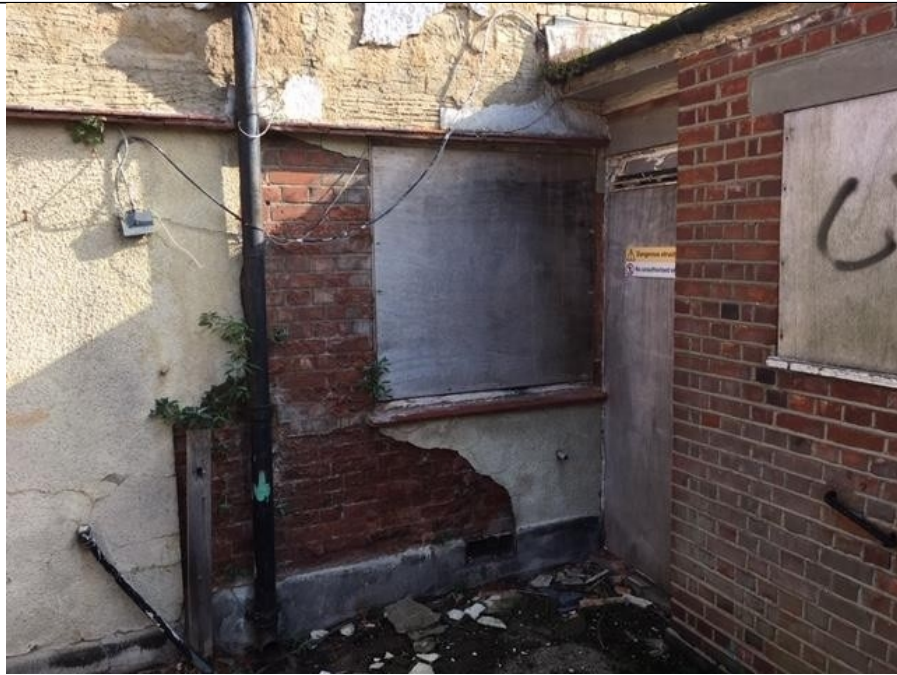
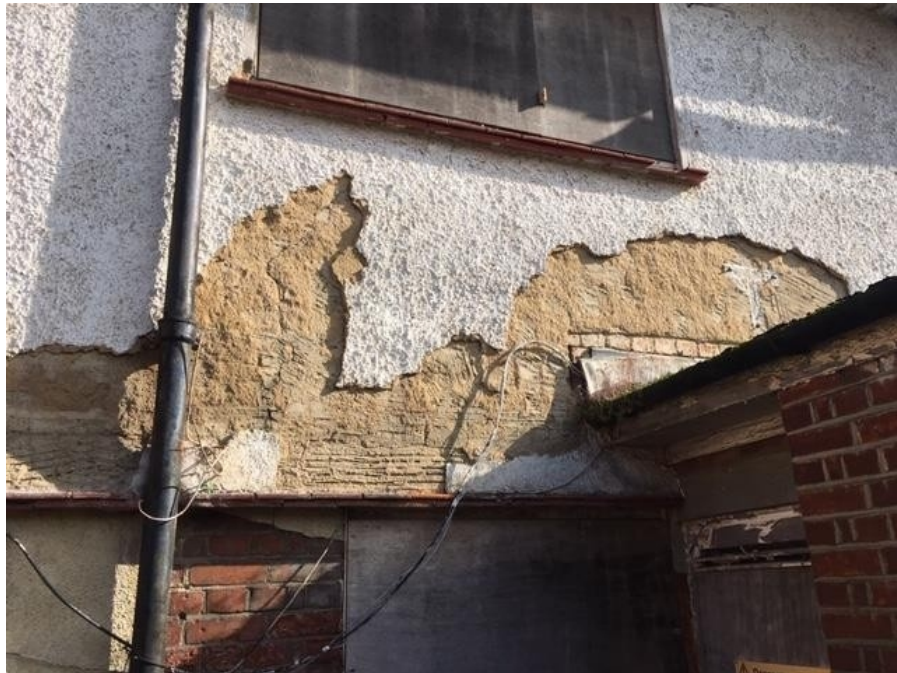
| House 2, Rear elevation with missing render at high and low levels, poor pointing on rear addition.<br><b>Photos 21 &amp; 22</b> | Improper, impervious render and/or penetrating damp or interstitial condensation. at low level causing delamination of the brickwork. General wear and tear of aged render and pointing | Arrange for a specialist to check all L/L render for soundness, and suitability of the brick base for re-rendering | Low level problem and repair to be agreed, High level render repairs. Pointing repairs to rear addition | Continued falling away of render and pointing, deterioration of exposed brickwork, and further internal damp problems |

Picture 21 - House 2, main house rear elevation with large areas of original and newer render coming away.

Picture 22 – House 2, main house rear elevation with large areas of original and render coming away.

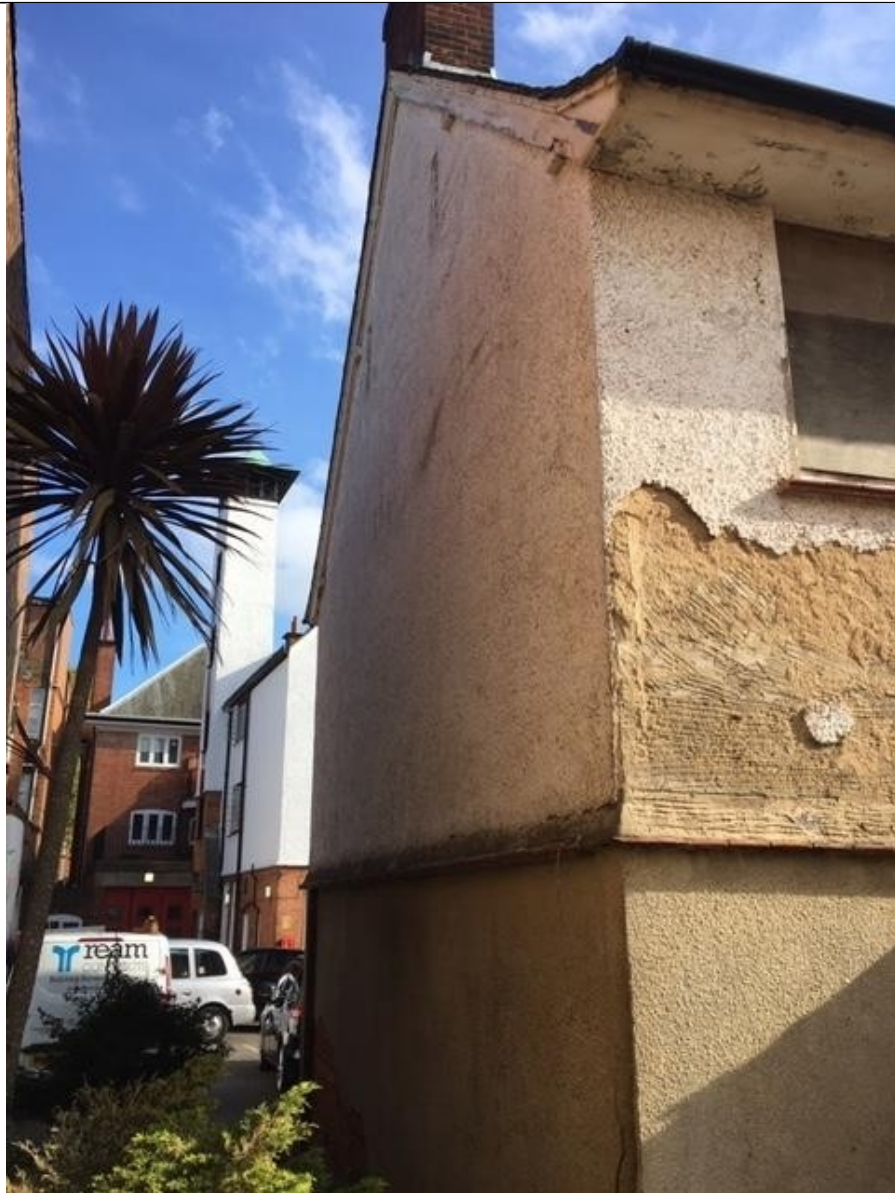
| House 4, Side gable elevation with large patches of loose and hollow render & missing render at low level. <b>Photo 23</b> | Improper, impervious render and/or penetrating damp or interstitial condensation. causing delamination of the brickwork | Arrange for specialist to check all L/L render for soundness, and suitability of the brick base for re-rendering | To be agreed | Continued falling away of render, deterioration of exposed brickwork, and further internal damp problems |

Picture 23 – House 4, Flank gable wall with loose and hollow rendering at low level and some missing render.
