**TECHNICAL REPORT ON A SUBSIDENCE CLAIM**

**46 Parliament Hill  
London  
NW3 2TL**

DATE 18 February 2019

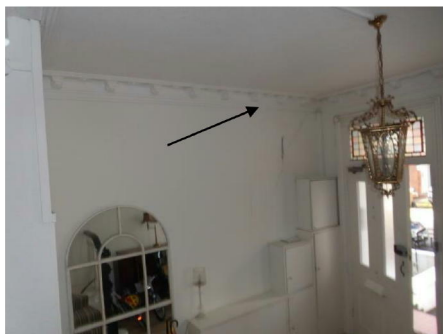
Communal hall – crack

Diagonal crack to left partition wall to flat no. 2 front lounge - full height 1 to 5mm

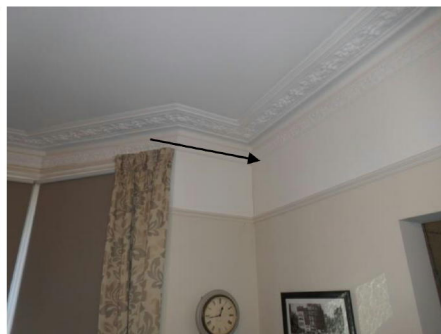
Flat 3 front lounge - crack

Vertical crack to front left corner and front wall/left partition wall corner 1 to 4mm

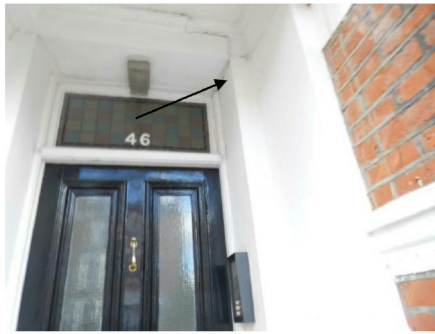
Cracks round front door

Stepped crack above right of front door 1 to 7mm

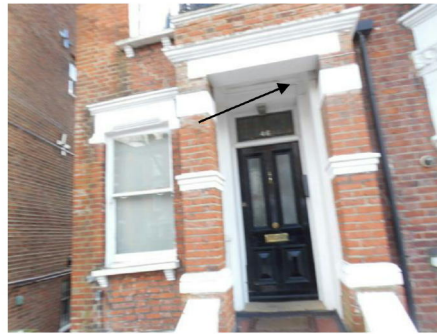
Cracks around front door

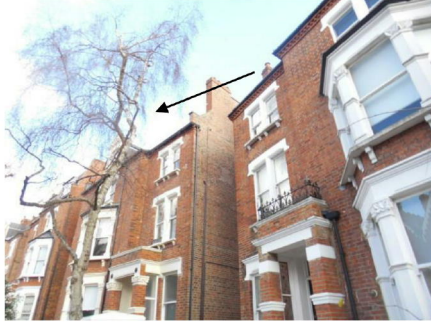
Tree T1

Type	Height	Distance	Ownership
T1 Deciduous	8 m	4 m	Owner

The timing of the event, the presence of shrinkable clay beneath the foundations and the proximity of vegetation where there is damage indicates the shrinkage to be root induced. This is a commonly encountered problem and probably accounts for around 70% of subsidence claims notified to insurers.

The cause of the movement needs to be dealt with first. We have completed a Soil Risk Analysis (VISCAT Assessment) and we are satisfied that the tree T1 (please see drawing) can be removed. We recommended tree removal works be undertaken, however we note that the property falls within a conservation area and as such our mitigation department will be in contact to discuss further.

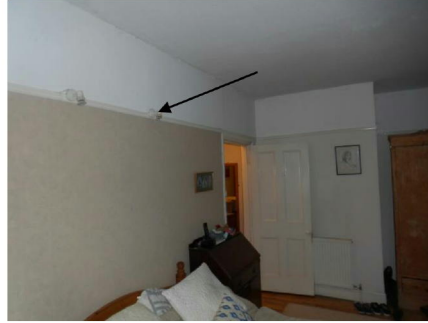
Fine cracks above dado rail - to left partition wall

Basement flat 1 – unrelated damage

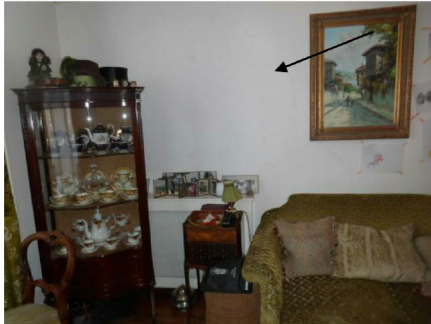
Diagonal crack to left partition wall - full height 1 to 4mm which continues across the front left of front bay structure

The pattern and nature of the cracks is indicative of an episode of subsidence. The cause of movement appears to be clay shrinkage.

Flat 2 front lounge – crack

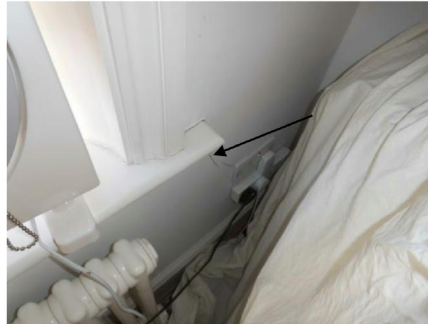
Vertical crack below rear window

Flat 3 rear bedroom – unrelated damage
